# **ARBORICULTURAL TREE HEALTH & HAZARD ASSESSMENT**

**TreeTop Adventure Park  
Yarra Flats  
IVANHOE EAST VIC 3079**

**prepared by  
Russell Kingdom  
Qualified AQF5 Arboriculturist**

31/08/2018

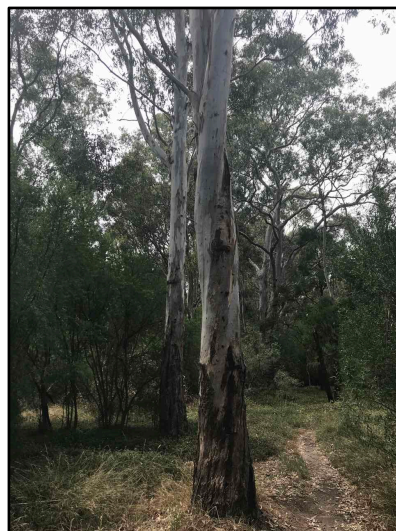
Figure 2: Tree 2 & 3.

**Tree 3** is a *E. camaldulensis* (River Red Gum). This tree is mature, in good health and structural condition. There is small deadwood present. It passes the VTA. Hazard rating is 4. SULE is 2B.

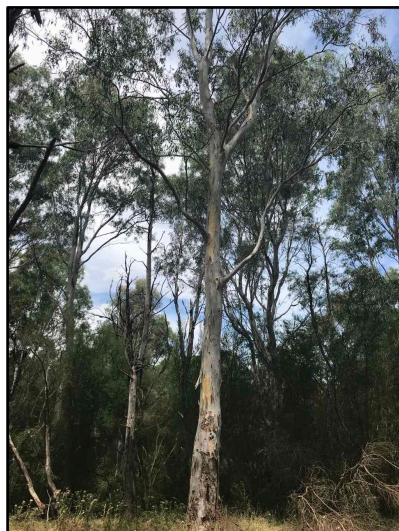
Figure 4: Tree 25.

**Tree 25** is a *E. camaldulensis* (River Red Gum). This tree is mature, in good health and fair structural condition. There is an inclusive main fork union, small deadwood and a tropism to the East.

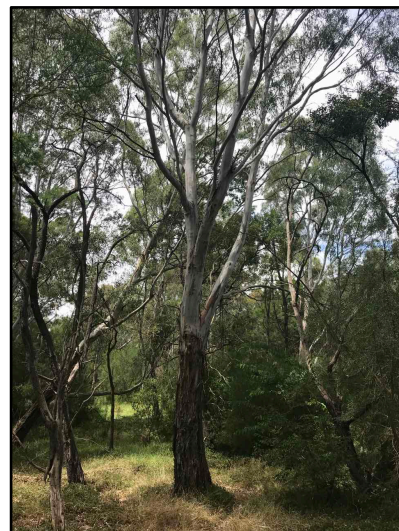
Figure 5: Tree 26.

**Tree 26** is a *E. camaldulensis* (River Red Gum). This tree is very mature, in good health and structural condition. There are small trunk wounds (scars?). It passes the VTA. Hazard rating is 6. SULE is 2B.

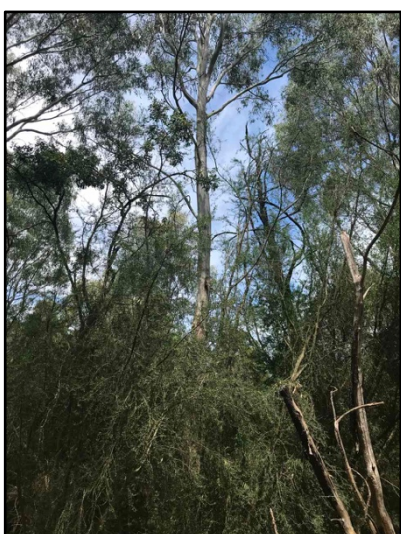
Figure 6: Tree 27.

**Tree 27** is a *E. camaldulensis* (River Red Gum). This tree is mature, in good health and structural condition. There is small deadwood present. The tree is located on a bank. It passes the VTA. Hazard rating is 4. SULE is 2B.

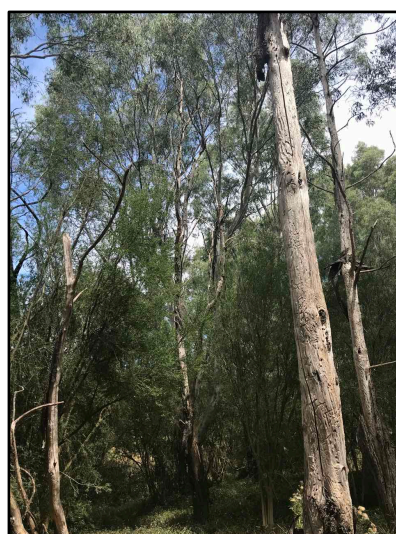
Figure 7: Tree 1.

**Tree 1** is a *Eucalyptus camaldulensis* (River Red Gum). This tree is mature, in good health and very good structural condition. It is co-dominant at 6 metres. There is small deadwood, epicormics and a previous failure site. It passes the VTA. Hazard rating is 5. SULE is 2B.

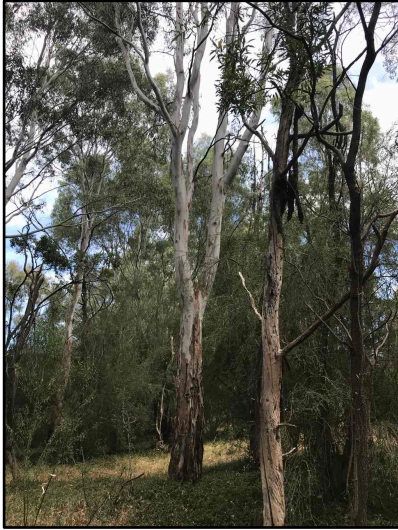
Figure 8: Tree 23.

**Tree 23** is a *E. camaldulensis* (River Red Gum). This tree is mature, co-dominant, in good health and structural condition. There is a tropism to the north. It passes the VTA. Hazard rating is 5. SULE is 2B.

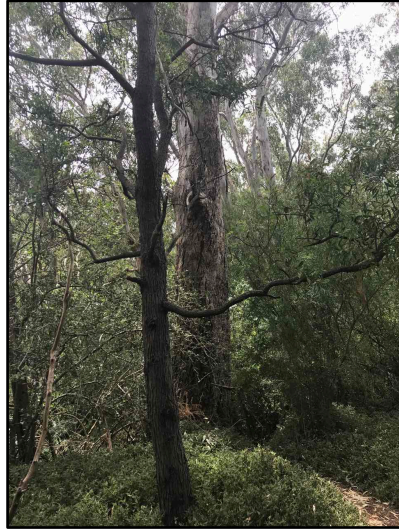
Figure 9: Tree 24.

**Tree 24** is a *E. camaldulensis* (River Red Gum). This tree is young mature, in good health and structural condition. There is small deadwood present and some trunk lesions. It passes the VTA. Hazard rating is 4. SULE is 2B.

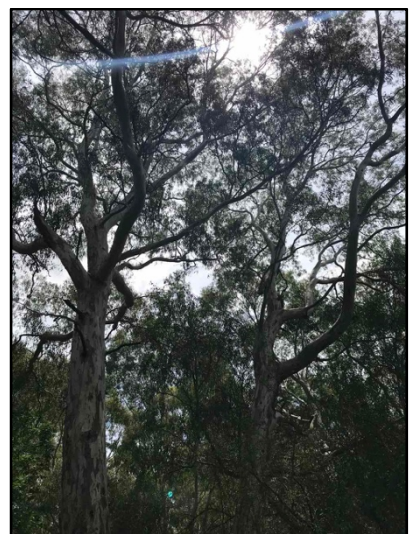
Figure 15: Tree 58.

**Tree 58** is a *E. camaldulensis* (River Red Gum). This tree is young mature, in good health and structural condition. There is small deadwood present. It passes the VTA. Hazard rating is 4. SULE is 2B.

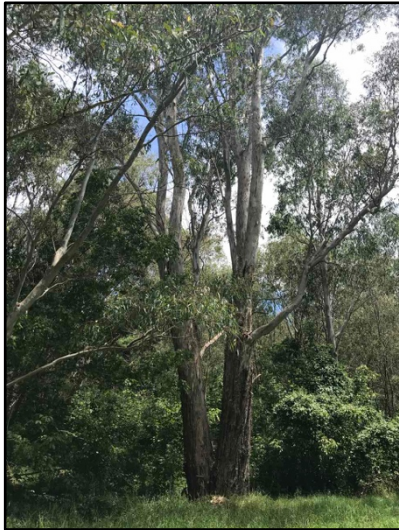
**Tree 56** is a *E. camaldulensis* (River Red Gum). This tree is very mature, in good health and structural condition. There is small deadwood present. It passes the VTA. Hazard rating is 4. SULE is 2B.

Figure 16: Tree 56. This tree is in very good condition.

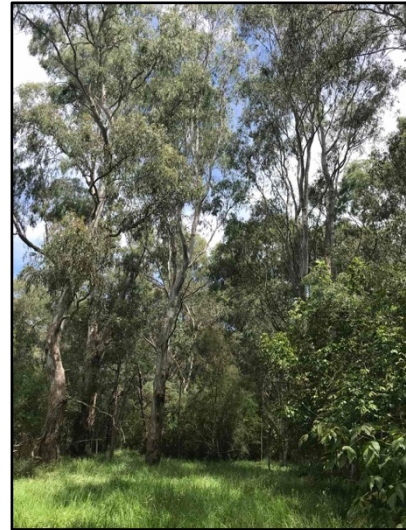
**Tree 53** is a *E. camaldulensis* (River Red Gum). This tree is a young mature, in good health and structural condition. There is an inclusive fork union and small deadwood present. It passes the VTA. Hazard rating is 4. SULE is 2B.

**Tree 54** is a *E. camaldulensis* (River Red Gum). This tree is mature, in good health and fair structural condition. There is a hollow at 3 metres and small deadwood present.

**Tree 55** is a *E. camaldulensis* (River Red Gum). This tree is a young mature, in good health and structural condition. There is a tropism to the south. There is leaf damage and evidence of chewing mouthpiece insects present. It passes the VTA. Hazard rating is 4. SULE is 2B.

Figure 17: Tree 53, 54, 55 & 56. These trees are all in good condition with no issues.

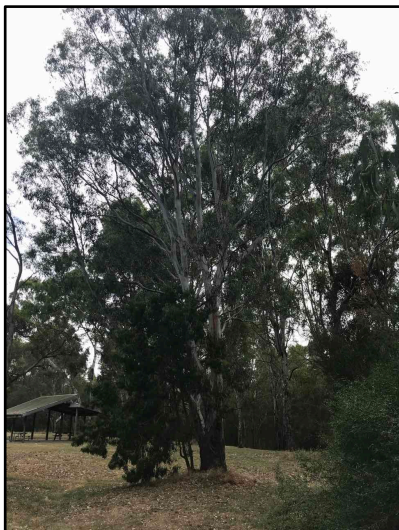
Figure 18: Tree 52.

**Tree 52** is a *E. camaldulensis* (River Red Gum). This tree is mature, in good health and structural condition. There is a tropism to the east, a previous failure site and trunk lesions. It passes the VTA. Hazard rating is 4. SULE is 2B.

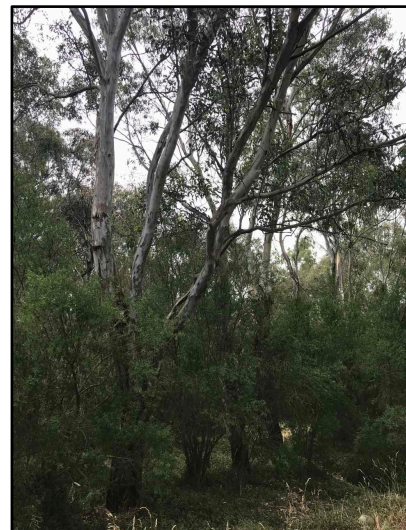
Figure 19: Tree 44, 45 & 46.

**Tree 46** is a *E. camaldulensis* (River Red Gum). This tree is mature, in good health and structural condition. There is small deadwood present. It passes the VTA. Hazard rating is 4. SULE is 2B.

**Tree 45** is a *E. camaldulensis* (River Red Gum). This tree is a young mature, in good health and fair structural condition. There is small deadwood present. It passes the VTA. Hazard rating is 4. SULE is 2B.

**Tree 44** is a *E. camaldulensis* (River Red Gum). This tree is mature, in good health and structural condition. There is a tropism to the south. It passes the VTA. Hazard rating is 4. SULE is 2B.

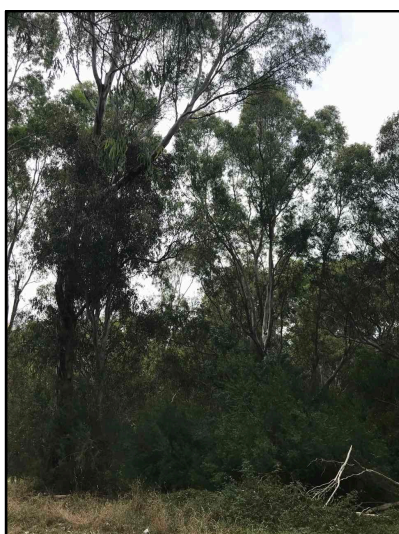
Figure 20: Tree 51 & 50.

**Tree 50** is a *E. camaldulensis* (River Red Gum). This tree is a young mature, in good health and structural condition. There is small deadwood and a previous failure site. It passes the VTA. Hazard rating is 4. SULE is 2B.

**Tree 51** is a *E. camaldulensis* (River Red Gum). This tree is mature, in good health and structural condition. It passes the VTA. Hazard rating is 4. SULE is 2B.

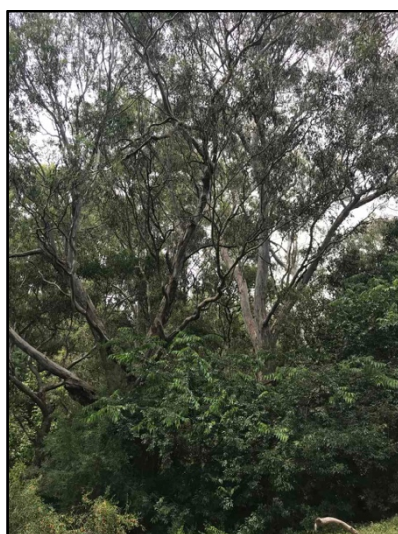
Figure 21: Tree 48 & 47.

**Tree 47** is a *E. camaldulensis* (River Red Gum). This tree is mature, co-dominant in good health and structural condition. There is a 5° trunk lean to the west and small deadwood present. The big leader is being used. It passes the VTA. Hazard rating is 4. SULE is 2B.

**Tree 48** is a *E. camaldulensis* (River Red Gum). This tree is mature, co-dominant, in good health and structural condition. There is small deadwood present. It passes the VTA. Hazard rating is 4. SULE is 2B.

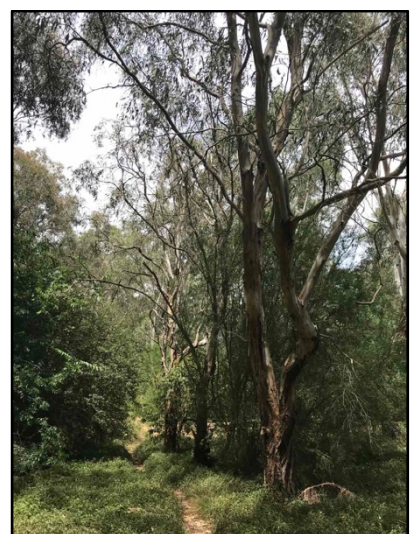
Figure 22: Tree 42, 41 & 49.

**Tree 41** is a *E. camaldulensis* (River Red Gum). This tree is mature, in good health and structural condition. It has small and large deadwood. It passes the VTA. Hazard rating is 4. SULE is 2B.

**Tree 42** is a *E. camaldulensis* (River Red Gum). This tree is mature, in good health and structural condition. It has small deadwood and trunk lesions. It passes the VTA. Hazard rating is 4. SULE is 2B.

**Tree 49** is a *E. camaldulensis* (River Red Gum). This tree is very mature, in good health and fair structural condition. There is a failure at 4 metres, decay, termites and an unbalanced canopy. It passes the VTA. Hazard rating is 6. SULE is 2B.
