Warringal Park Facility Audit

Document number	000208
Client / Site	Tennis Victoria
Location	Plymouth Street Heidelberg VIC 3084
Auditor	Andrew Sodomaco
Audit date	28 Aug 2015

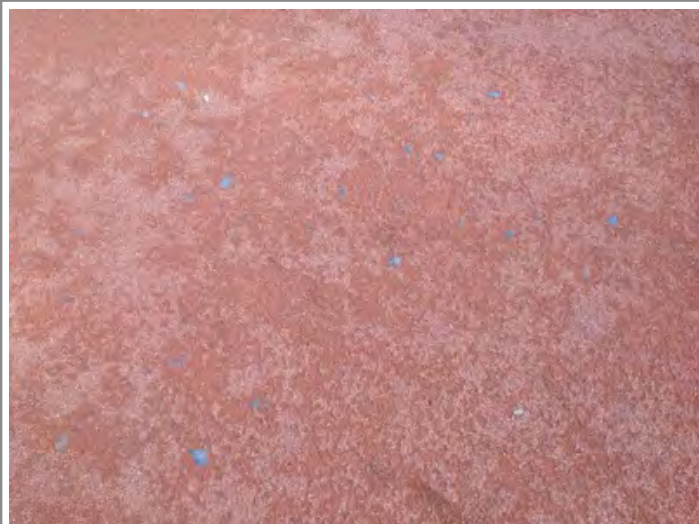
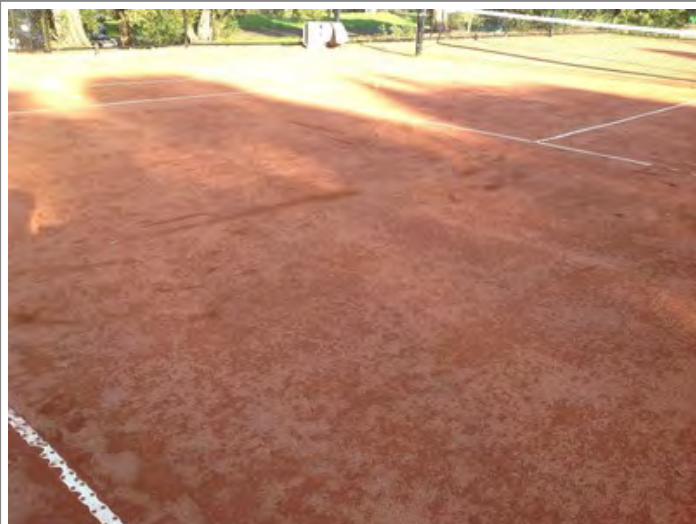
Unique court number	1
Surface condition rating	Moderate Issues/Observations: Aged surface Excessively worn surface in high wear areas
Surface type	Red Porous
Surface life span	6-10 years
Court condition notes	This court is well worn and there is multiple areas of aggregate base showing through the surface.

Are there any critical safety issues?	No
Enclosure recommendations	In the long term, plan for the replacement of the court surface. In the short term, maintain supporting infrastructure by trimming vegetation from fencelines as appropriate.

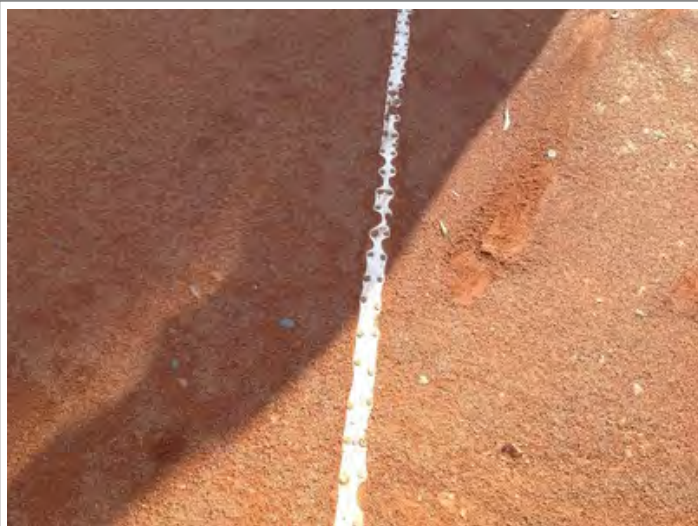
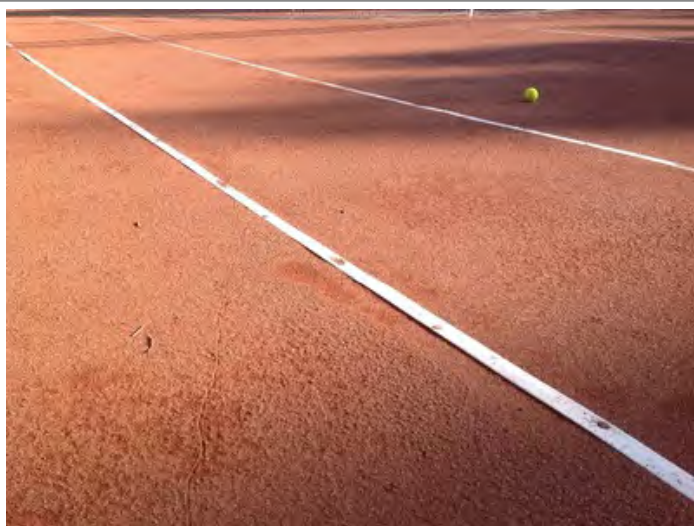
Line marking rating	Poor
	Issues/Observations: Cracked Trip hazard Inconsistent bounce likely
Line marking condition notes	Standard lines on this court are aged and cracking in multiple areas. Some lines present a trip hazard.

Court	Trim trees/shrubs away from court enclosure and fencing Repair lines
Drainage	
Infrastructure	Trim vegetation away from fencing
Lighting	Conduct a lighting lux level test

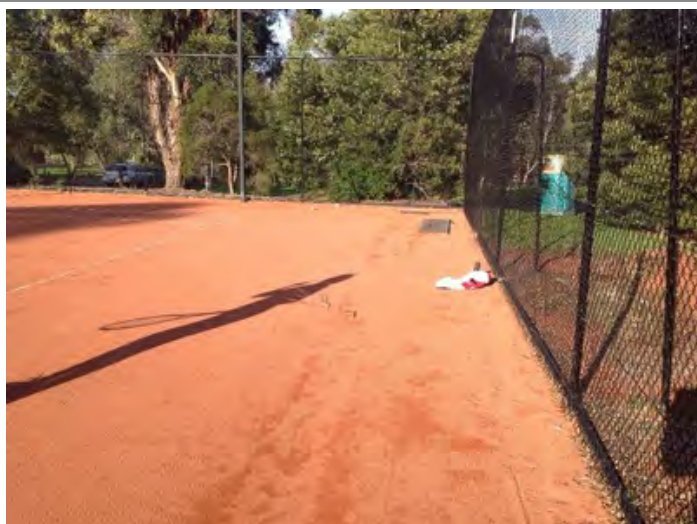
Could the court be made compliant?	no
Is the court to the standard dimensions?	yes
Court orientation	North-south
Are netball goal posts outside tennis court run off areas?	no
Are lockable post hole covers fitted and safe?	no
Compliance notes	The court is not run off compliant to the north and south behind the baselines.
Compliance photos

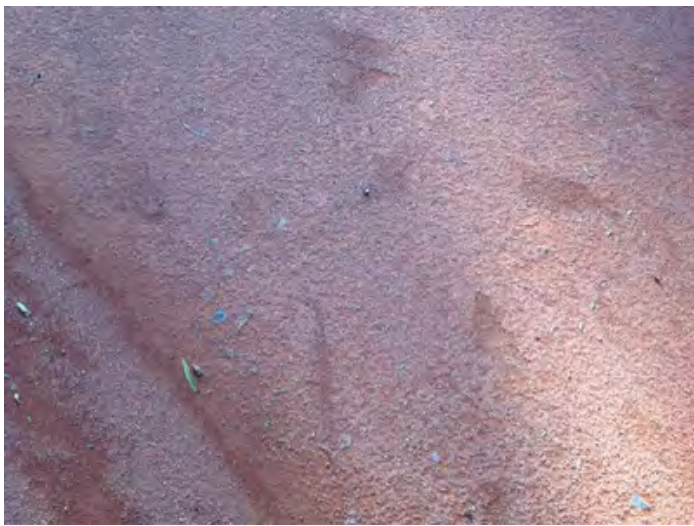
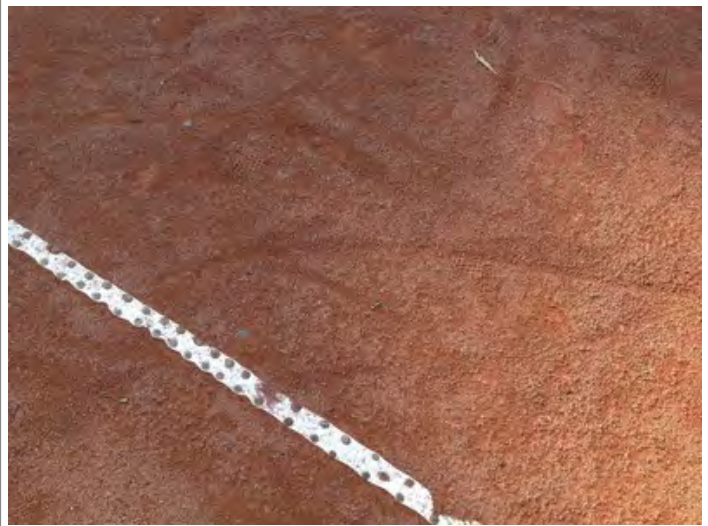
Unique court number	2
Surface condition rating	Moderate Issues/Observations: Aged surface Excessively worn surface in high wear areas
Surface type	Red Porous
Surface life span	6-10 years
Court condition notes	This court is well worn and there is multiple areas of aggregate base showing through the surface.

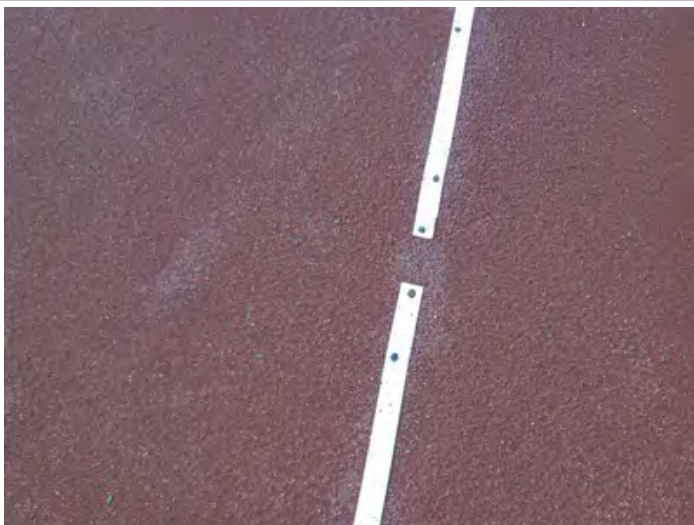
Line marking description	Tennis only lines
Line marking rating	Poor Issues/Observations: Cracked Trip hazard Inconsistent bounce likely
Line marking condition notes	Standard lines on this court are aged and cracking in multiple areas. Some lines present a trip hazard.

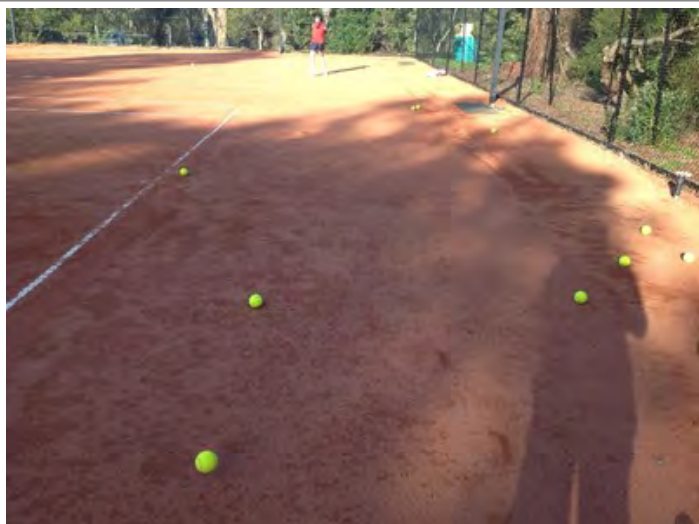
Is the court run off compliant?	no Runoffs North: 4800m South: 4700m East: 3600m West: 3600m
Could the court be made compliant?	no
Is the court to the standard dimensions?	yes
Court orientation	North-south
Are netball goal posts outside tennis court run off areas?	no
Are lockable post hole covers fitted and safe?	no
Compliance notes	The court is not run off compliant to the north and south behind the baselines.

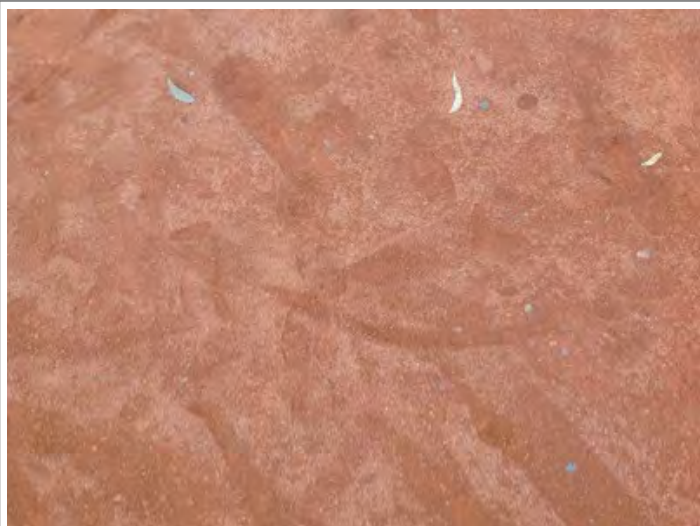
Surface condition rating	Moderate
	Issues/Observations: Aged surface
Surface type	Red Porous
Surface life span	6-10 years
Court condition notes	This court is well worn and there is multiple areas of aggregate base showing through the surface. It appears slightly more damp, and this may be due to the bank of trees to the side of the enclosure and the shade they provide.

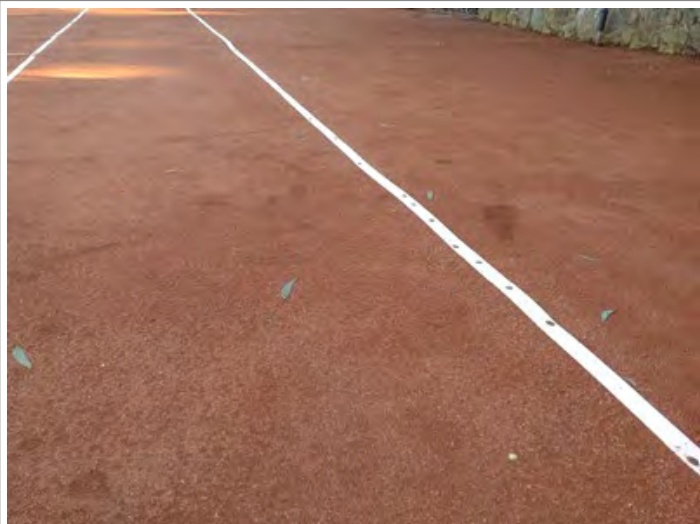
Line marking description	Tennis only lines
Line marking rating	Poor
	Issues/Observations: Cracked Trip hazard
Line marking condition notes	Standard lines on this court are aged and cracking in multiple areas. Some lines present a trip hazard.

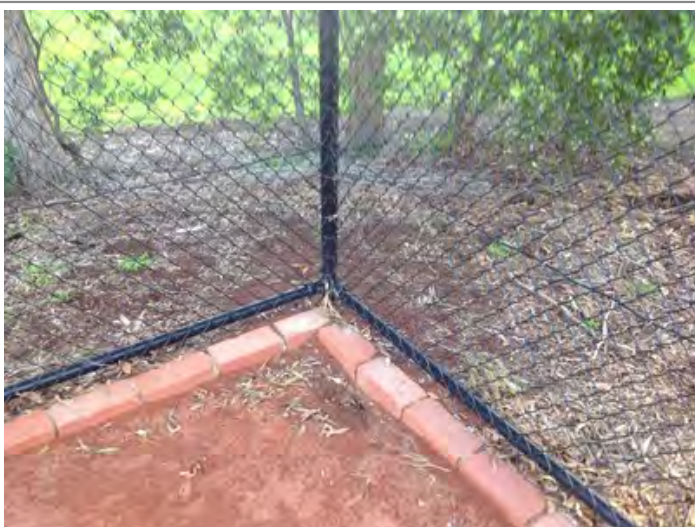
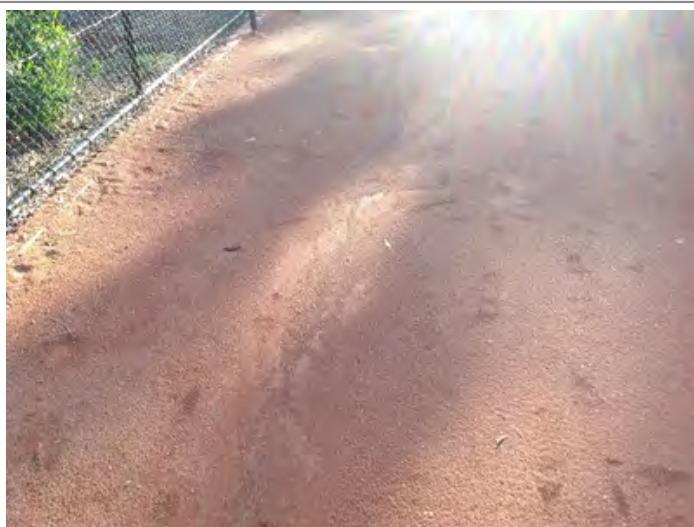
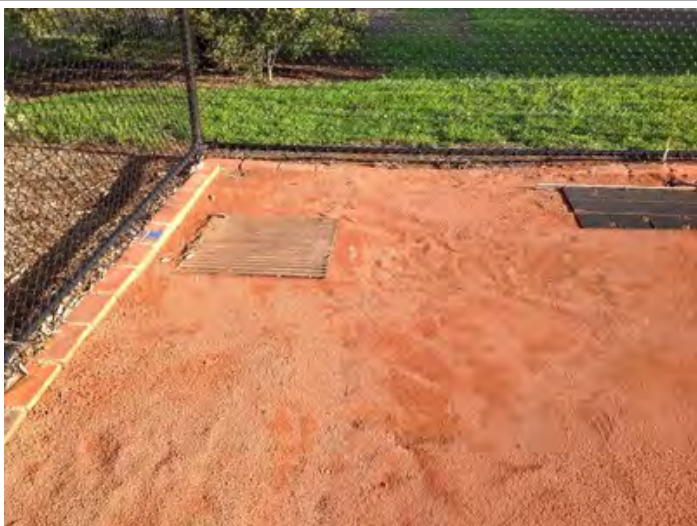
Drainage infrastructure	Formed
What type of drainage is in place?	Grated pit(s)
Are drains, pits or other infrastructure provided within the court enclosure?	yes
Are drains, pits or other infrastructure provided within the run-off areas?	yes
Drainage rating	Good
	Issues/Observations: Ponding evident Leaf litter build up
Drainage notes	A grated pit exists in the south eastern corner of the enclosure. There are some ruts along the southern end of the court where water appears to flow into the grated pit, although this is not extensive. Water appears to drain into the south western corner as well, although there is no drain in this location.

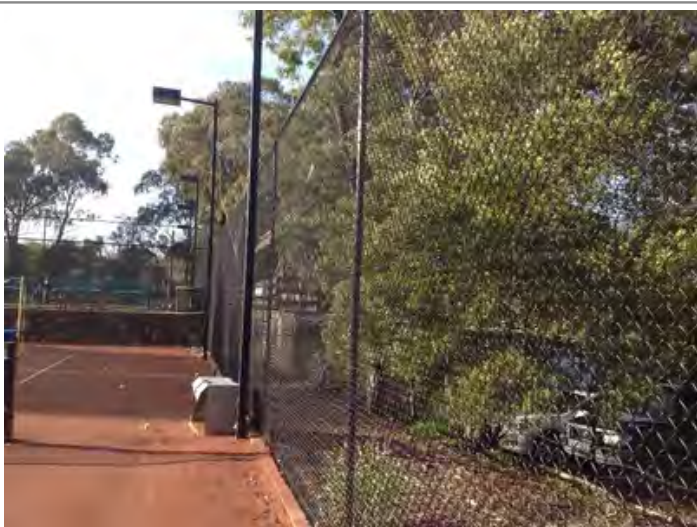
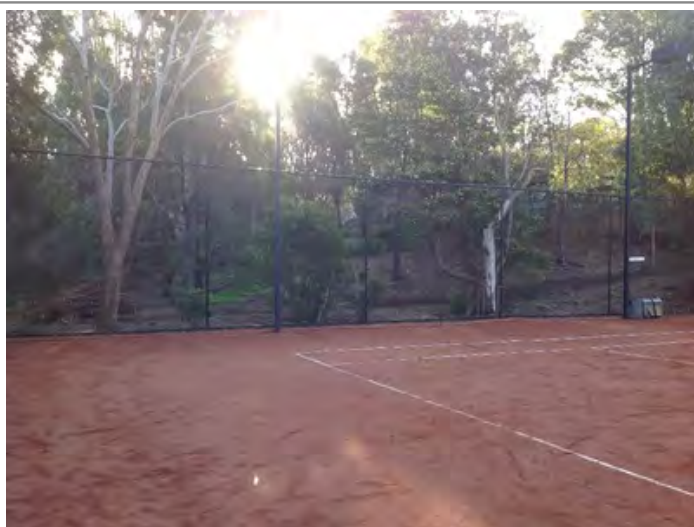
Fence type	Black PVC chain mesh
Fence Rails	Fence rail top: yes Fence rail bottom: yes
Fence height	3m to 3.5m Low level side fencing installed: no
Fence attachments	There are no fence attachments.
Fence condition rating	Very Good Issues/Observations: Trees overhanging enclosure Trees/shrubs growing through mesh
Fencing life span	10+ years
Fence notes	All fencing appears in very good condition. There are some trees close to the enclosure which will need to be trimmed periodically. The stone retaining wall at the baseline of the northern end of the court appears to be stable.

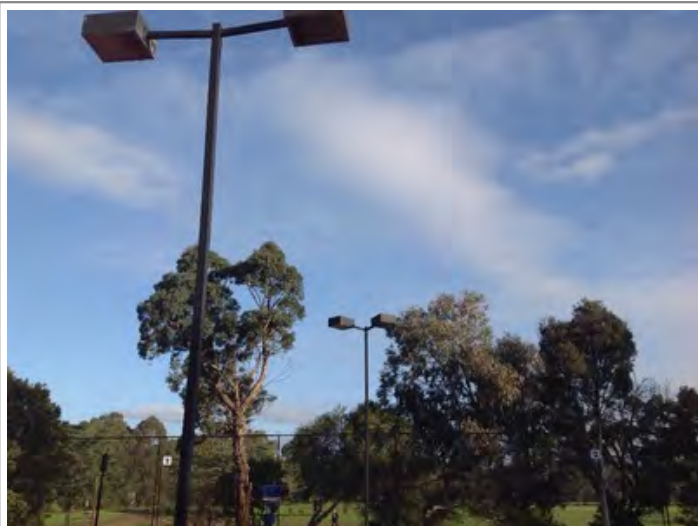
Does this enclosure have lighting	Yes
Total number of lit courts per enclosure	3
Lighting infrastructure type	Black powder coated low level - Steel poles
Lighting infrastructure position	Side
Light fittings	One per tower
Lighting infrastructure design	Standard
Lighting infrastructure rating	Good Issues/Observations: Infrastructure and fittings in very good condition - likely to achieve required lux standards
Lighting life span	10+ years
Lighting notes	The lighting appears to be quite new, although there are a couple of small spots where paint has peeled from the light box.

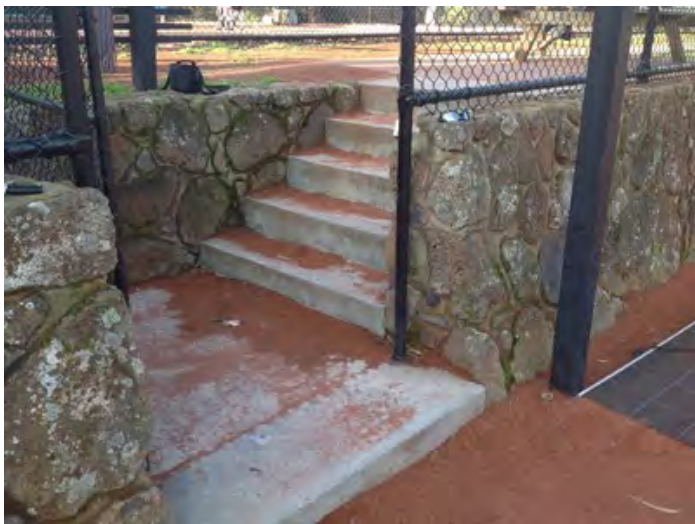
Court enclosure accessibility	Formed paths Trip hazards identified: yes Ramped access provided: no
Path material(s)	Concrete
Main gate dimensions	Standard pedestrian gate 1000mm x 2100mm
Accessibility notes	Steps are provided from down the path on to the court surface.

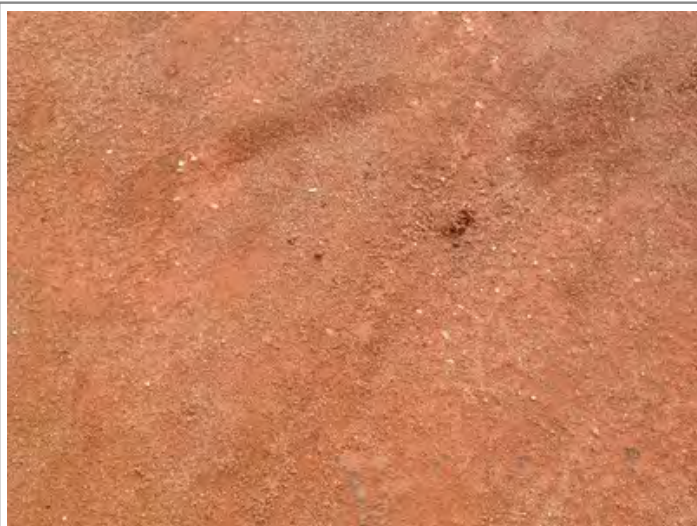
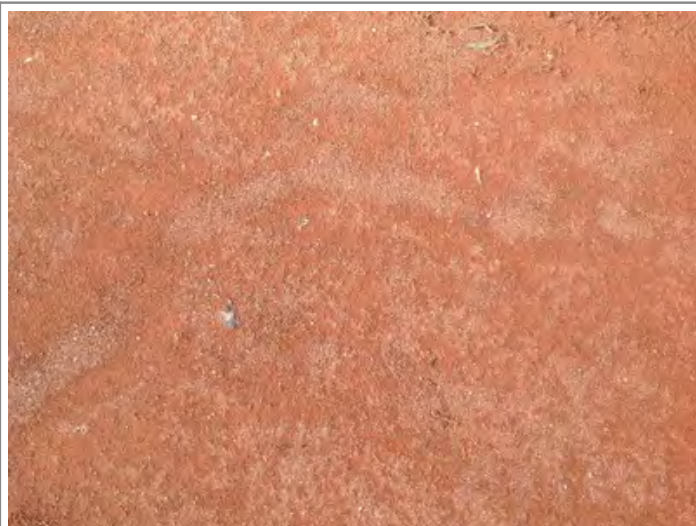
Unique court number	4
Surface condition rating	Moderate Issues/Observations: Aged surface Excessively worn surface in high wear areas
Surface type	Red Porous
Surface life span	6-10 years
Court condition notes	This court is well worn and there is multiple areas of aggregate base showing through the surface. The courts in this enclosure appear to be of similar age to those in enclosure one.

Are there any critical safety issues?	No
Enclosure recommendations	Plan for replacement of the surface in the long term. Trim branches that are overhanging the fence line.

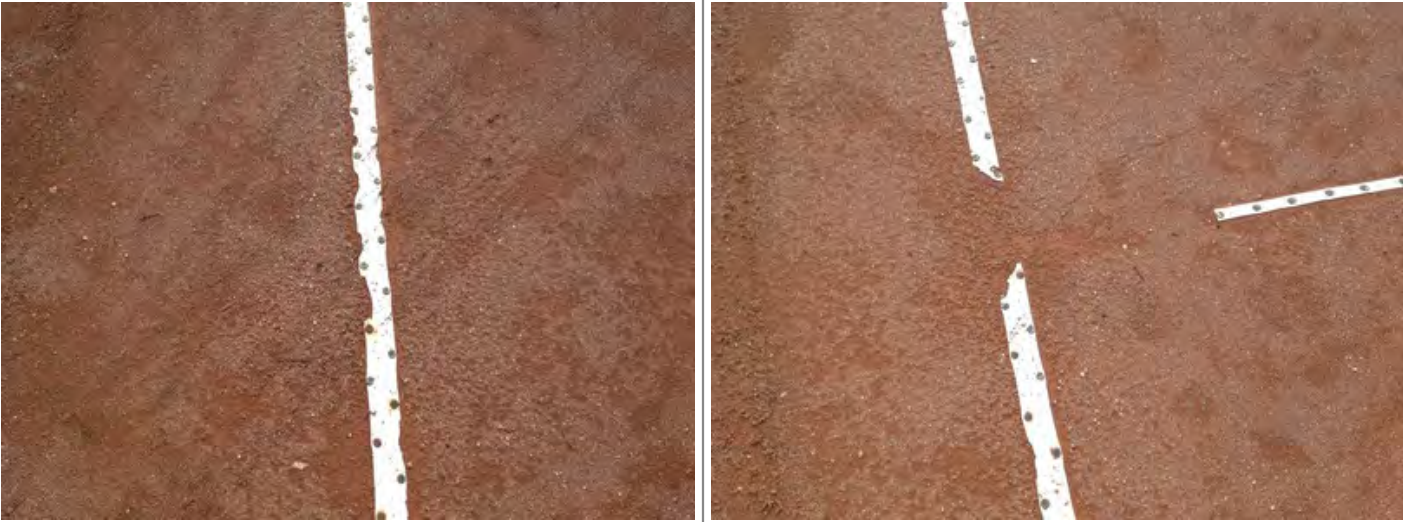
Line marking rating	Poor
	Issues/Observations: Cracked Trip hazard Inconsistent bounce likely
Line marking condition notes	Standard lines on this court are aged and cracking in multiple areas. Some lines present a trip hazard.
Line marking condition photos

Court	Trim trees/shrubs away from court enclosure and fencing Repair lines
Drainage	
Infrastructure	Trim vegetation away from fencing
Lighting	Conduct a lighting lux level test

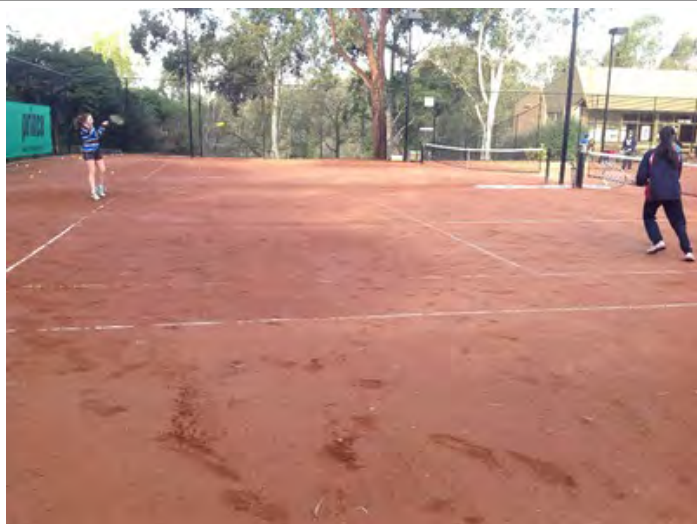
Unique court number	5
Surface condition rating	Moderate Issues/Observations: Aged surface Excessively worn surface in high wear areas
Surface type	Red Porous
Surface life span	6-10 years
Court condition notes	This court is well worn and there is multiple areas of aggregate base showing through the surface.

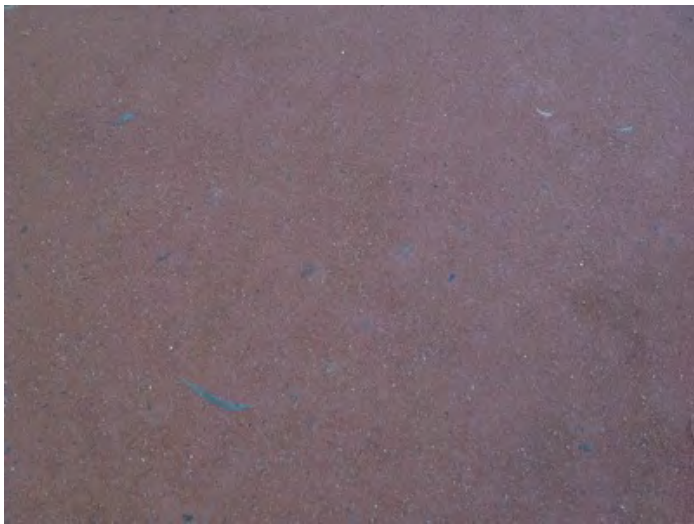
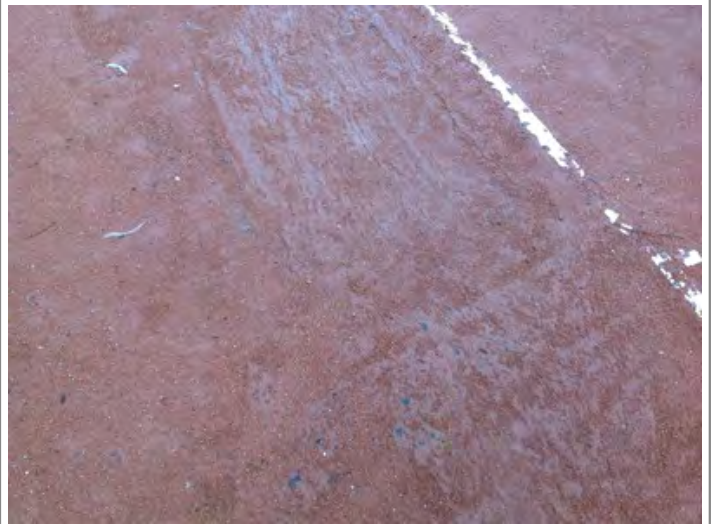
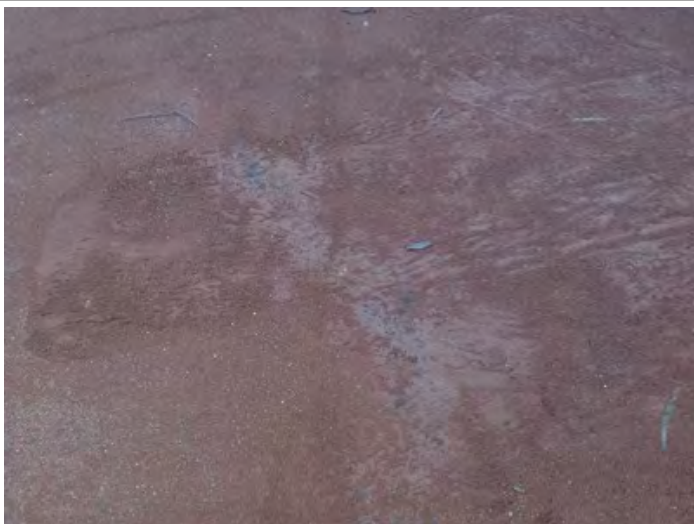
Unique court number	6
Surface condition rating	Moderate Issues/Observations: Aged surface Excessively worn surface in high wear areas
Surface type	Red Porous
Surface life span	6-10 years
Court condition notes	This court is well worn and there is multiple areas of aggregate base showing through the surface. On the day of inspection this court was the only one not in use and appears to have suffered from sever puddling across the surface which has been attempted to be soaked up.

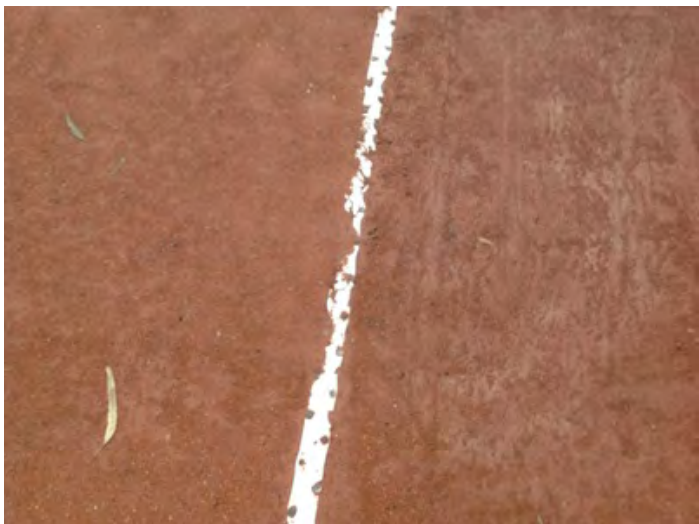
Line marking rating	Poor
	Issues/Observations: Cracked Inconsistent bounce likely
Line marking condition notes	Standard lines on this court are aged and cracking in multiple areas. Some lines present a trip hazard.
Line marking condition photos

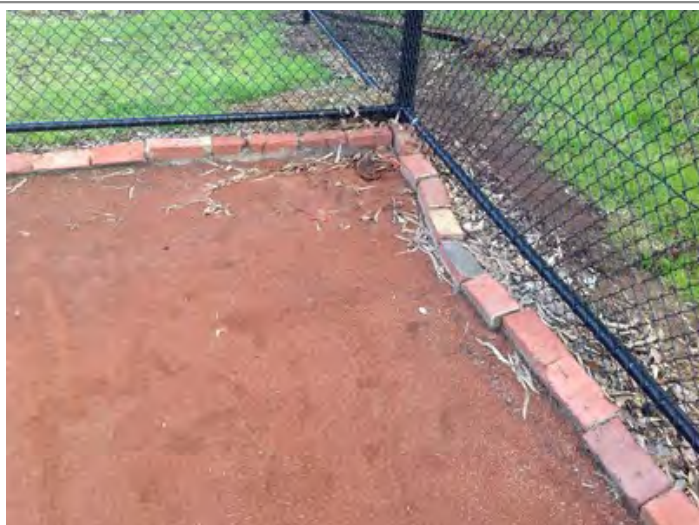
Drainage infrastructure	Formed
What type of drainage is in place?	Grated pit(s)
Are drains, pits or other infrastructure provided within the court enclosure?	yes
Are drains, pits or other infrastructure provided within the run-off areas?	yes
Drainage rating	Good
	Issues/Observations: Ponding evident
Drainage notes	There is a small grated pit in the south western corner which would likely be inadequate to service the entire enclosure. The northern end of the enclosure is quite wet and appears to not drain as effectively as the southern end. Court six is quite wet, in particular.

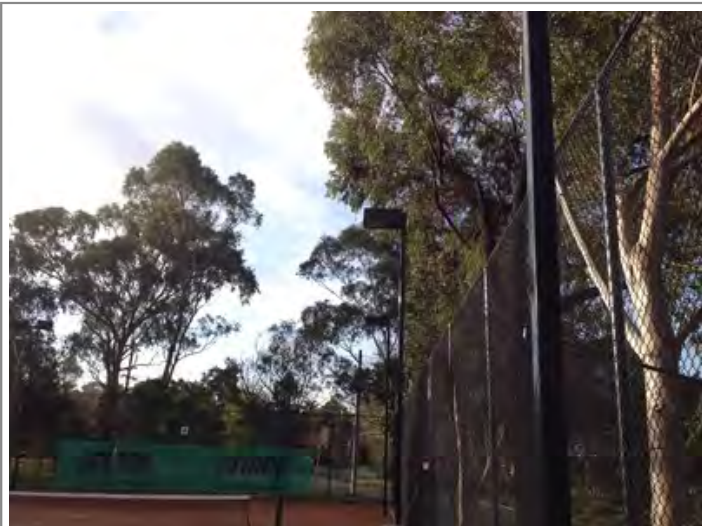
Fence type	Black PVC chain mesh
Fence Rails	Fence rail top: yes Fence rail bottom: yes
Fence height	3m to 3.5m Low level side fencing installed: no
Fence attachments	There are no fence attachments.
Fence condition rating	Very Good Issues/Observations: Trees overhanging enclosure Trees/shrubs growing through mesh
Fencing life span	10+ years
Fence notes	All fencing appears in very good condition. There are some trees overhanging the enclosure which will need to be trimmed periodically.

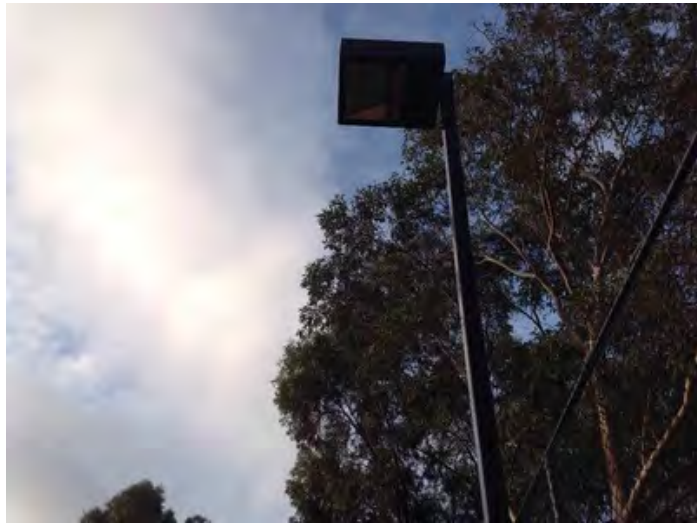
Does this enclosure have lighting	Yes
Total number of lit courts per enclosure	3
Lighting infrastructure type	Black powder coated low level - Steel poles
Lighting infrastructure position	Side
Light fittings	One per tower
Lighting infrastructure design	Standard
Lighting infrastructure rating	Good Issues/Observations: Infrastructure and fittings in very good condition - likely to achieve required lux standards
Lighting life span	10+ years
Lighting notes	The lighting appears to be quite new, although there are a couple of small spots where paint has peeled from the light box.

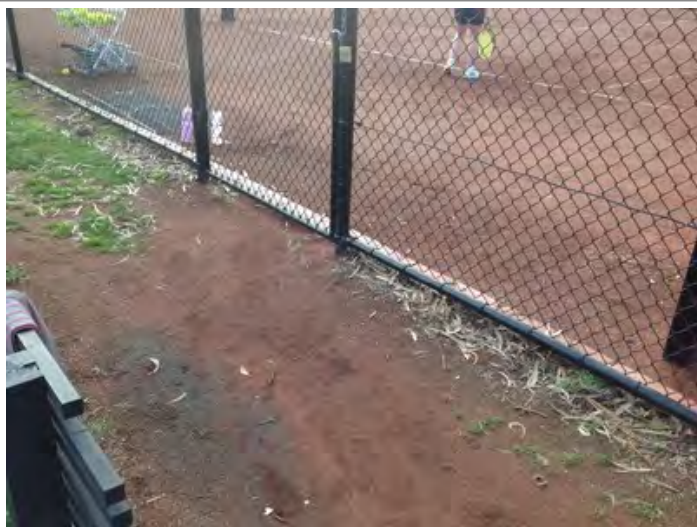
Court enclosure accessibility	Formed paths Trip hazards identified: yes Ramped access provided: no
Path material(s)	Concrete
Main gate dimensions	Standard pedestrian gate 1000mm x 2100mm
Accessibility notes	Access provided through grass and gravel from the concrete path.

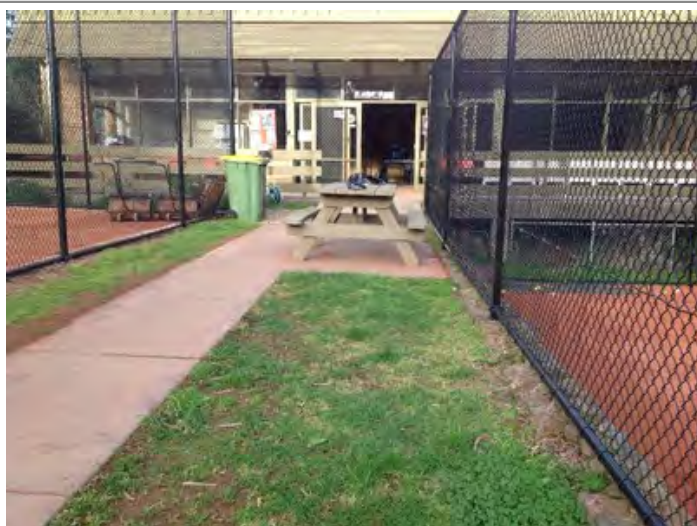
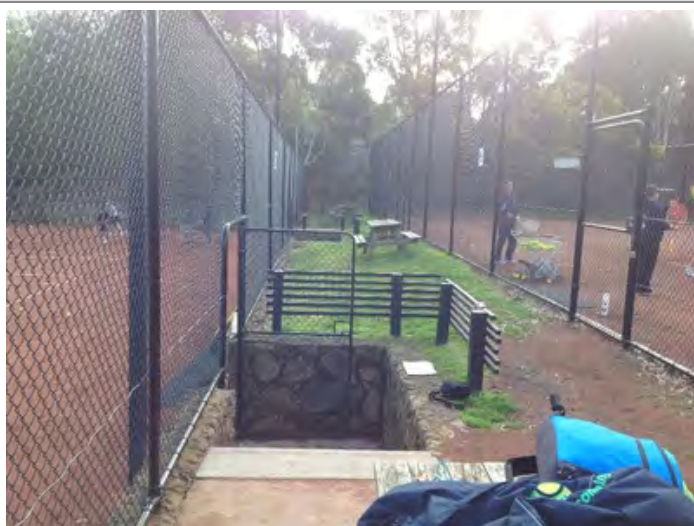
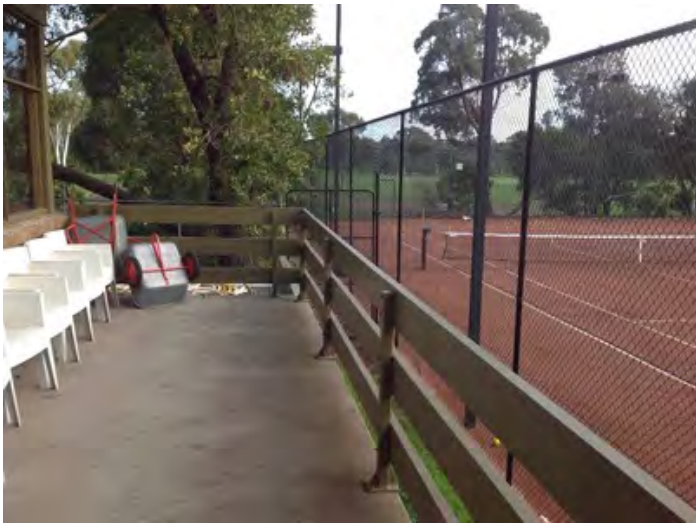
Condition of ground and court surrounds	Good
Court surround notes	The grounds are limited to a small area of grass and a couple of plants near the entrance along with concrete and red porous pathways. An open space used as an off lead dog area is located to the south. A clubhouse verandah sits above the court enclosure and provides views of all courts.
Water supply	Potable
Water notes	
Natural Shade	No natural shade
Man made Shade	Clubhouse veranda
Shade notes	
Car parking	On street: Off street: 0-20 spaces Overflow:
Does the site have any hit up walls	no
Car park notes	A small car park is offered behind the clubhouse.
Adjacent facilities	Oval/playing field Park/playground
Does the site have any potential expansion opportunities?	no

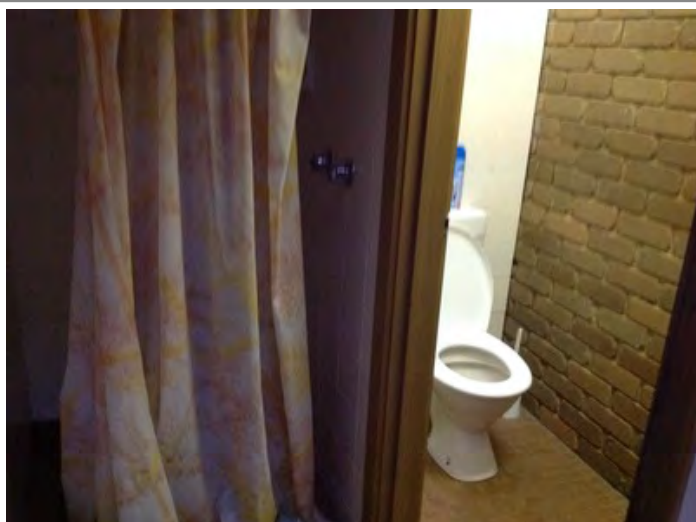
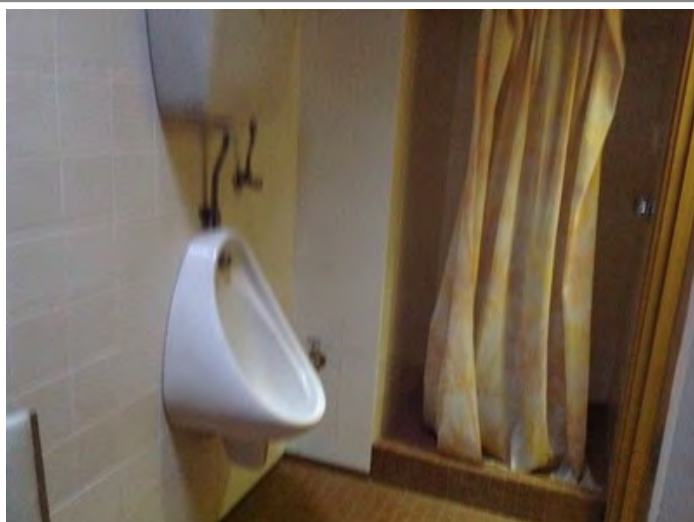
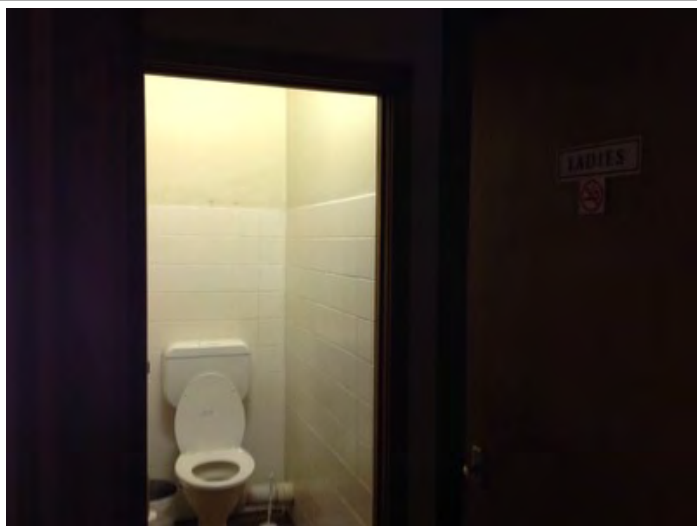
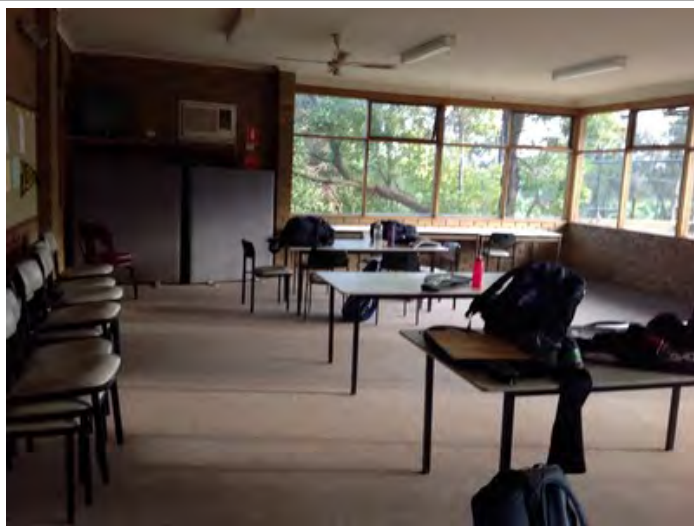
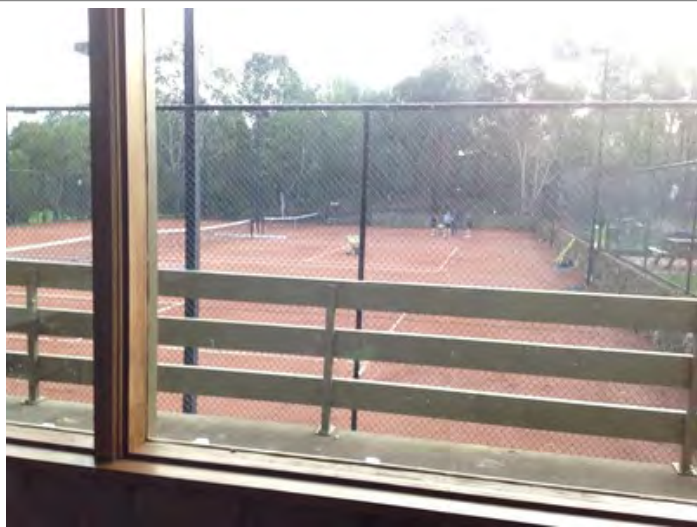
Building Condition	Moderate
Estimated building age	30+ years
Building materials	Brick
Accessible entry to building	no
Kitchen	Standard
Bar	no
Player change rooms	Male: 1 Female: 1 Unisex: 0
Social area	84 m2
Social area comments	
Toilets	Male: yes Female: yes Accessible: no
Clubroom condition notes	The clubhouse is in good condition, although it is aged and offers only basic amenities. It does offer views over the entire complex, however. The kitchen and toilets are particularly aged and could benefit from an upgrade.
Other amenities provided within or outside clubrooms	BBQ /outdoor seating area
Other amenities condition notes	
Are there any safety concerns within clubrooms?	no

Plan for the long term upgrade of the courts. They are in good condition from a playing perspective at the moment, but are well worn and will only deteriorate further in time. Consider benefits of updating the clubhouse, in particular the kitchen and toilets.
