## Yallambie Park Facility Audit

Document number	000206
Client / Site	Tennis Victoria
Location	Off Moola Close Yallambie VIC 3085
Auditor	Andrew Sodomaco
Audit date	28 Aug 2015

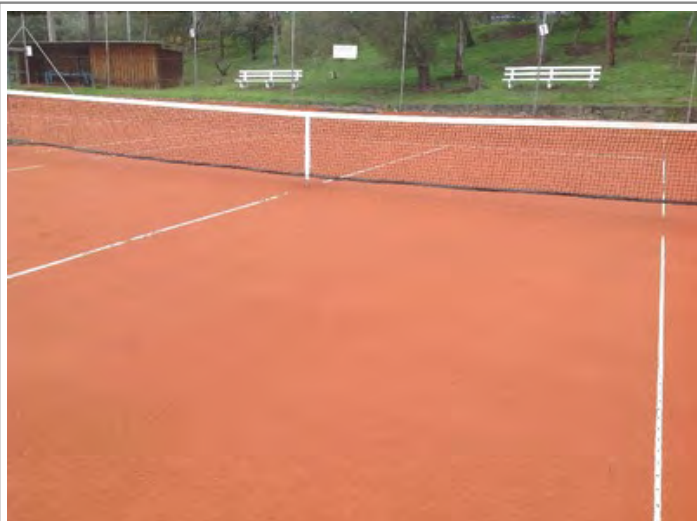
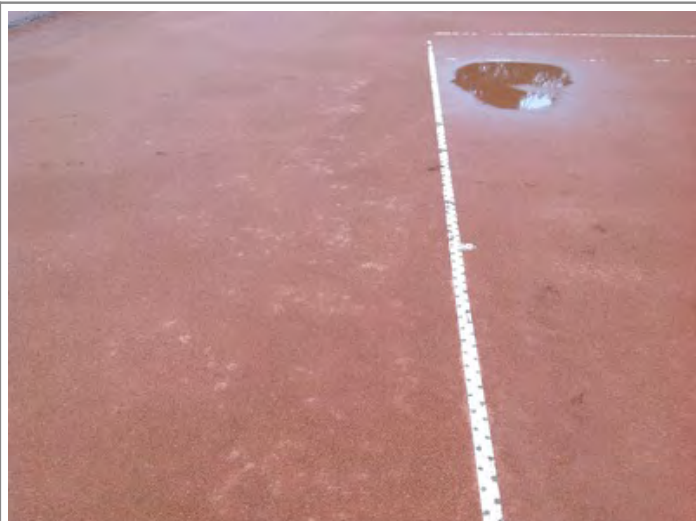
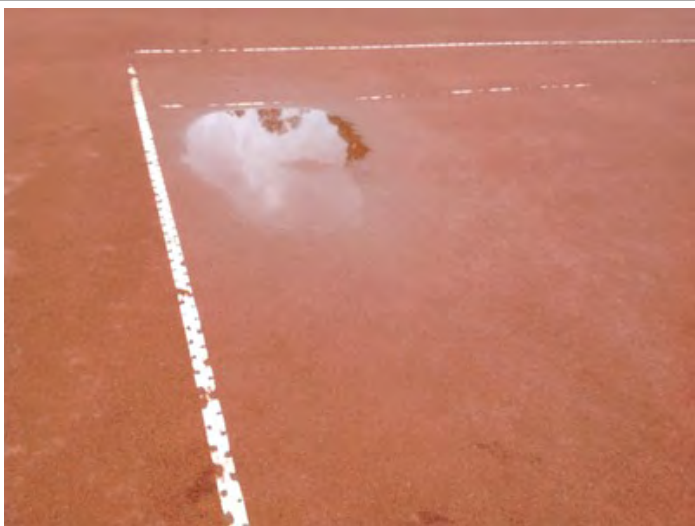
Unique court number	1
Surface condition rating	Good  <b>Issues/Observations:</b> Minor ponding evident Aged surface Excessively worn surface in high wear areas
Surface type	Red Porous
Surface life span	6-10 years
Court condition notes	This red porous court is in good condition, although is starting to show some signs of age. There is some aggregate showing through along the baseline. Otherwise, there is good covering of top dressing across the court surface.

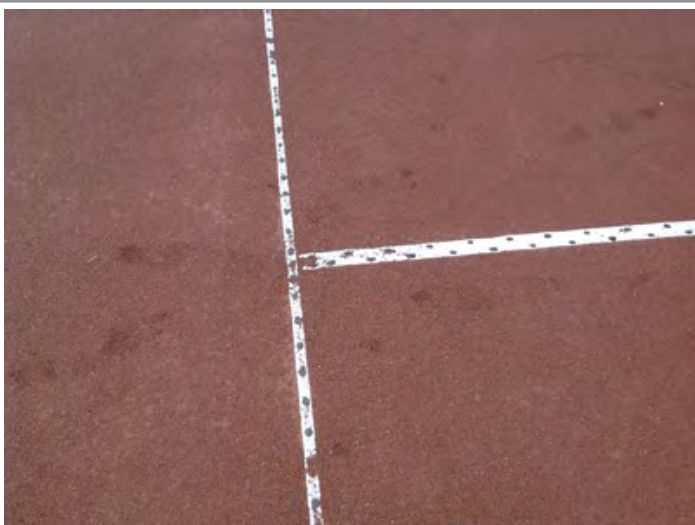
Line marking description	Tennis only lines
Line marking rating	Good  <b>Issues/Observations:</b> Inconsistent bounce likely
Line marking condition notes	The lines on this court are standard for this surface and are nailed into the court. Some inconsistent bounce is likely, but expected.

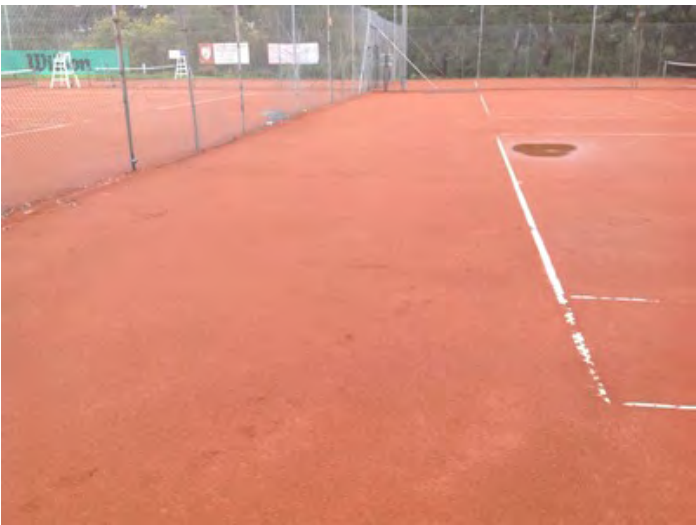
Net post life span	10+ years
Net life span	6-10 years
Net / post notes	
Net / post photos	
No photos taken	
<b>Court compliance</b>	
Is the court run off compliant?	no  <b>Runoffs</b> North: 4800m South: 4900m East: 3600m West: 3900m
Could the court be made compliant?	no
Is the court to the standard dimensions?	yes
Court orientation	North-south
Are netball goal posts outside tennis court run off areas?	no
Are lockable post hole covers fitted and safe?	no
Compliance notes	The court is not run off compliant to the north or south behind the baselines.
Compliance photos

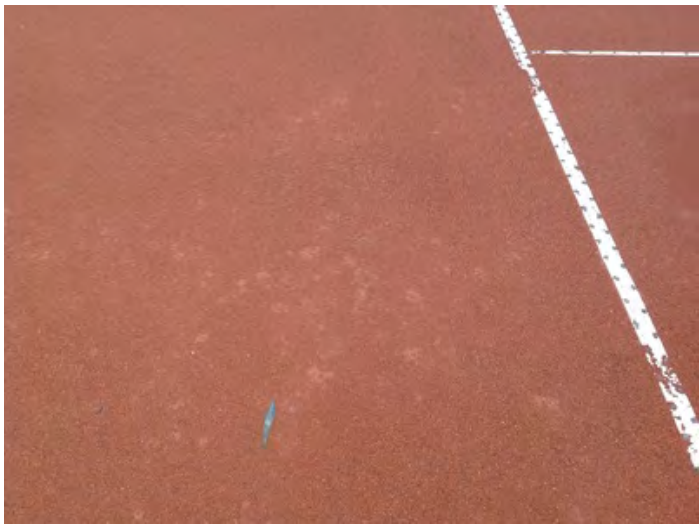
Surface condition rating	Good
	<b>Issues/Observations:</b> Aged surface Excessively worn surface in high wear areas
Surface type	Red Porous
Surface life span	6-10 years
Court condition notes	This red porous court is in good condition, although is starting to show some signs of age. There is some aggregate showing through along the baseline. Otherwise, there is good covering of top dressing across the court surface.
Court condition photos

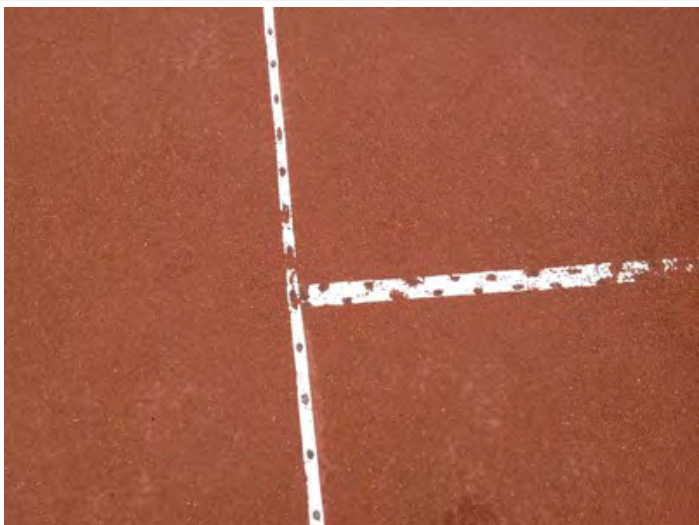
Line marking	
Line marking description	Tennis only lines
Line marking rating	Good
	<b>Issues/Observations:</b> Inconsistent bounce likely
Line marking condition notes	The lines on this court are standard for this surface and are nailed into the court. Some inconsistent bounce is likely, but expected.
Line marking condition photos

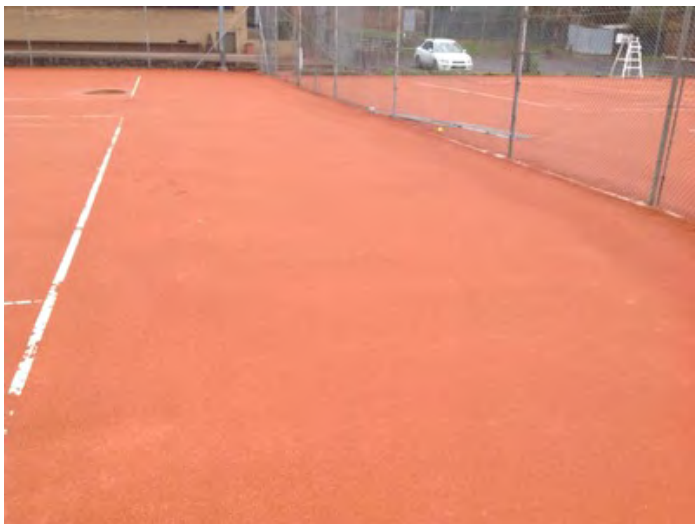
Net posts	
Net post type	Round galvanised - Installed directly into pavement
Net post condition	Good  <b>Issues/Observations:</b> Straight
Net post winders	Protruding winders
Net condition	Good
Net structure	Tethered to the posts : yes Centre strap fitted: yes
Net post life span	10+ years
Net life span	6-10 years
Net / post notes	
Net / post photos	
No photos taken	
Court compliance	
Is the court run off compliant?	no  <b>Runoffs</b> North: 4800m South: 4900m East: 3900m West: 3600m
Could the court be made compliant?	no
Is the court to the standard dimensions?	yes
Court orientation	North-south
Are netball goal posts outside tennis court run off areas?	no
Are lockable post hole covers fitted and safe?	no
Compliance notes	The court is not run off compliant to the north or south behind the baselines.
Compliance photos

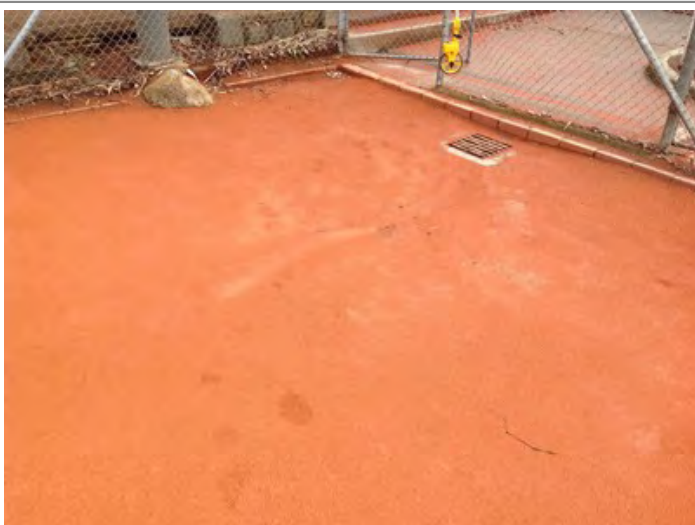
Drainage infrastructure	Formed
What type of drainage is in place?	Grated pit(s)
Are drains, pits or other infrastructure provided within the court enclosure?	yes
Are drains, pits or other infrastructure provided within the run-off areas?	yes
Drainage rating	Good
	<b>Issues/Observations:</b> Ponding evident
Drainage notes	There is a grated pit in the north eastern and western corner and there is evidence that water flows into these. Water would also be expected to drain through the surface on these courts, and this appears to be the case.

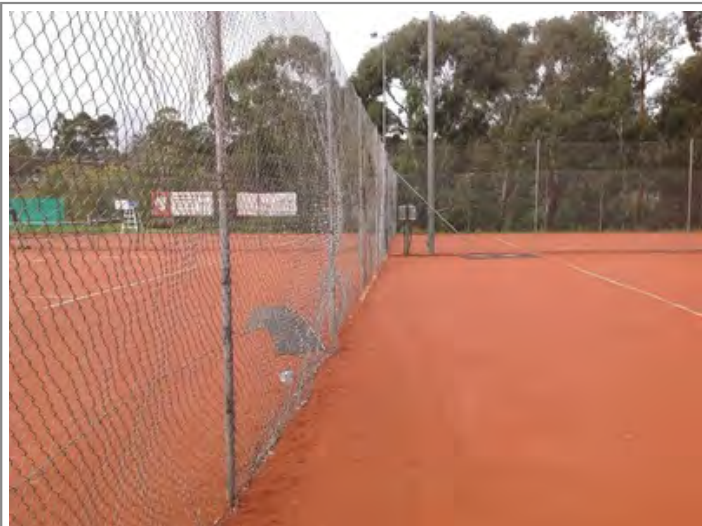
Fence type	Galvanised chain mesh
Fence Rails	Fence rail top: no Fence rail bottom: no
Fence height	3m to 3.5m Low level side fencing installed: no
Fence attachments	There are no fence attachments.
Fence condition rating	Moderate  <b>Issues/Observations:</b> Slack mesh Mesh curling at base
Fencing life span	6-10 years
Fence notes	The fencing has begun to sag and is slack in many places. Despite this, it is structurally sound and there are no obvious holes or gaps for tennis balls to pass through.

<b>Are there any critical safety issues?</b>	No
<b>Enclosure recommendations</b>	Plan for fencing upgrade. Plan for surface upgrade in the long term.

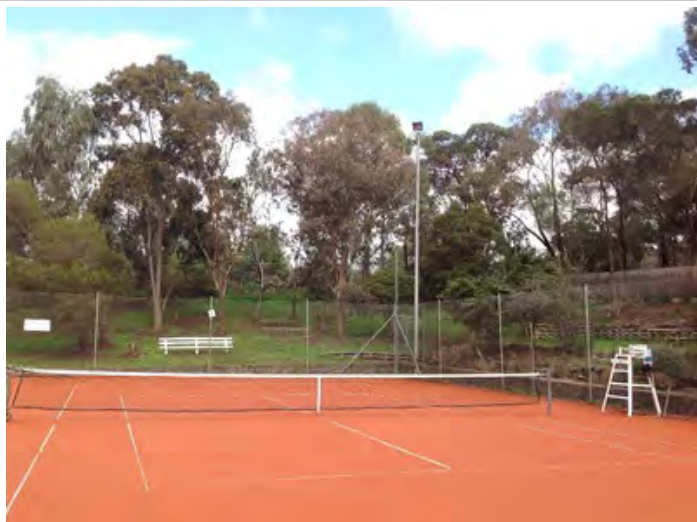
Does this enclosure have lighting	Yes
Total number of lit courts per enclosure	2
Lighting infrastructure type	High tower - Steel poles
Lighting infrastructure position	Corner
Light fittings	One per tower
Lighting infrastructure design	Standard
Lighting infrastructure rating	Moderate  <b>Issues/Observations:</b> Old however in good condition - potential upgrade required
Lighting life span	10+ years
Lighting notes	The lights appear to be in good condition, although a lux test should be performed to discover their suitability to night tennis.

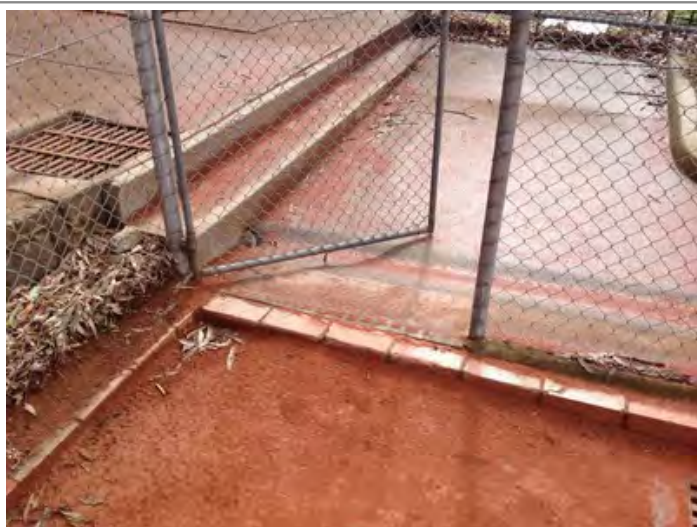
Court enclosure accessibility	Formed paths Trip hazards identified: yes Ramped access provided: no
Path material(s)	Concrete
Main gate dimensions	Standard pedestrian gate 1000mm x 2100mm
Accessibility notes	Participants are required to step down concrete steps to enter the enclosure.

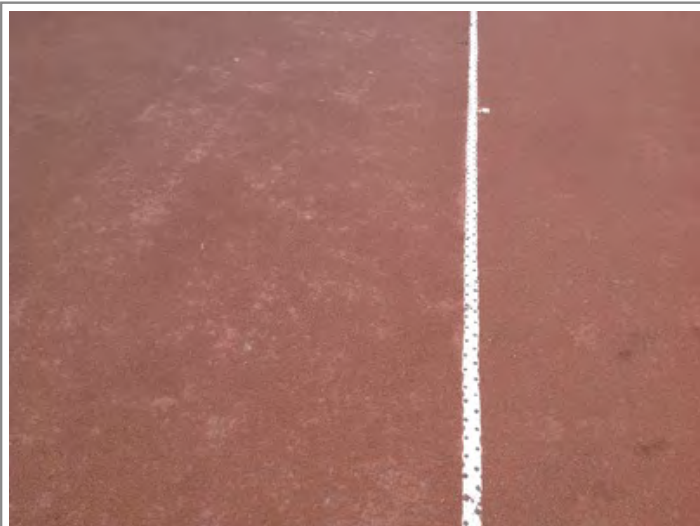
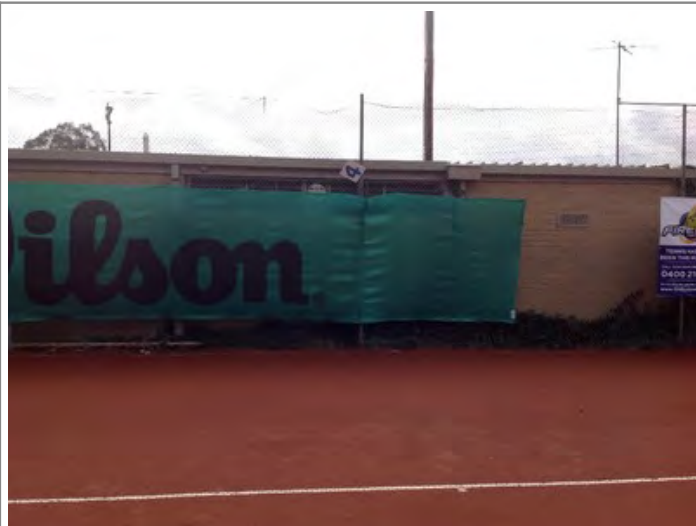
Unique court number	4
Surface condition rating	Good  <b>Issues/Observations:</b> Minor ponding evident Aged surface Excessively worn surface in high wear areas
Surface type	Red Porous
Surface life span	6-10 years
Court condition notes	This red porous court is in good condition, although is starting to show some signs of age. There is some aggregate showing through along the baseline. Otherwise, there is good covering of top dressing across the court surface.

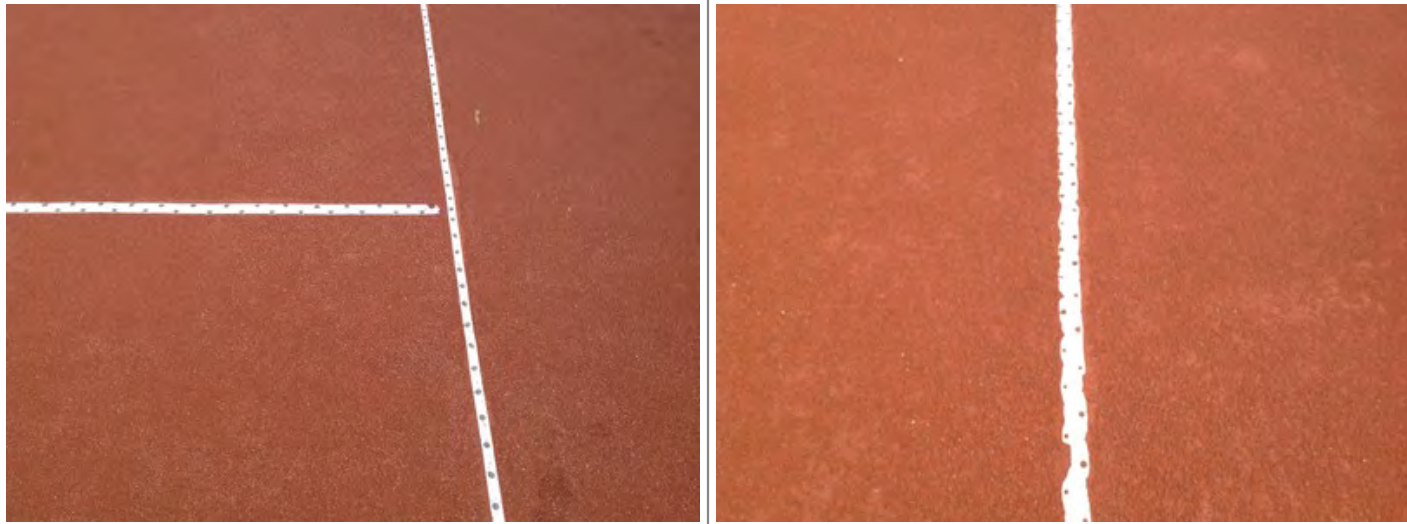
Line marking rating	Good
	<b>Issues/Observations:</b> Cracked Inconsistent bounce likely
Line marking condition notes	The lines on this court are standard for this surface and are nailed into the court. Some inconsistent bounce is likely, but expected. There is some cracking of the line at the southern end and it appears to be quite brittle.
Line marking condition photos

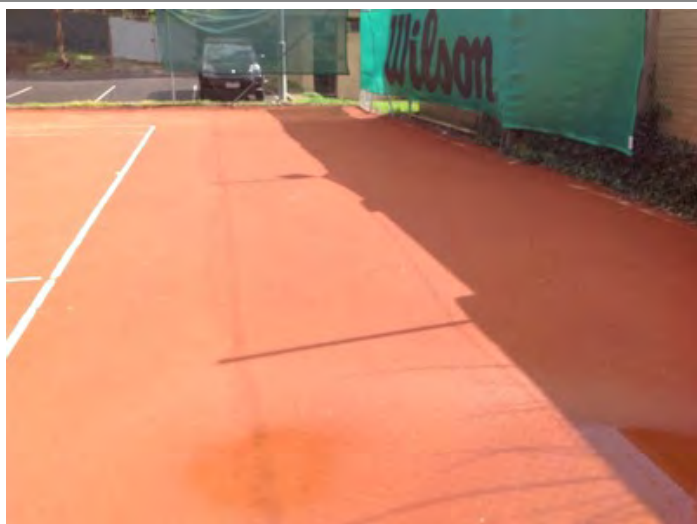
Could the court be made compliant?	no
Is the court to the standard dimensions?	yes
Court orientation	North-south
Are netball goal posts outside tennis court run off areas?	no
Are lockable post hole covers fitted and safe?	no
Compliance notes	The court is not run off compliant to the north or south behind the baselines.
Compliance photos

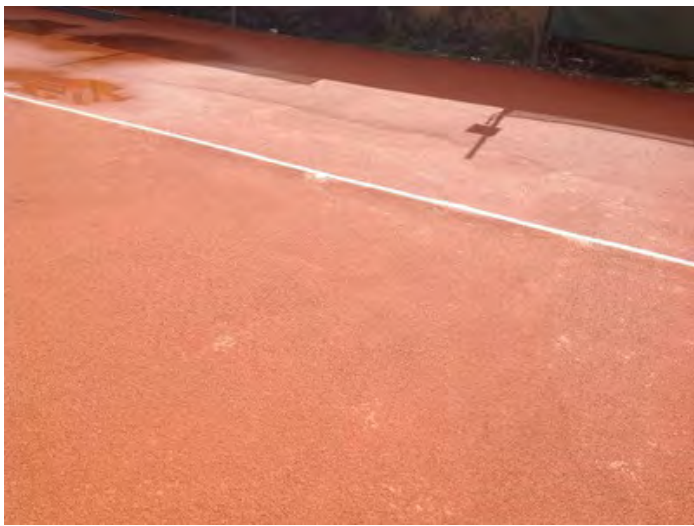
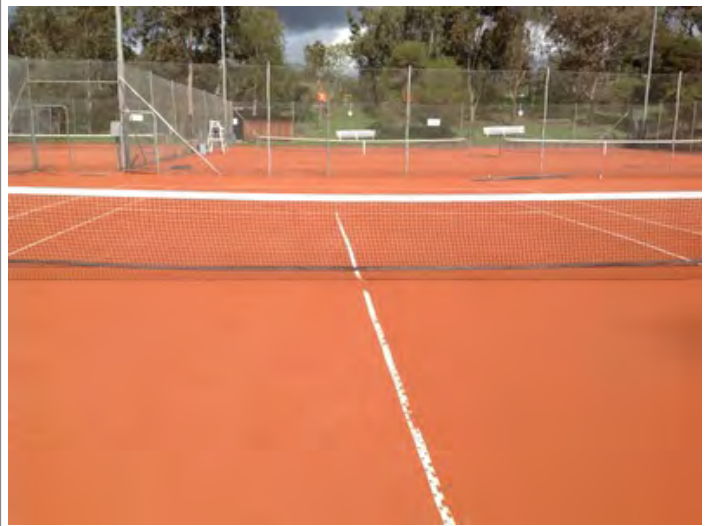
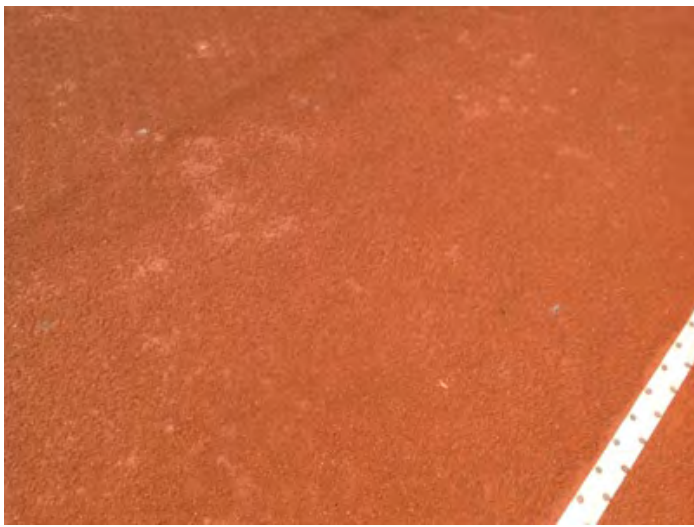
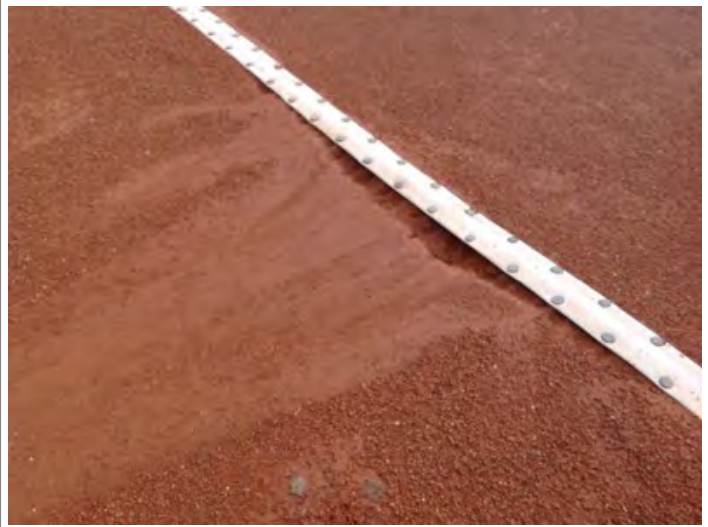
Unique court number	5
Surface condition rating	Good  <b>Issues/Observations:</b> Minor ponding evident Aged surface Excessively worn surface in high wear areas
Surface type	Red Porous
Surface life span	6-10 years
Court condition notes	This red porous court is in good condition, although is starting to show some signs of age. There is some aggregate showing through along the baseline. Otherwise, there is good covering of top dressing across the court surface. There is one patch of significant erosion at the southern baseline which requires urgent attention.

<b>Are there any critical safety issues?</b>	Yes
<b>Critical safety notations requiring immediate action</b>	The erosion on court five should be immediately rectified as it poses a trip hazard.
<b>Critical safety issue notification</b>	Inside Edge admin
<b>Safety issue photos</b>

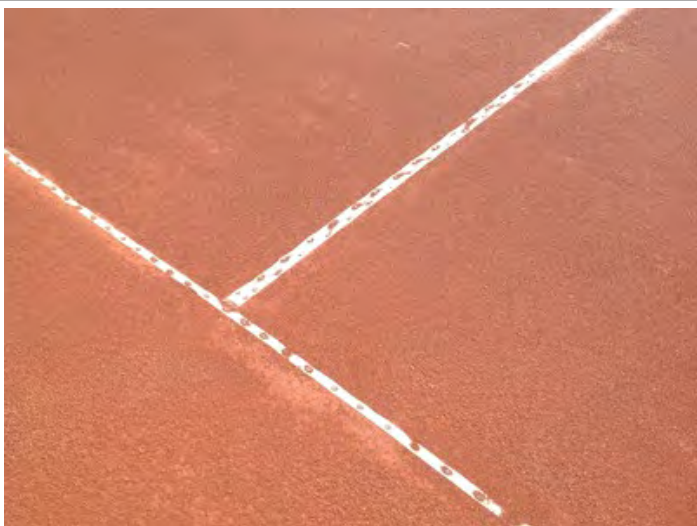
Line marking	
Line marking description	Tennis only lines
Line marking rating	Good
	<b>Issues/Observations:</b> Inconsistent bounce likely
Line marking condition notes	The lines on this court are standard for this surface and are nailed into the court. Some inconsistent bounce is likely, but expected.
Line marking condition photos

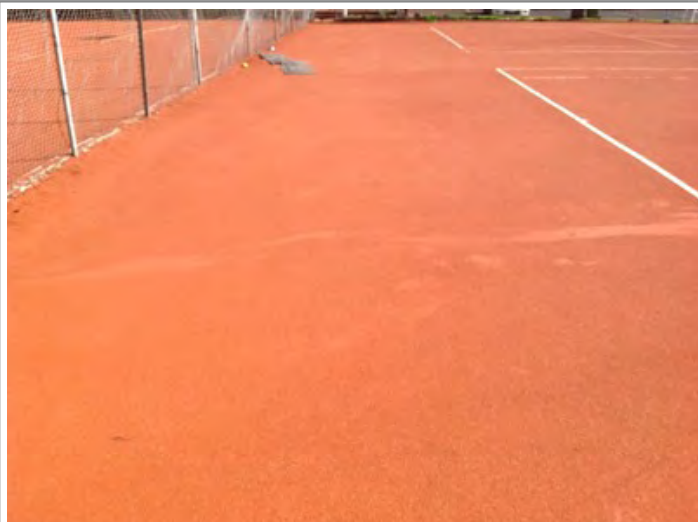
Compliance notes	The court is not run off compliant to the north or south behind the baselines.
------------------	--

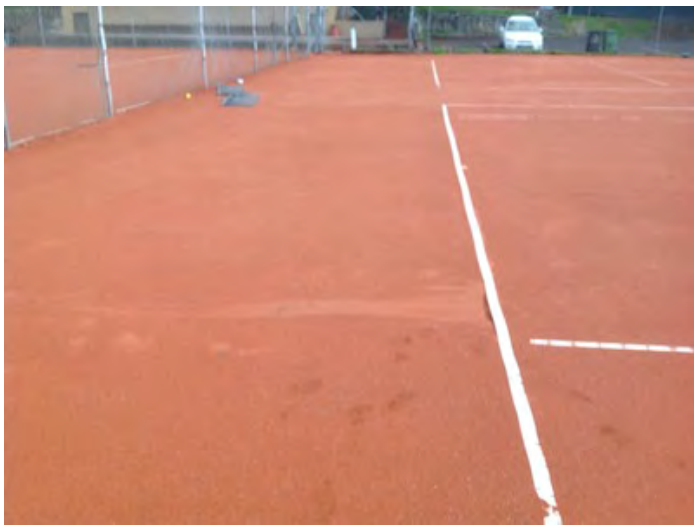
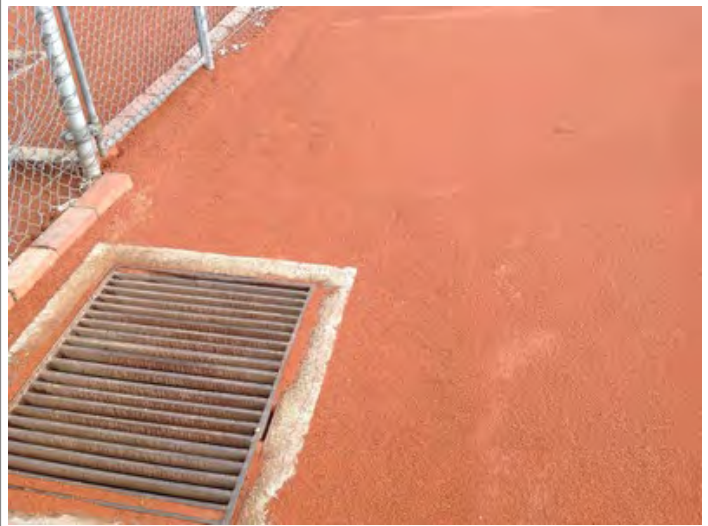
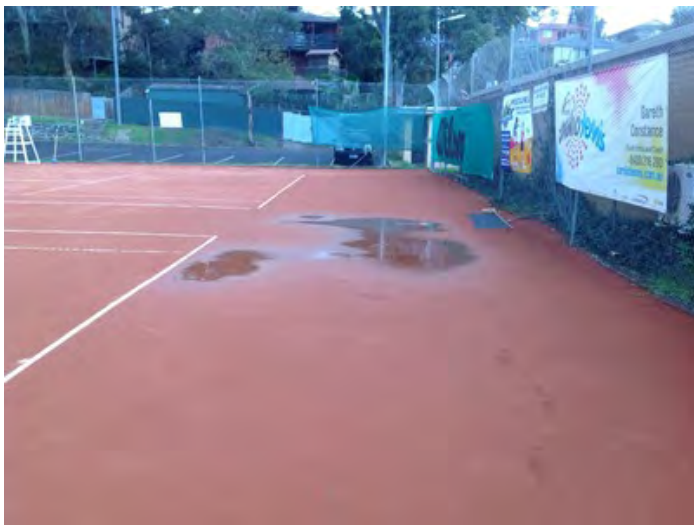
Drainage infrastructure	Formed
What type of drainage is in place?	Grated pit(s)
Are drains, pits or other infrastructure provided within the court enclosure?	yes
Are drains, pits or other infrastructure provided within the run-off areas?	yes
Drainage rating	Moderate  <b>Issues/Observations:</b> Ponding evident
Drainage notes	There is a grated pit in the south eastern corner and there is evidence that water flows into it. Water would also be expected to drain through the surface on these courts, and this appears to be the case. Puddling has occurred at the northern end of the enclosure, mostly in between the two courts. The erosion behind the baseline appears to also have been caused by the flow of water across the surface.

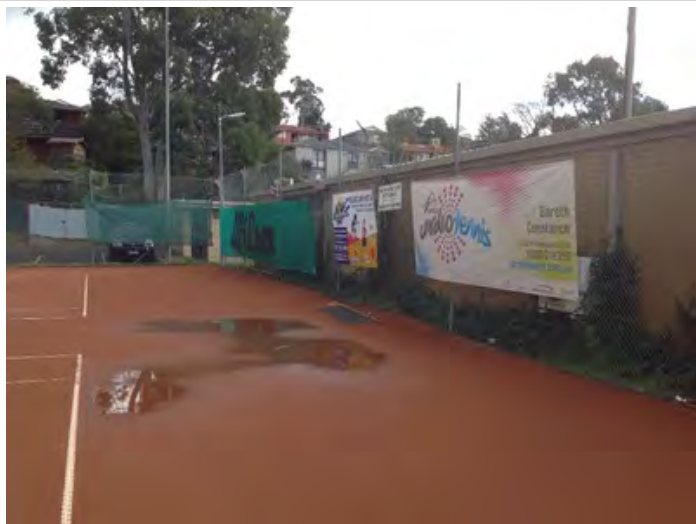
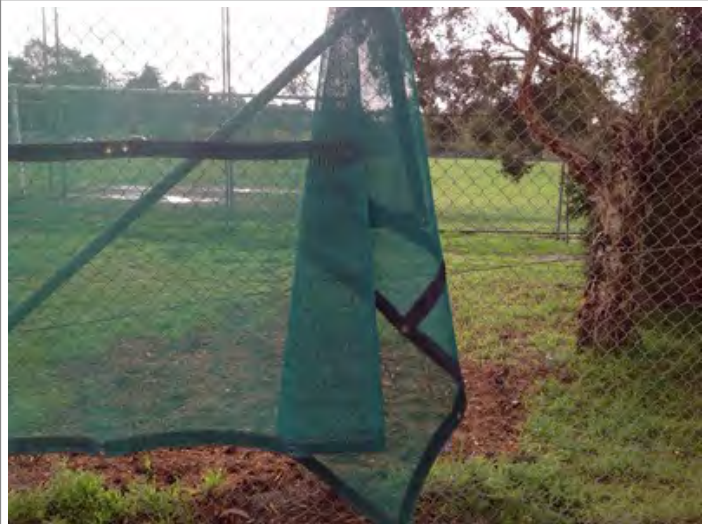
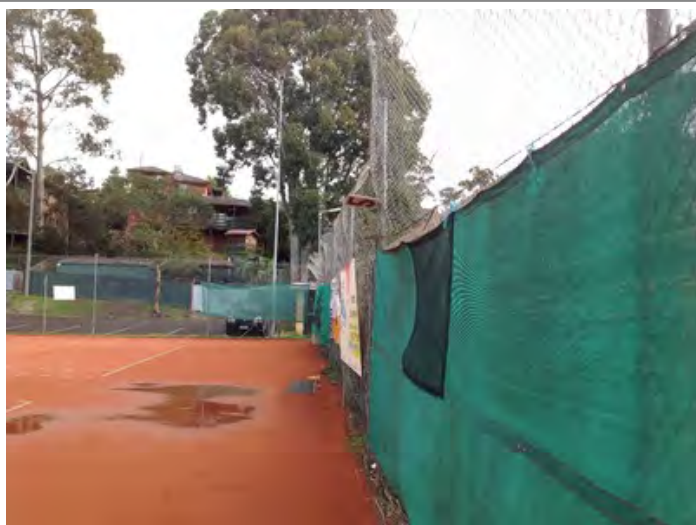
Fence type	Galvanised chain mesh
Fence Rails	Fence rail top: no Fence rail bottom: no
Fence height	3m to 3.5m Low level side fencing installed: no
Fence attachments	Sightscreens Windbreaks Sponsor advertising
Fence condition rating	Moderate  <b>Issues/Observations:</b> Slack mesh Mesh curling at base
Fencing life span	6-10 years
Fence notes	The fencing has begun to sag and is slack in many places. Despite this, it is structurally sound and there are no obvious holes or gaps for tennis balls to pass through.

<b>Enclosure recommendations</b>	Plan for fencing upgrade and upgrade to courts surfaces.

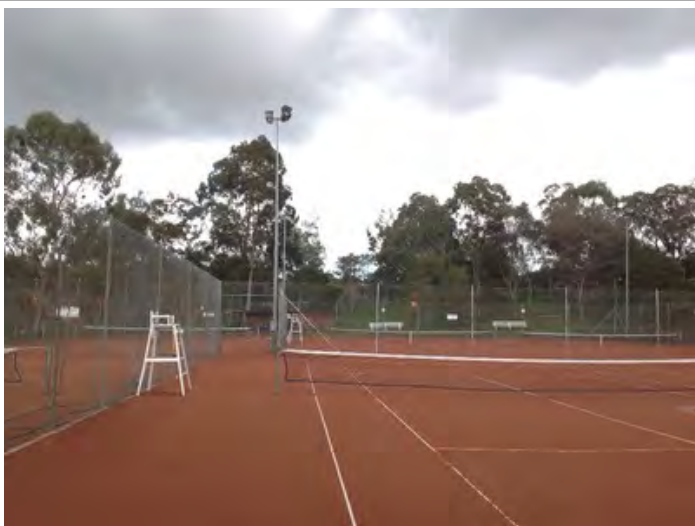
Does this enclosure have lighting	Yes
Total number of lit courts per enclosure	2
Lighting infrastructure type	High tower - Steel poles
Lighting infrastructure position	Corner
Light fittings	One per tower
Lighting infrastructure design	Standard
Lighting infrastructure rating	Moderate
	<b>Issues/Observations:</b> Old however in good condition - potential upgrade required
Lighting life span	10+ years
Lighting notes	The lights appear to be in good condition, although a lux test should be performed to discover their suitability to night tennis.
Lighting photos

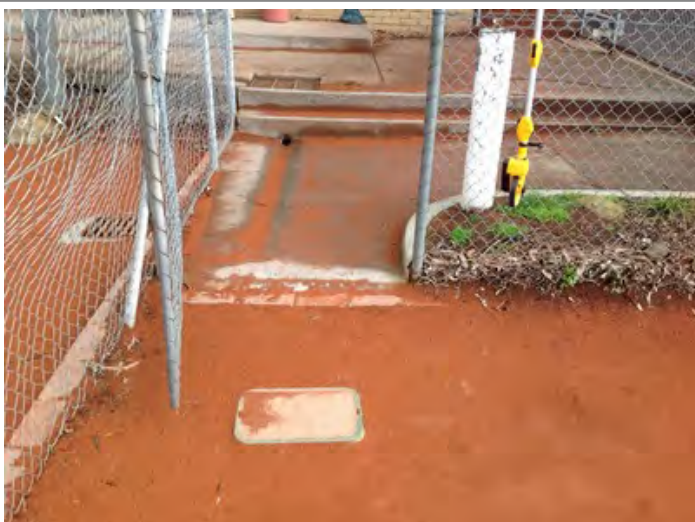
<b>Court enclosure accessibility</b>	Formed paths Trip hazards identified: yes Ramped access provided: no
<b>Path material(s)</b>	Concrete
<b>Main gate dimensions</b>	Standard pedestrian gate 1000mm x 2100mm
<b>Accessibility notes</b>	Participants are required to step down concrete steps to enter the enclosure.

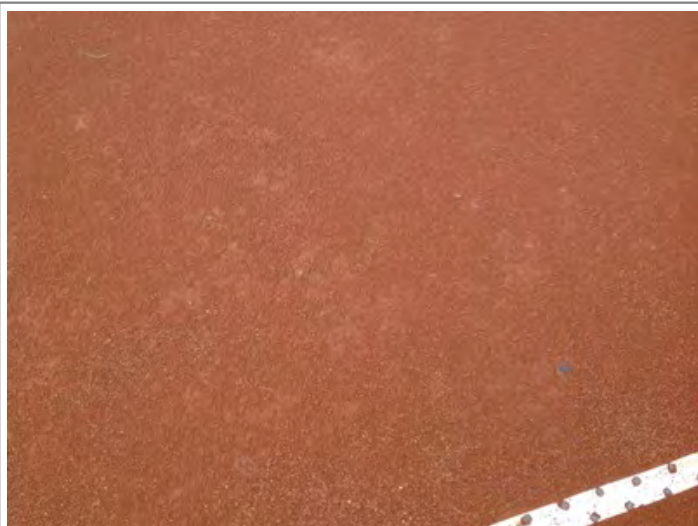
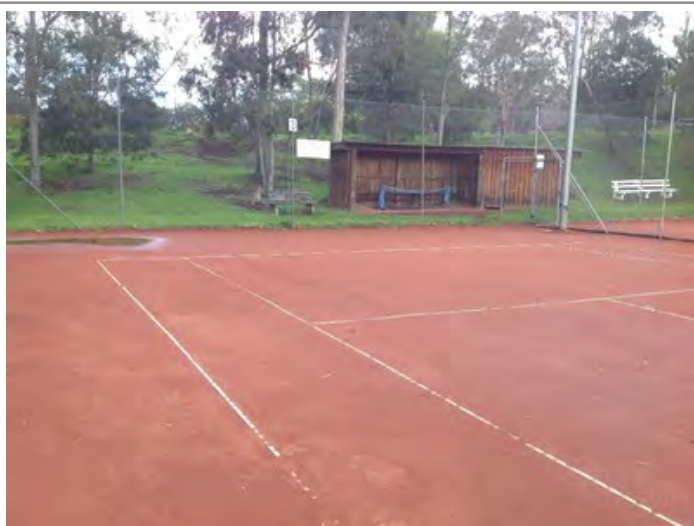
Unique court number	3
Surface condition rating	Good  <b>Issues/Observations:</b> Minor ponding evident Aged surface Excessively worn surface in high wear areas
Surface type	Red Porous
Surface life span	6-10 years
Court condition notes	This red porous court is in good condition, although is starting to show some signs of age. There is some aggregate showing through along the baseline. Otherwise, there is a good covering of top dressing across the court surface.

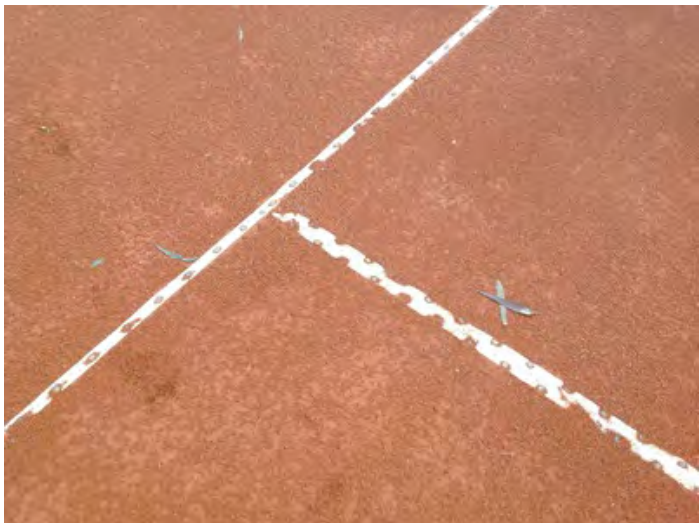
Line marking rating	Good
	<b>Issues/Observations:</b> Inconsistent bounce likely
Line marking condition notes	The lines on this court are standard for this surface and are nailed into the court. Some inconsistent bounce is likely, but expected.
Line marking condition photos

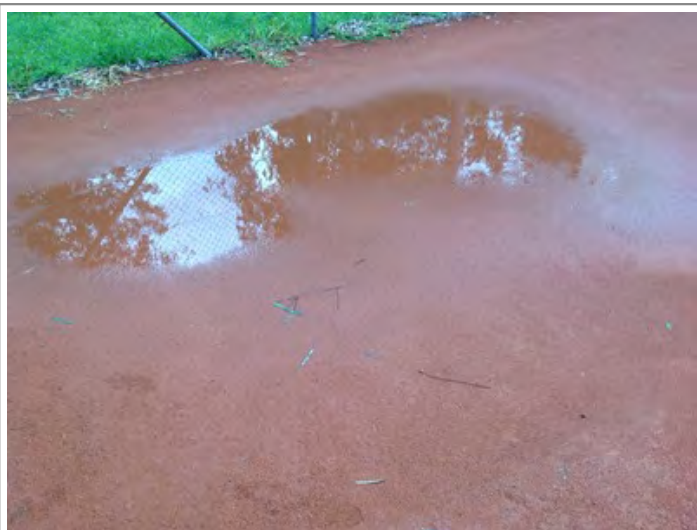
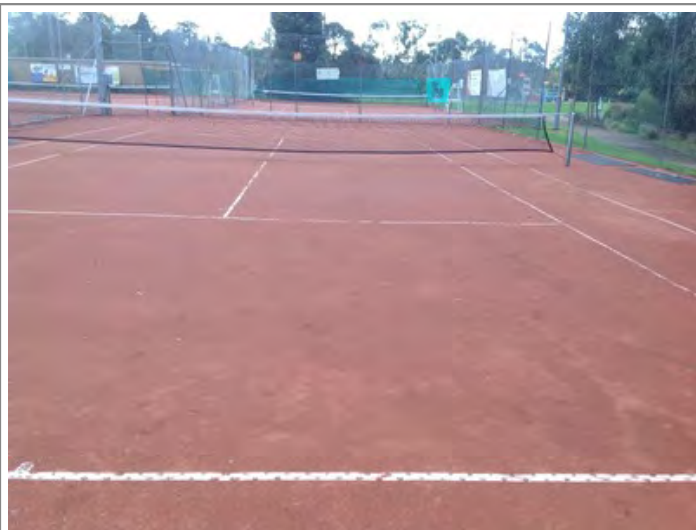
Drainage infrastructure	Unformed
What type of drainage is in place?	No drainage infrastructure
Are drains, pits or other infrastructure provided within the court enclosure?	no
Are drains, pits or other infrastructure provided within the run-off areas?	no
Drainage rating	Good  <b>Issues/Observations:</b> Ponding evident
Drainage notes	Water appears to simply drain through the surface in this court. There is some puddling at the south eastern corner of the enclosure.

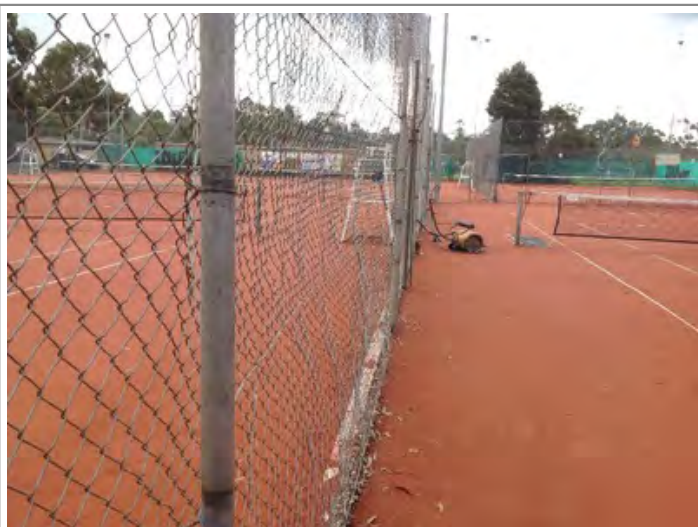
Fence Rails	Fence rail top: no Fence rail bottom: no
Fence height	3m to 3.5m Low level side fencing installed: no
Fence attachments	Sponsor advertising
Fence condition rating	Moderate  <b>Issues/Observations:</b> Slack mesh Trees overhanging enclosure
Fencing life span	6-10 years
Fence notes	The fencing has begun to sag and is slack in many places. Despite this, it is structurally sound and there are no obvious holes or gaps for tennis balls to pass through.

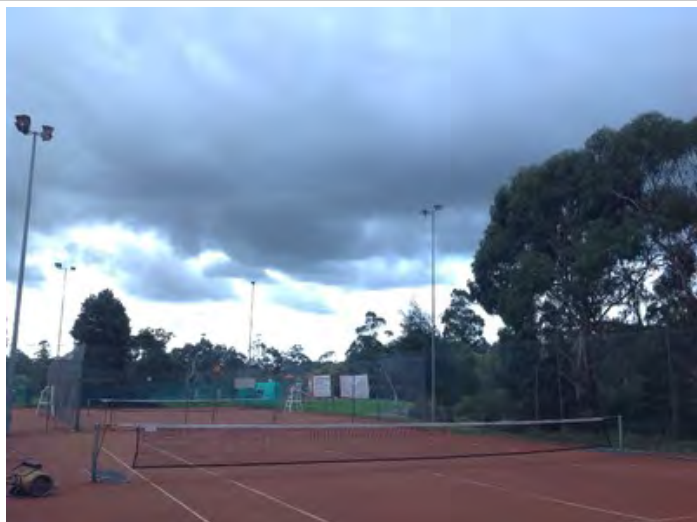
Does this enclosure have lighting	Yes
Total number of lit courts per enclosure	2
Lighting infrastructure type	High tower - Steel poles
Lighting infrastructure position	Corner
Light fittings	One per tower
Lighting infrastructure design	Standard
Lighting infrastructure rating	Moderate  <b>Issues/Observations:</b> Old however in good condition - potential upgrade required
Lighting life span	10+ years
Lighting notes	The lights appear to be in good condition, although a lux test should be performed to discover their suitability to night tennis.

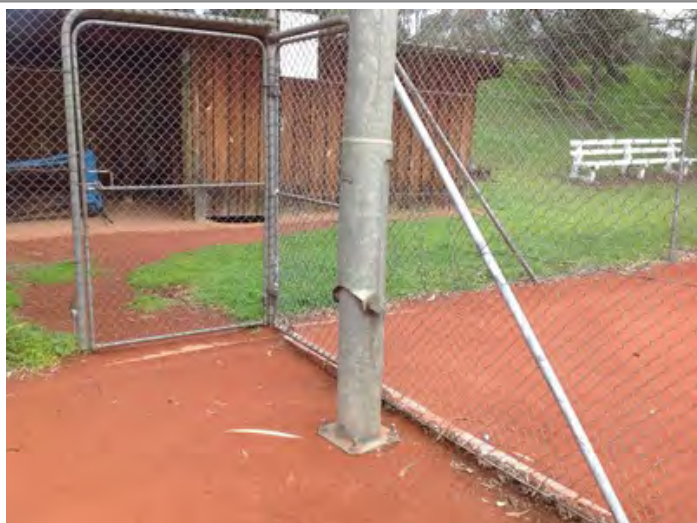
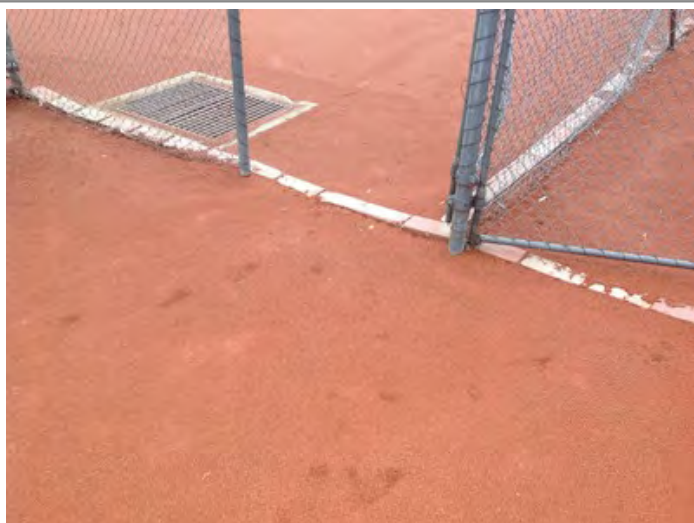
Court enclosure accessibility	Unformed paths Trip hazards identified: yes Ramped access provided: no
Path material(s)	Concrete
Main gate dimensions	Standard pedestrian gate 1000mm x 2100mm
Accessibility notes	Participants are required to walk through enclosure one or two to access the enclosure, or through grassland to the south of the courts.

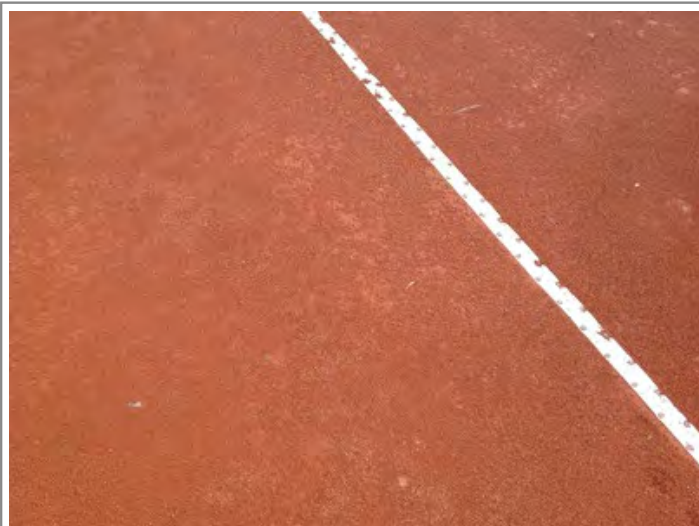
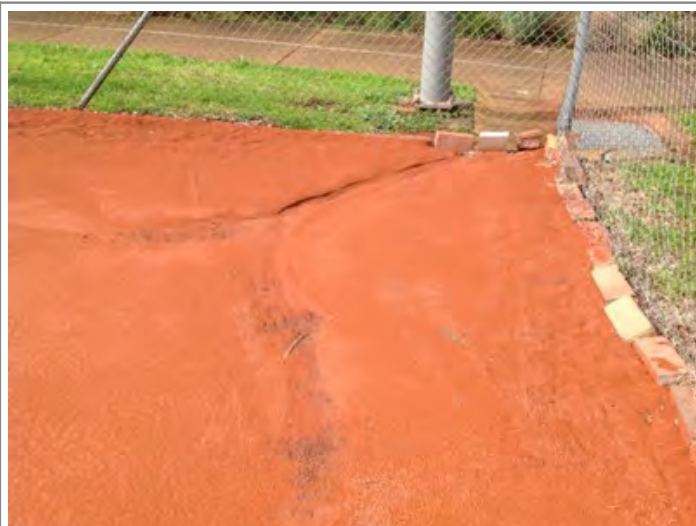
Unique court number	6
Surface condition rating	Good  <b>Issues/Observations:</b> Aged surface Excessively worn surface in high wear areas
Surface type	Red Porous
Surface life span	6-10 years
Court condition notes	This red porous court is in good condition, although is starting to show some signs of age. There is some aggregate showing through along the baseline. Otherwise, there is good covering of top dressing across the court surface.

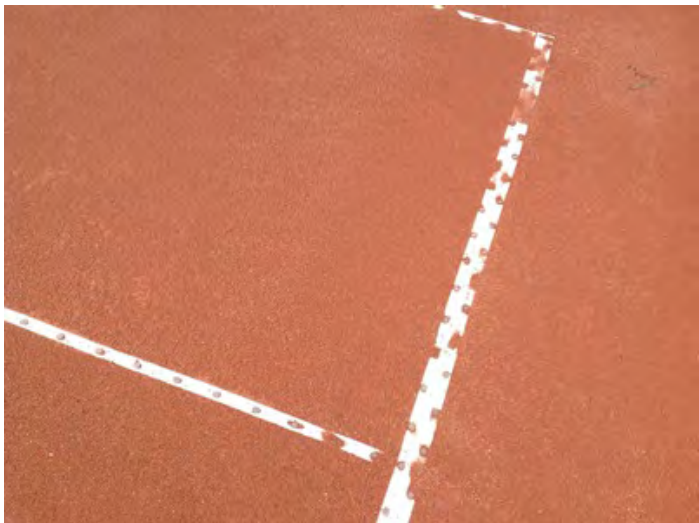
Line marking rating	Good
	<b>Issues/Observations:</b> Inconsistent bounce likely
Line marking condition notes	The lines on this court are standard for this surface and are nailed into the court. Some inconsistent bounce is likely, but expected.
Line marking condition photos

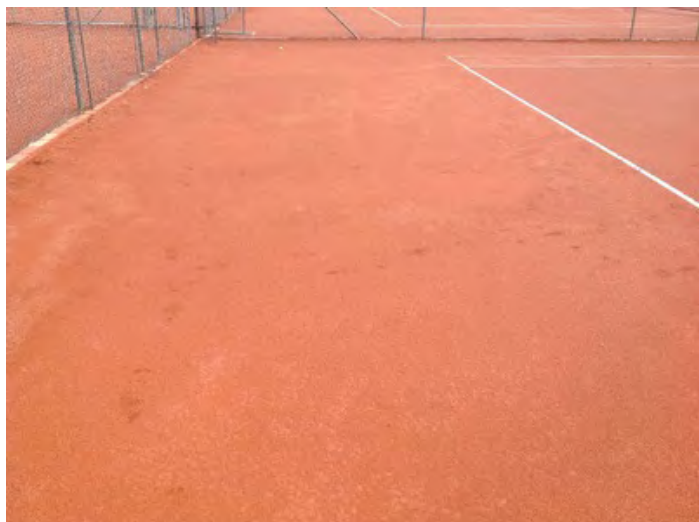
Could the court be made compliant?	no
Is the court to the standard dimensions?	yes
Court orientation	North-south
Are netball goal posts outside tennis court run off areas?	no
Are lockable post hole covers fitted and safe?	no
Compliance notes	The court is not run off compliant to the north or south behind the baselines. Light posts are also within run off areas.

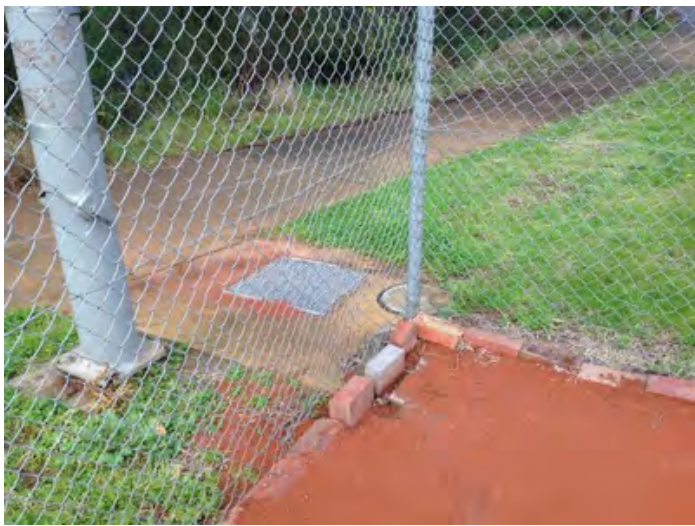
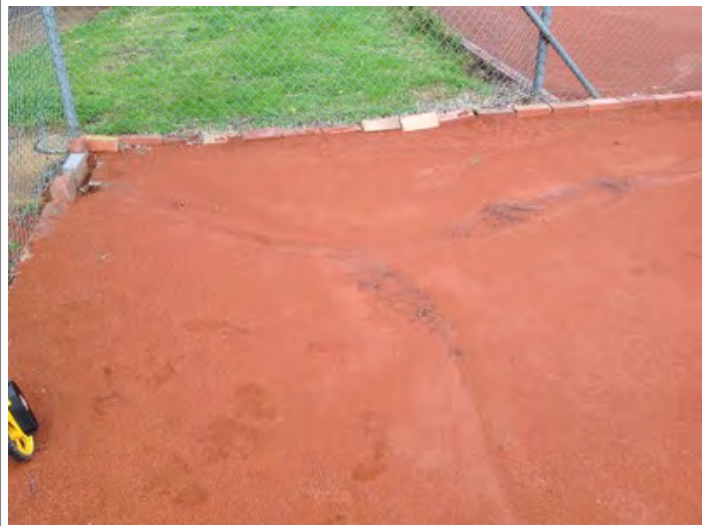
Drainage infrastructure	Formed
What type of drainage is in place?	Grated pit(s)
Are drains, pits or other infrastructure provided within the court enclosure?	no
Are drains, pits or other infrastructure provided within the run-off areas?	no
Drainage rating	Moderate
	<b>Issues/Observations:</b>
Drainage notes	There is a grated pit outside the enclosure on the south eastern side. Ruts have been cut into the court as water flows into this area. Some top dressing has flowed off the court as a result. Otherwise, there is no signs of puddling anywhere on the court surface.

<b>Court</b>	Trim trees/shrubs away from court enclosure and fencing Hang drag mats on fencing
<b>Drainage</b>	Qualified Engineer required to further investigate drainage issues.
<b>Infrastructure</b>	Repair damaged fencing Trim vegetation away from fencing
<b>Lighting</b>	Conduct a lighting lux level test

<b>Are there any critical safety issues?</b>	No
<b>Enclosure recommendations</b>	Plan for fencing upgrade and upgrade to court surface. Assess the loss of top dressing through drainage in the south eastern corner.

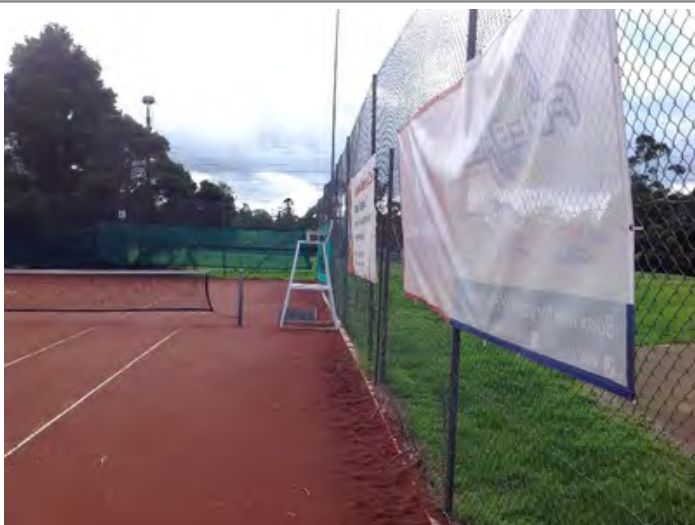
Fence type	Galvanised chain mesh
Fence Rails	Fence rail top: no Fence rail bottom: no
Fence height	3m to 3.5m Low level side fencing installed: no
Fence attachments	Sightscreens Windbreaks Sponsor advertising
Fence condition rating	Moderate  <b>Issues/Observations:</b> Slack mesh Trees overhanging enclosure
Fencing life span	6-10 years
Fence notes	The fencing has begun to sag and is slack in many places. Despite this, it is structurally sound and there are no obvious holes or gaps for tennis balls to pass through.

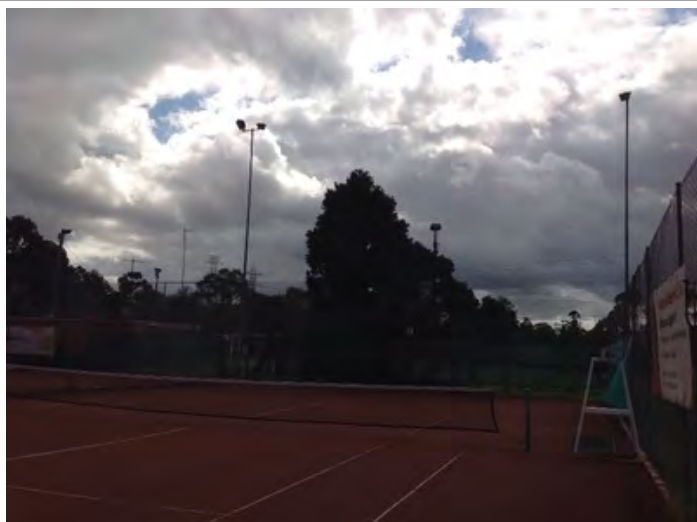
Does this enclosure have lighting	Yes
Total number of lit courts per enclosure	2
Lighting infrastructure type	High tower - Steel poles
Lighting infrastructure position	Corner
Light fittings	One per tower
Lighting infrastructure design	Standard
Lighting infrastructure rating	Moderate
	<b>Issues/Observations:</b> Old however in good condition - potential upgrade required
Lighting life span	10+ years
Lighting notes	The lights appear to be in good condition, although a lux test should be performed to discover their suitability to night tennis.

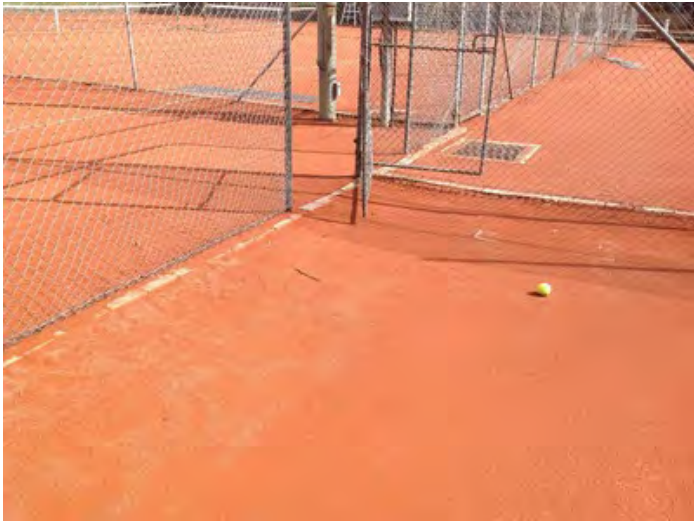
Court enclosure accessibility	Unformed paths Trip hazards identified: yes Ramped access provided: no
Path material(s)	Concrete
Main gate dimensions	Standard pedestrian gate 1000mm x 2100mm
Accessibility notes	Participants are required to walk through enclosure one or two to access the enclosure.
