## Yallambie Park Facility Audit

Document number	000206
Client / Site	Tennis Victoria
Location	Off Moola Close Yallambie VIC 3085
Auditor	Andrew Sodomaco
Audit date	28 Aug 2015

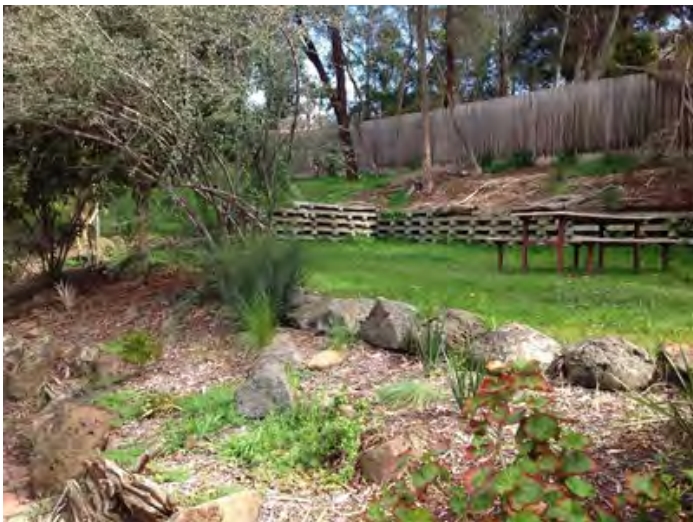
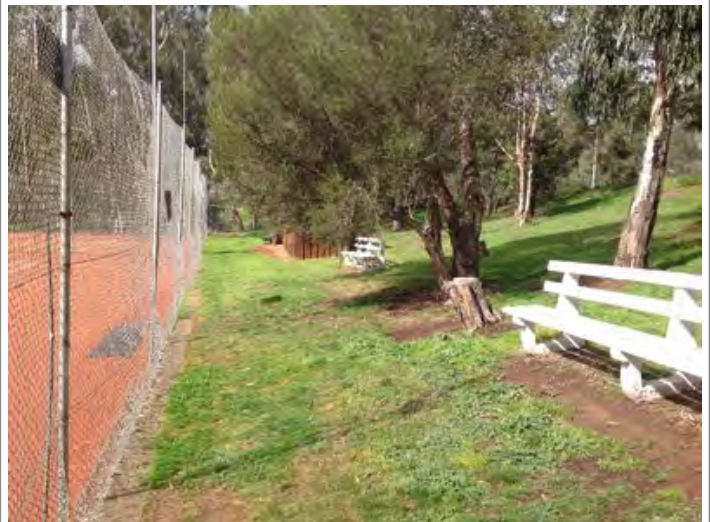
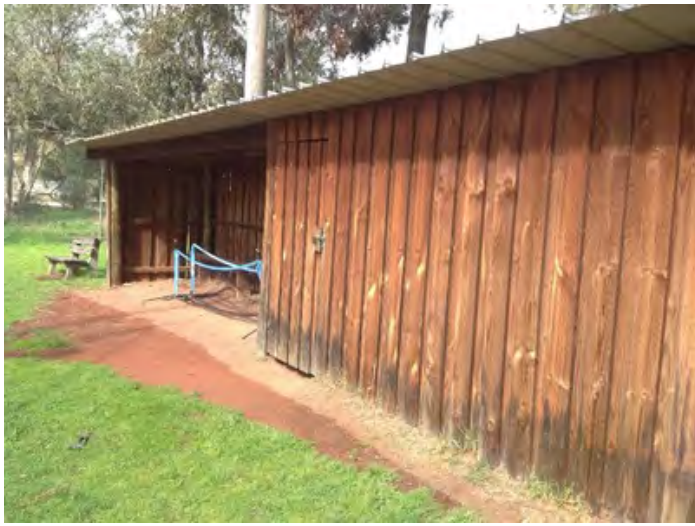
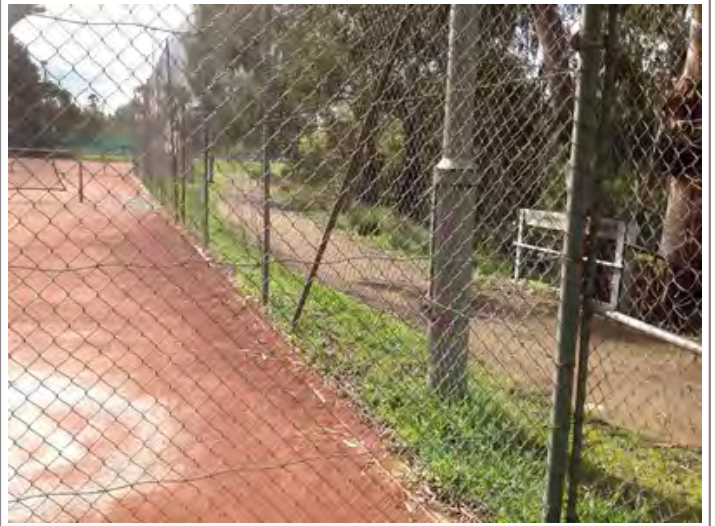
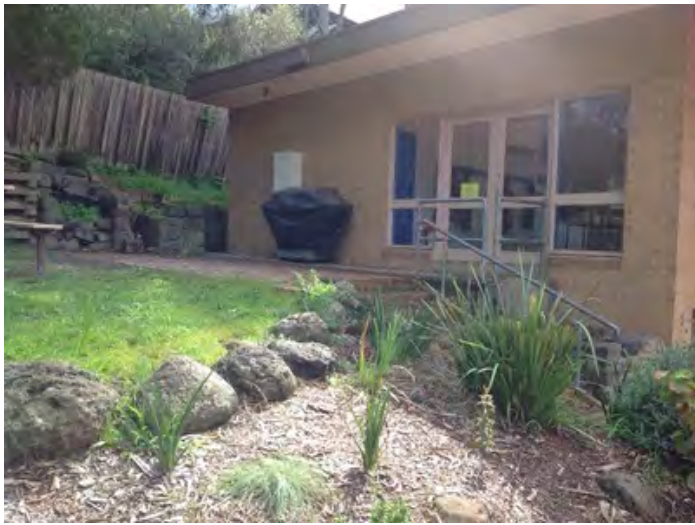
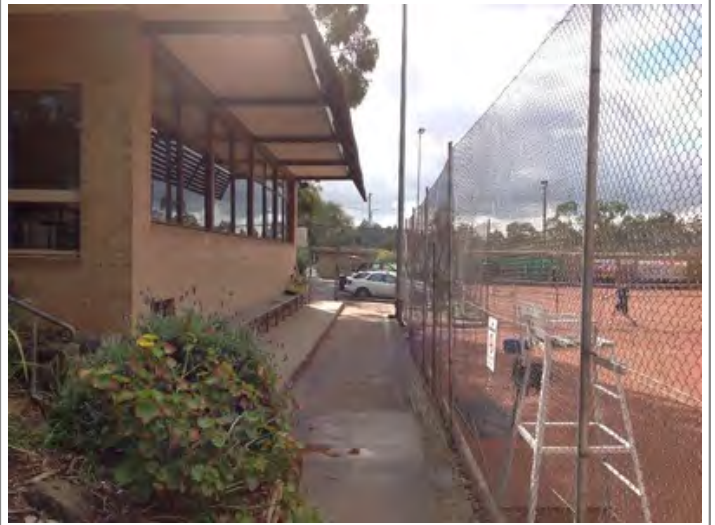
Condition of ground and court surrounds	Good
Court surround notes	Landscaped gardens, seating, a verandah and a shelter shed are offered in viewing distance of the court. It is mostly a well kept and inviting area for spectators. A public walkway and soccer pitch are adjacent to the facility.
Water supply	Potable
Water notes	Drinking taps are provided on court.
Natural Shade	Sufficient shade available within viewing range
Man made Shade	Purpose built shelter
Shade notes	There is both a purpose built shelter and a clubhouse verandah.
Car parking	On street: Off street: 21-40 spaces Overflow:
Does the site have any hit up walls	no
Car park notes	The car parking off street is shared with the adjacent soccer club.
Adjacent facilities	Oval/playing field  Park/playground
Does the site have any potential expansion opportunities?	no

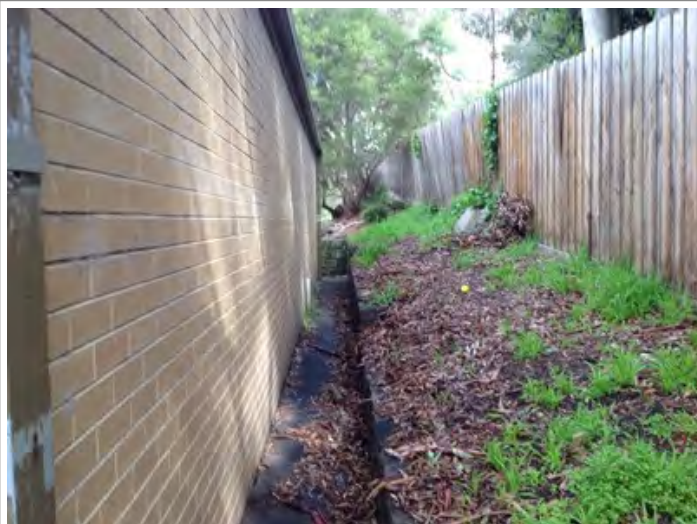
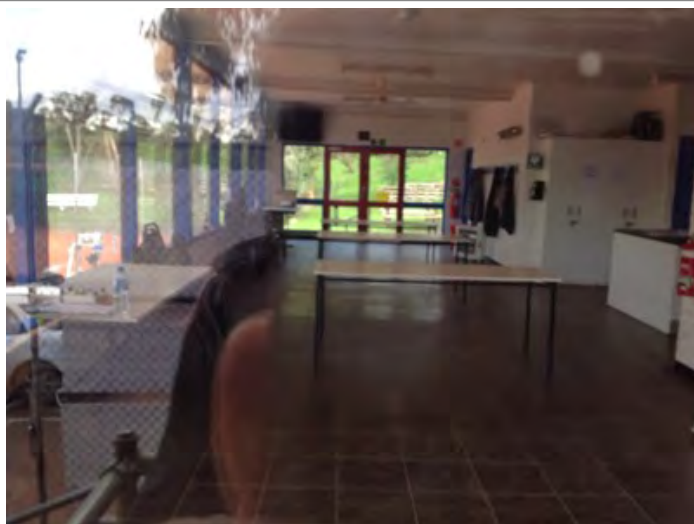
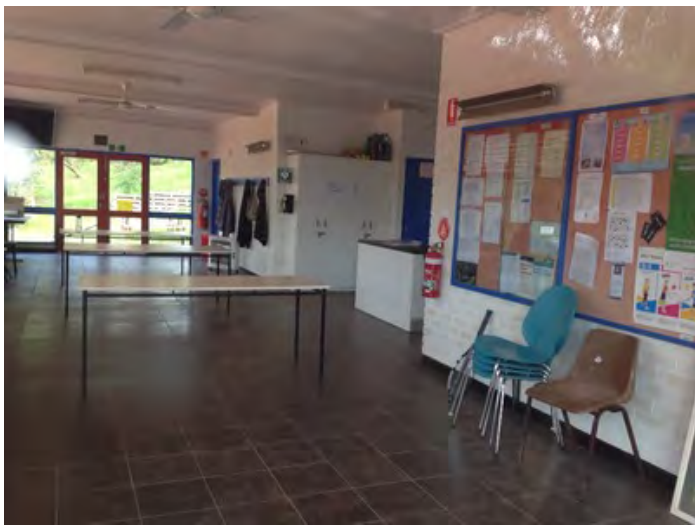
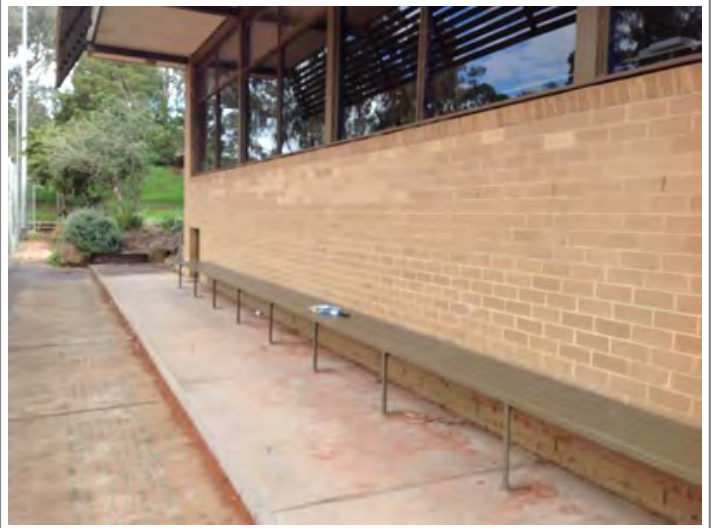
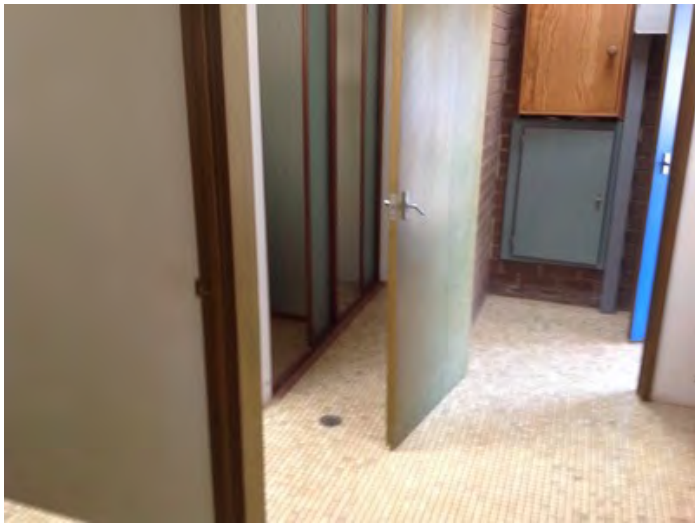
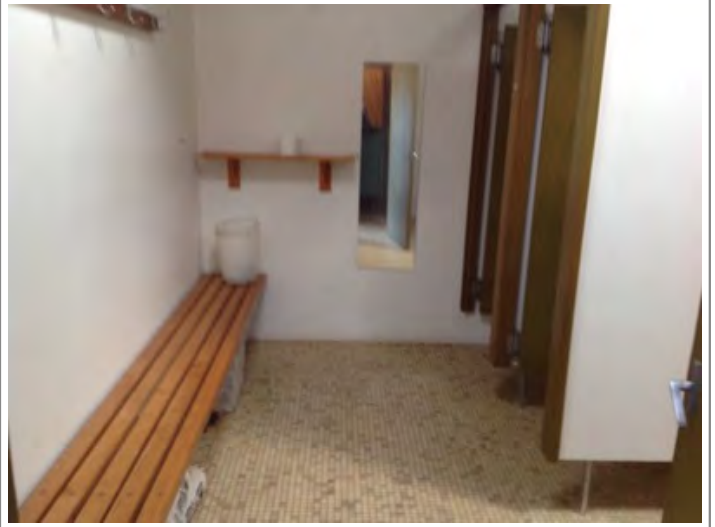
Building Condition	Good
Estimated building age	30+ years
Building materials	Brick
Accessible entry to building	no
Kitchen	Standard
Bar	no
Player change rooms	Male: 1 Female: 1 Unisex: 0
Social area	65 m2
Social area comments	
Toilets	Male: yes Female: yes Accessible: no
Clubroom condition notes	The clubhouse is neat and tidy and appears to be in good condition. It sits higher than the courts and offers excellent views. Despite being a little aged, the toilets and change facilities offer some room for players to get changed after their match.
Other amenities provided within or outside clubrooms	Equipment storage BBQ /outdoor seating area
Other amenities condition notes	
Are there any safety concerns within clubrooms?	no
