Rutherford Facility Audit

Document number	000207
Client / Site	Tennis Victoria
Location	96-120 Rutherford Road Viewbank VIC 3084
Auditor	Andrew Sodomaco
Audit date	28 Aug 2015

Site summary	
Total number of enclosures	5
Total number of courts	8
Total number of floodlit courts	8
Total number of enclosed mini courts	0
Hierarchy	District

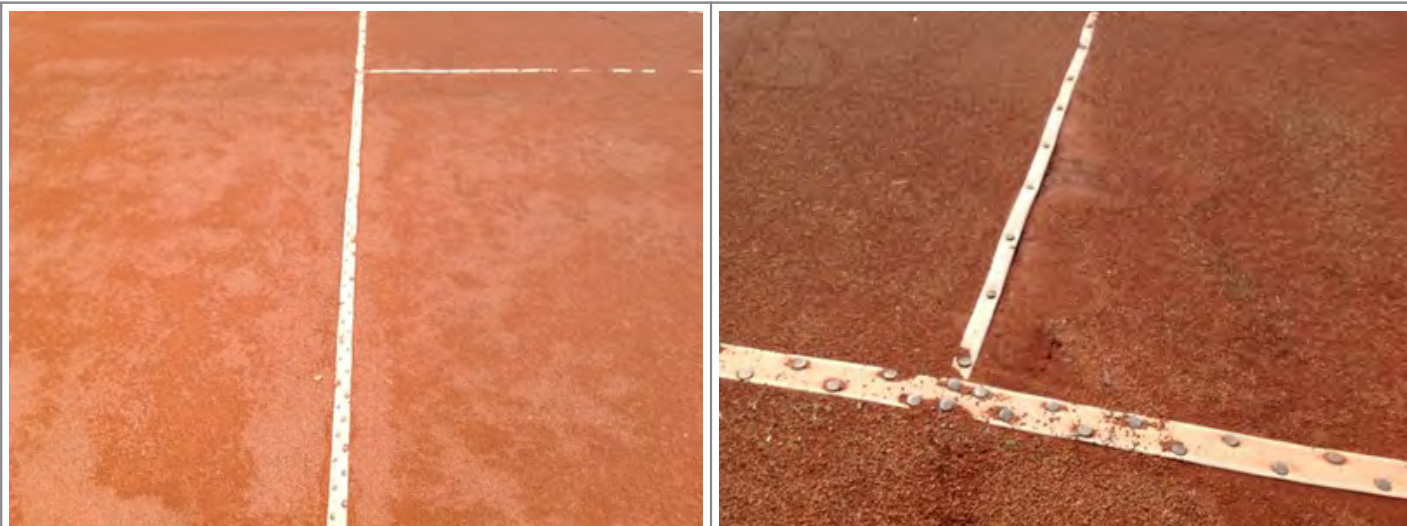
Unique court number	1
Surface condition rating	Good
	Issues/Observations:
Surface type	Red Porous
Surface life span	10+ years
Court condition notes	This court appears to be in very good condition. There is little sign of puddling and few signs of aggregate showing through the top dressing. There is a small patch of erosion on the south western singles sideline which will need to be repaired.

Are there any critical safety issues?	No
Enclosure recommendations	Repair court erosion on both courts before a significant trip hazard eventuates. Plan for upgrade to fencing.

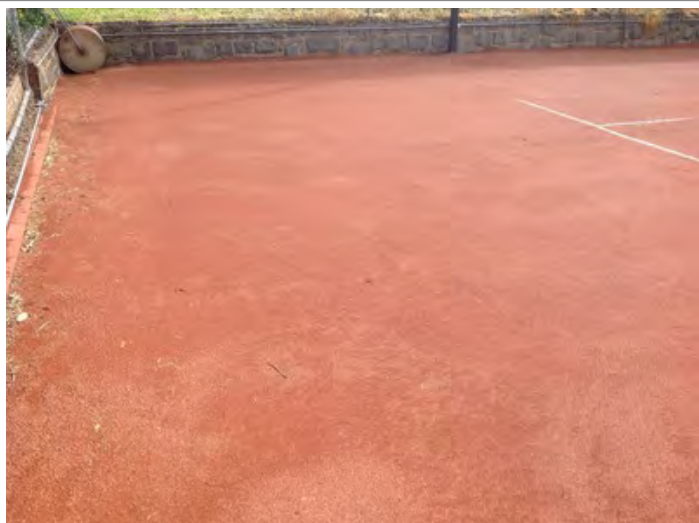
Is the court run off compliant?	no Runoffs North: 4800m South: 4800m East: 3700m West: 3700m
Could the court be made compliant?	no
Is the court to the standard dimensions?	yes
Court orientation	North-south
Are netball goal posts outside tennis court run off areas?	no
Are lockable post hole covers fitted and safe?	no
Compliance notes	The court is not run off compliant to the north or south behind the baselines.
Compliance photos

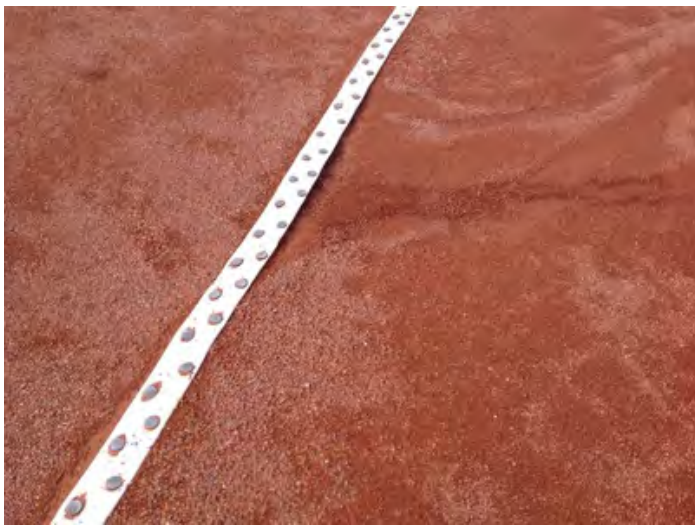
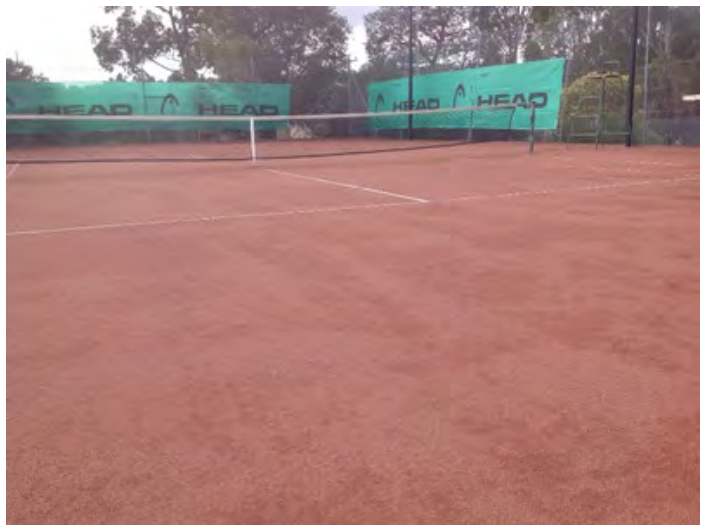
Unique court number	2
Surface condition rating	Good Issues/Observations:
Surface type	Red Porous
Surface life span	10+ years
Court condition notes	This court appears to be in very good condition. There is little sign of puddling and few signs of aggregate showing through the top dressing. There is an area of erosion on the southern baseline which needs to be rectified as it poses a trip hazard.
Court condition photos

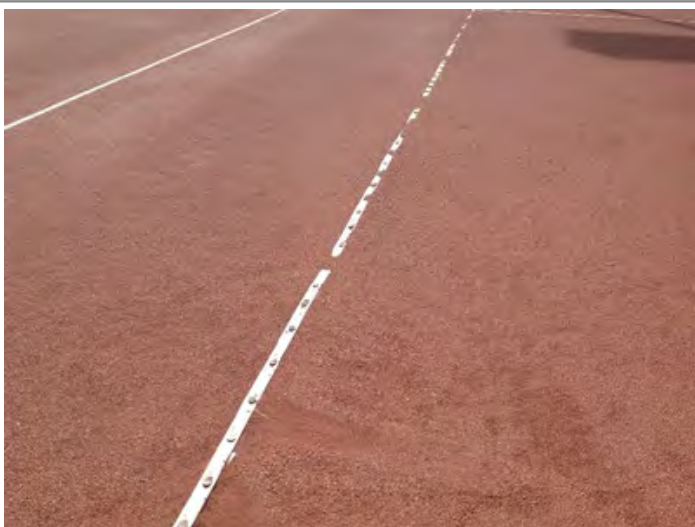
Line marking description	Tennis only lines
Line marking rating	Moderate Issues/Observations: Inconsistent bounce likely
Line marking condition notes	The court lines are standard for a red porous court and are nailed into the surface. They are a little aged but otherwise do not appear to be cracked or broken.

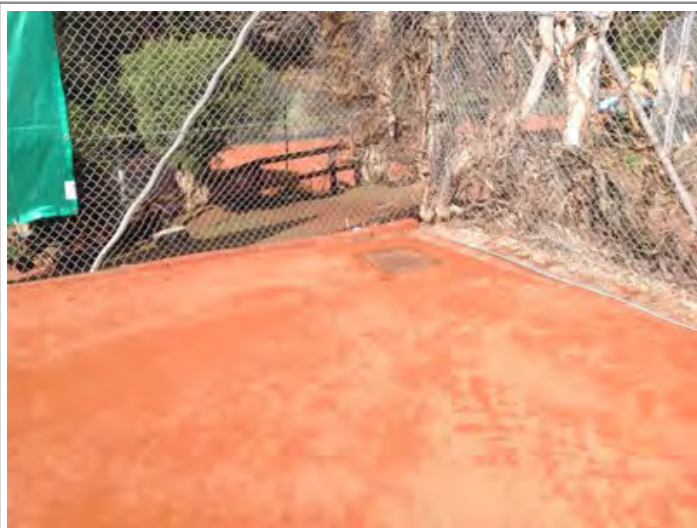
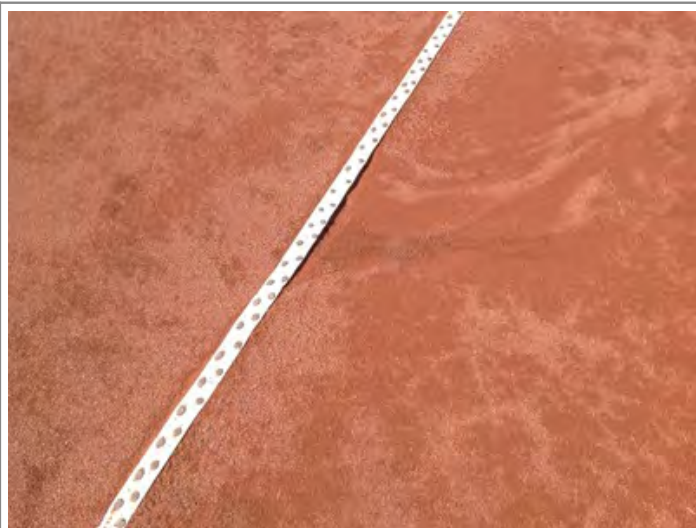
Are drains, pits or other infrastructure provided within the court enclosure?	yes
Are drains, pits or other infrastructure provided within the run-off areas?	yes
Drainage rating	Good
	Issues/Observations:
Drainage notes	Although the courts appear to drain very well, the flow of water across the surface has in some places created erosion at the back of the lines. Otherwise, there are few signs of puddling across the enclosure. The grated pit is located in the south eastern corner.

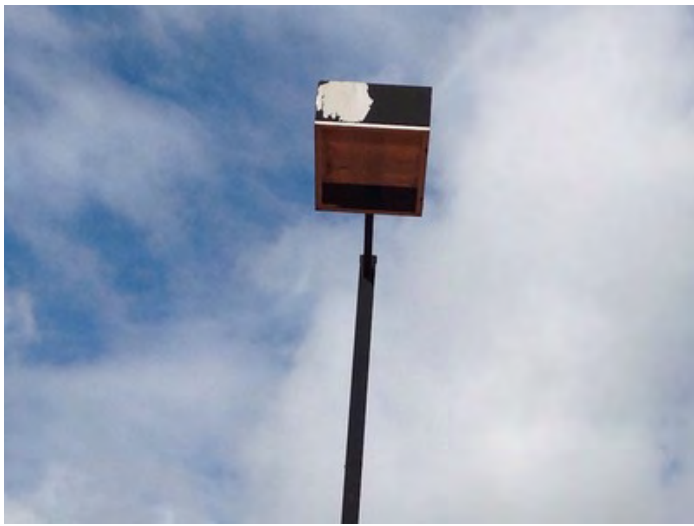
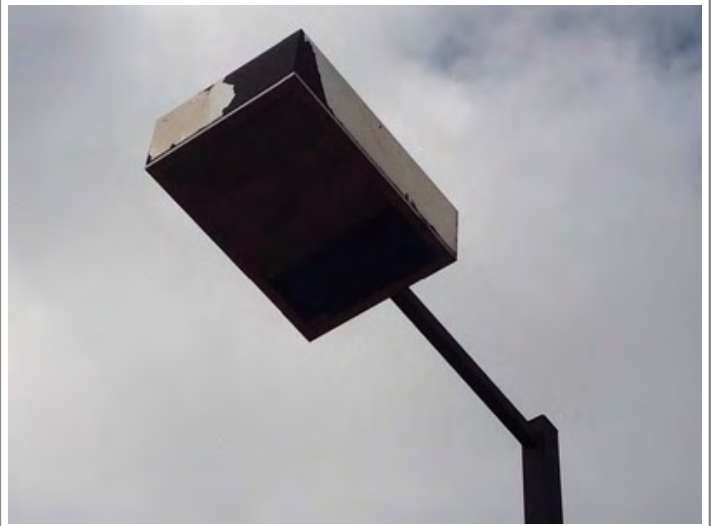
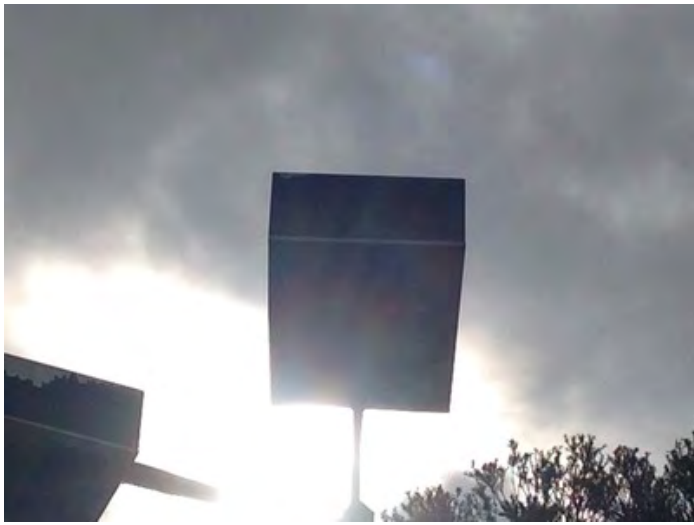
Lighting			
Does this enclosure have lighting	Yes		
Total number of lit courts per enclosure	2		
Lighting infrastructure type	Black powder coated low level - Steel poles		
Lighting infrastructure position	Side		
Light fittings	One per tower		
Lighting infrastructure design	Standard		
Lighting infrastructure rating	Moderate		
	Issues/Observations:		
Lighting life span	6-10 years		
Lighting notes	The lighting is subject to large pieces of paint which have peeled from the lighting boxes. On some lights, it appears some rust has begun to collect.		
Lighting photos

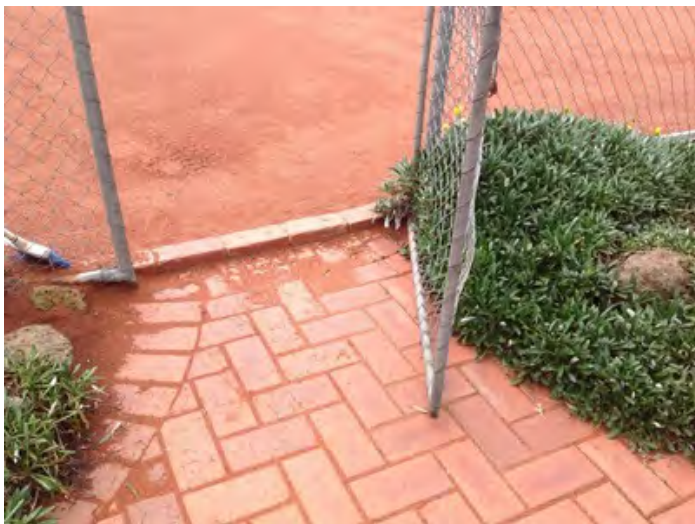
Court enclosure accessibility	Formed paths Trip hazards identified: yes Ramped access provided: no
Path material(s)	Other material?
Main gate dimensions	Standard pedestrian gate 1000mm x 2100mm
Accessibility notes	Pavers lead from the clubhouse to the enclosure. There is a step to enter into the enclosure.

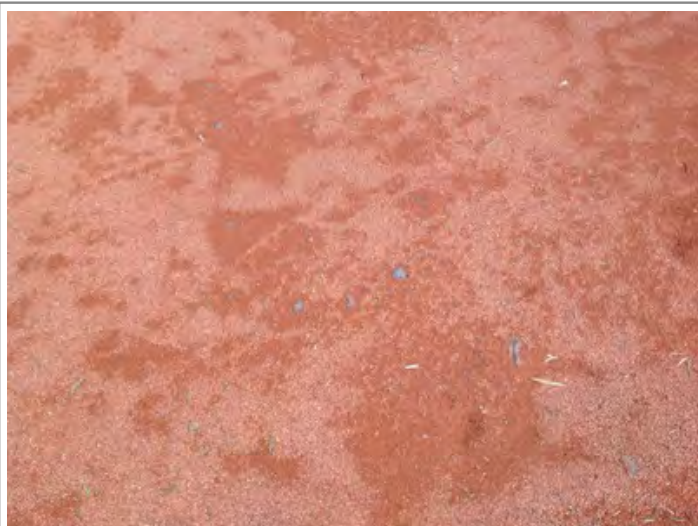
Unique court number	8
Surface condition rating	Moderate Issues/Observations: Aged surface Excessively worn surface in high wear areas
Surface type	Red Porous
Surface life span	10+ years
Court condition notes	The court has some signs of aggregate showing through the top dressing of the surface. There is some leaf litter across the court due to trees and bushes being in close proximity.

Are there any critical safety issues?	No
Enclosure recommendations	Plan for the upgrade of the court surface in the long term. Plan for replacement of fencing.

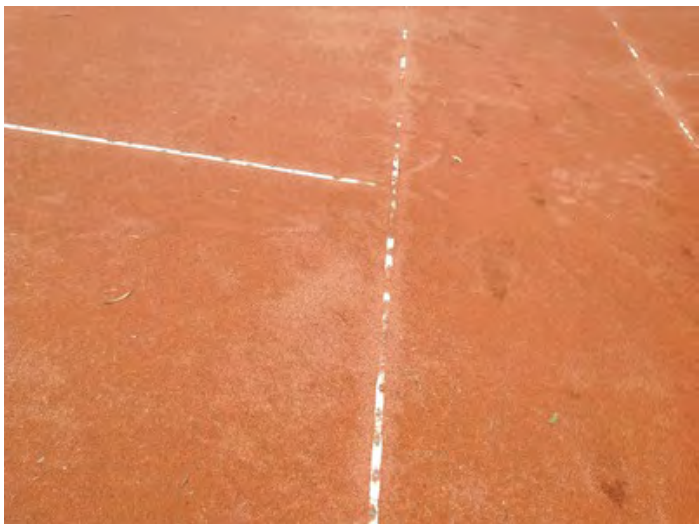
Line marking rating	Moderate
	Issues/Observations: Inconsistent bounce likely
Line marking condition notes	The court lines are standard for a red porous court and are nailed into the surface. They are a little aged but otherwise do not appear to be cracked or broken.
Line marking condition photos

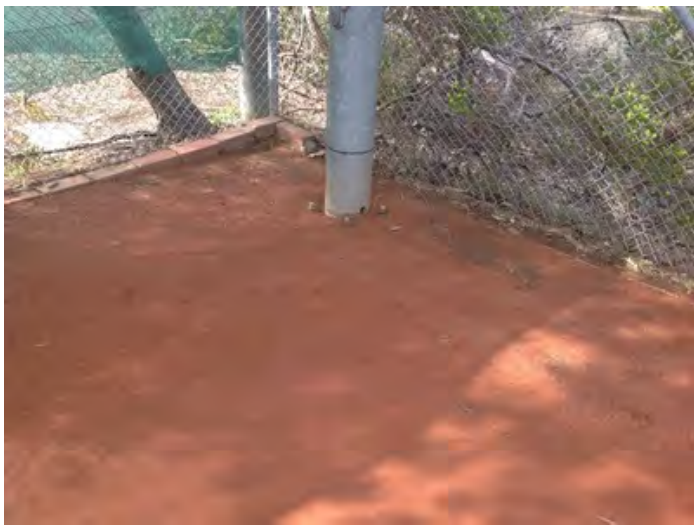
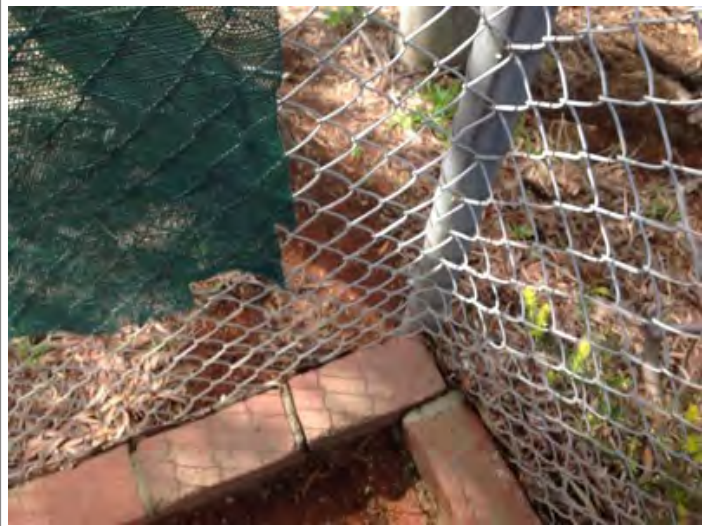
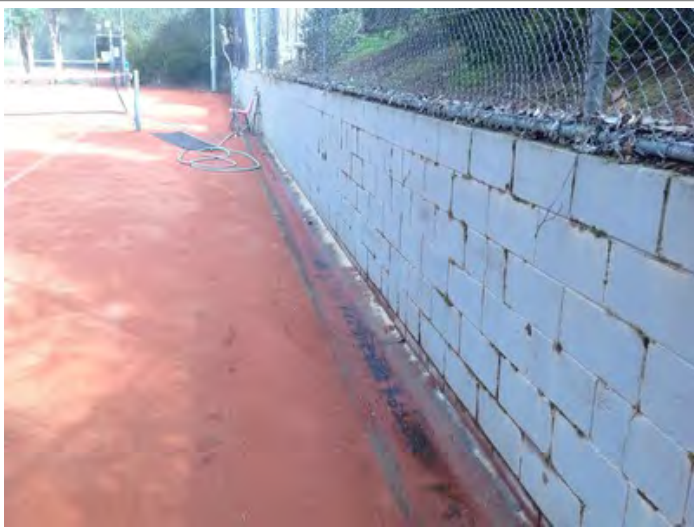
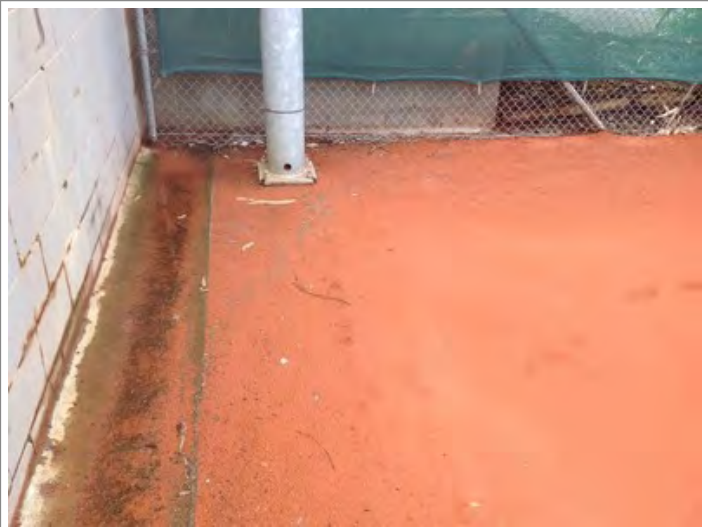
Drainage infrastructure	Formed
What type of drainage is in place?	Concrete spoon drains
Are drains, pits or other infrastructure provided within the court enclosure?	yes
Are drains, pits or other infrastructure provided within the run-off areas?	no
Drainage rating	Moderate
	Issues/Observations: Leaf litter build up
Drainage notes	A concrete spoon drain runs along the western and northern border, and appears to run off down the embankment into a garden bed and eventually into a drain located in the car park. There is extensive leaf litter in the spoon drain.

Court	Trim trees/shrubs away from court enclosure and fencing Hang drag mats on fencing
Drainage	Remove build-up of debris from drainage infrastructure to allow efficient water movement.
Infrastructure	Repair damaged fencing Trim vegetation away from fencing
Lighting	Conduct a lighting lux level test

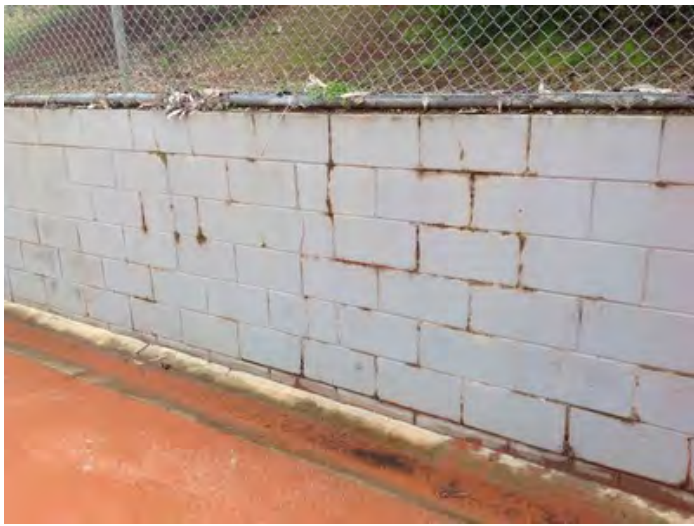
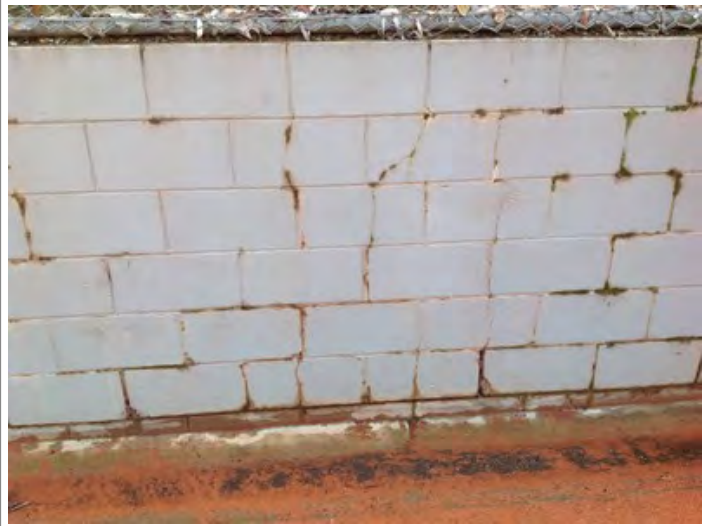
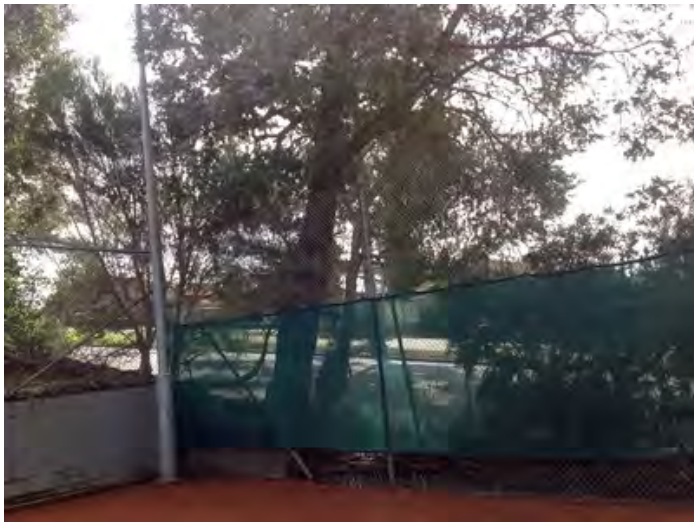
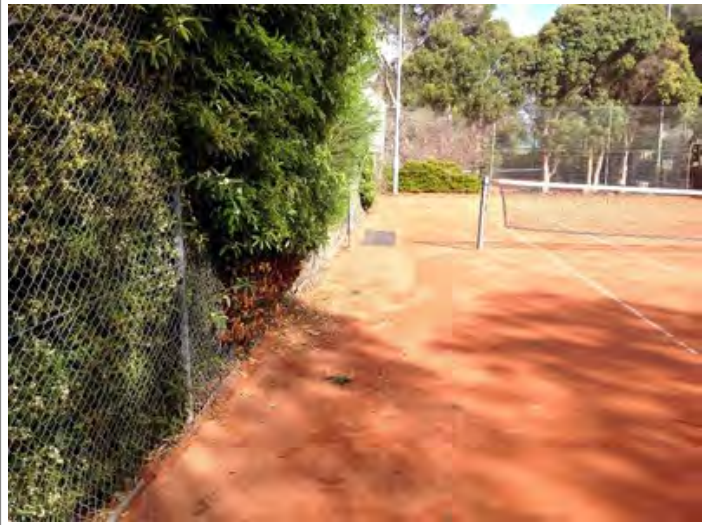
Fence type	Galvanised chain mesh
Fence Rails	Fence rail top: no Fence rail bottom: yes
Fence height	3m to 3.5m Low level side fencing installed: yes
Fence attachments	There are no fence attachments.
Fence condition rating	Poor Issues/Observations: Slack mesh Rusted mesh Damaged mesh Excessive gap under fencing - allows balls to escape enclosure Trees overhanging enclosure Trees/shrubs growing through mesh
Fencing life span	6-10 years
Fence notes	There is extensive damage to the fence throughout the enclosure. Whilst it is generally stable, it will continue to deteriorate over time.
Fencing photos

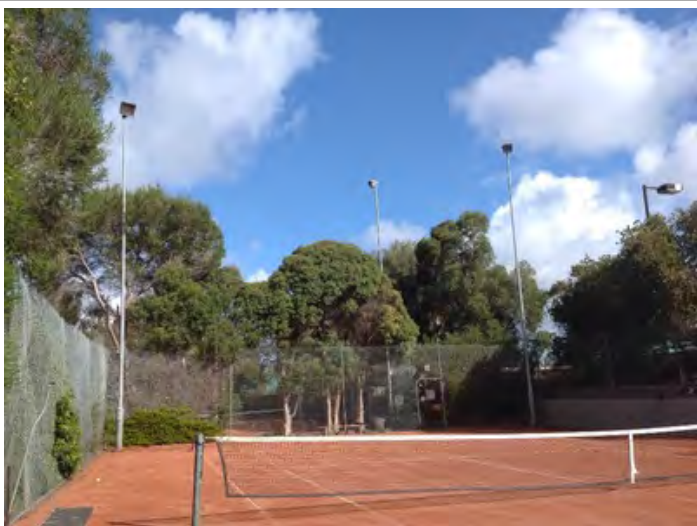
Does this enclosure have lighting	Yes
Total number of lit courts per enclosure	1
Lighting infrastructure type	High tower - Steel poles
Lighting infrastructure position	Corner
Light fittings	One per tower
Lighting infrastructure design	Standard
Lighting infrastructure rating	Moderate
	Issues/Observations: Old however in good condition - potential upgrade required
Lighting life span	6-10 years
Lighting notes	The lighting would likely not meet minimum lux standards for night tennis, although the infrastructure is otherwise in good condition.
Lighting photos

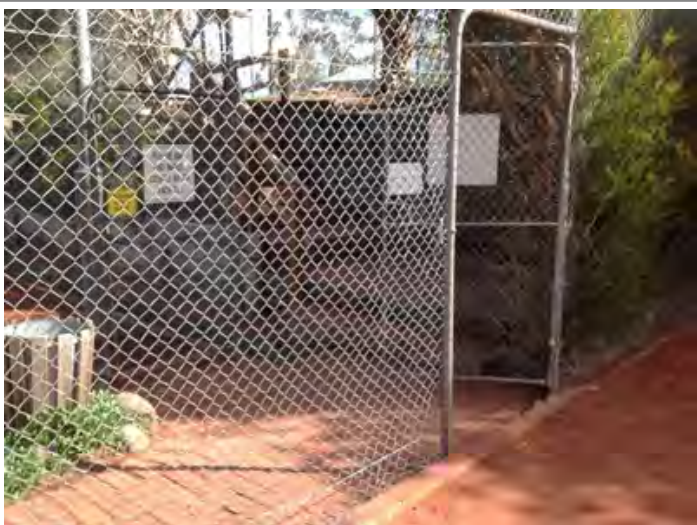
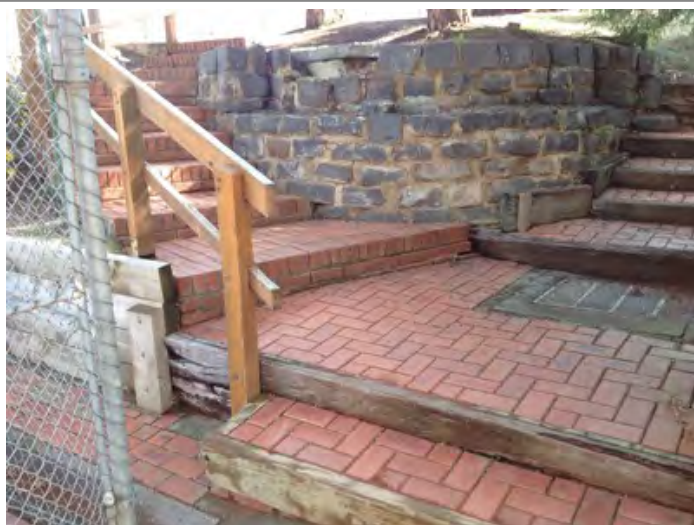
Court enclosure accessibility	Formed paths Trip hazards identified: yes Ramped access provided: no
Path material(s)	Concrete
Main gate dimensions	Standard pedestrian gate 1000mm x 2100mm
Accessibility notes	Users are required to step over pavers to enter the enclosure.

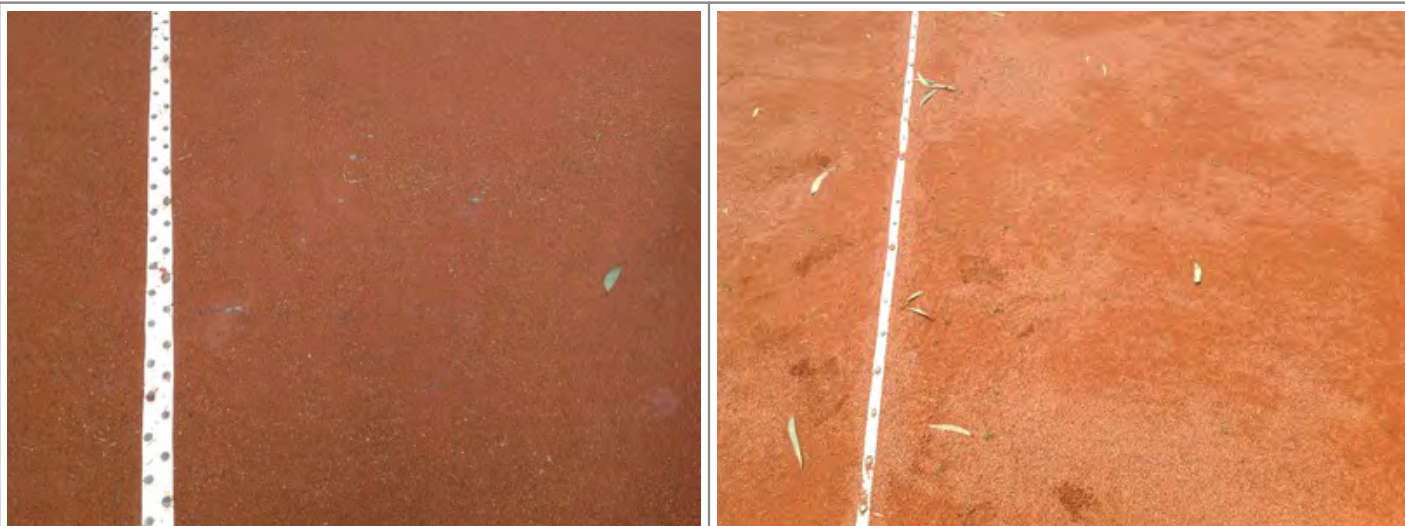
Unique court number	7
Surface condition rating	Moderate Issues/Observations: Weed growth Aged surface Excessively worn surface in high wear areas
Surface type	Red Porous
Surface life span	10+ years
Court condition notes	The court has some signs of aggregate showing through the top dressing of the surface. There is some leaf litter across the court due to trees and bushes being in close proximity.

Repair lines
Drainage	
Infrastructure	Repair damaged fencing Trim vegetation away from fencing
Lighting	Conduct a lighting lux level test
Safety Issues	
Are there any critical safety issues?	No
Enclosure recommendations	Plan for upgrade to court base to rectify the compacted surface. Plan for upgrade to fencing.

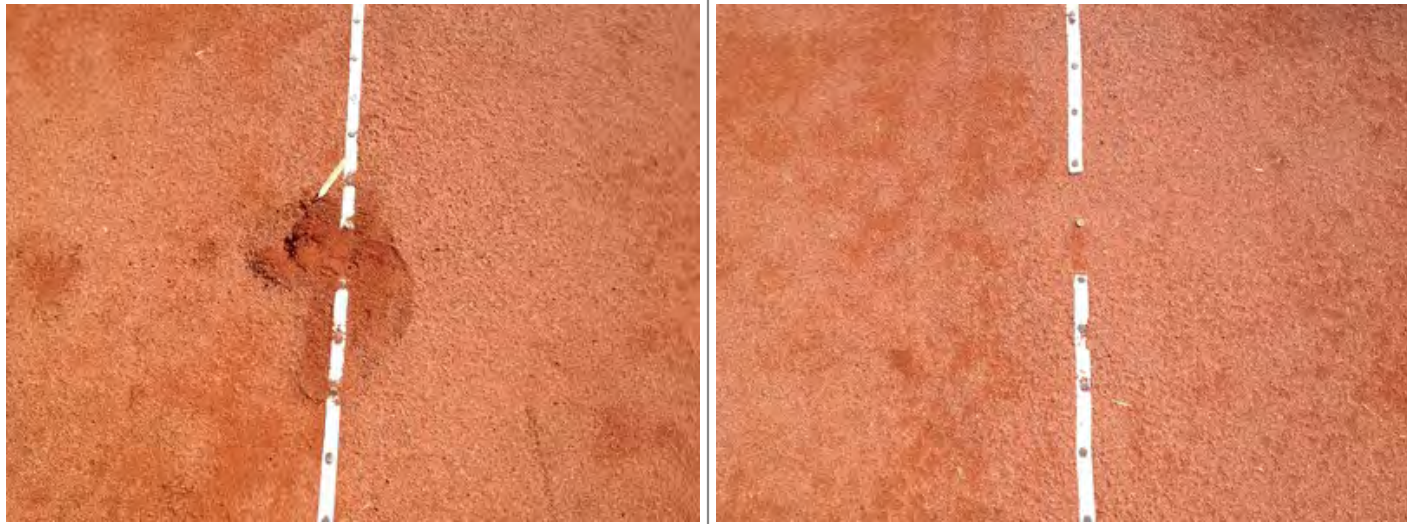
Line marking rating	Moderate
	Issues/Observations: Cracked Inconsistent bounce likely
Line marking condition notes	The court lines are standard for a red porous court and are nailed into the surface. They are a little aged but otherwise do not appear to be cracked or broken, except along the service line of the southern end.
Line marking condition photos

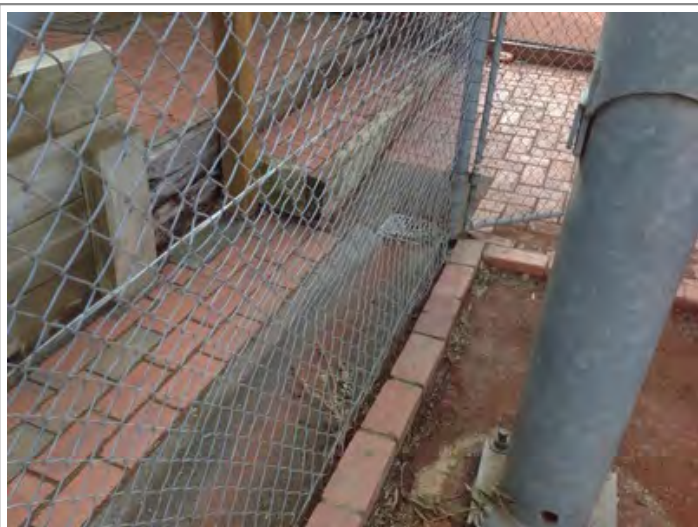
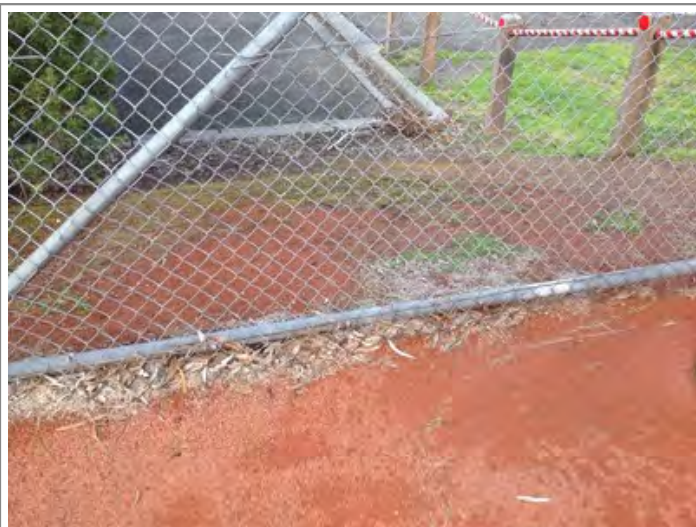
Drainage infrastructure	Formed
What type of drainage is in place?	Concrete spoon drains
Are drains, pits or other infrastructure provided within the court enclosure?	no
Are drains, pits or other infrastructure provided within the run-off areas?	no
Drainage rating	Good
	Issues/Observations:
Drainage notes	A concrete spoon drain runs along the western border, into the north western corner to a small pit drain. Additionally, the court falls away down a grassed slope on the eastern side and there is evidence that water flows off this way too.

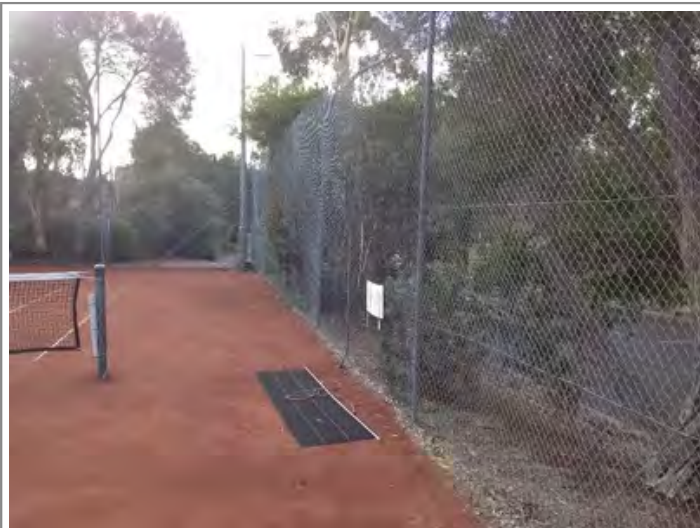
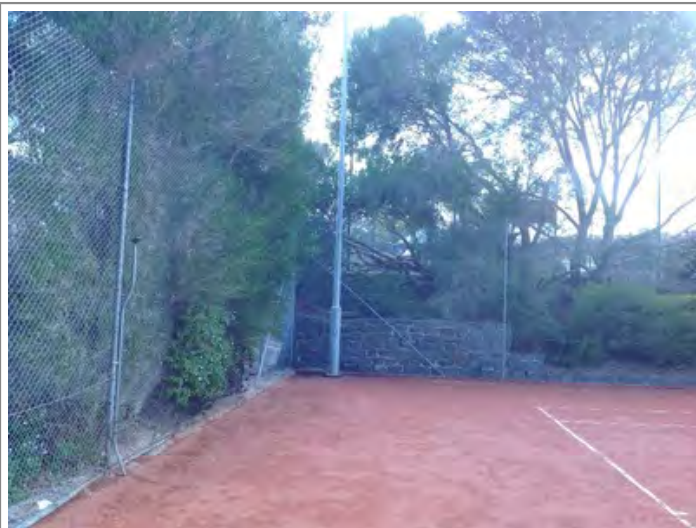
Fence type	Galvanised chain mesh
Fence Rails	Fence rail top: no Fence rail bottom: yes
Fence height	3m to 3.5m Low level side fencing installed: yes
Fence attachments	There are no fence attachments.
Fence condition rating	Poor Issues/Observations: Slack mesh Rusted mesh Damaged mesh Excessive gap under fencing - allows balls to escape enclosure Trees overhanging enclosure Trees/shrubs growing through mesh
Fencing life span	6-10 years
Fence notes	There is extensive damage to the fence throughout the enclosure. Whilst it is generally stable, it will continue to deteriorate over time.

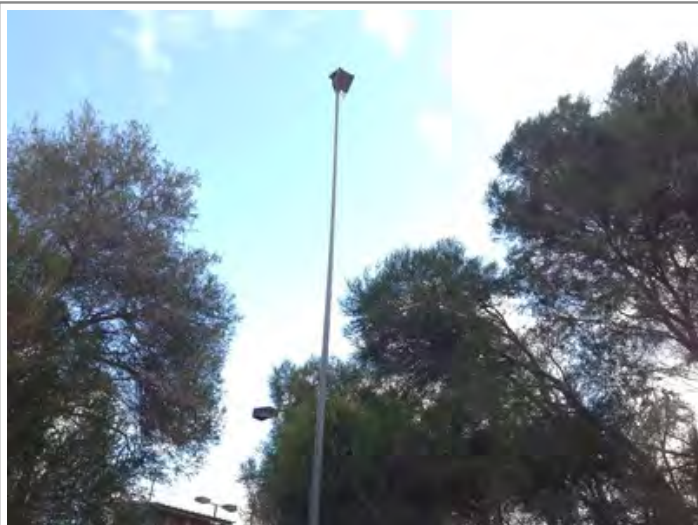
Lighting life span	6-10 years
Lighting notes	This lighting design should be tested to discover if it is appropriate for night tennis, although it is in otherwise good condition.
Lighting photos

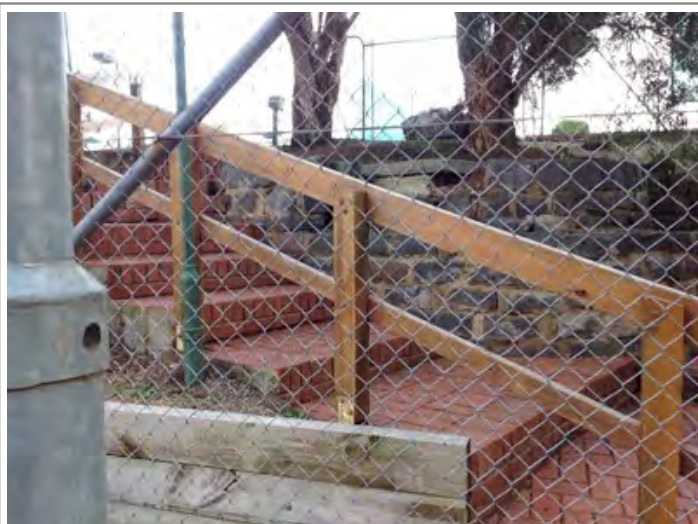
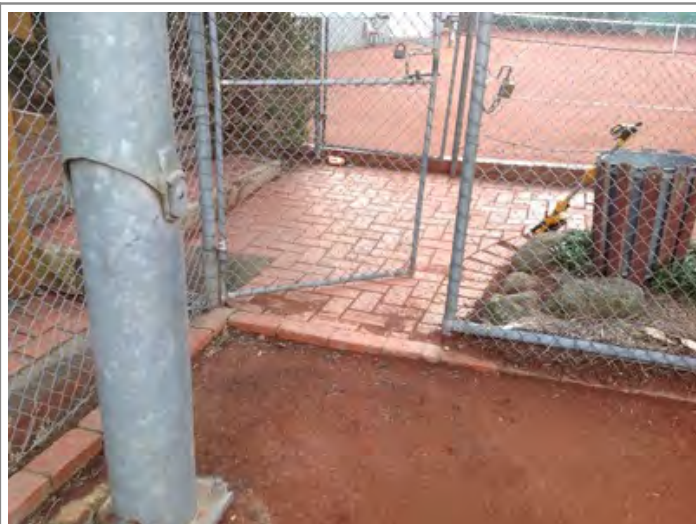
Court enclosure accessibility	Formed paths Trip hazards identified: yes Ramped access provided: no
Path material(s)	Other material?
Main gate dimensions	Standard pedestrian gate 1000mm x 2100mm
Accessibility notes	Pavers lead from the clubhouse to the enclosure. There is a step to enter into the enclosure, and also a series of steps down to the enclosure from the path between the upper enclosures.

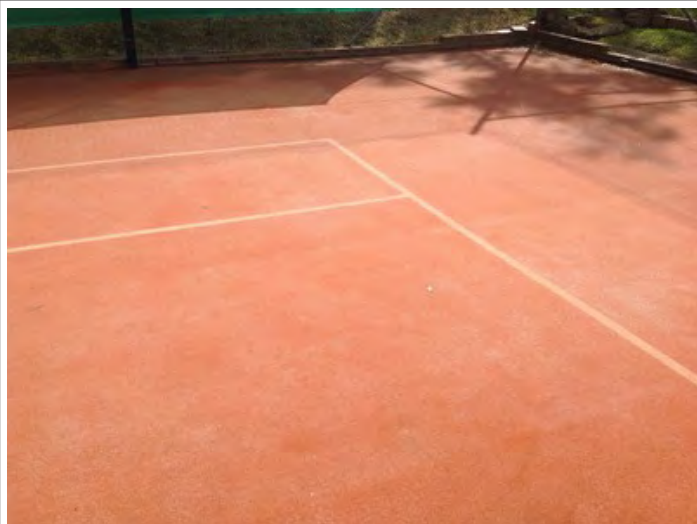
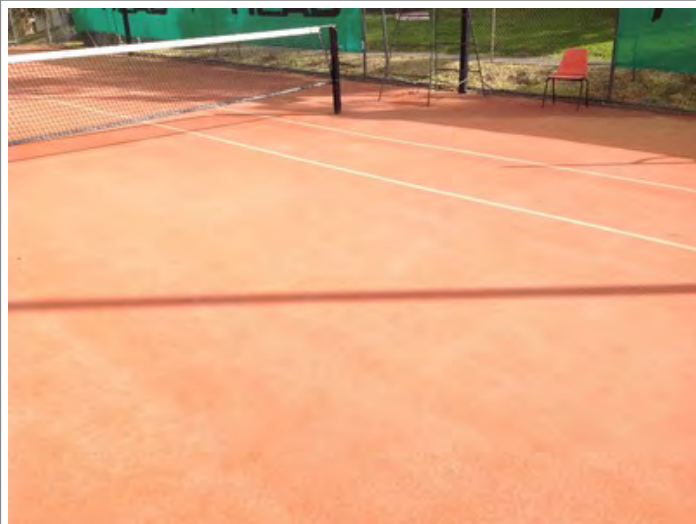
Unique court number	4
Surface condition rating	Good
	Issues/Observations:
Surface type	Synthetic Clay
Surface life span	6-10 years
Court condition notes	This court appears to be in very good condition. There are no obvious signs of seam stress and there is an even cover of sand across the surface.

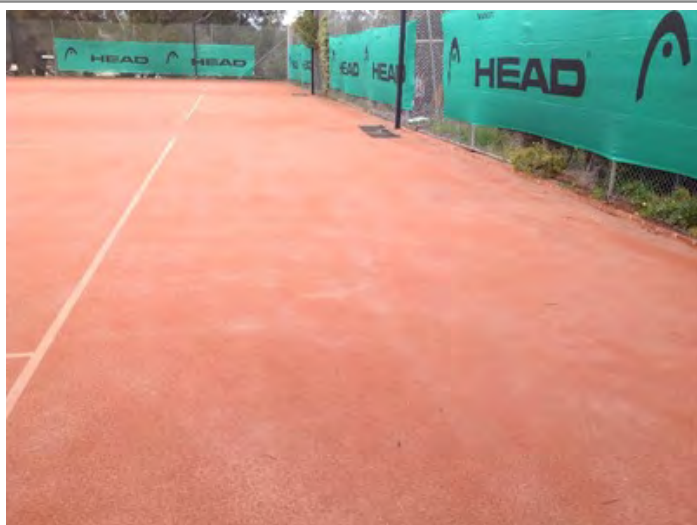
Are netball goal posts outside tennis court run off areas?	no
Are lockable post hole covers fitted and safe?	no
Compliance notes	The court is not run off compliant to the north or south behind the baselines.
Compliance photos

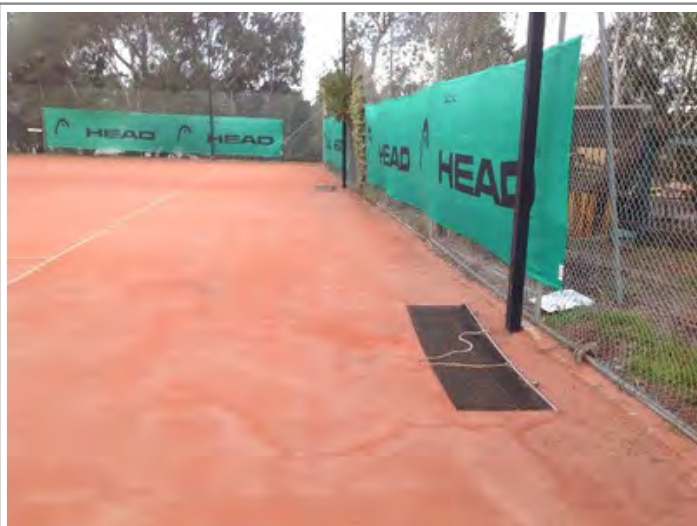
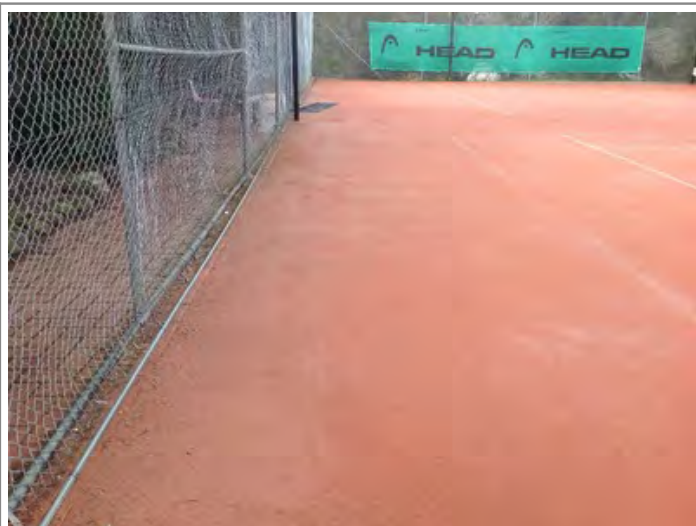
Are drains, pits or other infrastructure provided within the run-off areas?	yes
Drainage rating	Good
	Issues/Observations: Ponding evident
Drainage notes	There is no apparent drainage infrastructure for these courts. Instead, they appear to drain straight through the surface. There are some signs of pooling of water along the southern and northern fence lines.

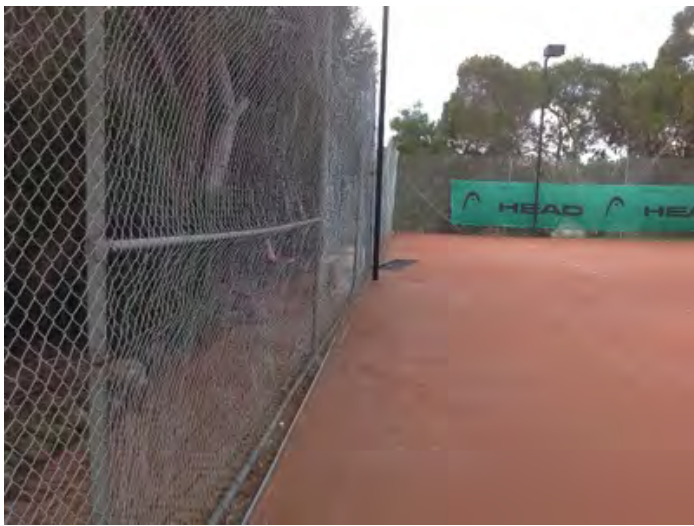
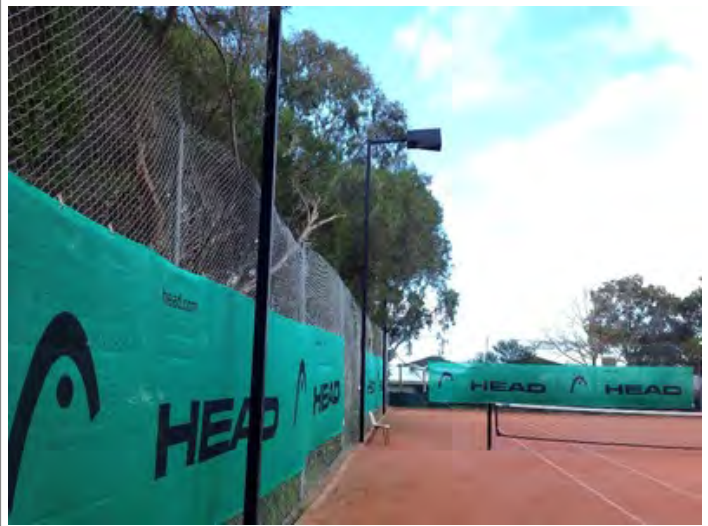
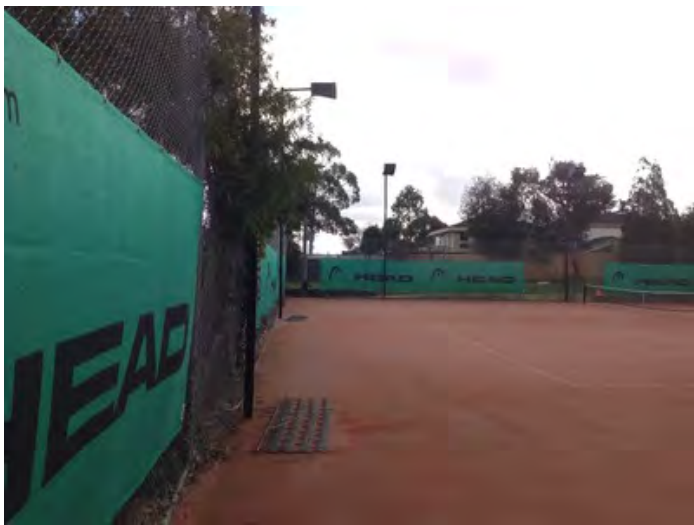
Fence type	Galvanised chain mesh
Fence Rails	Fence rail top: no Fence rail bottom: yes
Fence height	3m to 3.5m Low level side fencing installed: no
Fence attachments	Sightscreens Windbreaks
Fence condition rating	Poor
	Issues/Observations: Slack mesh Rusted mesh Damaged mesh Excessive gap under fencing - allows balls to escape enclosure Trees overhanging enclosure Trees/shrubs growing through mesh
Fencing life span	6-10 years
Fence notes	There is extensive damage to the fence throughout the enclosure. Whilst it is generally stable, it will continue to deteriorate over time.

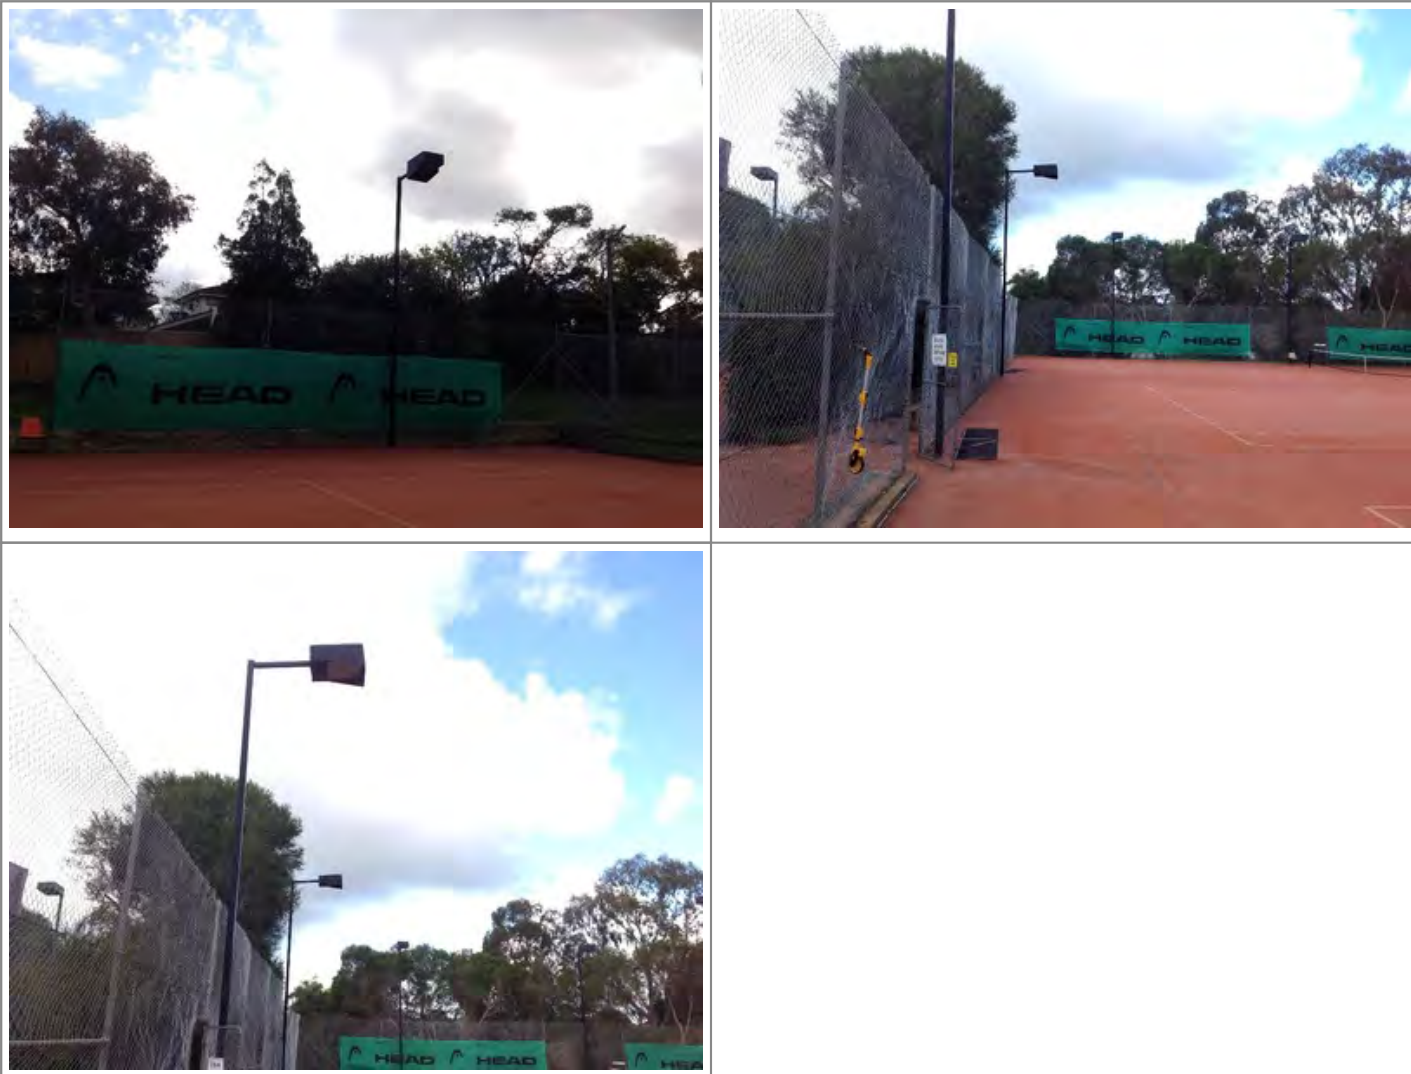
Does this enclosure have lighting	Yes
Total number of lit courts per enclosure	3
Lighting infrastructure type	Black powder coated low level - Steel poles
Lighting infrastructure position	Side
Light fittings	One per tower
Lighting infrastructure design	Standard
Lighting infrastructure rating	Good
	Issues/Observations: Infrastructure and fittings in very good condition - likely to achieve required lux standards
Lighting life span	6-10 years
Lighting notes	The lighting all appears in good condition. They do, however, have a non-standard capping around the light fitting. This capping in the light between courts four and five and five and six at the northern end rattles and makes a noise when subject to wind. It is unknown if it requires attention or not.

Are there any critical safety issues?	No
Enclosure recommendations	Investigate the rattling lights at the northern end between courts four and five and five and six. Plan for upgrade to fencing.

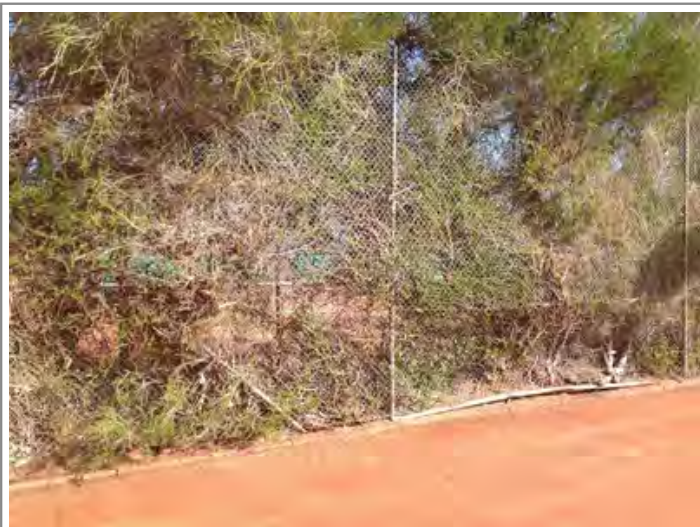
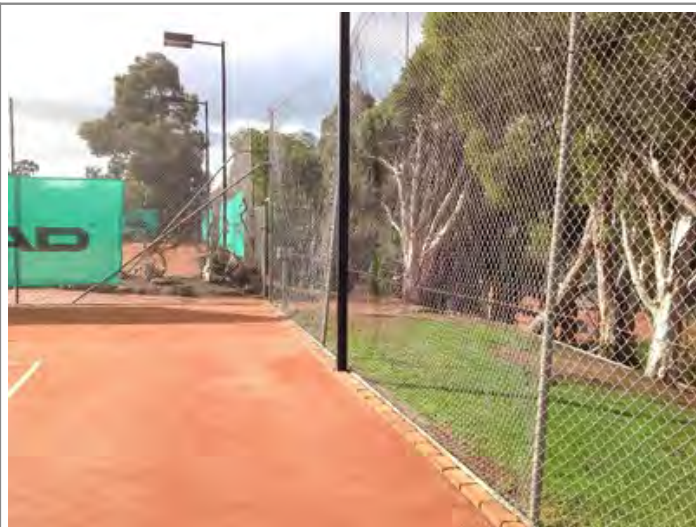
Fence attachments	There are no fence attachments.
Fence condition rating	Poor Issues/Observations: Slack mesh Rusted mesh Damaged mesh Excessive gap under fencing - allows balls to escape enclosure Trees overhanging enclosure Trees/shrubs growing through mesh
Fencing life span	6-10 years
Fence notes	There is extensive damage to the fence throughout the enclosure. Whilst it is generally stable, it will continue to deteriorate over time.

Are there any critical safety issues?	No
Enclosure recommendations	Plan for upgrade to fencing.

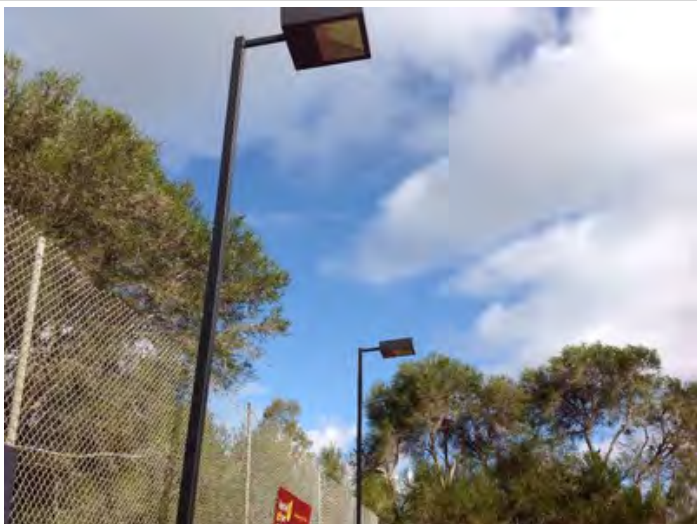
Does this enclosure have lighting	Yes
Total number of lit courts per enclosure	1
Lighting infrastructure type	Black powder coated low level - Steel poles
Lighting infrastructure position	Side
Light fittings	One per tower
Lighting infrastructure design	Standard
Lighting infrastructure rating	Very Good Issues/Observations: Infrastructure and fittings in very good condition - likely to achieve required lux standards
Lighting life span	6-10 years
Lighting notes	The lighting appears very new, and does not have the non-standard fittings evident in enclosure four.
