Arboricultural Impact Assessment & Tree Management Report

421 Upper Heidelberg Road, Ivanhoe

Prepared for Development Victoria

Tree Logic Ref. 12133

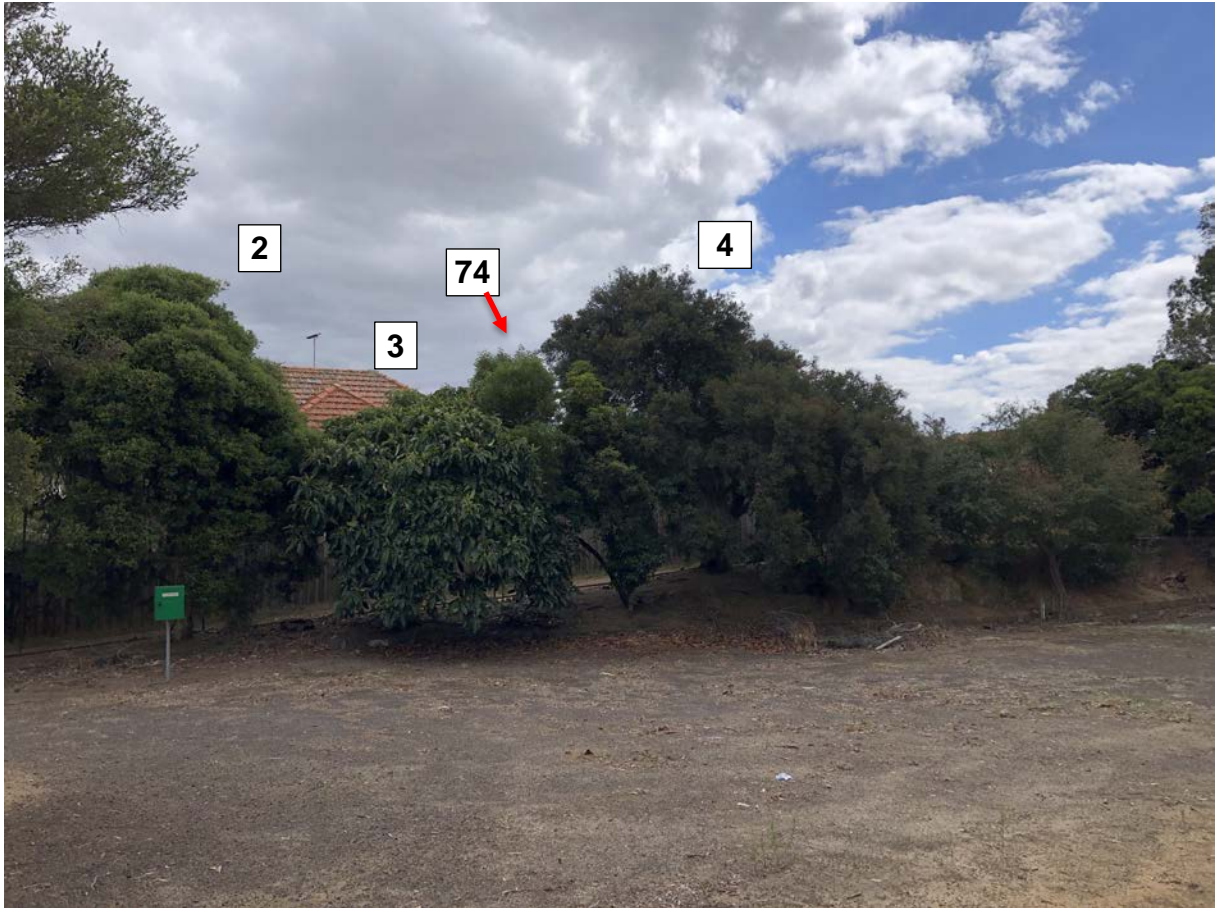
Image 1: Trees along the western boundary, facing northwest within proposed new Park.

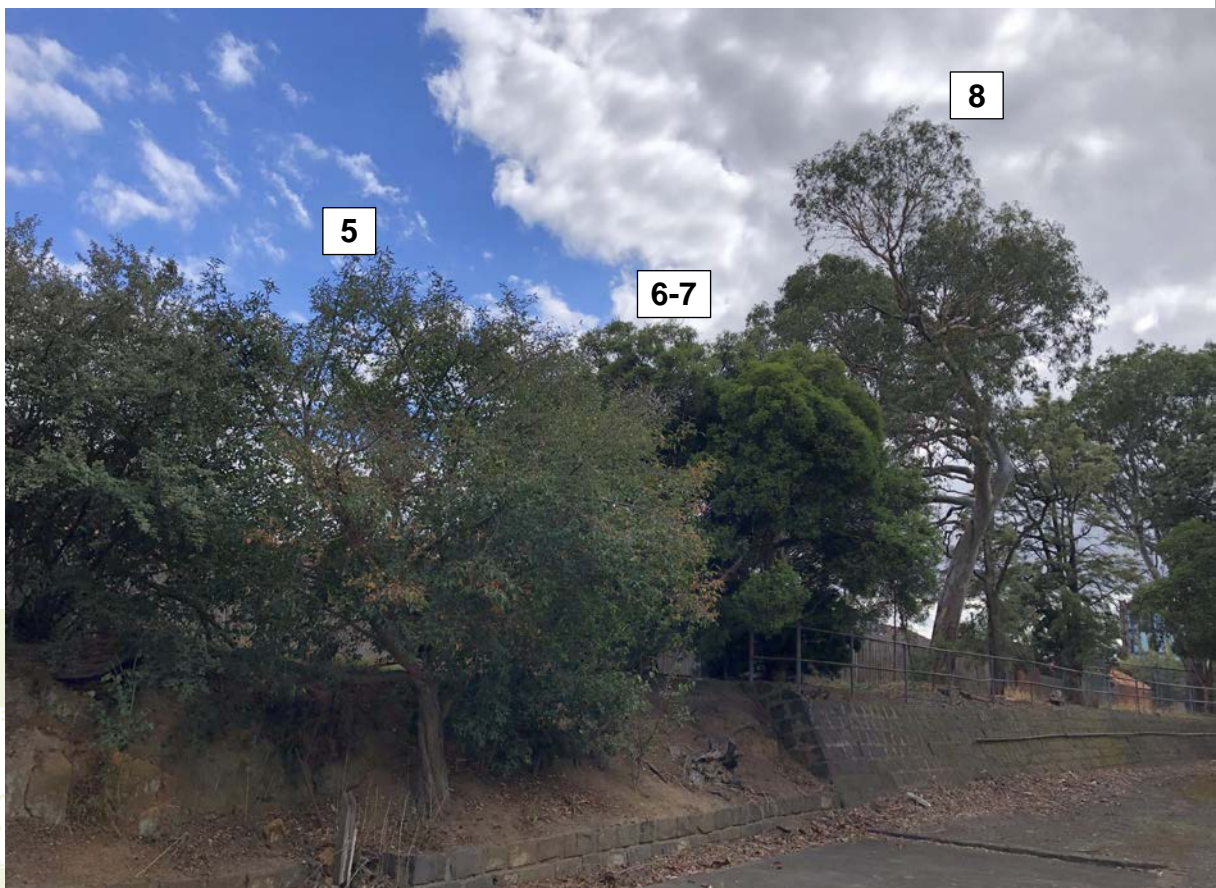
Image 2: Trees along the western boundary, facing north within proposed new Park.

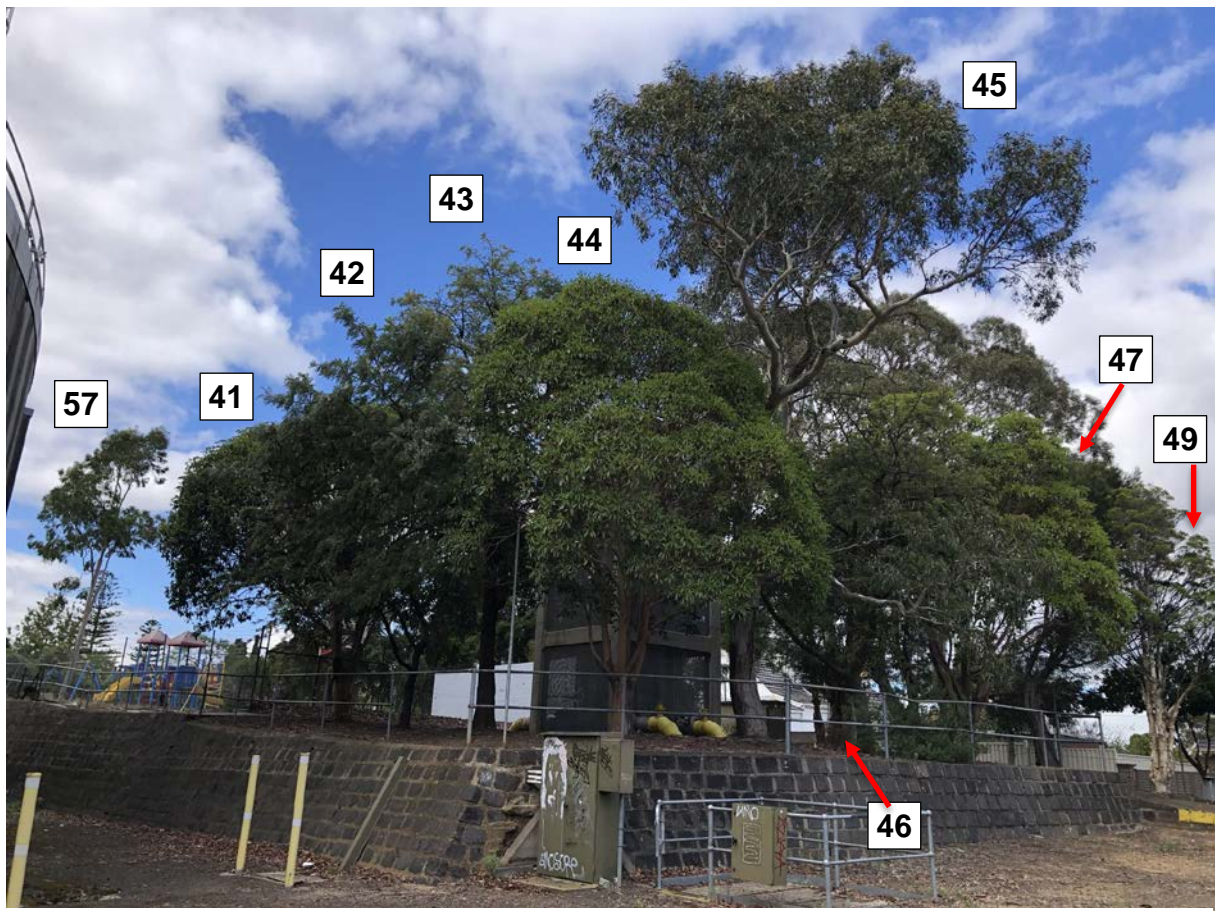
Image 3: Trees around pump infrastructure south-west of tank, facing south will be mostly within the new Park. Tree 57 will need to be removed.

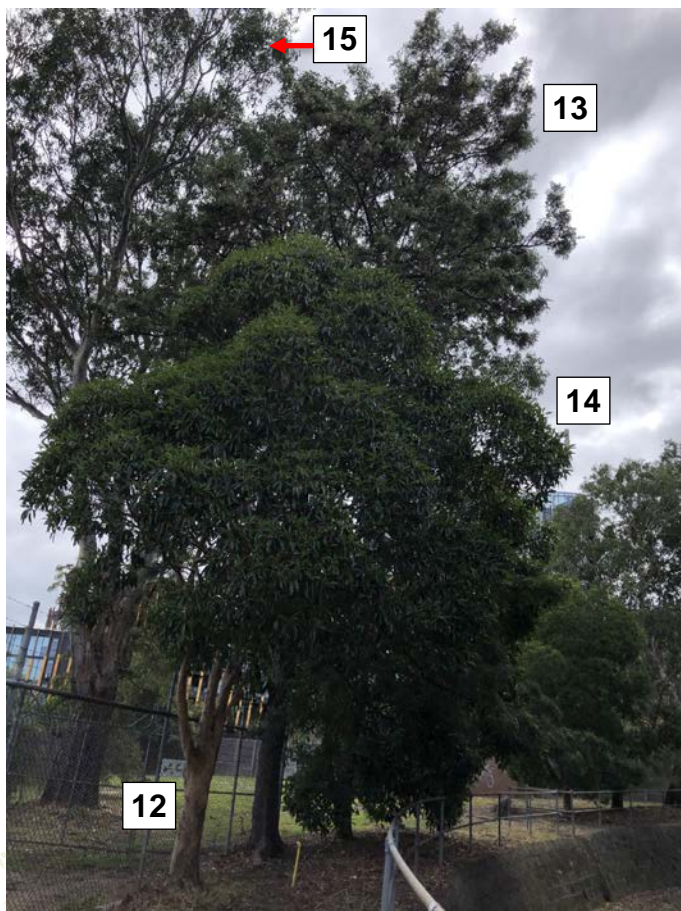
Image 4: Trees along western boundary, facing northeast. These trees will be impacted by proposed development.

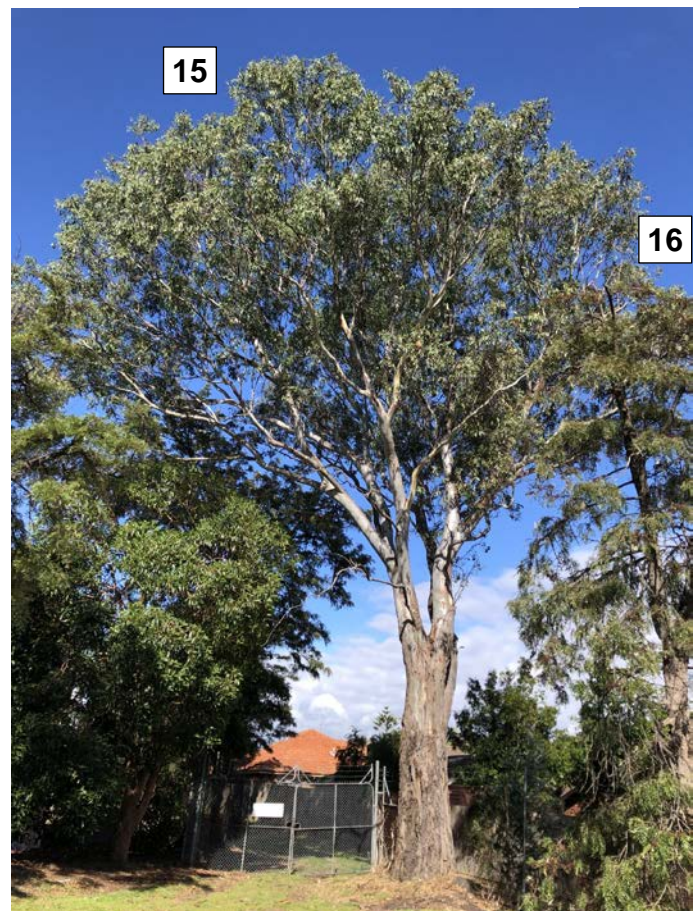
This includes Tree 15, a Moderate A rated River Red Gum, which cannot be retained under the proposed design due to a TPZ encroachment of approximately 32% (irrespective of location of retaining walls) and no contiguous root space for the tree to recover from such significant root loss. Additionally, retention of such a large tree of this species in such close proximity to a new development is not recommended due to ongoing maintenance issues as well as the high risk potential from large tree part failure onto building structures, due to tree decline exacerbated by construction impacts.

Image 5: Closeup of Tree 15, Mod. A-rated River Red Gum in northwest corner of site, facing west. The tree will be unsustainable with proposed development.

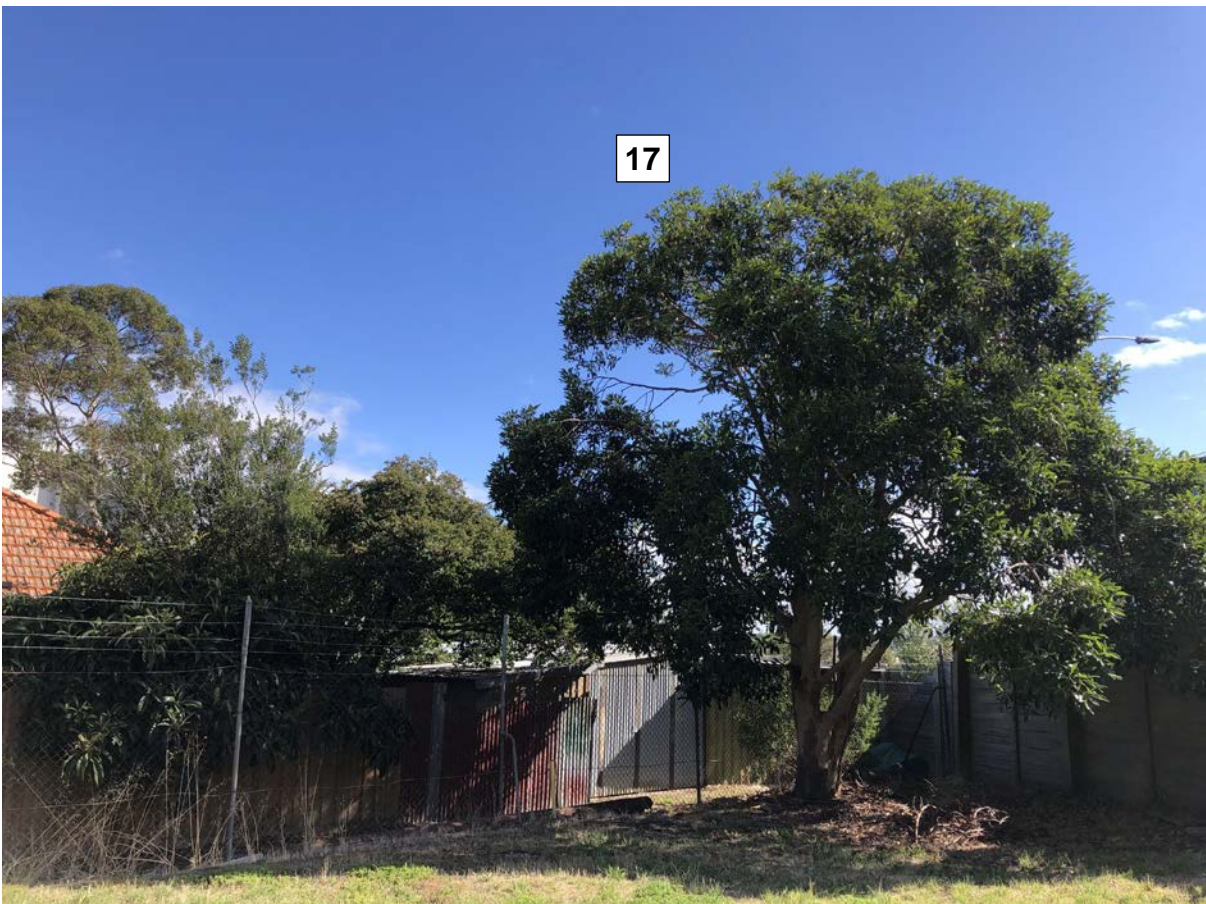
Image 6: Tree 17 and surrounds will be impacted by 13% TPZ incursion. It could be retained with arborist supervision during initial site works and will require TPZ fencing at edge of works for the duration of construction works.

- Tree 17 will have TPZ encroachment of 13%. Arborist supervision will be required when the initial site excavation works occur to determine the quantity and condition of any roots exposed during the initial excavation and to appropriately prune them if necessary.

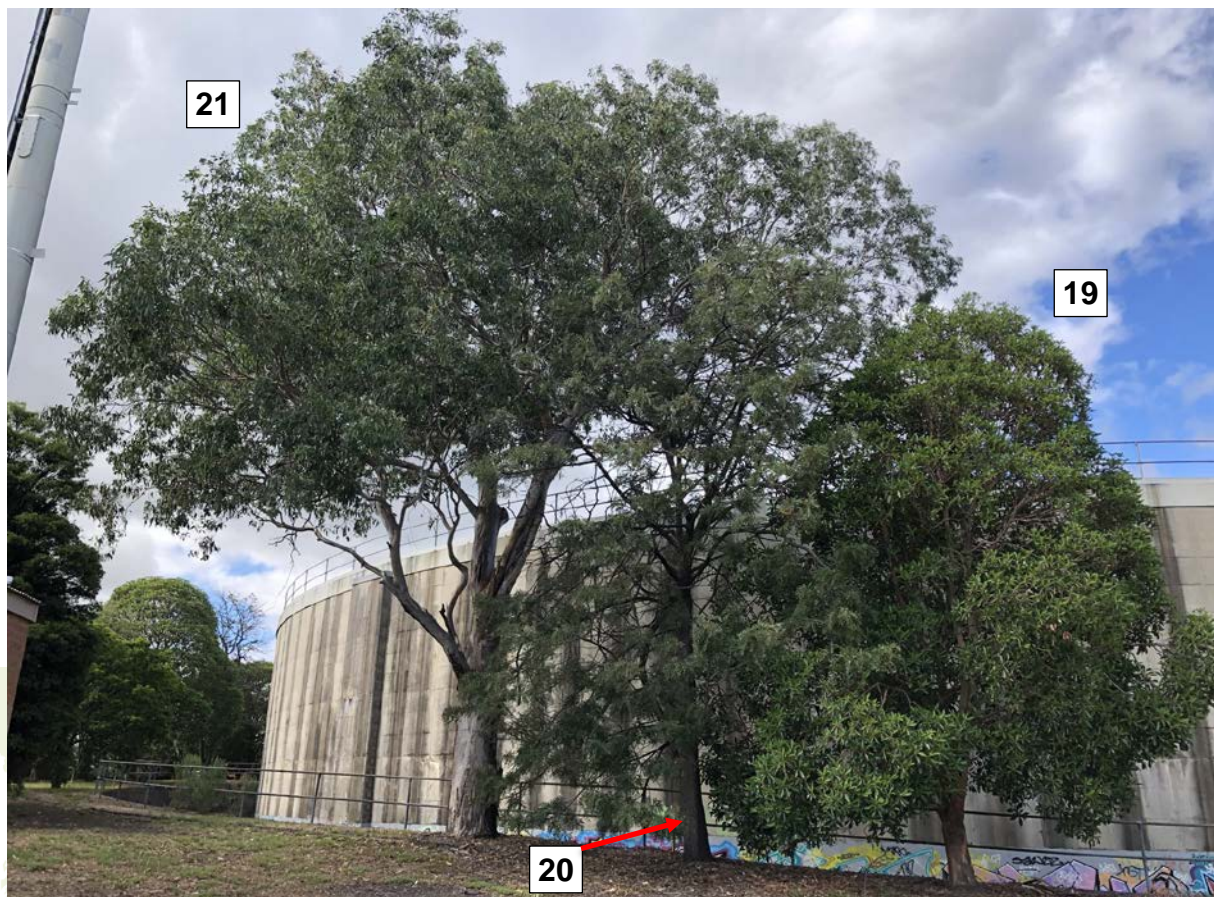
Image 7: Trees along northern portion of retaining wall, facing southeast are within the design footprint and cannot be retained.

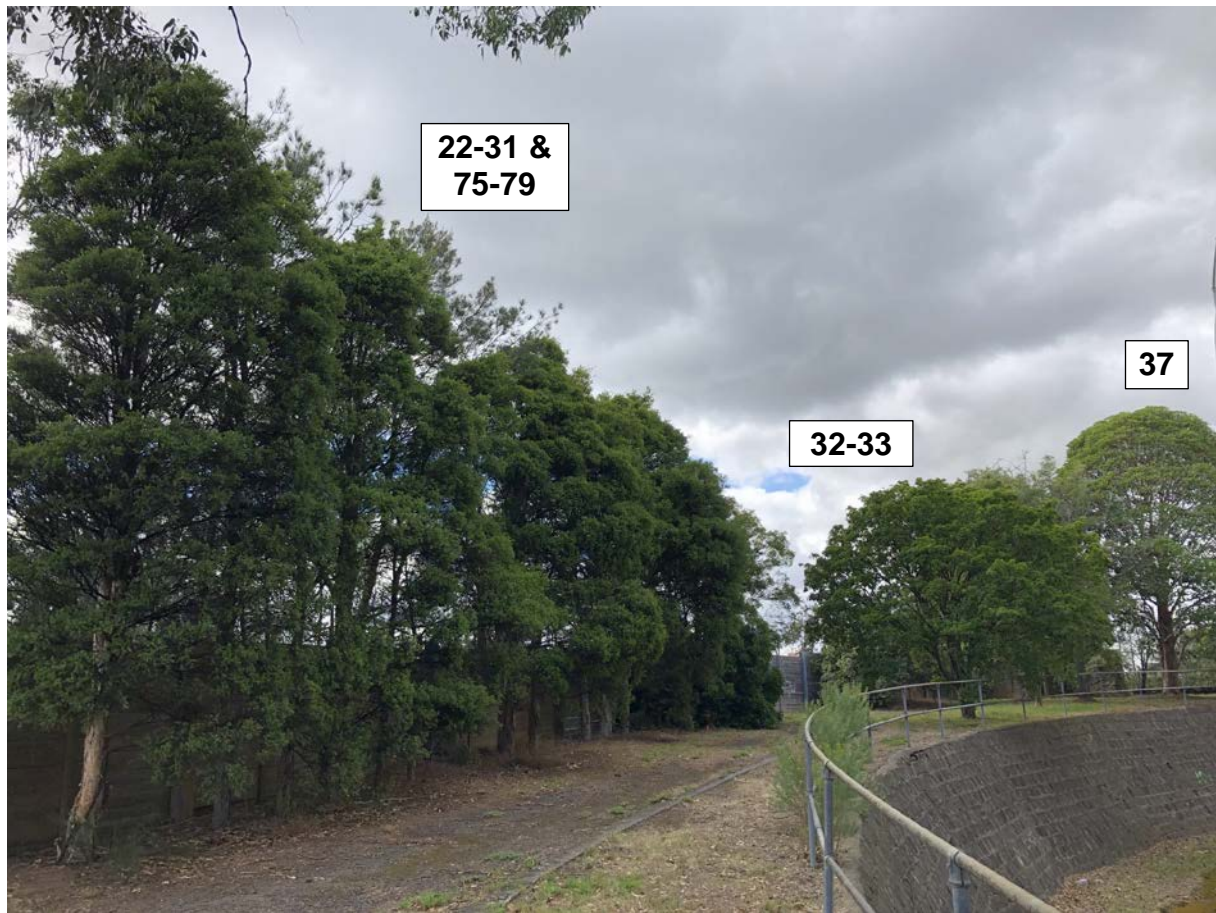
Image 8: Trees along northern boundary of tank site, facing east. All are within the design footprint and cannot be retained.

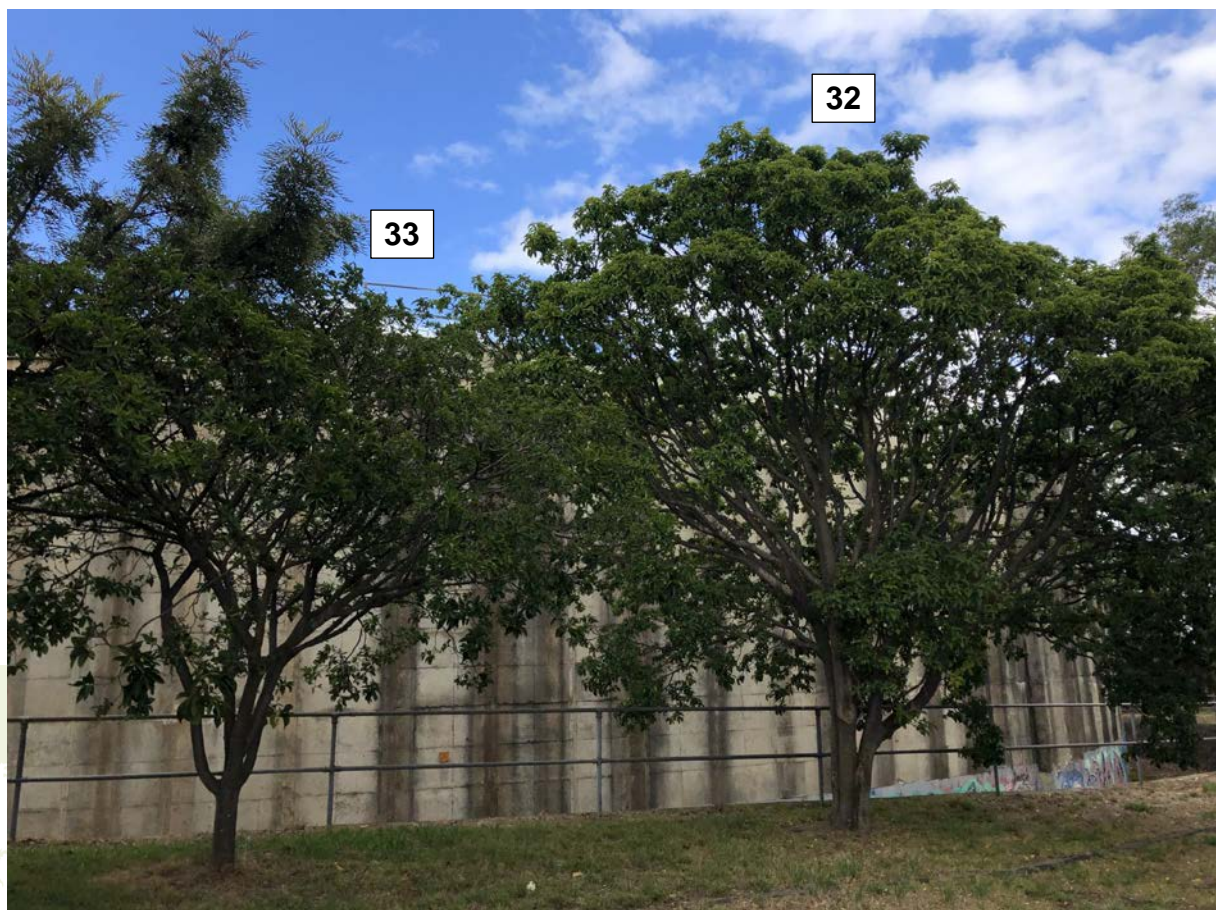
Image 9: Trees 32-33, Cape Chesnut (*Calodendrum capense*) in north east corner of tank site are within the design footprint and cannot be retained. (Facing southwest)

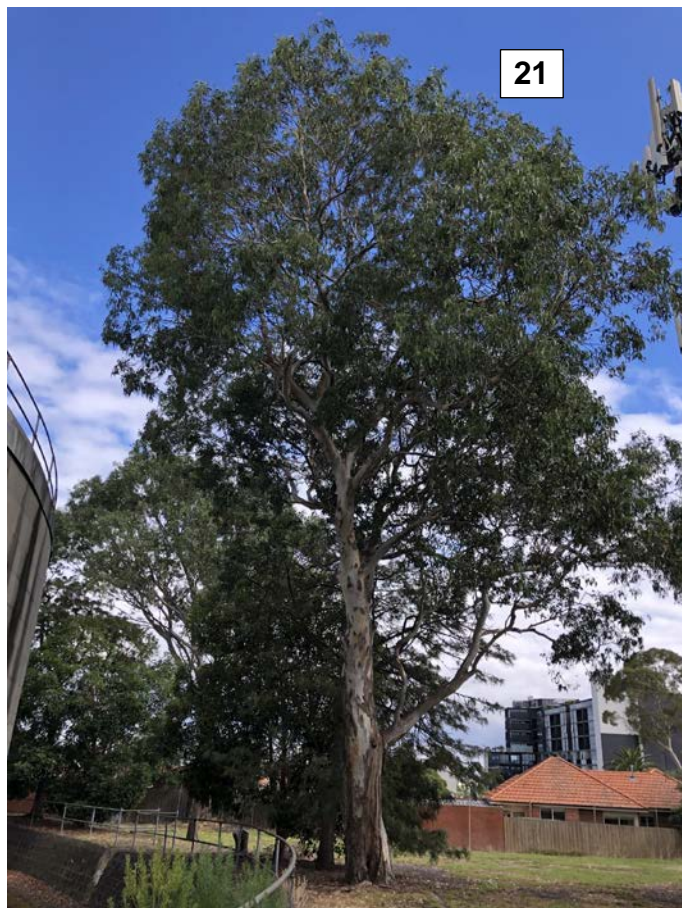
Image 10: Tree 21, Mod.B River Red Gum is unsustainable within the construction footprint. (facing west)

21	<i>Eucalyptus camaldulensis</i>	River Red Gum	Early-mature	Victorian native	81	17	15	Fair	Fair	Mod.B	>40	Past branch tearout to west however good response growth. Minor possum damage.	9.7	3.3	Proposed devt site	Within	100	Remove
22	<i>Melaleuca styphelioides</i>	Prickly-leaved Paperbark	Semi-mature	Australian native	17,13	7	4	Fair	Fair to Poor	Low	21-40		2.6	1.8	Proposed devt site	Within	86.08	Remove

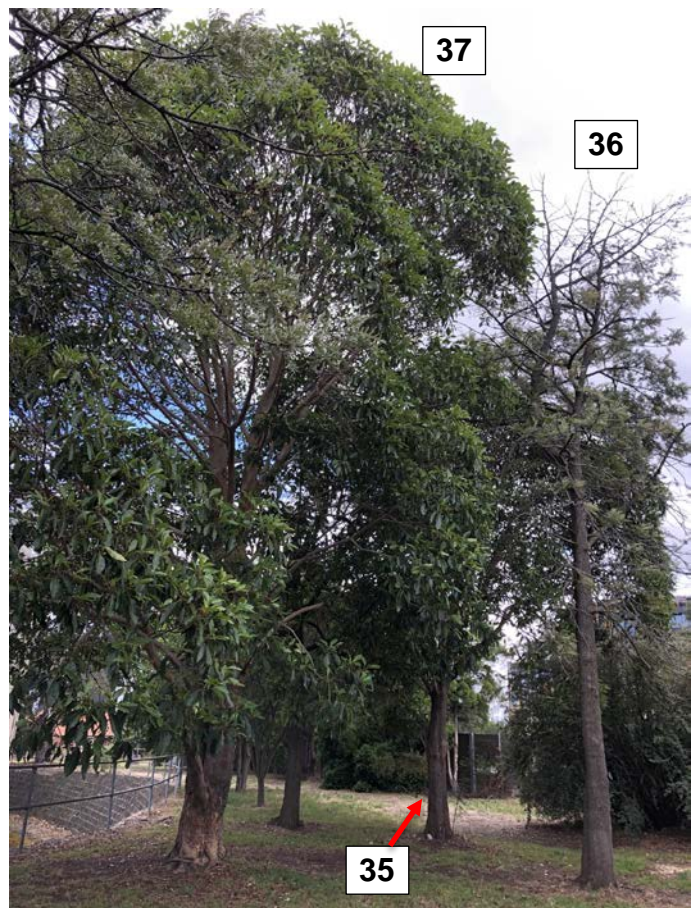
Image 11: Trees in north-east corner of tank site are unsustainable within the construction footprint. (facing northwest)

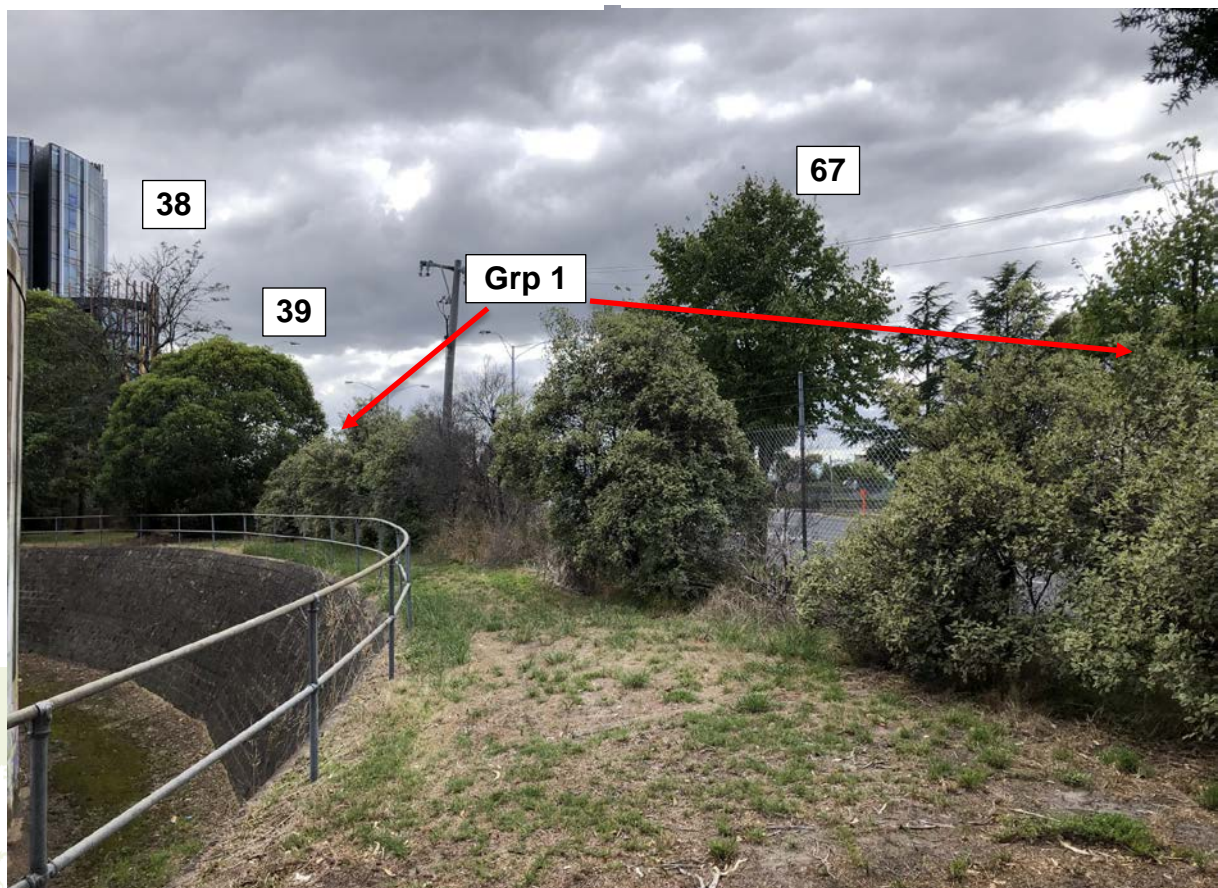
Image 12: Portion of Group 1 along Upper Heidelberg Road frontage. These trees are unsustainable within the construction footprint. (facing northeast). Tree 63 to 67 are street trees external to the site and should be retained & appropriately protected for the duration of the development process.

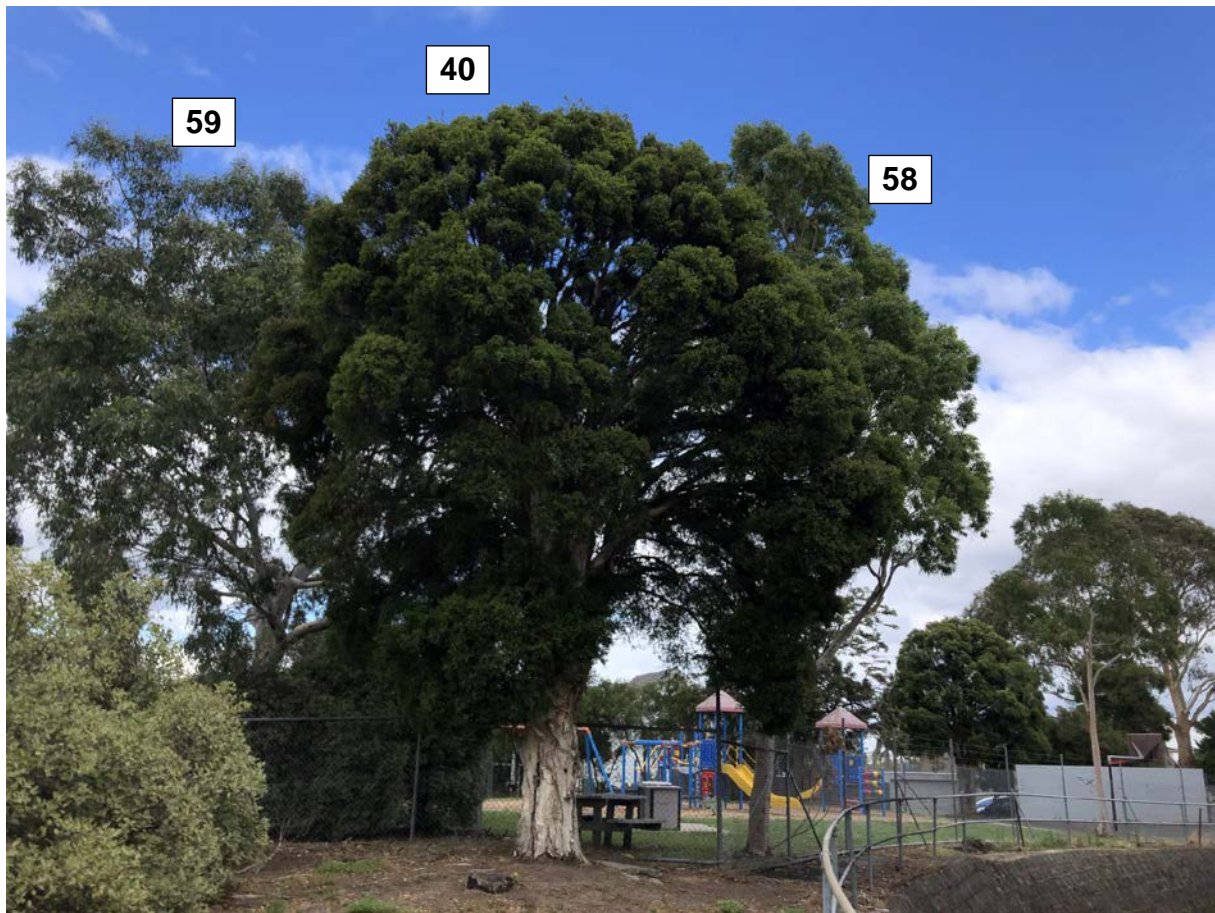
Image 13: Tree 40, facing southwest. This tree is unsustainable within the construction footprint.

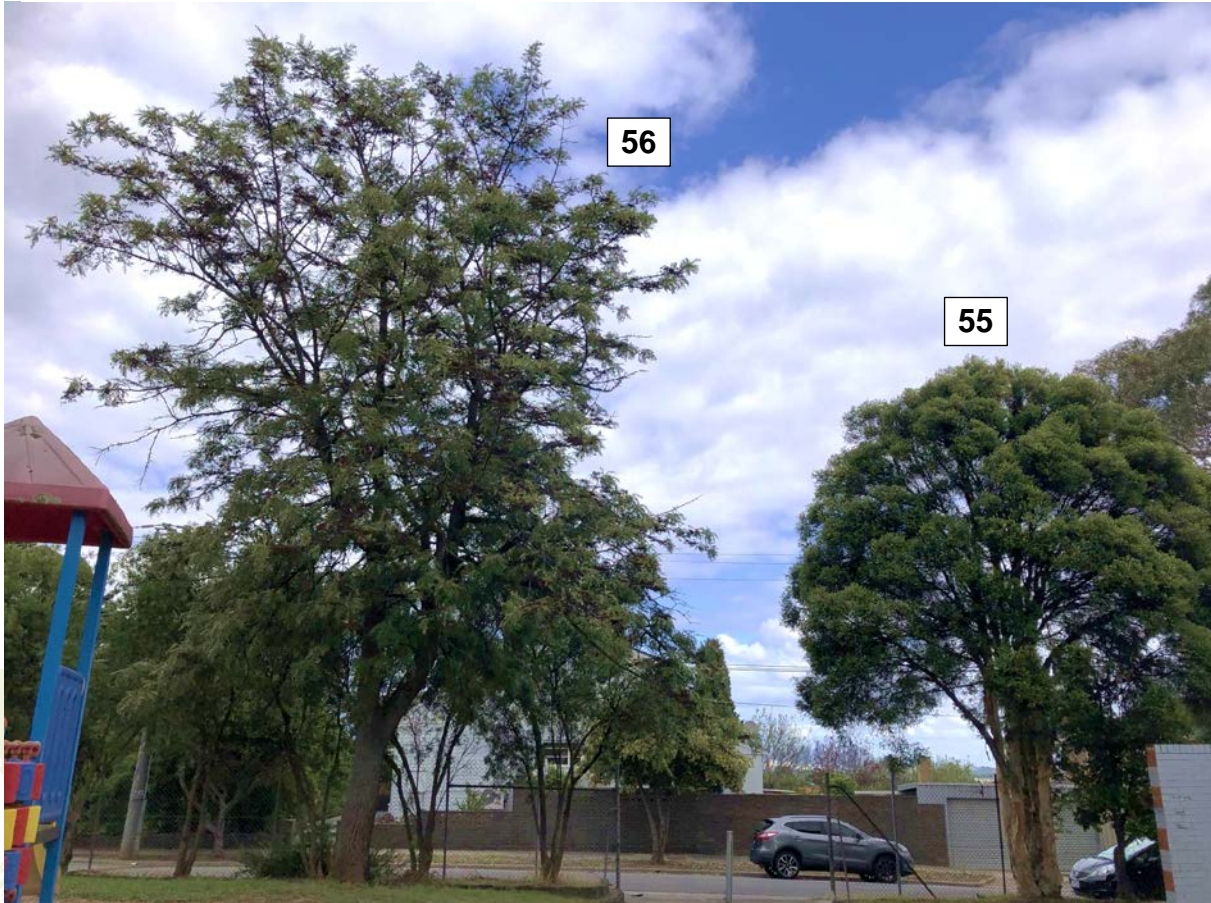
Image 14: Moderate B Park trees, facing southwest. Tree 55 could be retained with appropriate TPZ fencing. Tree 56 is unsustainable within the construction footprint.

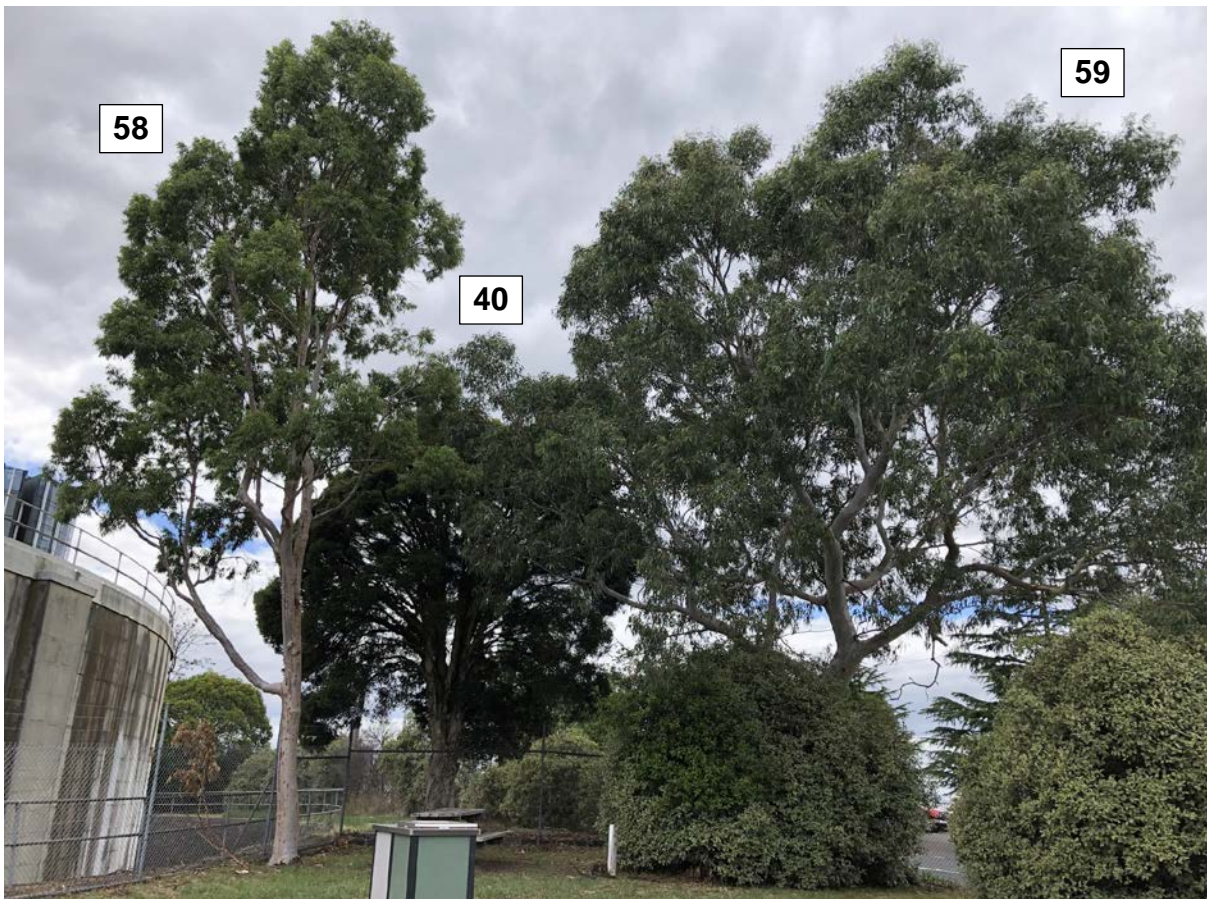
Image 15: Trees in northeast corner of park, facing northeast. These trees are unsustainable within the construction footprint.

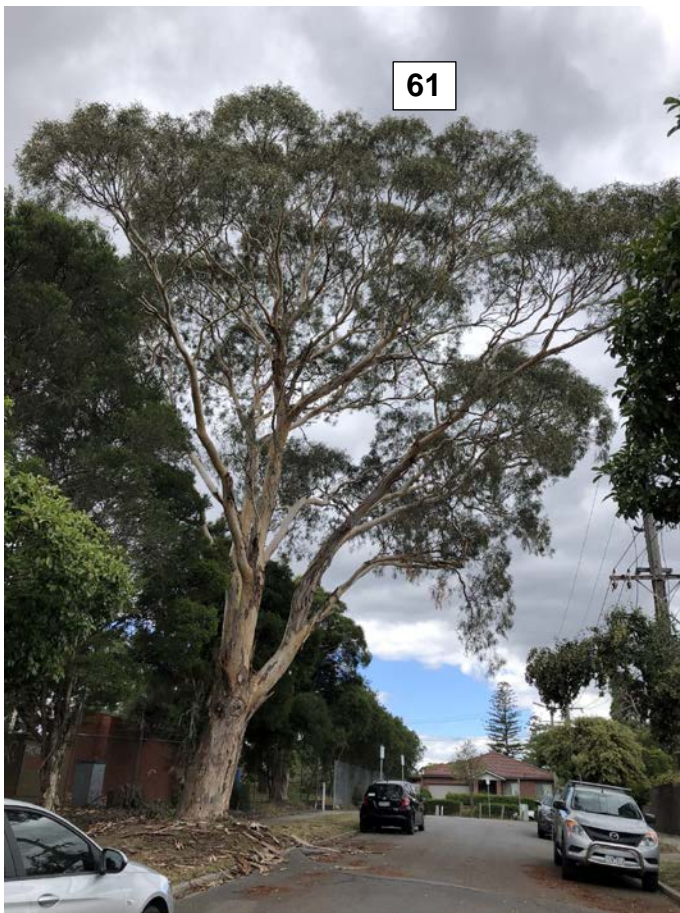
Tree 61 is the largest and most prominent of the trees assessed in this report, being a tree over 20 metres tall with an approximately 20-metre-wide canopy and a trunk diameter of 97 centimetres. The tree has no observable structural defects with good branch attachment, spacing and taper, a generally symmetrical canopy and no visible symptoms of extensive decay or damage. Tree 61 is of an exceptional size and vigour given the typically harsh growing conditions of a street tree including extensive soil compaction and hard, impermeable surfaces.

Image 17: Tree 61, River Red Gum street tree along Forster Street, facing east. Tree can be retained without impact.

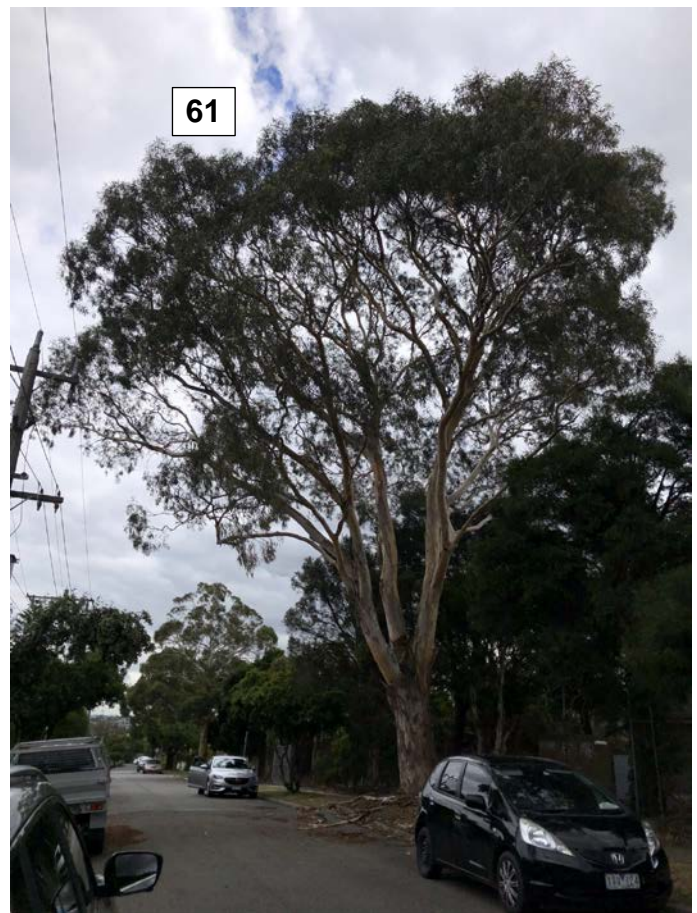
Image 18: Tree 61, facing northwest. Appropriate TPZ fencing must be established and maintained for the duration of site works.

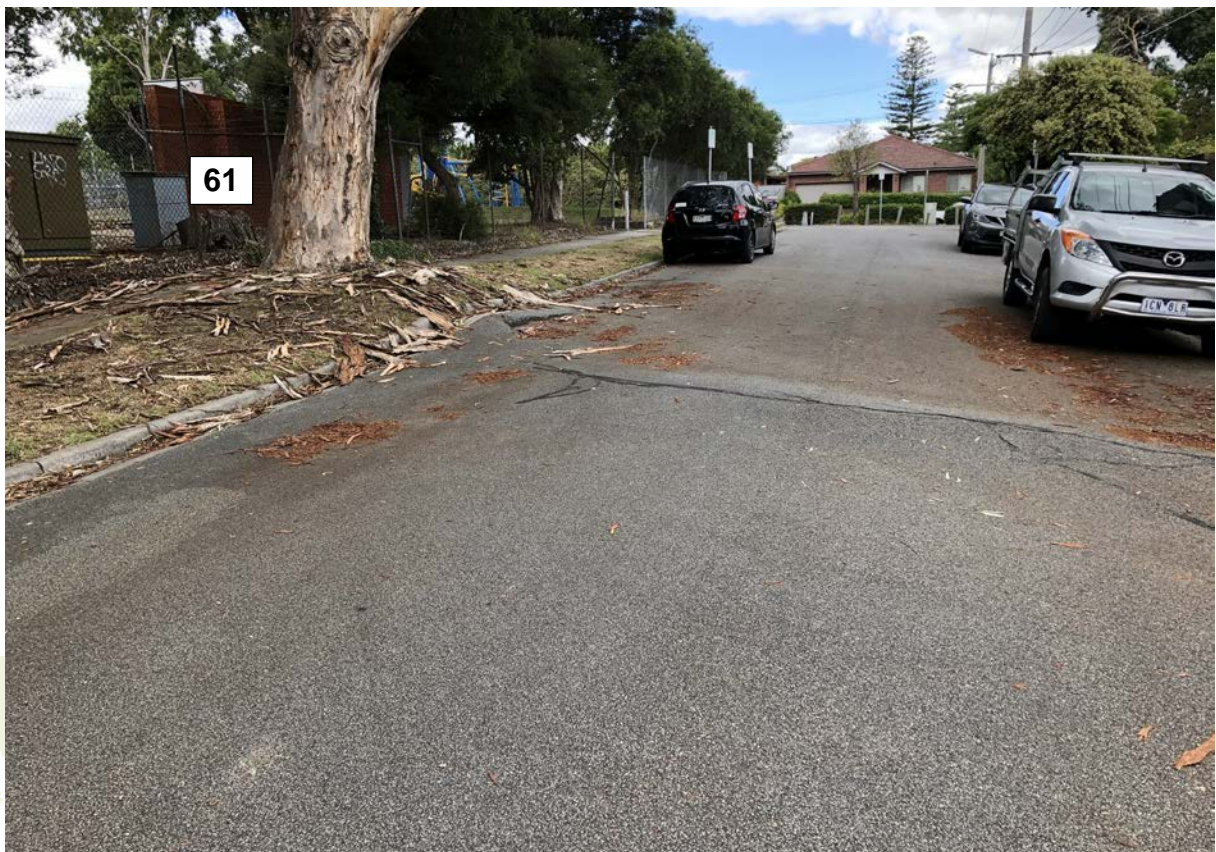
However, the remarkable condition of the tree despite apparent site constraints is due, in part, to the tree's demonstrated disruption of these constraints, evident by vigorous root growth underneath adjacent road, pavement and kerb surfaces, causing considerable damage. There is pronounced cracking and heaving of the pavement to the north of the tree, major disruption of the kerb to the south of the tree and evidence of a large surface root growing underneath the road surface causing longitudinal protrusion and cracking that has necessitated repeated repair of the road surface.

Per the descriptors used by Treelogic (refer to Appendix 3) this places the tree in a category of short useful life-expectancy (*"Infrastructure conflicts with heightened risk potential. Tree has outgrown site constraints."*) and a Low arboricultural rating (*"Tree (species) is functionally inappropriate to the specific location. Is causing excessive damage/nuisance to adjacent infrastructure or would be expected to be problematic if retained"*).

Image 19: Base of Tree 61 facing east, showing longitudinal damage to road surface and repairs. Appropriate TPZ fencing must be established and maintained for the duration of site works. Any alteration to the existing site conditions must be based on arboricultural advice and subject to arborist supervision to ensure no damage occurs to roots, buttress, trunk and limbs.

An alternative road layout design or other interventions and repairs to accommodate root growth while maintaining required access around the tree could change the perception of the tree from being unsuitable to becoming a highly valued and more functional element in the landscape with an accordingly higher rating. Any such amendments to the existing site conditions would need to be planned with arboricultural input and implemented with great care under arborist supervision to ensure the tree is not damaged in the process.

The repairs required around the tree may be costly or require an unconventional approach, but whether these costs are disproportionate to the condition of the tree in its location (noting relatively low usage in a residential cul-de-sac) is subject to the perceived values of the tree owner / manager being Banyule City Council and the surrounding community.
