St Mary's Facility Audit

Document number	000205
Client / Site	Tennis Victoria
Location	58 Yando Street Greensborough VIC 3088
Auditor	Andrew Sodomaco
Audit date	28 Aug 2015

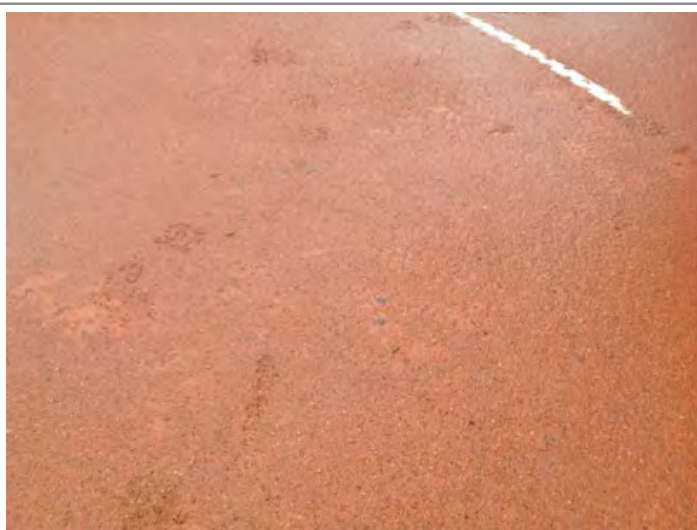
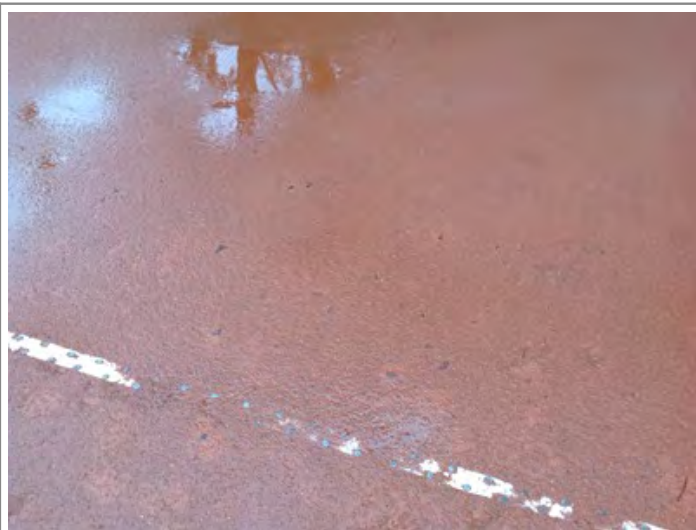
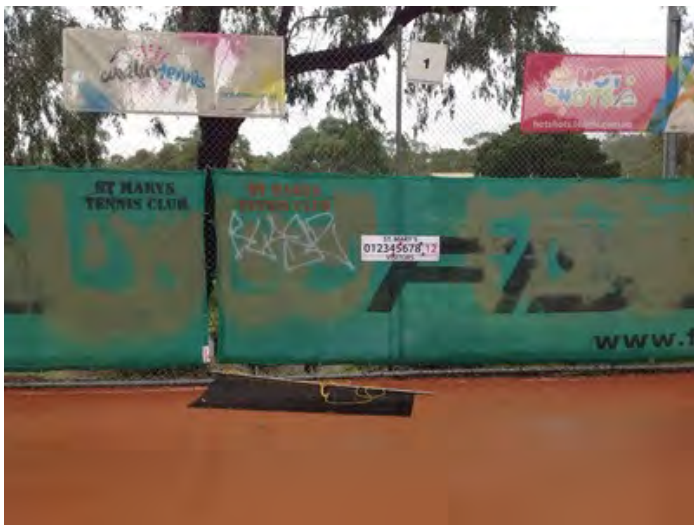
Unique court number	1
Surface condition rating	Moderate Issues/Observations: Minor ponding evident Poor drainage Aged surface Excessively worn surface in high wear areas
Surface type	Red Porous
Surface life span	4-5 years
Court condition notes	The court has been quite heavily worn, with some scoria aggregate from the court base showing through the top dressing in high wear areas. There is some pooling of water over the surface suggesting a compacted surface. This is consistent with an aged court surface and base.

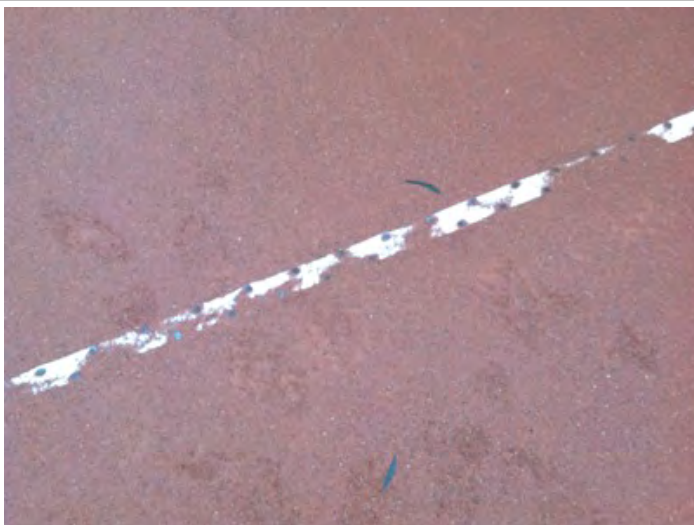
Line marking description	Tennis only lines
Line marking rating	Good Issues/Observations: Inconsistent bounce likely
Line marking condition notes	These lines are nailed into the surface, and although would result in some inconsistent bounce they are not obviously in poor condition, cracked or broken.

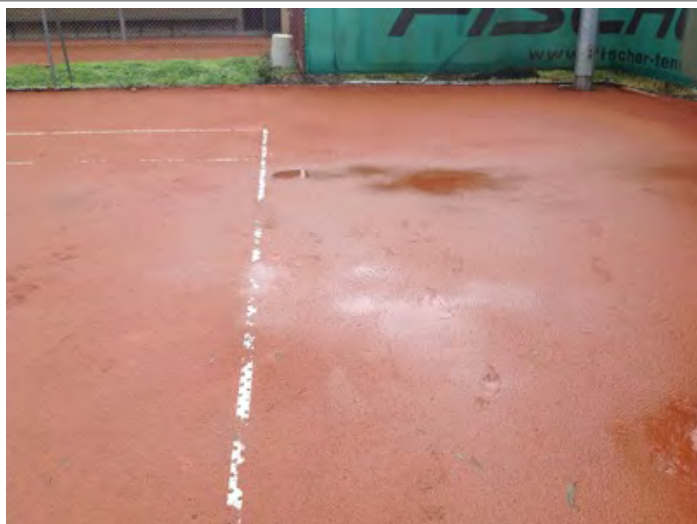
Is the court run off compliant?	no Runoffs North: 5100m South: 4900m East: 4500m West: 3100m
Could the court be made compliant?	no
Is the court to the standard dimensions?	yes
Court orientation	North-south
Are netball goal posts outside tennis court run off areas?	no
Are lockable post hole covers fitted and safe?	no
Compliance notes	The courts are not run off compliant to the north and south behind baselines.

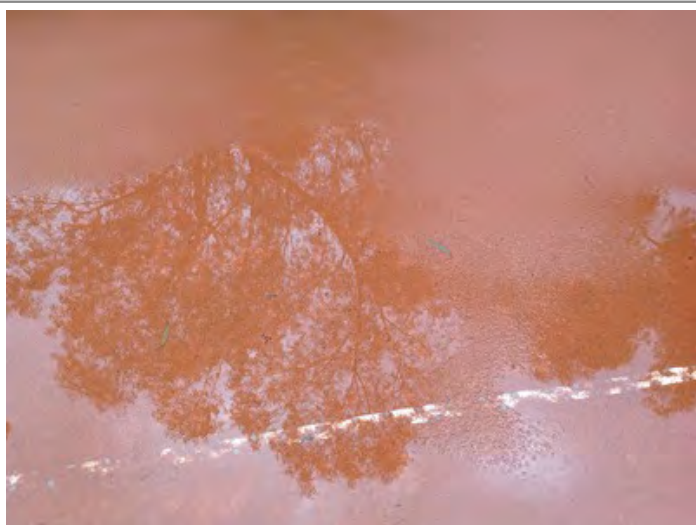
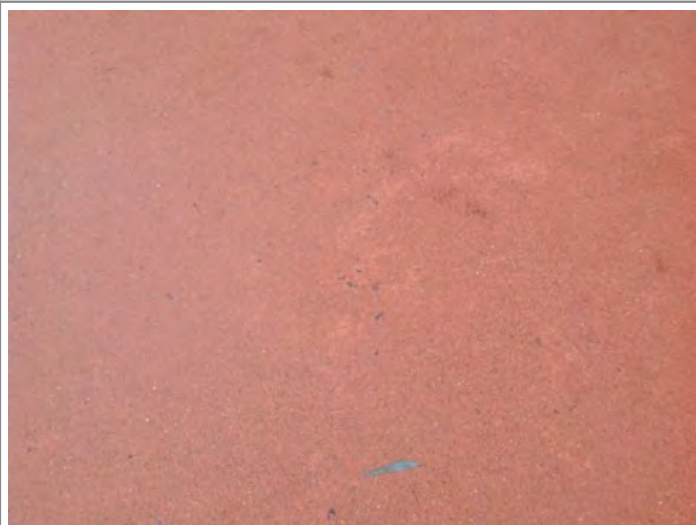
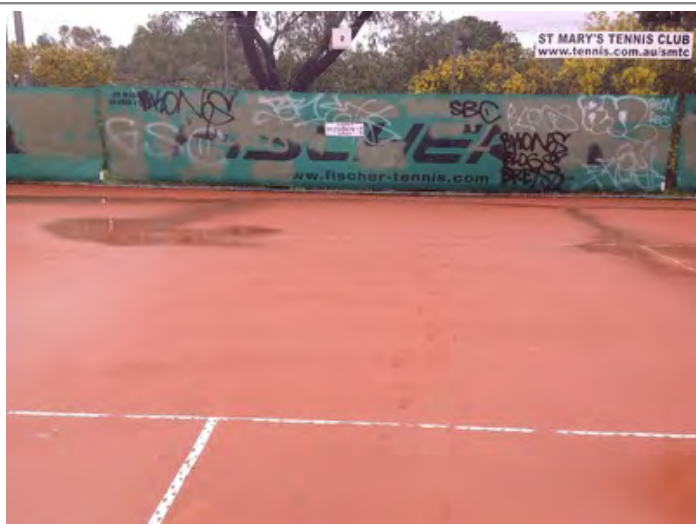
Surface condition rating	Moderate Issues/Observations: Minor ponding evident Poor drainage Aged surface Excessively worn surface in high wear areas
Surface type	Red Porous
Surface life span	4-5 years
Court condition notes	The court has been quite heavily worn, with some scoria aggregate from the court base showing through the top dressing in high wear areas. There is some pooling of water over the surface suggesting a compacted surface. This is consistent with an aged court surface and base.

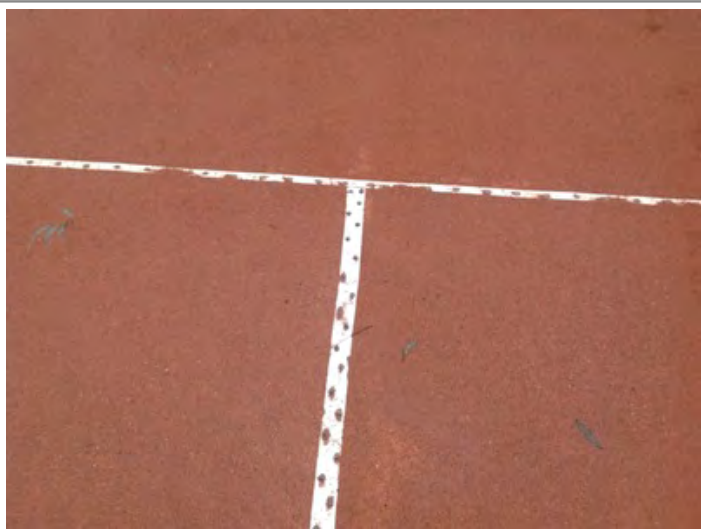
Line marking condition notes	These lines are nailed into the surface, and although would result in some inconsistent bounce they are not obviously in poor condition, cracked or broken.
Line marking condition photos

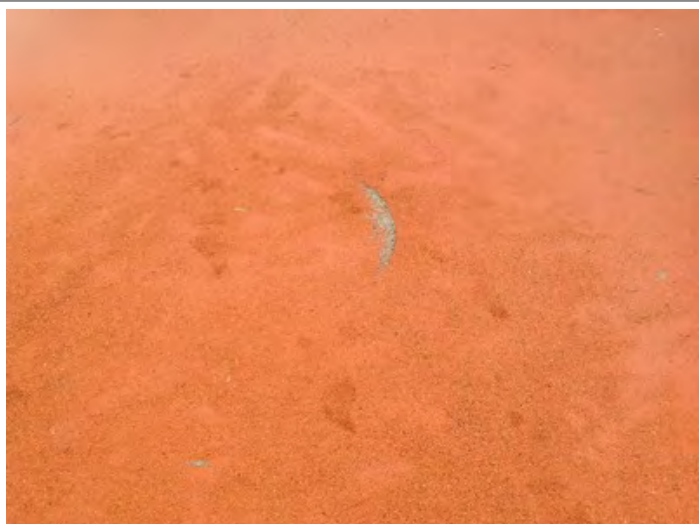
Court orientation	North-south
Are netball goal posts outside tennis court run off areas?	no
Are lockable post hole covers fitted and safe?	no
Compliance notes	The courts are not run off compliant to the north and south behind baselines. There is a concrete pad between court two and three which is partially covered by top dressing. It should be ensured this remains fully covered at all times as it is a slip and trip hazard.

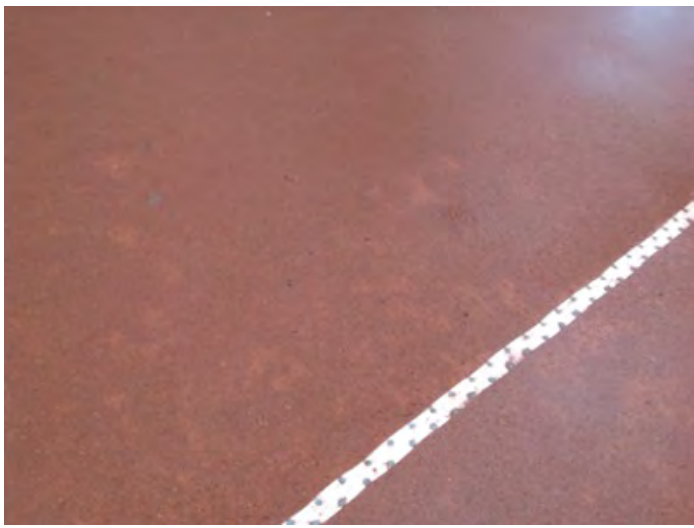
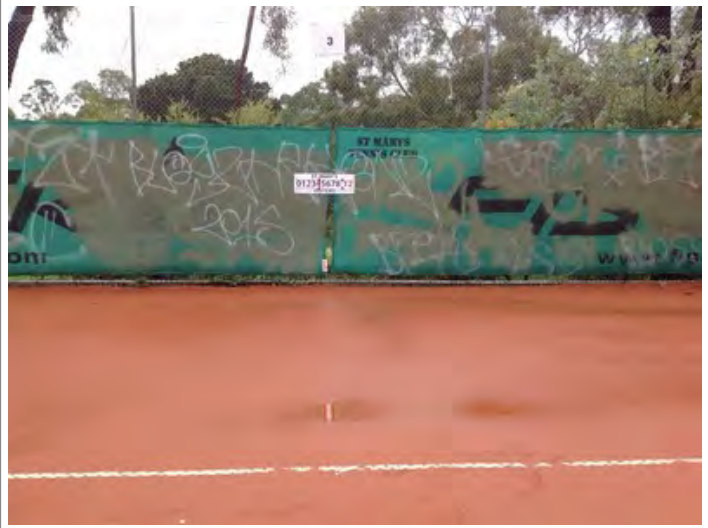
Unique court number	3
Surface condition rating	Moderate Issues/Observations: Minor ponding evident Poor drainage Aged surface Excessively worn surface in high wear areas
Surface type	Red Porous
Surface life span	4-5 years
Court condition notes	The court has been quite heavily worn, with some scoria aggregate from the court base showing through the top dressing in high wear areas. There is some pooling of water over the surface suggesting a compacted surface. This is consistent with an aged court surface and base.

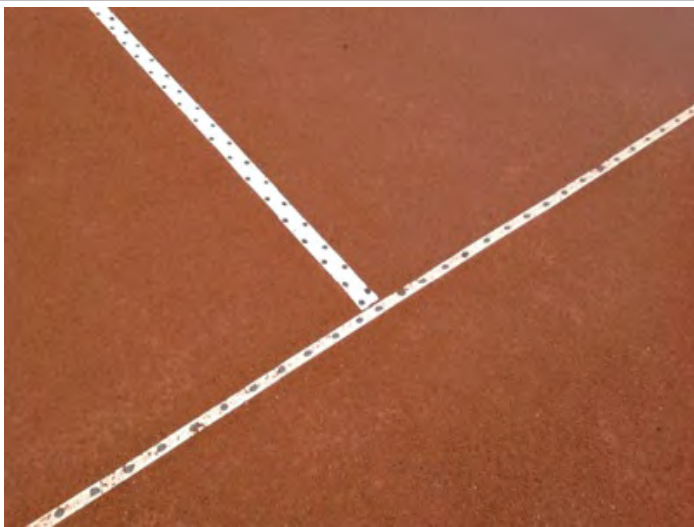
Line marking description	Tennis only lines
Line marking rating	Good Issues/Observations: Inconsistent bounce likely
Line marking condition notes	These lines are nailed into the surface, and although would result in some inconsistent bounce they are not obviously in poor condition, cracked or broken.

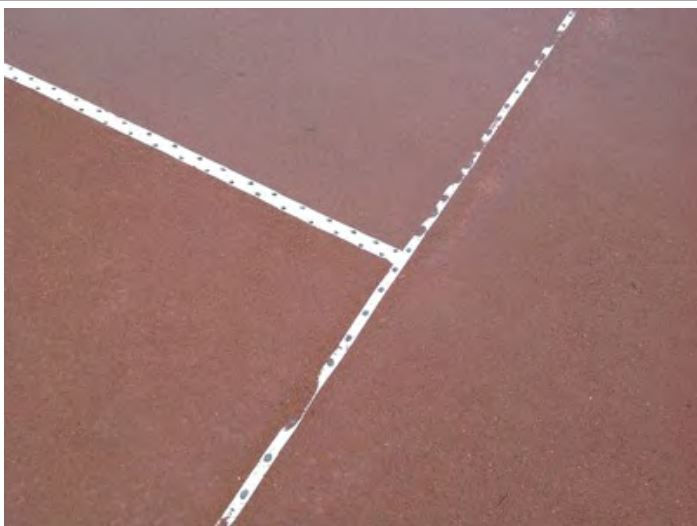
Line marking description	Tennis only lines
Line marking rating	Good Issues/Observations: Inconsistent bounce likely
Line marking condition notes	These lines are nailed into the surface, and although would result in some inconsistent bounce they are not obviously in poor condition, cracked or broken.

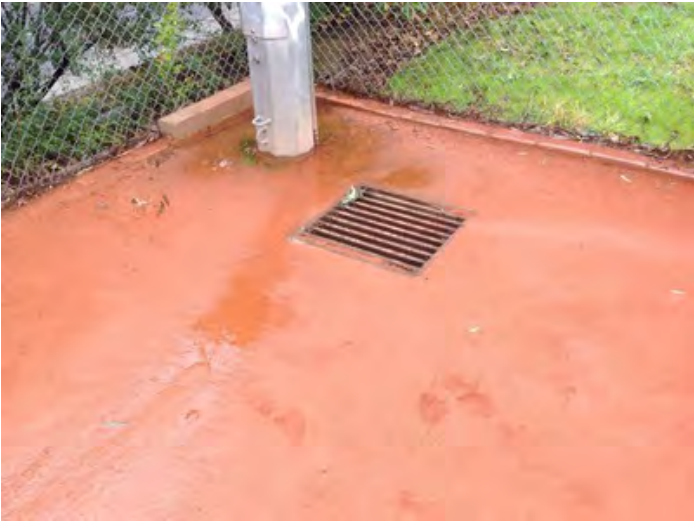
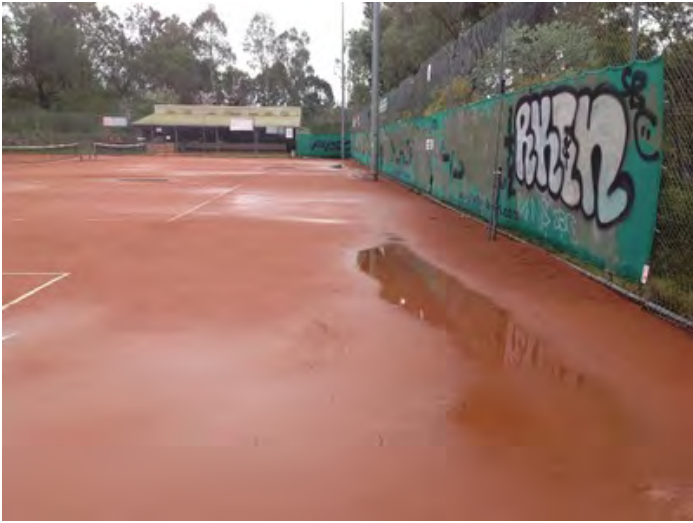
Compliance notes	The courts are not run off compliant to the north and south behind baselines. A grated pit at the northern end encroaches on run off areas.
Compliance photos	
No photos taken	
Drainage	
Drainage infrastructure	Formed
What type of drainage is in place?	Grated pit(s)
Are drains, pits or other infrastructure provided within the court enclosure?	yes
Are drains, pits or other infrastructure provided within the run-off areas?	yes
Drainage rating	Moderate Issues/Observations: Ponding evident Drainage infrastructure requires maintenance or repair
Drainage notes	There is a grated pit in the north eastern corner of the enclosure. This court surface would be expected to drain through the surface, although it appears to be compacted in places, causing water to pool along the surface. This is particularly the case at the northern end of the enclosure, where extensive puddling occurs along the back of the courts.

Court	Trim trees/shrubs away from court enclosure and fencing Hang drag mats on fencing
Drainage	Qualified Engineer required to further investigate drainage issues.
Infrastructure	Trim vegetation away from fencing
Lighting	Conduct a lighting lux level test

Are there any critical safety issues?	No
Enclosure recommendations	Plan for reinvigoration of the court base to improve drainage in future.

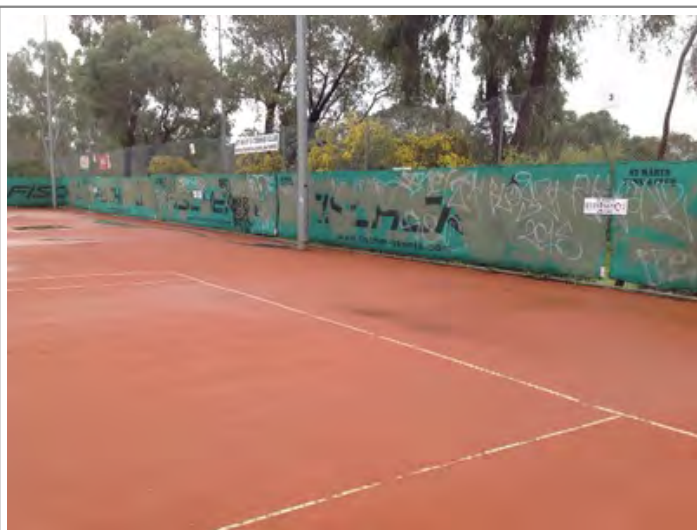
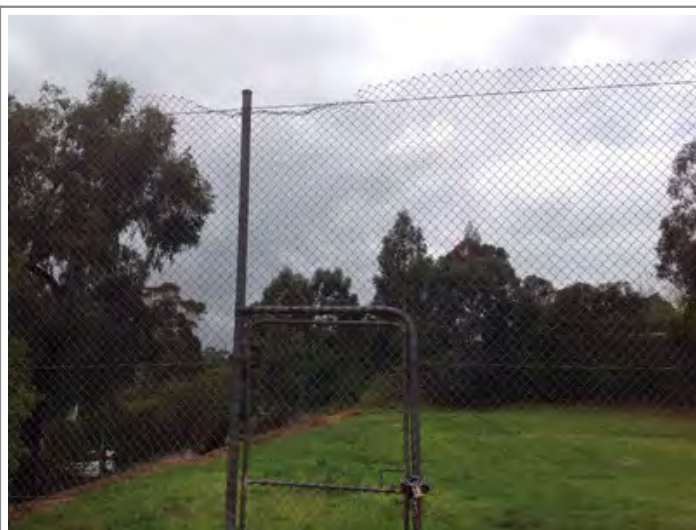
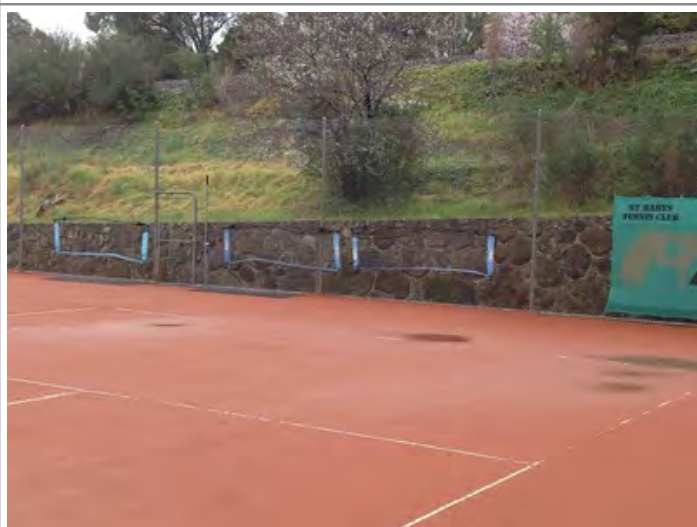
Fence attachments	Sightscreens Windbreaks Sponsor advertising
Fence condition rating	Moderate Issues/Observations: Slack mesh Trees overhanging enclosure
Fencing life span	6-10 years
Fence notes	The fencing appears to be structurally sound, although there is some slack and curling mesh evident at the top of the fence line. The sight screens at the northern end of the court are heavily graffitied. Some hot shots nets are hanging from the fence at the southern end which could pose a safety hazard.

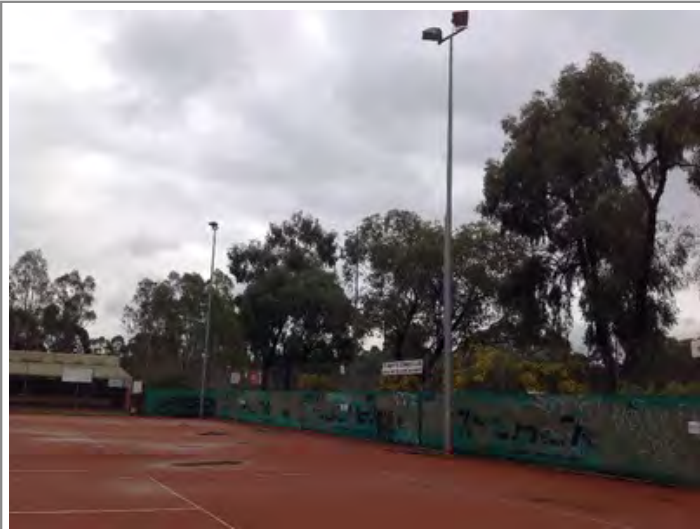
Lighting infrastructure position	Corner
Light fittings	One per tower
Lighting infrastructure design	Standard
Lighting infrastructure rating	Moderate Issues/Observations: Old however in good condition - potential upgrade required
Lighting life span	6-10 years
Lighting notes	High tower corner lighting is installed and appears to be structurally sound. A lux test would be required to understand their suitability to night tennis.
Lighting photos

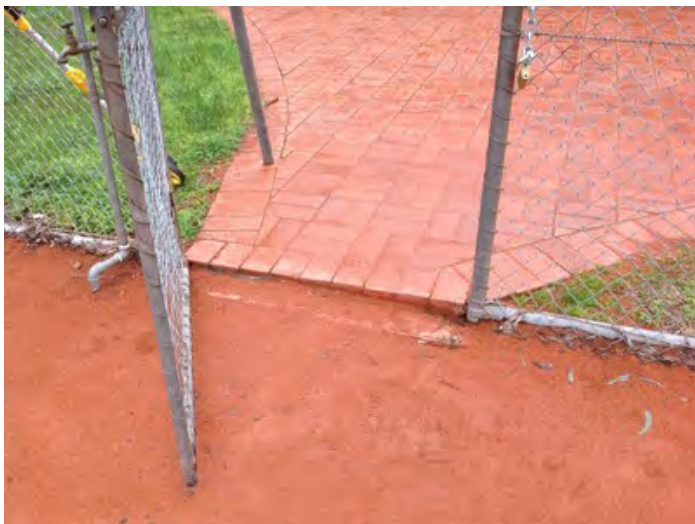
Court enclosure accessibility	Formed paths Trip hazards identified: yes Ramped access provided: no
Path material(s)	Other material?
Main gate dimensions	Standard pedestrian gate 1000mm x 2100mm
Accessibility notes	A paved area is provided from the clubhouse to the court enclosure, where a small step down on to the court surface is required. Note the venue as a whole is NOT accessible as a flight of steps needs to be climbed to access the main gate.
Accessibility photos

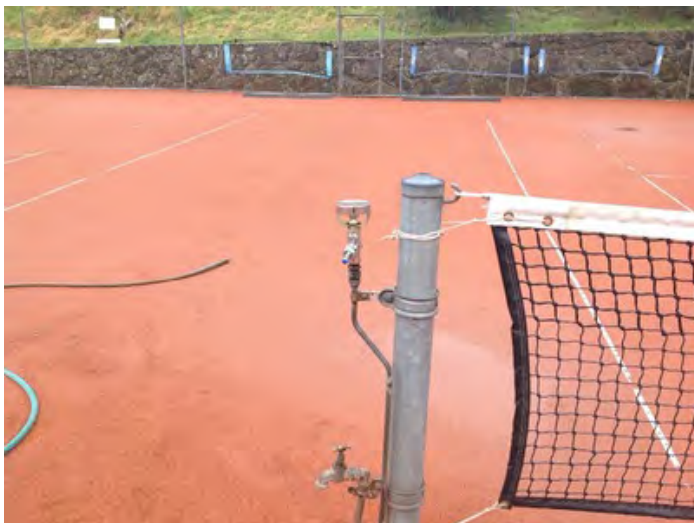
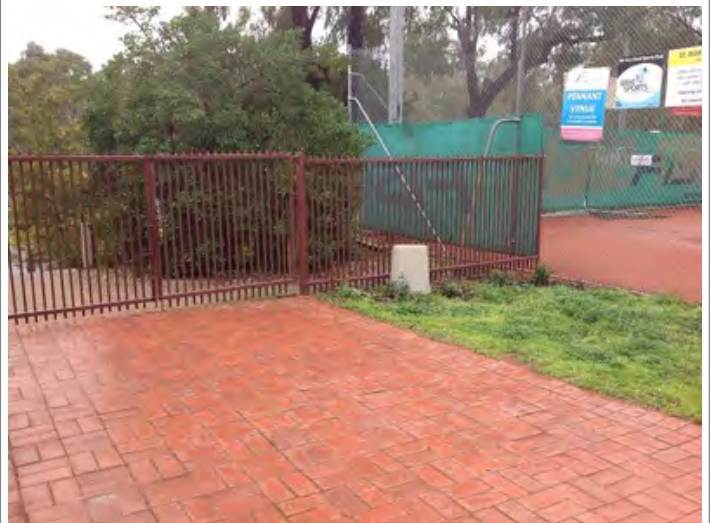
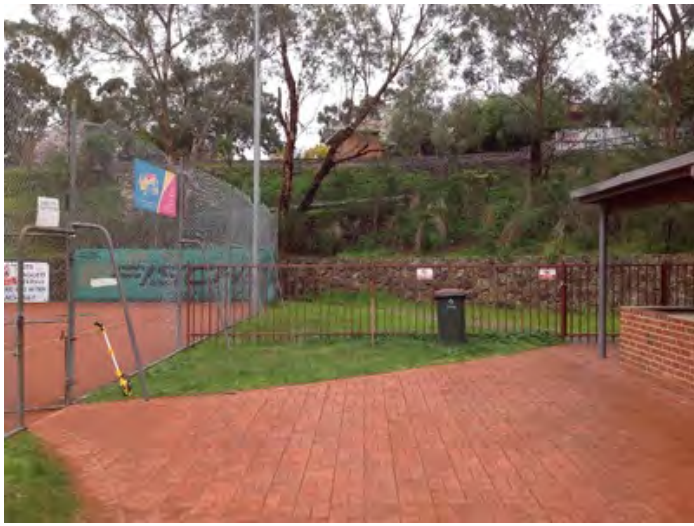
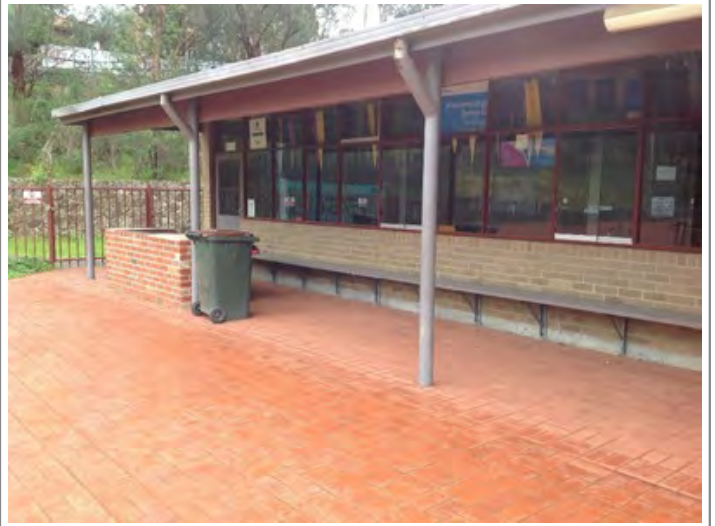
Condition of ground and court surrounds	Moderate
Court surround notes	Within the enclosure the grounds are limited to a couple of grassed areas and a paved section out the front of the clubhouse. A verandah offering views of the courts and a bbq area is provided.
Water supply	Potable
Water notes	Some drinks taps are located on the courts.
Natural Shade	No natural shade
Man made Shade	Clubhouse veranda
Shade notes	
Car parking	On street: 21-40 spaces Off street: Overflow:
Does the site have any hit up walls	no
Car park notes	
Adjacent facilities	Park/playground
Does the site have any potential expansion oppotunities?	no

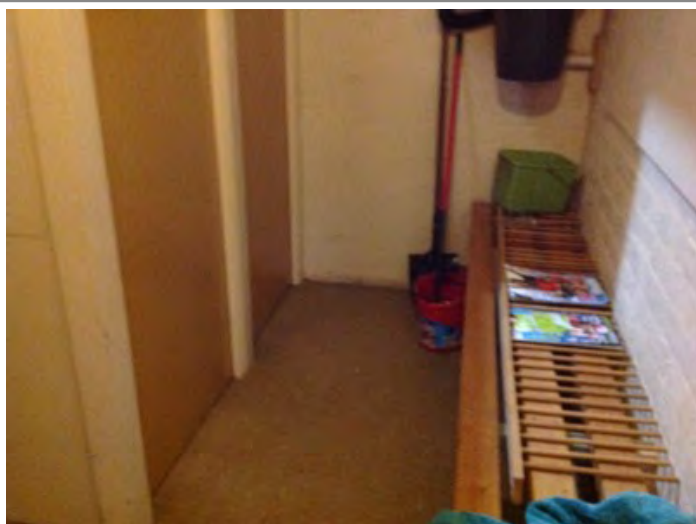
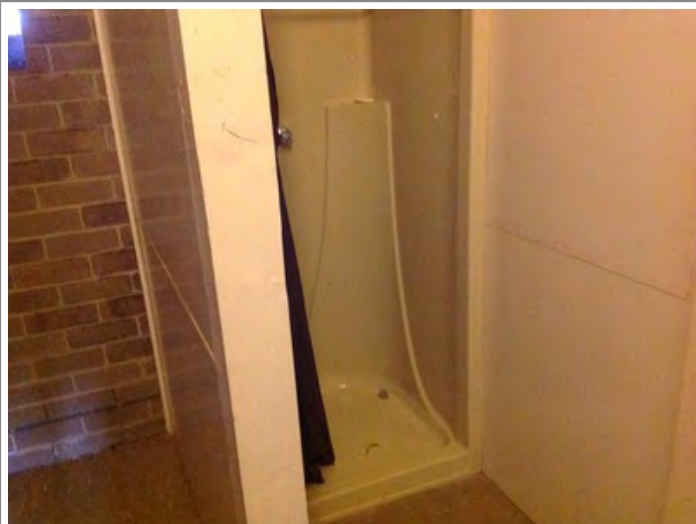
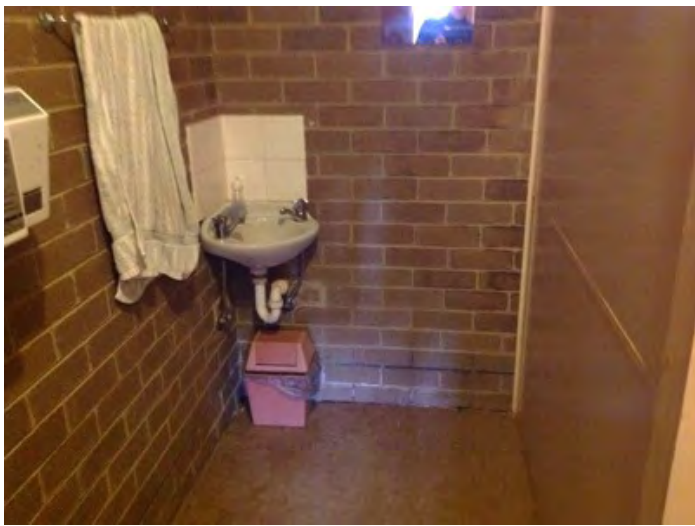
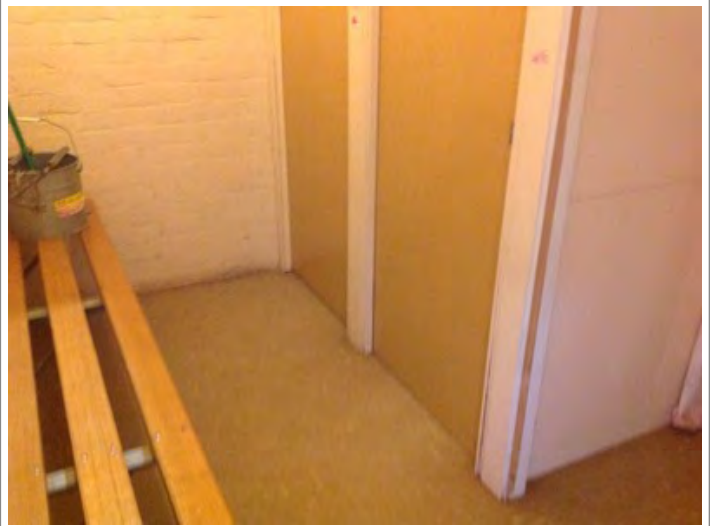
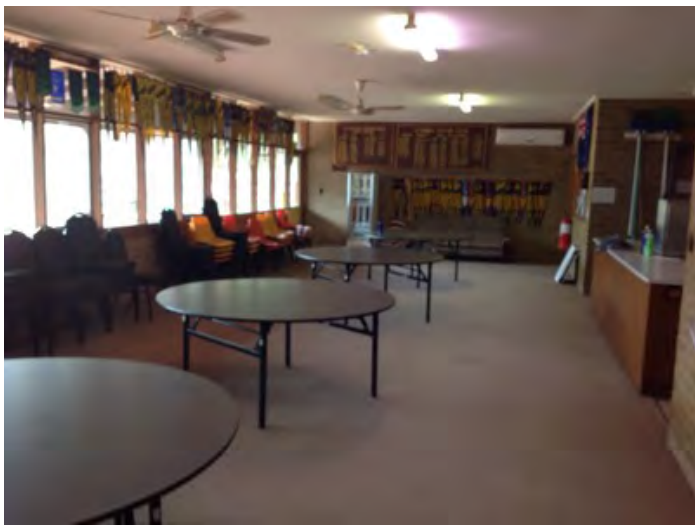
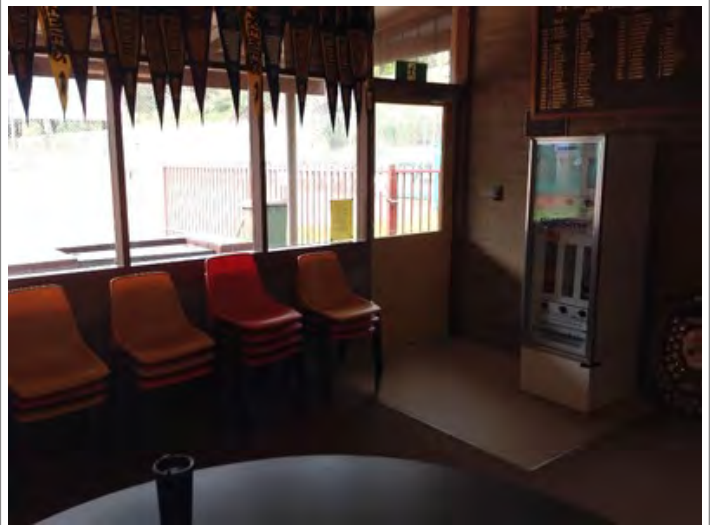
Building Condition	Moderate
Estimated building age	30+ years
Building materials	Brick
Accessible entry to building	no
Kitchen	Standard
Bar	no
Player change rooms	Male: 1 Female: 1 Unisex: 0
Social area	81 m2
Social area comments	
Toilets	Male: yes Female: yes Accessible: no
Clubroom condition notes	The clubhouse is in reasonable condition, although it is aged and in need of refurbishment. The change rooms and toilet areas are particularly in need of replacement. The roof of the clubhouse and verandah is heavily covered in algae and appears to be quite aged.
Other amenities provided within or outside clubrooms	BBQ /outdoor seating area
Other amenities condition notes	
Are there any safety concerns within clubrooms?	no

Classification	-
Overall Facility recommendation(s)	Plan for refurbishment of clubhouse and the court base for each of the courts. Although aged, most facilities appear to have been well maintained.
