## Malcolm Blair Reserve Facility Audit

Document number	000214
Client / Site	Tennis Victoria
Location	Karingal Drive Briar Hill VIC 3088
Auditor	Andrew Sodomaco
Audit date	04 Sep 2015

## Enclosure 1

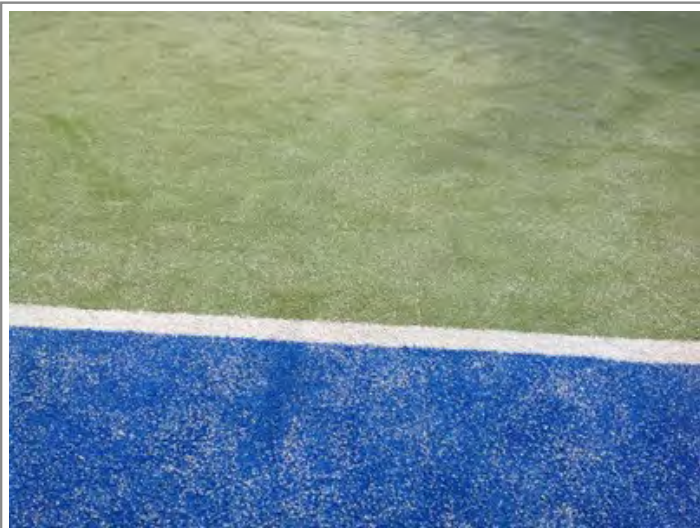
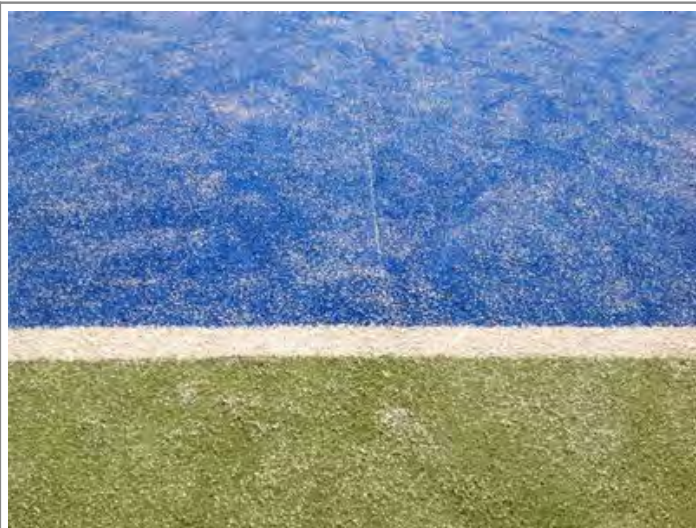
Unique court number	1
Surface condition rating	Good  <b>Issues/Observations:</b> Seam stress
Surface type	Synthetic Grass
Surface life span	6-10 years
Court condition notes	The court appears to be quite new and in good condition. There is a line where the carpet has been joined that has separated a little and should be investigated before it comes a major concern. Otherwise there is a good coverage of grass and a sufficient pile height for play.

Are there any critical safety issues?	No
Enclosure recommendations	Investigate seam stress evident across all courts, as this should be considered now before it becomes a significant issue. Repair damaged fencing and trim vegetation from fence line.

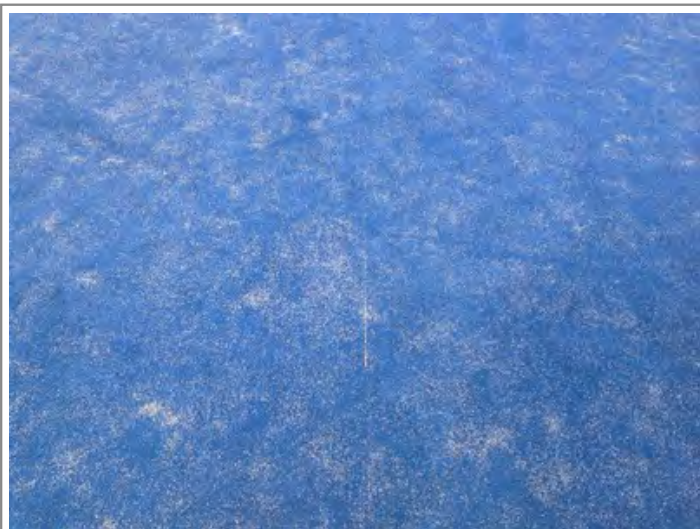
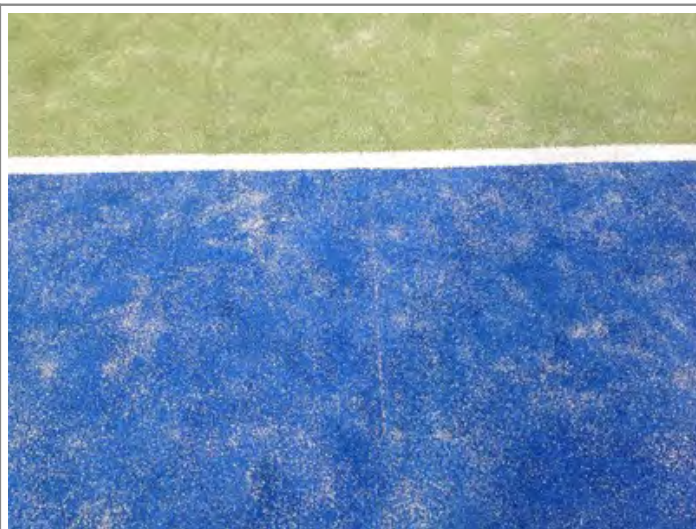
Unique court number	2
Surface condition rating	Good  <b>Issues/Observations:</b> Seam stress
Surface type	Synthetic Grass
Surface life span	6-10 years
Court condition notes	The court appears to be quite new and in good condition. There is a line where the carpet has been joined that has separated a little and should be investigated before it comes a major concern. Otherwise there is a good coverage of grass and a sufficient pile height for play.

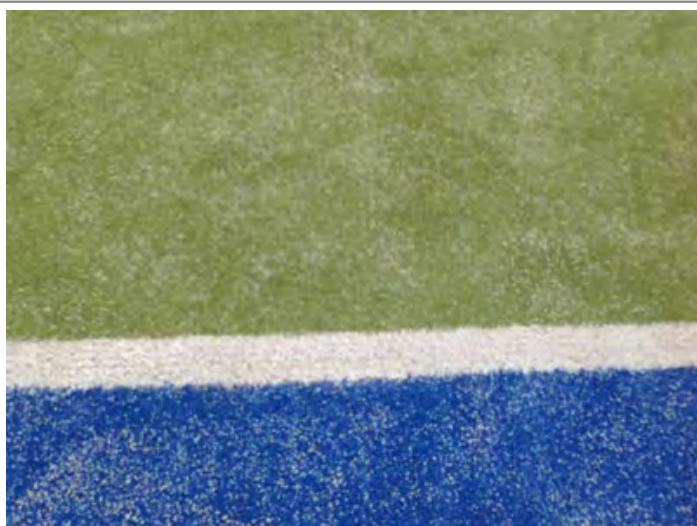
Unique court number	3
Surface condition rating	Good  <b>Issues/Observations:</b> Seam stress
Surface type	Synthetic Grass
Surface life span	6-10 years
Court condition notes	The court appears to be quite new and in good condition. There is a line where the carpet has been joined that has separated a little and should be investigated before it comes a major concern. Otherwise there is a good coverage of grass and a sufficient pile height for play.

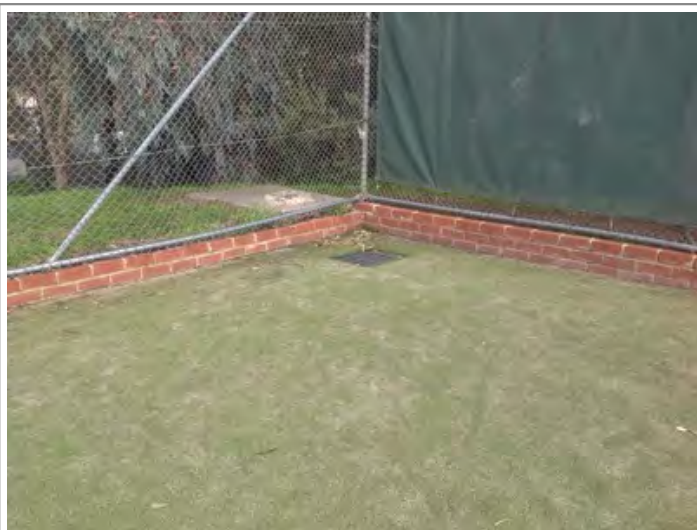
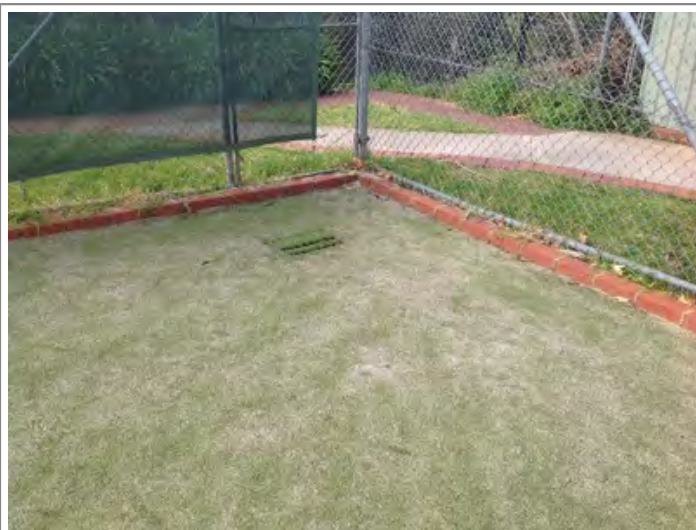
Drainage infrastructure	Formed
What type of drainage is in place?	Grated pit(s)
Are drains, pits or other infrastructure provided within the court enclosure?	yes
Are drains, pits or other infrastructure provided within the run-off areas?	no
Drainage rating	Good
	<b>Issues/Observations:</b>
Drainage notes	This four court enclosure appears to have its highest point in the middle, between courts two and three. It then falls to the south eastern and south western corner to grated pits located at both these areas. There is few signs of dirt and silt build up.

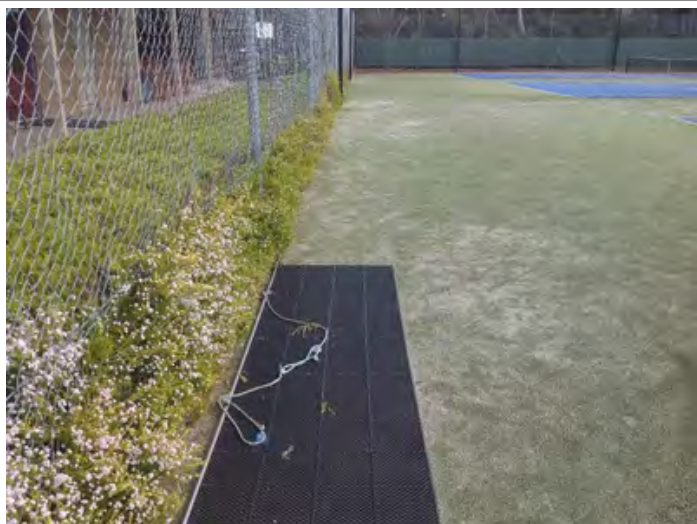
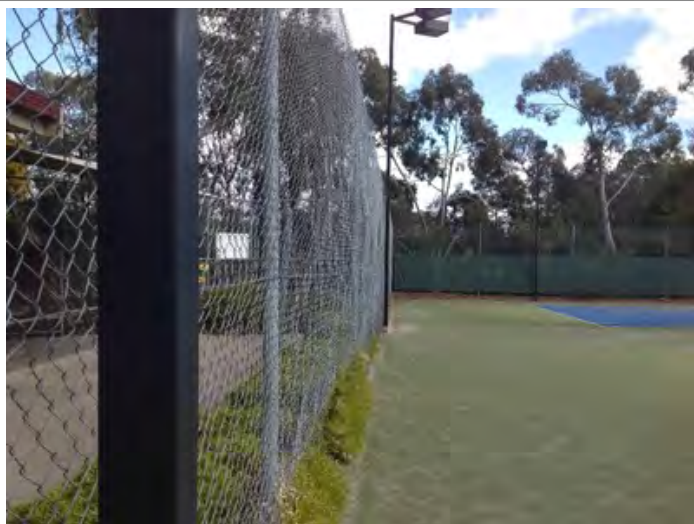
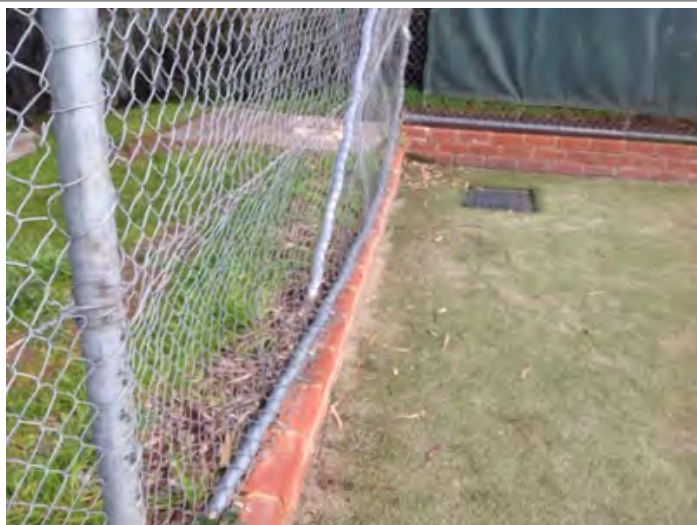
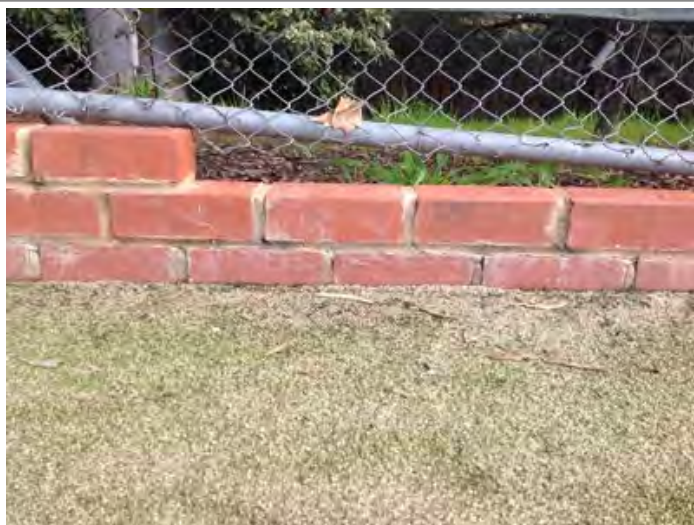
<b>Fence Rails</b>	Fence rail top: no Fence rail bottom: yes
<b>Fence height</b>	3m to 3.5m Low level side fencing installed: no
<b>Fence attachments</b>	Windbreaks Sponsor advertising
<b>Fence condition rating</b>	Moderate  <b>Issues/Observations:</b> Slack mesh Mesh curling at base Excessive gap under fencing - allows balls to escape enclosure Trees/shrubs growing through mesh
<b>Fencing life span</b>	10+ years
<b>Fence notes</b>	The fence appears to be aged although it is structurally sound. Trees are required to be trimmed in places.

Court	Trim trees/shrubs away from court enclosure and fencing Hang drag mats on fencing
Drainage	
Infrastructure	Repair damaged fencing Trim vegetation away from fencing
Lighting	Conduct a lighting lux level test

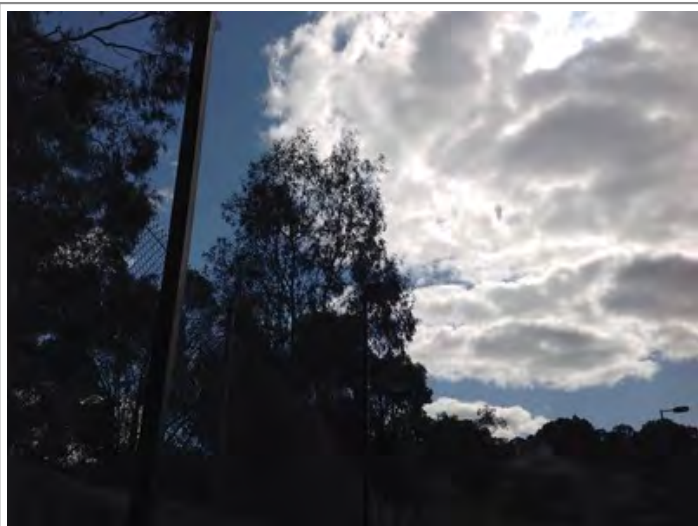
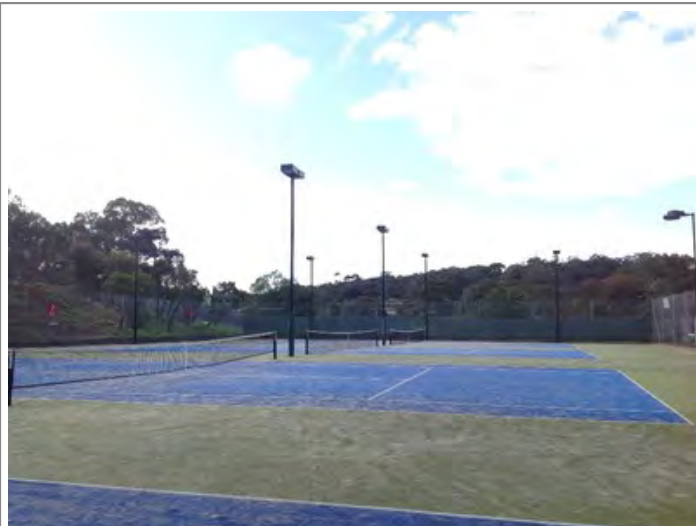
Total number of lit courts per enclosure	4
Lighting infrastructure type	Black powder coated low level - Steel poles
Lighting infrastructure position	Side
Light fittings	One per tower
Lighting infrastructure design	Standard
Lighting infrastructure rating	Very Good  <b>Issues/Observations:</b> Infrastructure and fittings in very good condition - likely to achieve required lux standards
Lighting life span	10+ years
Lighting notes	All lighting appears to be in very good condition and would likely achieve required lux standards.

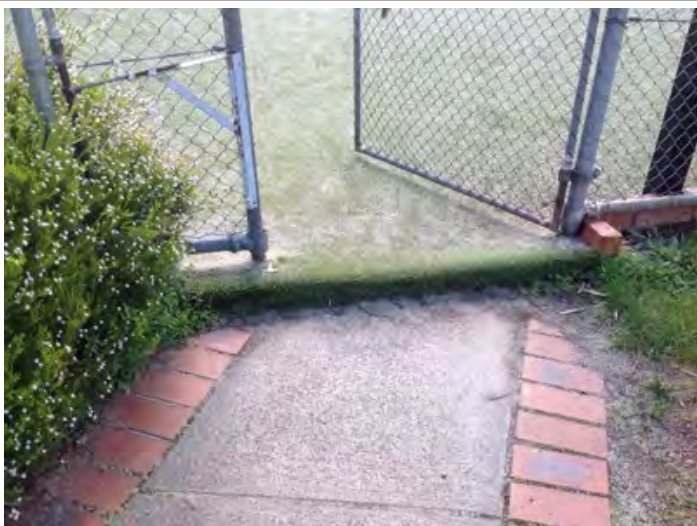
Court enclosure accessibility	Formed paths Trip hazards identified: yes Ramped access provided: no
Path material(s)	Concrete
Main gate dimensions	Standard pedestrian gate 1000mm x 2100mm
Accessibility notes	One entrance to the enclosure require participants to step up into the enclosure.

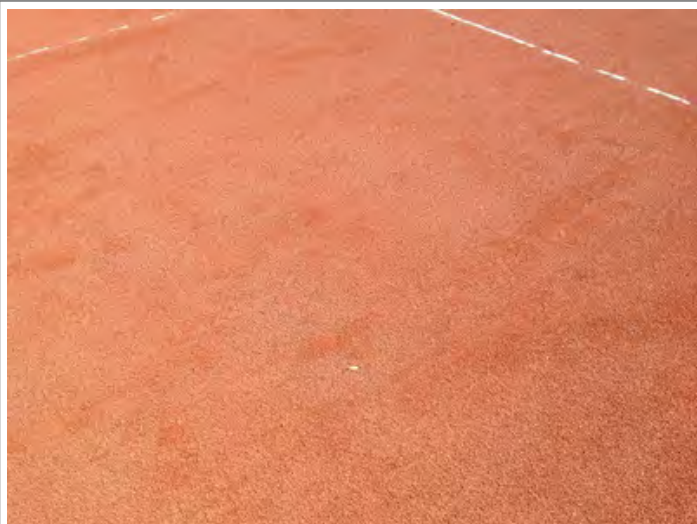
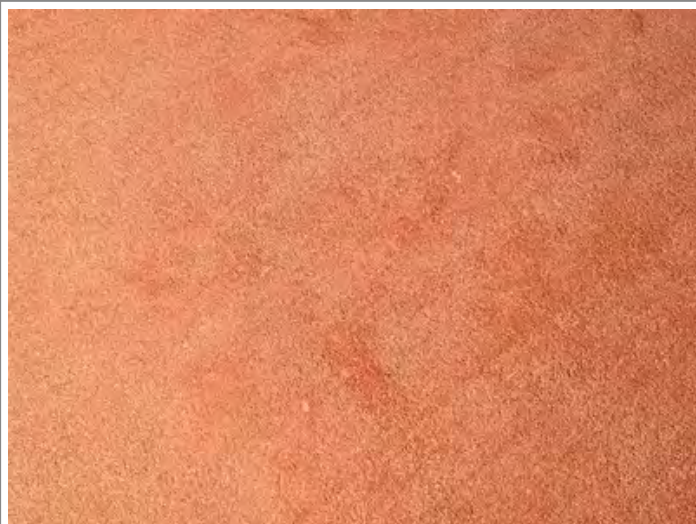
Unique court number	5
Surface condition rating	Good  <b>Issues/Observations:</b> Weed growth Excessively worn surface in high wear areas
Surface type	Red Porous
Surface life span	10+ years
Court condition notes	This court has some aggregate showing through the surface, but otherwise has a good amount of top dressing over the court.

<b>Are there any critical safety issues?</b>	No
<b>Enclosure recommendations</b>	Weed courts and repair fencing. Plan for surface replacement in the long term.

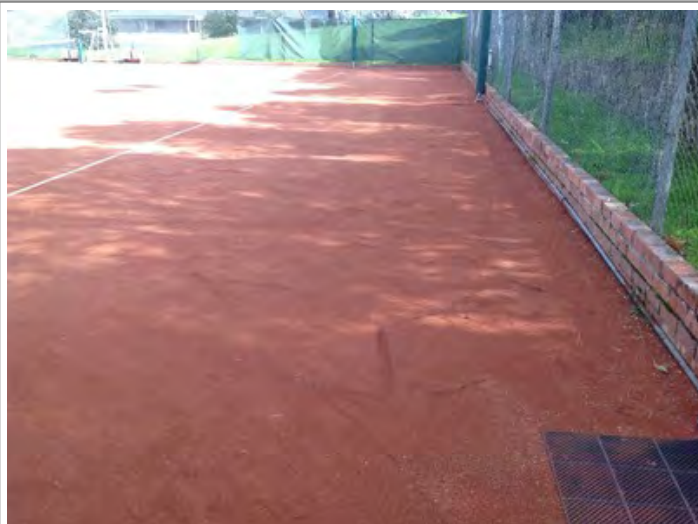
Are netball goal posts outside tennis court run off areas?	no
Are lockable post hole covers fitted and safe?	no
Compliance notes	The court does not meet run off requirements to the north and south behind the baselines, and probably not to the adjacent court as this measurement was very close to the required distance.

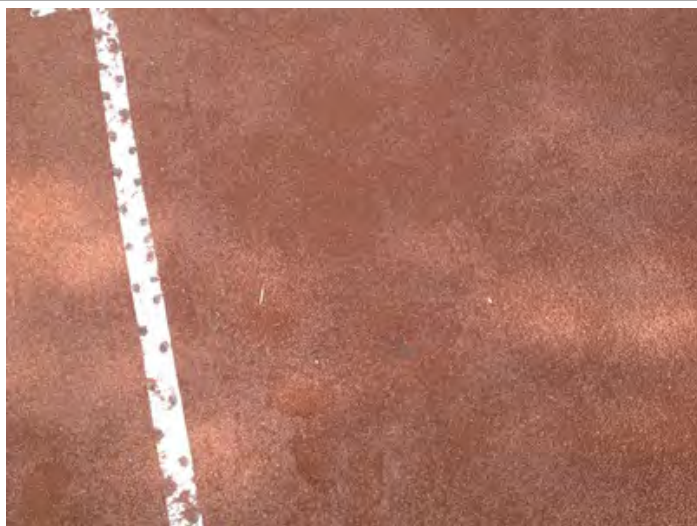
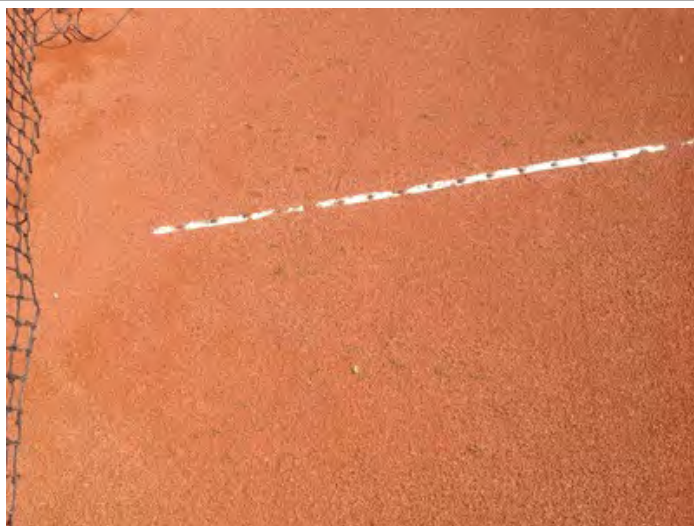
Unique court number	6
Surface condition rating	Good  <b>Issues/Observations:</b> Weed growth
Surface type	Red Porous
Surface life span	10+ years
Court condition notes	This court has some aggregate showing through the surface, but otherwise has a good amount of top dressing over the court.

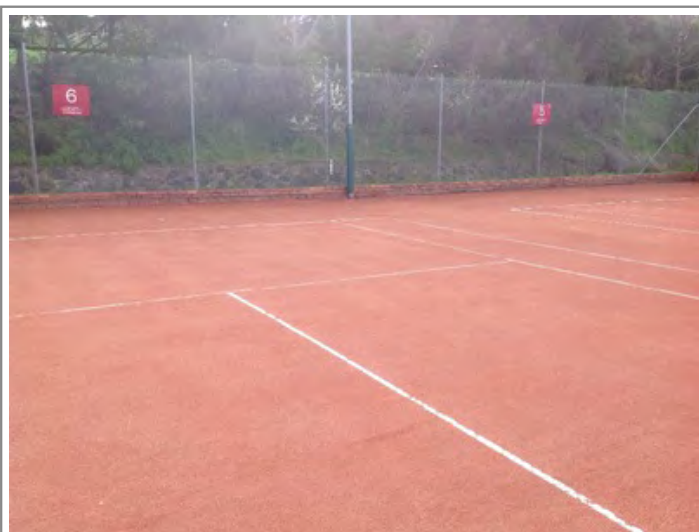
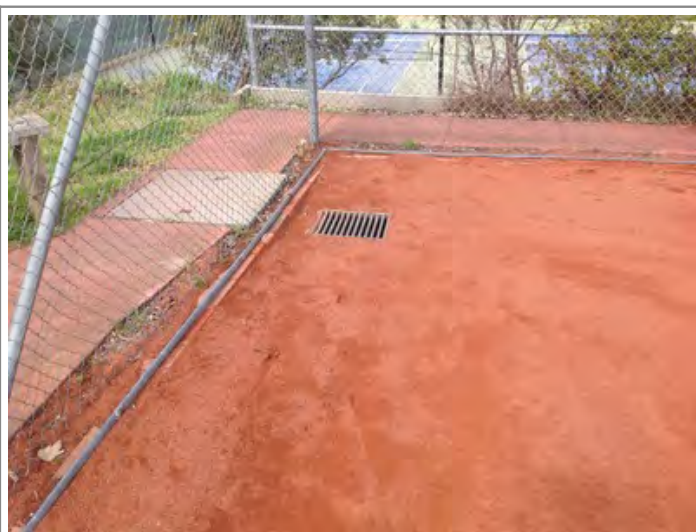
Are drains, pits or other infrastructure provided within the court enclosure?	yes
Are drains, pits or other infrastructure provided within the run-off areas?	no
Drainage rating	Good
	<b>Issues/Observations:</b>
Drainage notes	The court would be expected to drain effectively through the surface. In addition, a grated pit exists in the south eastern corner of the enclosure. There are few signs of pooling across the surface, although the enclosure is a little damp along the northern fence line where a bank of trees offers shade.

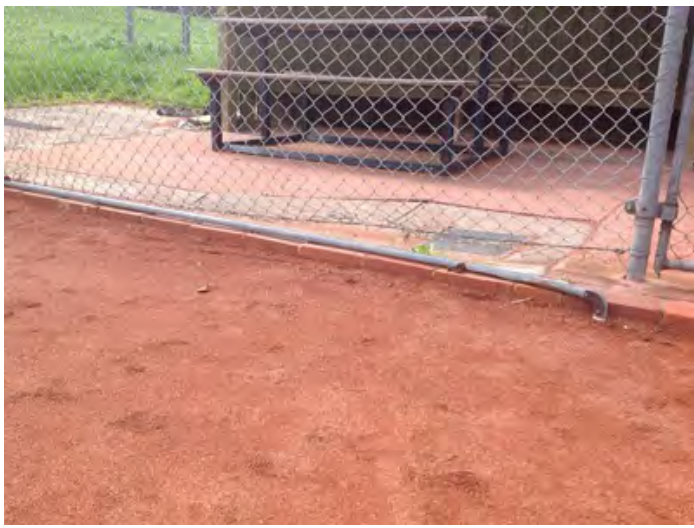
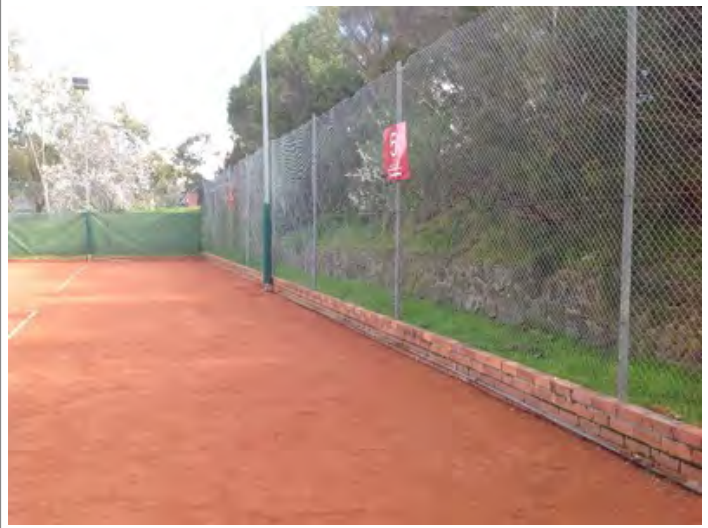
Fence type	Galvanised chain mesh
Fence Rails	Fence rail top: no Fence rail bottom: yes
Fence height	3m to 3.5m Low level side fencing installed: no
Fence attachments	Windbreaks Sponsor advertising
Fence condition rating	Moderate
	<b>Issues/Observations:</b> Slack mesh Excessive gap under fencing - allows balls to escape enclosure
Fencing life span	10+ years
Fence notes	The fence appears to be aged although it is structurally sound. Trees are required to be trimmed in places.

<b>Court</b>	Remove weed growth from court enclosure Trim trees/shrubs away from court enclosure and fencing Hang drag mats on fencing
<b>Drainage</b>	
<b>Infrastructure</b>	Repair damaged fencing Trim vegetation away from fencing
<b>Lighting</b>	Conduct a lighting lux level test

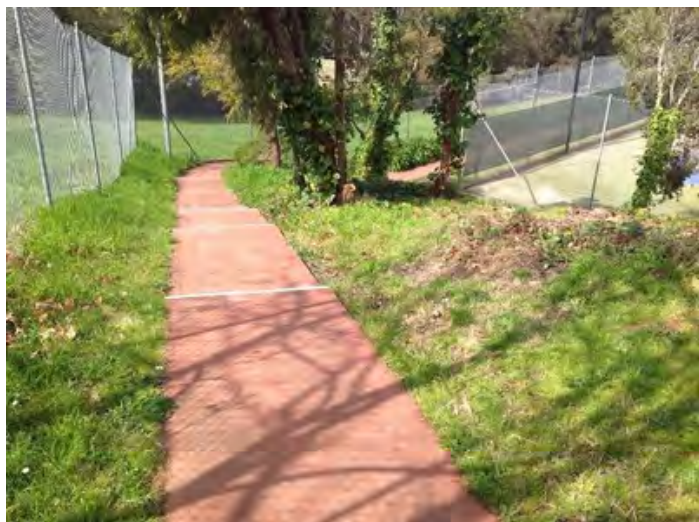
<b>Court enclosure accessibility</b>	Formed paths Trip hazards identified: yes Ramped access provided: no
<b>Path material(s)</b>	Concrete
<b>Main gate dimensions</b>	Standard pedestrian gate 1000mm x 2100mm
<b>Accessibility notes</b>	One entrance to the enclosure require participants to step into the enclosure. To access this enclosure, participants are required to walk up steps located to the east of enclosure one.
