Macleod Park Facility Audit

Document number	000219
Client / Site	Tennis Victoria
Location	Aberdeen Road Macleod VIC 3085
Auditor	Andrew Sodomaco
Audit date	11 Sep 2015

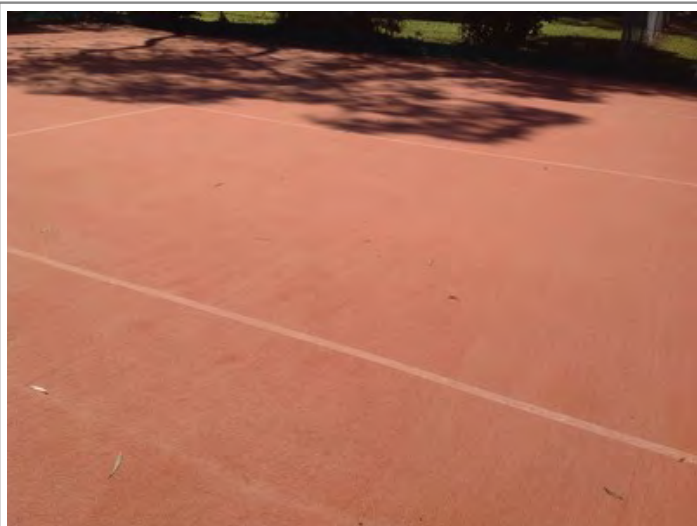
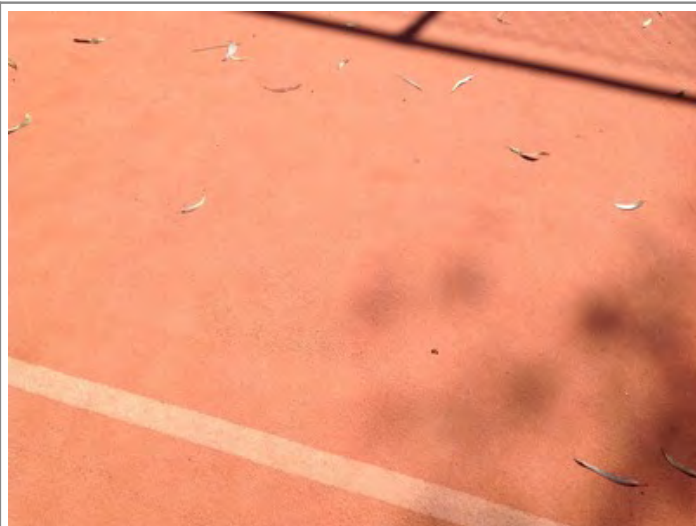
Court condition photos

Unique court number	1
Surface condition rating	Moderate Issues/Observations: Aged surface Compacted pile height Excessively worn surface in high wear areas
Surface type	Synthetic Grass
Surface life span	2-3 years
Court condition notes	This court is heavily compacted and could potentially be very slippery when wet. There are few signs of seam stress. Sand coverage is relatively even.

Court	Trim trees/shrubs away from court enclosure and fencing Hang drag mats on fencing Rejuvenate synthetic pile
Drainage	
Infrastructure	Repair damaged fencing Trim vegetation away from fencing
Lighting	Conduct a lighting lux level test

Are there any critical safety issues?	No
Enclosure recommendations	Plan for upgrade of surface. Plan for fencing upgrade.

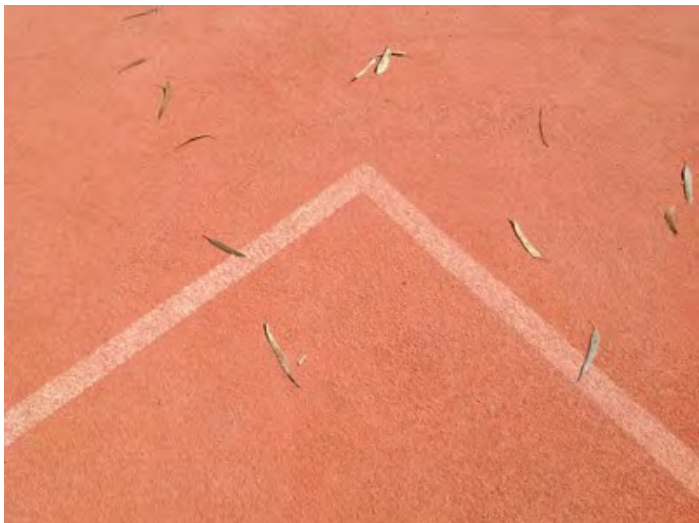
Line marking rating	Good
	Issues/Observations: Clear and bright Straight and clean
Line marking condition notes	The lines are in the same condition as the rest of the court.
Line marking condition photos

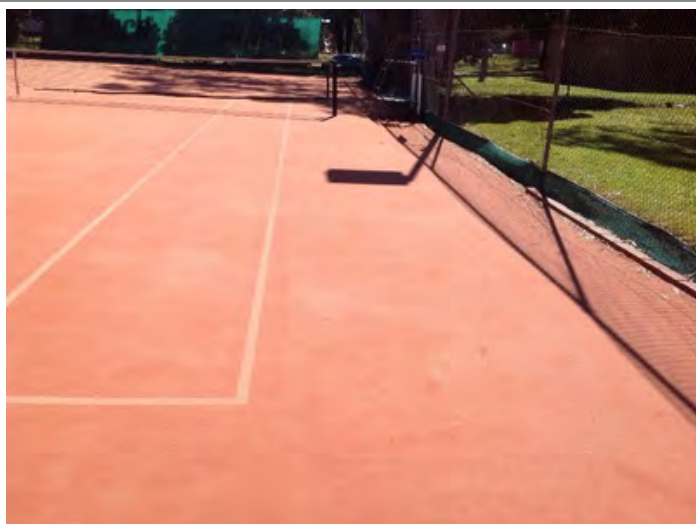
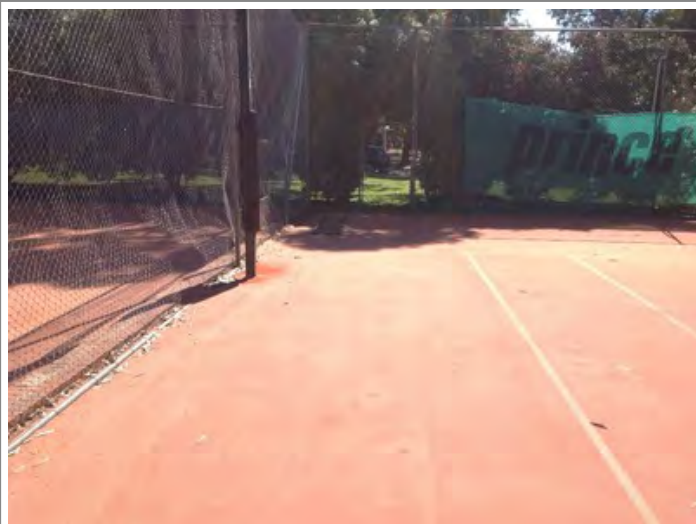
Could the court be made compliant?	no
Is the court to the standard dimensions?	yes
Court orientation	North-south
Are netball goal posts outside tennis court run off areas?	no
Are lockable post hole covers fitted and safe?	no
Compliance notes	The court does not meet run off requirements to any direction.
Compliance photos

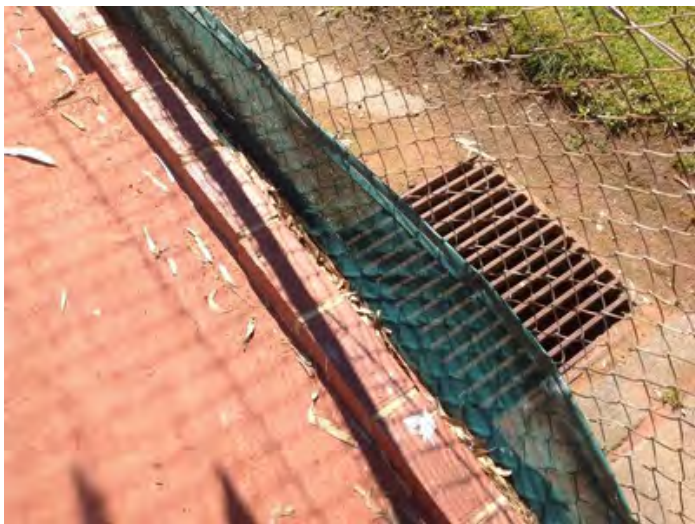
Drainage photos

Drainage infrastructure	Formed
What type of drainage is in place?	Grated pit(s)
Are drains, pits or other infrastructure provided within the court enclosure?	no
Are drains, pits or other infrastructure provided within the run-off areas?	no
Drainage rating	Good
	Issues/Observations:
Drainage notes	A grated pit is located outside the enclosure in the south eastern corner, although this court would be expected to drain effectively directly through the surface. There are no signs of dirt and silt build up which would suggest there is no pooling on the surface.

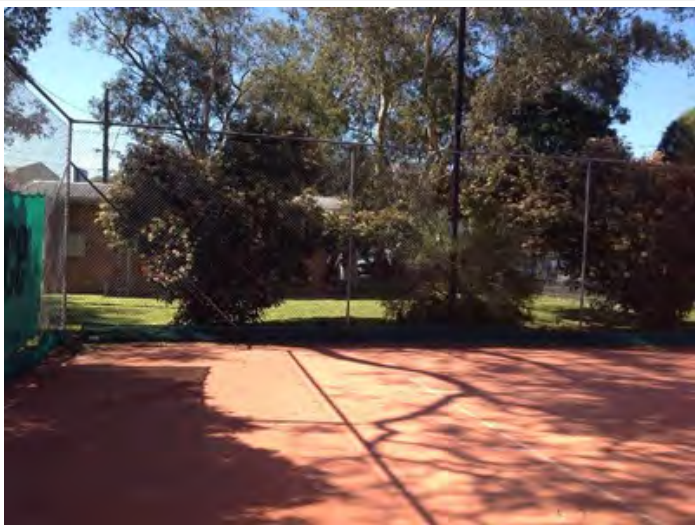
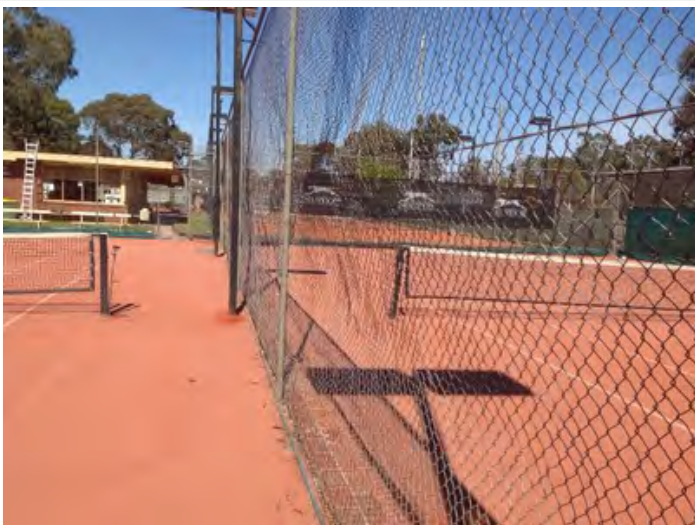
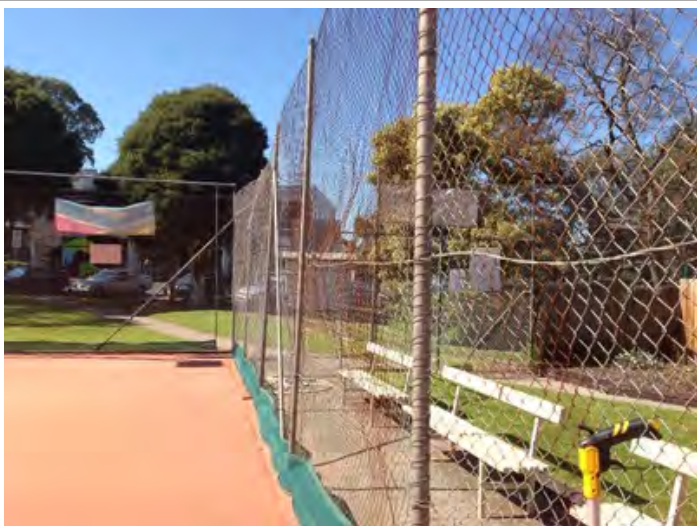
Fencing photos

Fence type	Galvanised chain mesh
Fence Rails	Fence rail top: yes Fence rail bottom: yes
Fence height	3.6m and over Low level side fencing installed: no
Fence attachments	Windbreaks
Fence condition rating	Moderate Issues/Observations: Slack mesh Mesh curling at base Trees/shrubs growing through mesh
Fencing life span	4-5 years
Fence notes	The fencing is in average condition, with multiple issues identified.

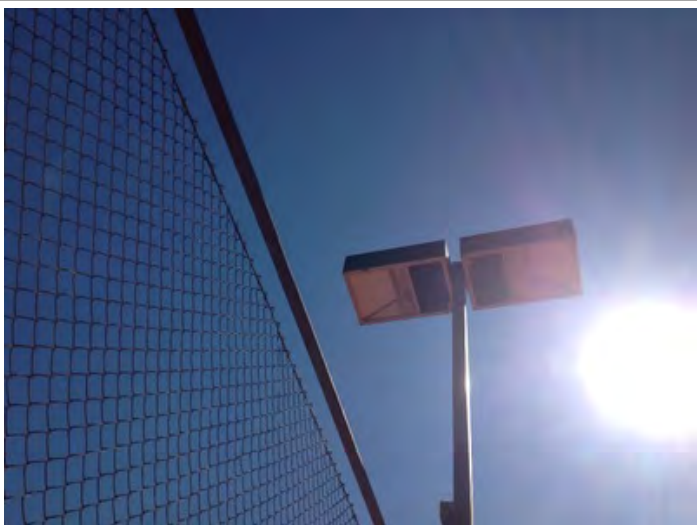
Lighting photos

Does this enclosure have lighting	Yes
Total number of lit courts per enclosure	1
Lighting infrastructure type	Black powder coated low level - Steel poles
Lighting infrastructure position	Side
Light fittings	One per tower
Lighting infrastructure design	Standard
Lighting infrastructure rating	Good Issues/Observations: Infrastructure and fittings in very good condition - likely to achieve required lux standards
Lighting life span	10+ years
Lighting notes	The lighting appears to be in very good condition, although some algae growth is evident on some fittings.

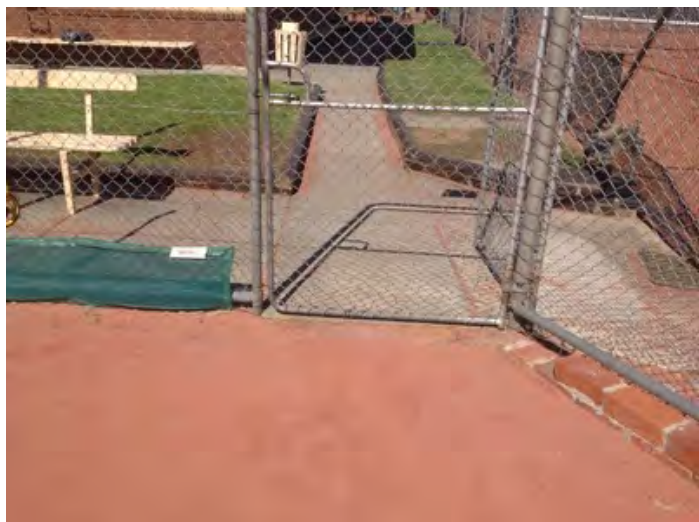
Court enclosure accessibility	Formed paths Trip hazards identified: yes Ramped access provided: no
Path material(s)	Concrete
Main gate dimensions	Standard pedestrian gate 1000mm x 2100mm
Accessibility notes	A row of avers must be stepped over in order to enter the enclosure.
Accessibility photos

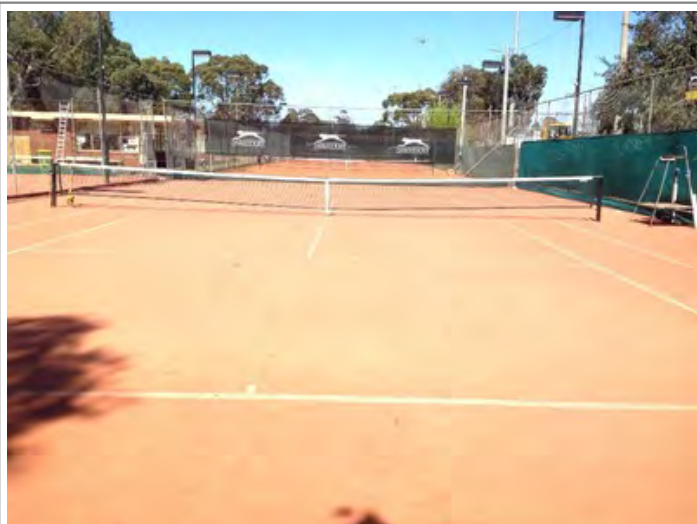
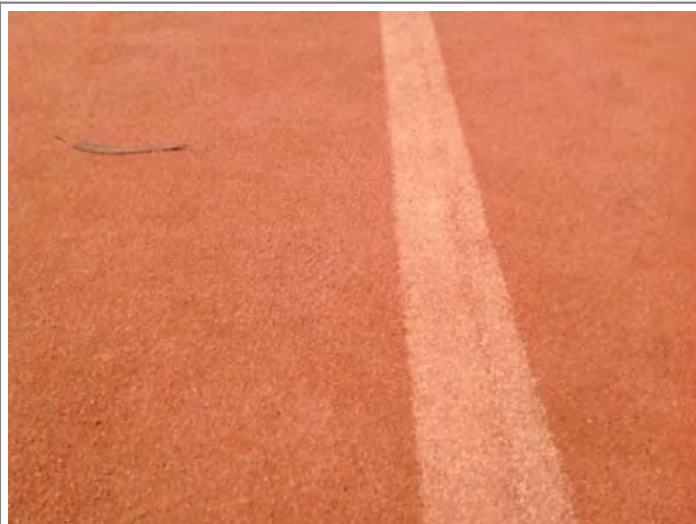
Court condition photos

Unique court number	2
Surface condition rating	Moderate Issues/Observations: Aged surface Compacted pile height Excessively worn surface in high wear areas
Surface type	Synthetic Grass
Surface life span	2-3 years
Court condition notes	This court is heavily compacted and could potentially be very slippery when wet. There are signs of seam stress along the lines. Sand coverage is relatively even.

Court	Rejuvenate synthetic pile
Drainage	
Infrastructure	Repair damaged fencing Trim vegetation away from fencing
Lighting	Conduct a lighting lux level test

Are there any critical safety issues?	No
Enclosure recommendations	Plan for upgrade of surface. Plan for fencing upgrade.

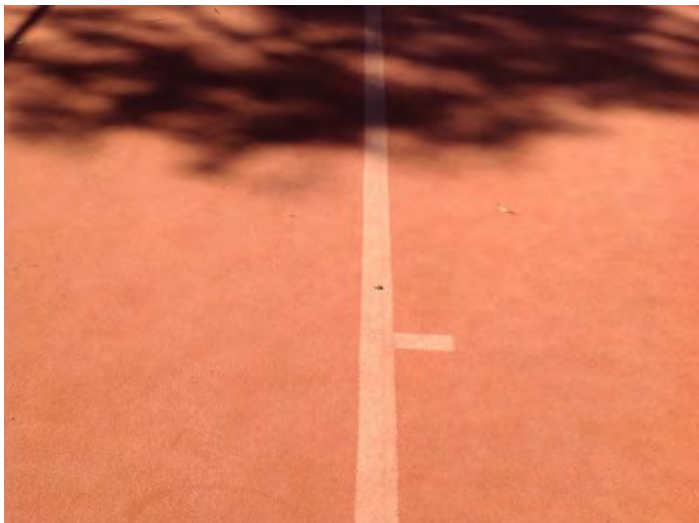
Line marking rating	Good
	Issues/Observations: Clear and bright Straight and clean
Line marking condition notes	The lines are in the same condition as the rest of the court.
Line marking condition photos

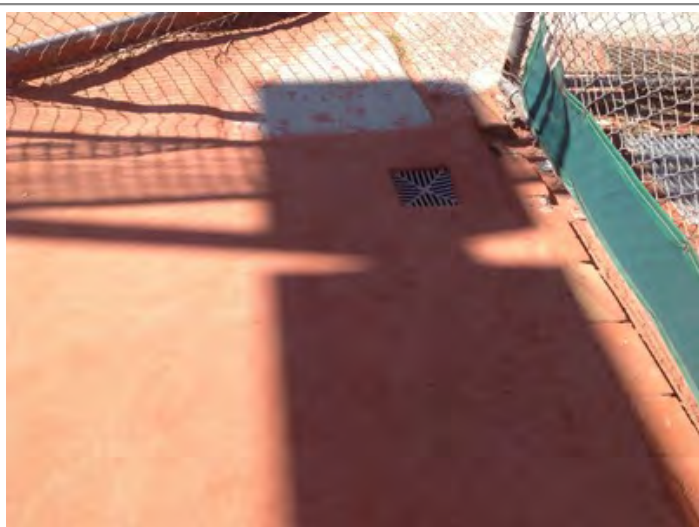
Drainage photos

Drainage infrastructure	Formed
What type of drainage is in place?	Grated pit(s)
Are drains, pits or other infrastructure provided within the court enclosure?	yes
Are drains, pits or other infrastructure provided within the run-off areas?	yes
Drainage rating	Good
	Issues/Observations:
Drainage notes	A grated pit is located inside the enclosure in the south eastern corner, although this court would be expected to drain effectively directly through the surface. There are no signs of dirt and silt build up which would suggest there is no pooling on the surface.

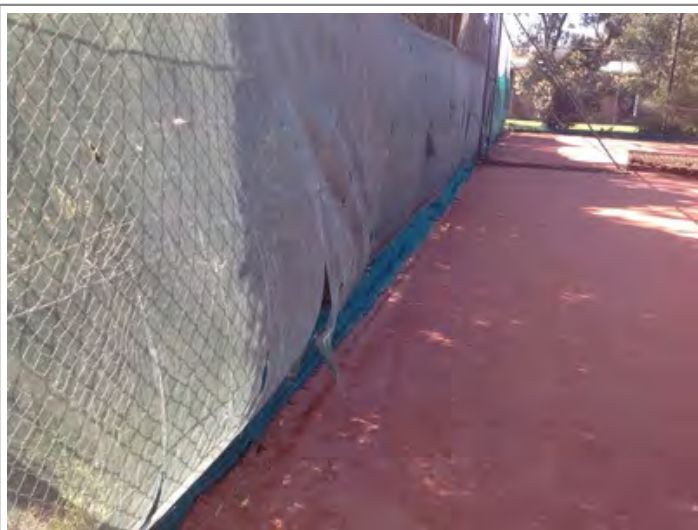
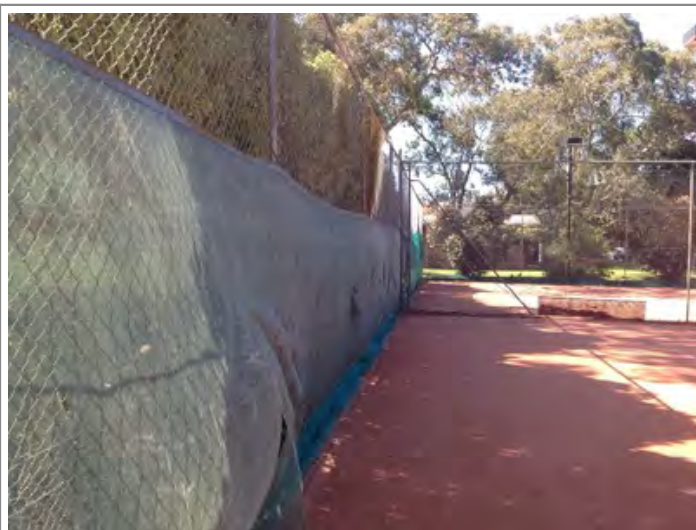
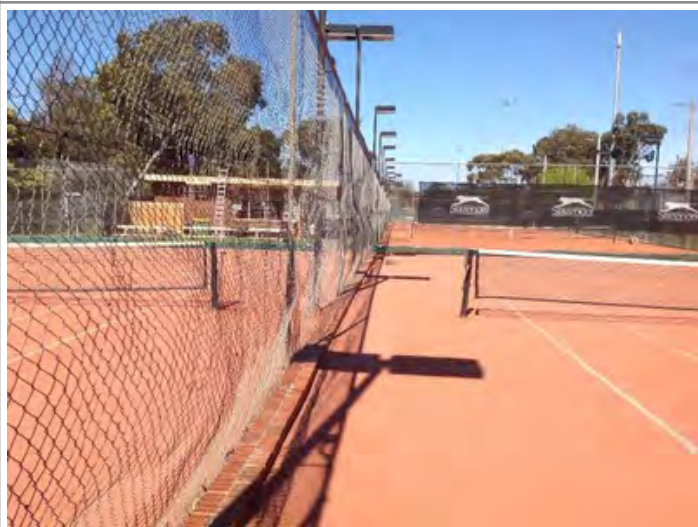
Fencing photos

Fence Rails	Fence rail top: yes Fence rail bottom: yes
Fence height	3.6m and over Low level side fencing installed: no
Fence attachments	Windbreaks Sponsor advertising
Fence condition rating	Moderate Issues/Observations: Slack mesh Rusted mesh
Fencing life span	4-5 years
Fence notes	The fencing is in average condition, with multiple issues identified.

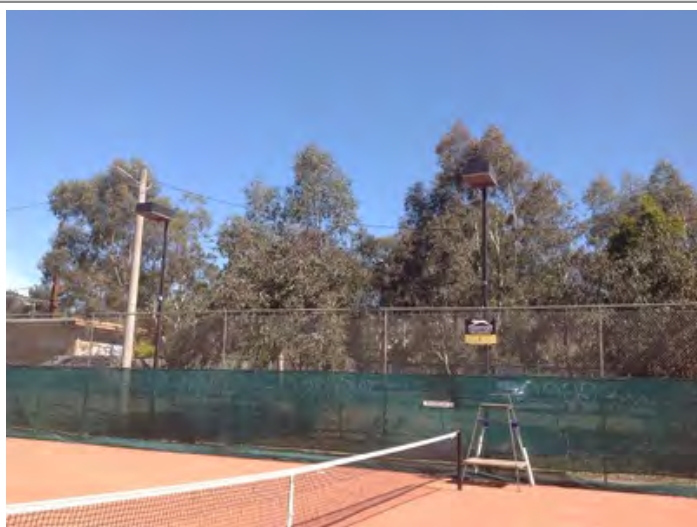
Lighting photos

Lighting infrastructure position	Side
Light fittings	One per tower
Lighting infrastructure design	Standard
Lighting infrastructure rating	Good Issues/Observations: Infrastructure and fittings in very good condition - likely to achieve required lux standards
Lighting life span	10+ years
Lighting notes	The lighting appears to be in very good condition, although some algae growth is evident on some fittings.

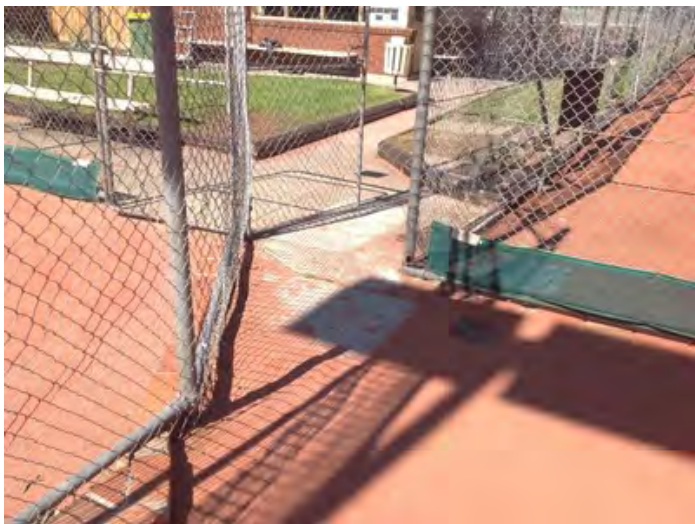
Accessibility photos

Court enclosure accessibility	Formed paths Trip hazards identified: yes Ramped access provided: no
Path material(s)	Concrete
Main gate dimensions	Standard pedestrian gate 1000mm x 2100mm
Accessibility notes	A concrete path leads to the enclosure.

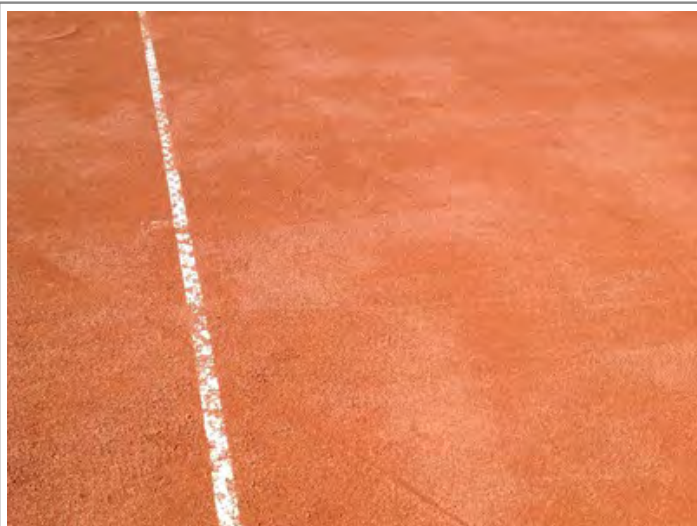
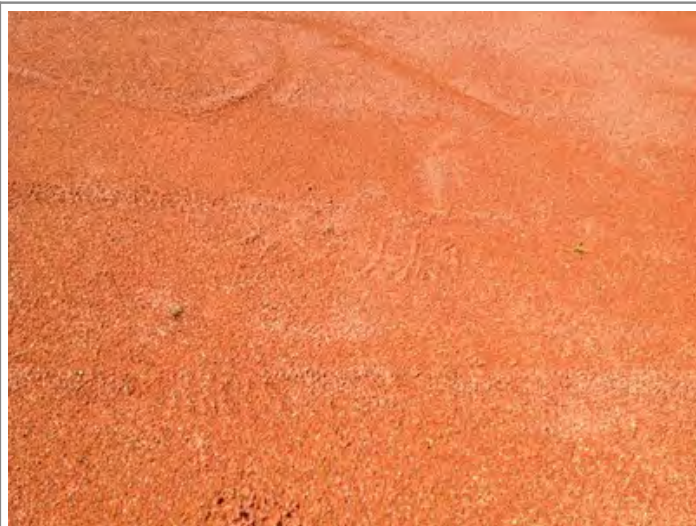
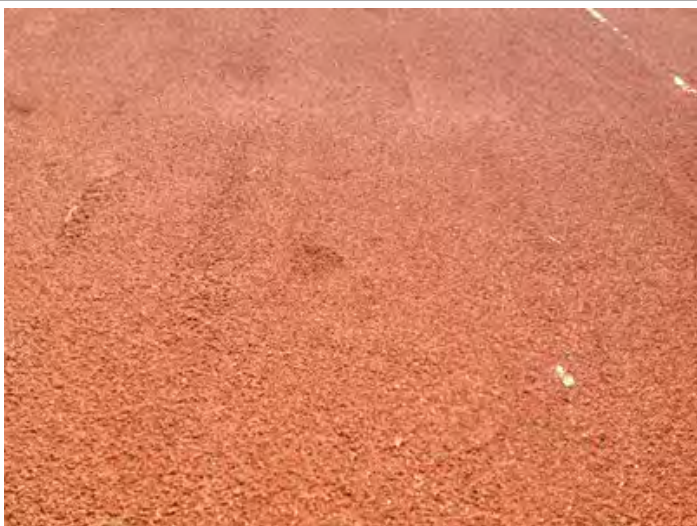
Court condition photos

Unique court number	3
Surface condition rating	Good Issues/Observations: Weed growth
Surface type	Red Porous
Surface life span	10+ years
Court condition notes	Grass and weed growth is evident across the court, albeit in small patches rather than extensively. There is a good coverage of top dressing and no obvious signs of the court aggregate from the base showing through.

Court	Remove weed growth from court enclosure
Drainage	
Infrastructure	Repair damaged fencing
Lighting	Conduct a lighting lux level test

Are there any critical safety issues?	No
Enclosure recommendations	Treat weed growth. Plan for fencing upgrade.

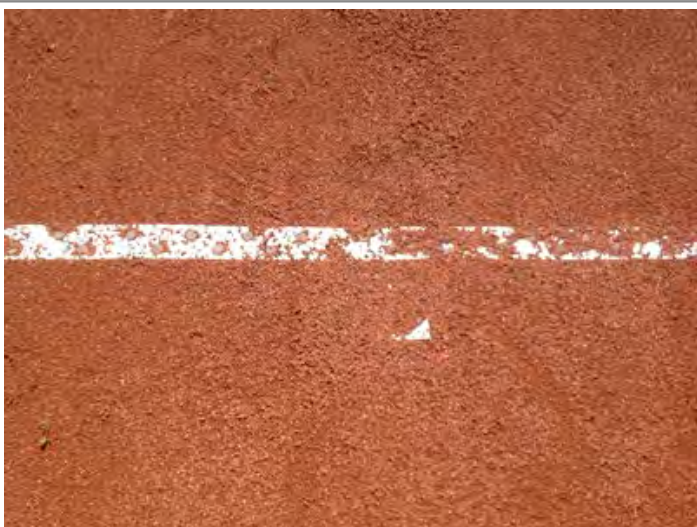
Line marking condition photos

Line marking description	Tennis only lines
Line marking rating	Good Issues/Observations: Inconsistent bounce likely
Line marking condition notes	The lines are standard for this surface and there are no obvious signs of breaks.

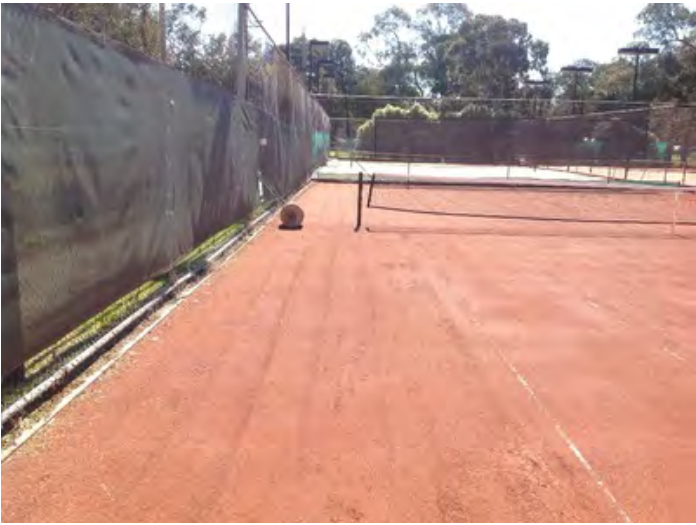
Net post life span	10+ years
Net life span	6-10 years
Net / post notes	
Net / post photos	
No photos taken	
Court compliance	
Is the court run off compliant?	no Runoffs North: 4700m South: 4700m East: 2900m West: 2800m
Could the court be made compliant?	no
Is the court to the standard dimensions?	yes
Court orientation	North-south
Are netball goal posts outside tennis court run off areas?	no
Are lockable post hole covers fitted and safe?	no
Compliance notes	The court does not meet run off requirements to any direction.
Compliance photos

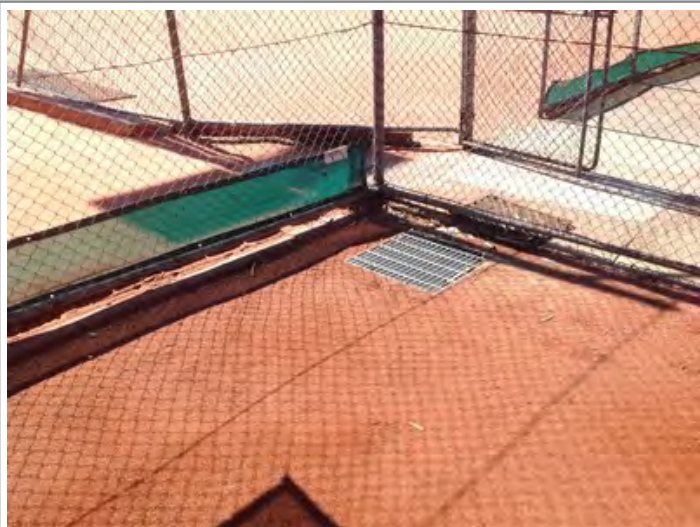
Drainage photos

Are drains, pits or other infrastructure provided within the run-off areas?	yes
Drainage rating	Good
	Issues/Observations:
Drainage notes	A grated pit is located inside the enclosure in the north eastern corner, although this court would be expected to drain effectively directly through the surface. There are no signs of dirt and silt build up which would suggest there is no pooling on the surface.

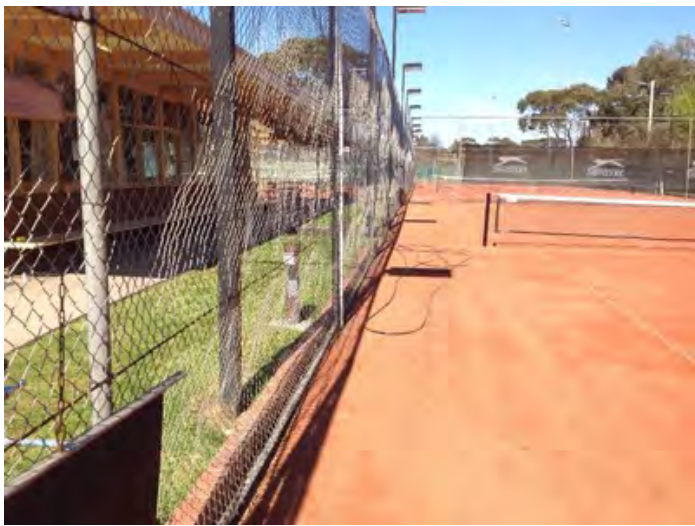
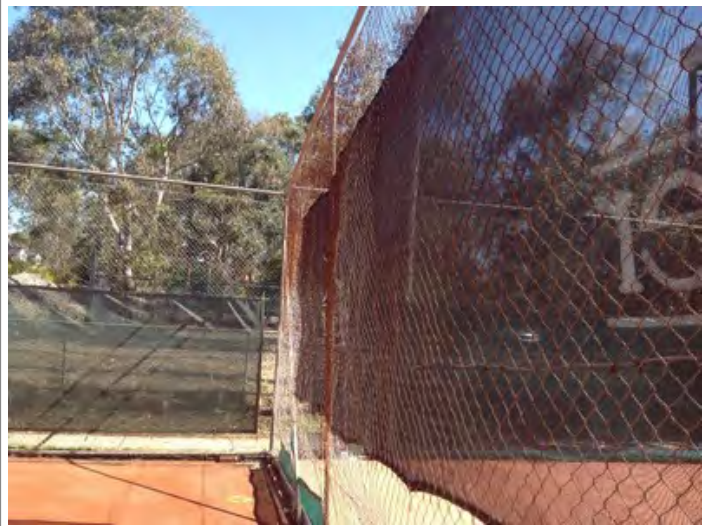
Fencing photos

Fence type	Galvanised chain mesh
Fence Rails	Fence rail top: yes Fence rail bottom: yes
Fence height	3.6m and over Low level side fencing installed: no
Fence attachments	Windbreaks Sponsor advertising
Fence condition rating	Moderate
	Issues/Observations: Slack mesh Mesh curling at base Rusted mesh
Fencing life span	4-5 years
Fence notes	The fencing is in average condition, with multiple issues identified.

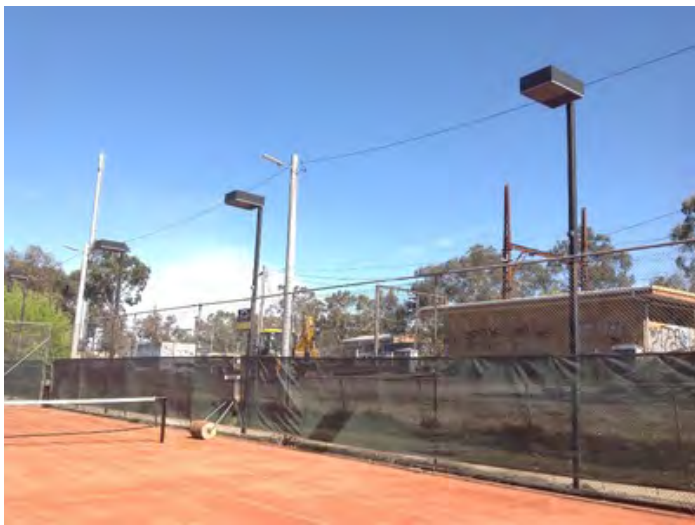
Lighting photos

Does this enclosure have lighting	Yes
Total number of lit courts per enclosure	1
Lighting infrastructure type	Black powder coated low level - Steel poles
Lighting infrastructure position	Side
Light fittings	One per tower
Lighting infrastructure design	Standard
Lighting infrastructure rating	Very Good
	Issues/Observations: Infrastructure and fittings in very good condition - likely to achieve required lux standards
Lighting life span	10+ years
Lighting notes	The lighting appears to be in very good condition.

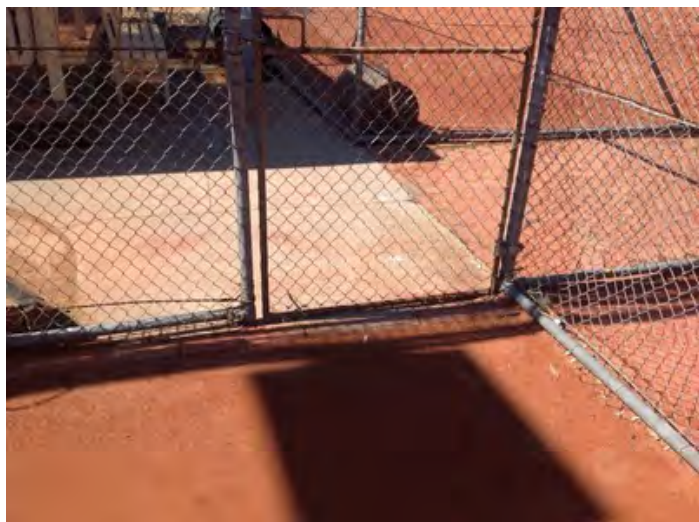
Accessibility photos

Court enclosure accessibility	Formed paths Trip hazards identified: yes Ramped access provided: no
Path material(s)	Concrete
Main gate dimensions	Standard pedestrian gate 1000mm x 2100mm
Accessibility notes	A row of pavers forms a tripping hazard entering the enclosure.

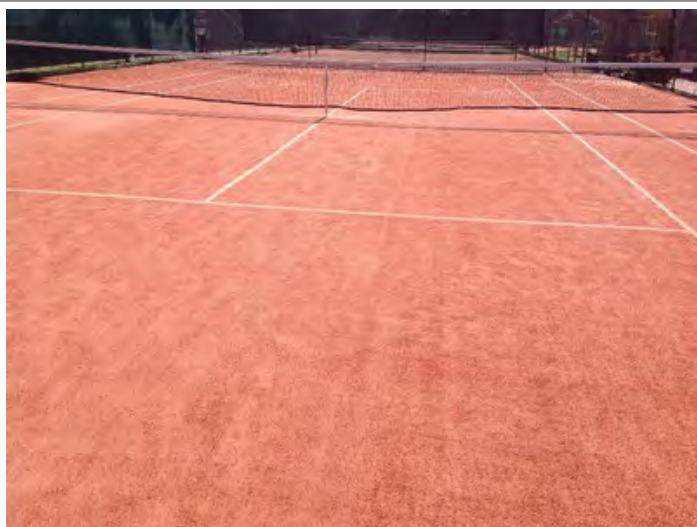
Court condition photos

Unique court number	4
Surface condition rating	Very Good
	Issues/Observations:
Surface type	Synthetic Clay
Surface life span	6-10 years
Court condition notes	This court appears to be very new and no issues are identified. The pile height remains quite high, and these courts would be less likely to be slippery when wet than courts one and two.

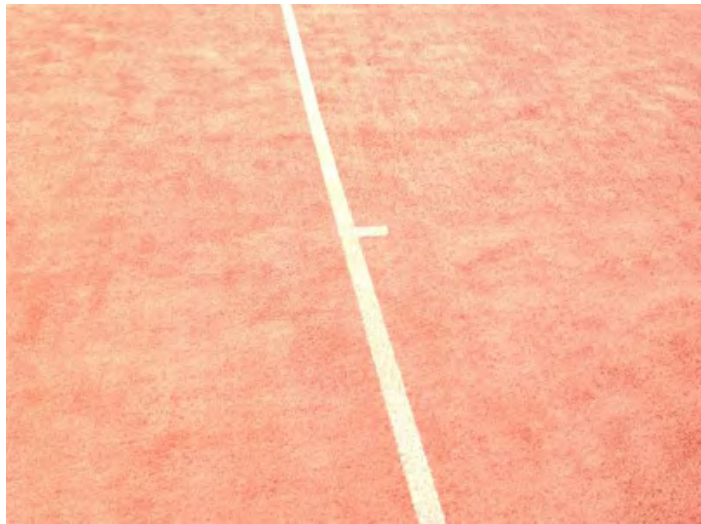
Line marking condition notes	The lines are in the same condition as the rest of the court.
Line marking condition photos

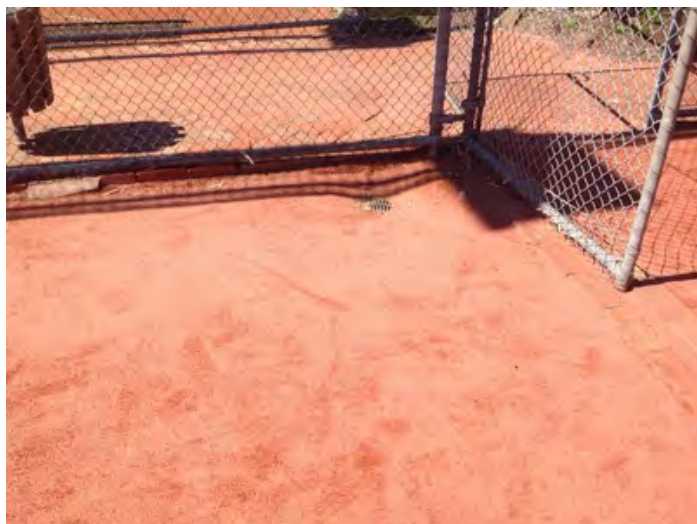
Drainage photos

Drainage infrastructure	Formed
What type of drainage is in place?	Grated pit(s)
Are drains, pits or other infrastructure provided within the court enclosure?	yes
Are drains, pits or other infrastructure provided within the run-off areas?	yes
Drainage rating	Good
	Issues/Observations:
Drainage notes	A grated pit is located inside the enclosure in the south eastern corner, although this court would be expected to drain effectively directly through the surface. There are no signs of dirt and silt build up which would suggest there is no pooling on the surface.

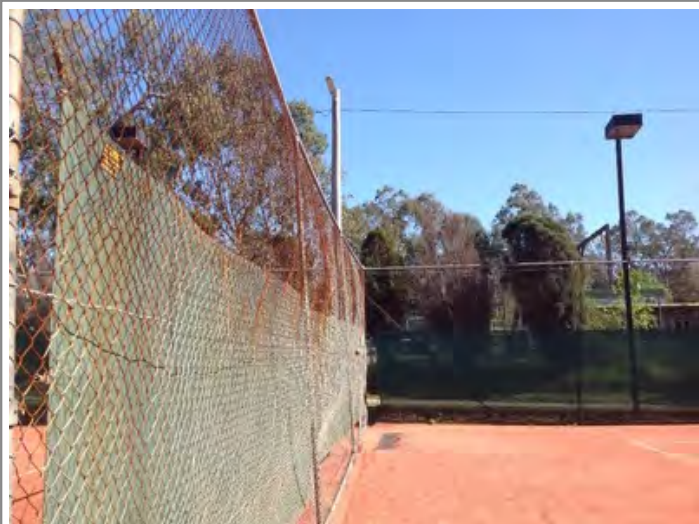
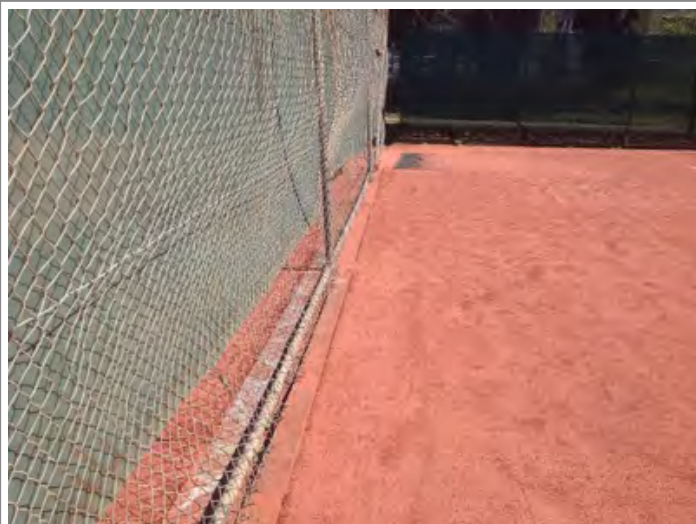
Fencing photos

Fence attachments	There are no fence attachments.
Fence condition rating	Moderate Issues/Observations: Slack mesh Rusted mesh
Fencing life span	4-5 years
Fence notes	The fencing is in average condition, with multiple issues identified.

Court	
Drainage	
Infrastructure	Repair damaged fencing
Lighting	Conduct a lighting lux level test

Are there any critical safety issues?	No
Enclosure recommendations	Plan for fencing upgrade.

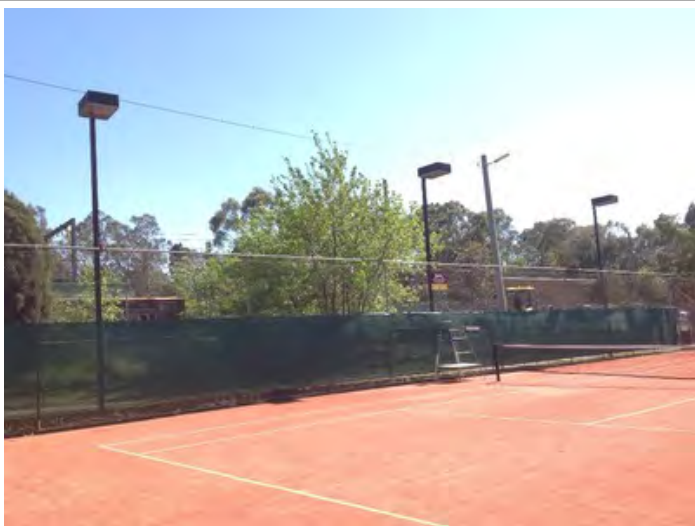
Lighting photos

Does this enclosure have lighting	Yes
Total number of lit courts per enclosure	1
Lighting infrastructure type	Black powder coated low level - Steel poles
Lighting infrastructure position	Side
Light fittings	One per tower
Lighting infrastructure design	Standard
Lighting infrastructure rating	Very Good Issues/Observations: Infrastructure and fittings in very good condition - likely to achieve required lux standards
Lighting life span	10+ years
Lighting notes	The lighting appears to be in very good condition.

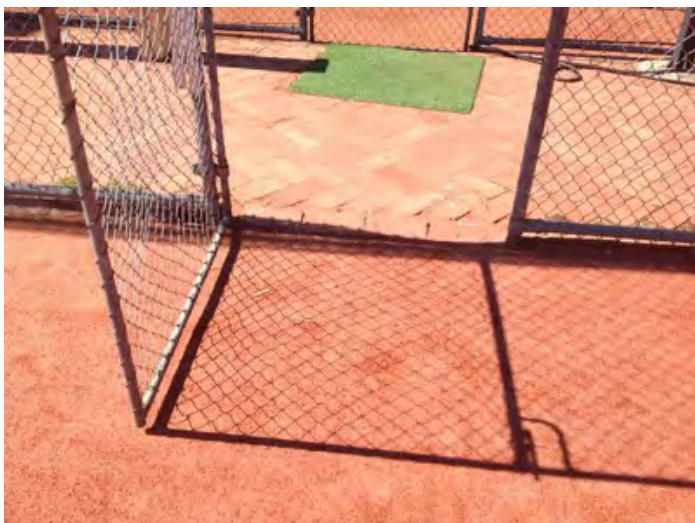
Accessibility photos

Court enclosure accessibility	Formed paths Trip hazards identified: yes Ramped access provided: no
Path material(s)	Concrete
Main gate dimensions	Standard pedestrian gate 1000mm x 2100mm
Accessibility notes	A row of pavers forms a tripping hazard entering the enclosure.

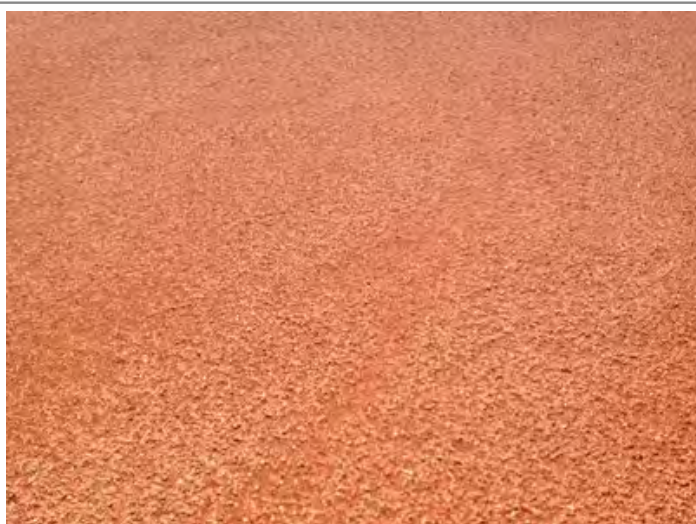
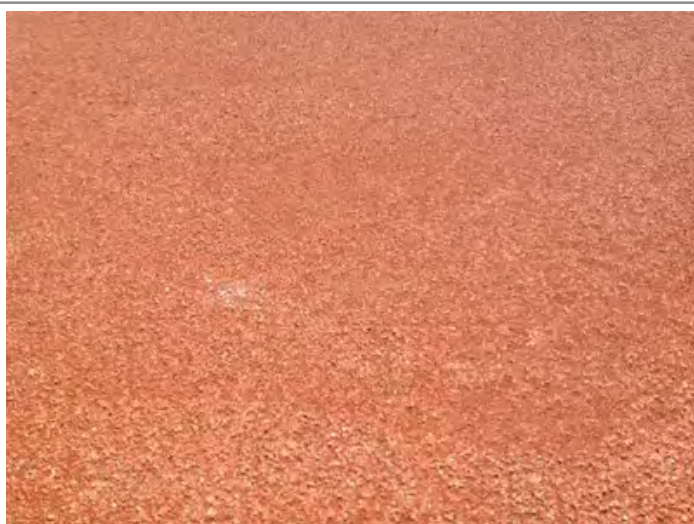
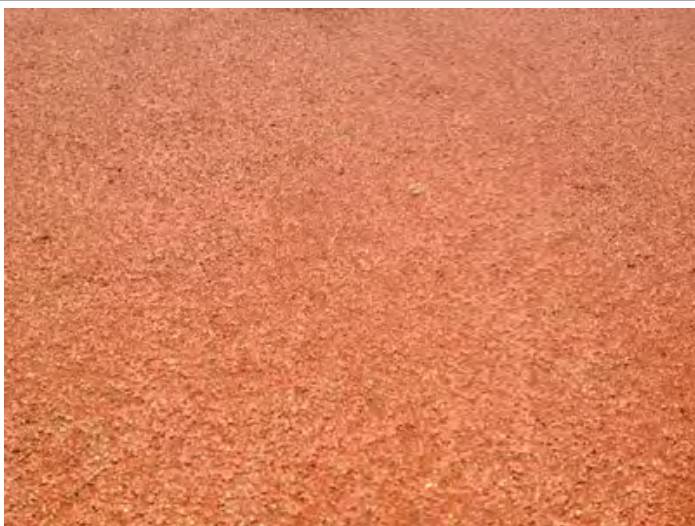
Court condition photos

Unique court number	5
Surface condition rating	Good Issues/Observations: Weed growth
Surface type	Red Porous
Surface life span	10+ years
Court condition notes	Grass and weed growth is evident across the court, albeit in small patches rather than extensively. There is a good coverage of top dressing and no obvious signs of the court aggregate from the base showing through. Weed growth is more extensive on this court than the other porous court, court three. There is a small hole down the southern end of the court.

Are there any critical safety issues?	No
Enclosure recommendations	Treat weed growth. Plan for fencing upgrade. Repair hole in the court as it is a tripping hazard.

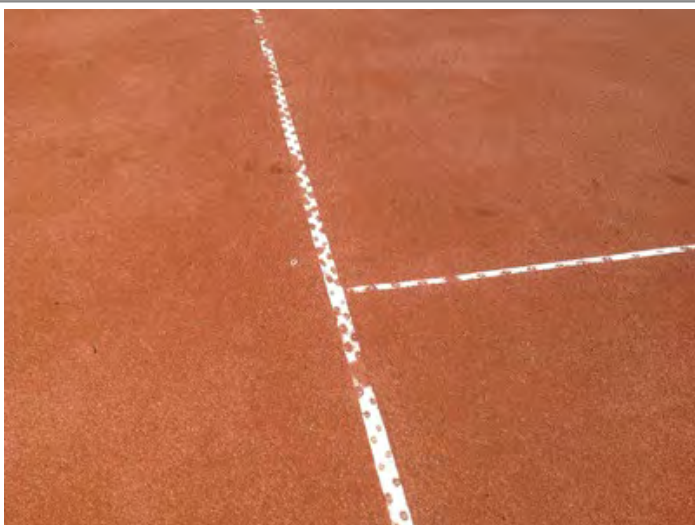
Line marking condition photos

Line marking description	Tennis only lines
Line marking rating	Good Issues/Observations: Inconsistent bounce likely
Line marking condition notes	The lines are standard for this surface and there are no obvious signs of breaks.

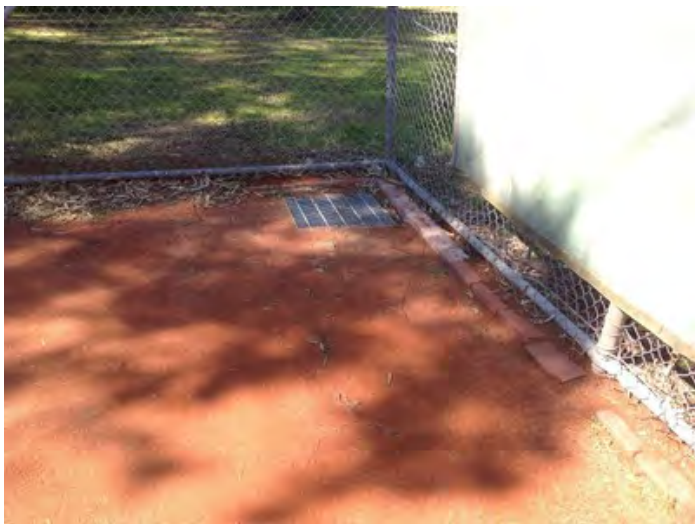
Drainage photos

Net post life span	10+ years
Net life span	6-10 years
Net / post notes	
Net / post photos	
No photos taken	
Court compliance	
Is the court run off compliant?	no Runoffs North: 4700m South: 4700m East: 2800m West: 2700m
Could the court be made compliant?	no
Is the court to the standard dimensions?	yes
Court orientation	North-south
Are netball goal posts outside tennis court run off areas?	no
Are lockable post hole covers fitted and safe?	no
Compliance notes	The court does not meet run off requirements to any direction.
Compliance photos	
No photos taken	
Drainage	
Drainage infrastructure	Formed
What type of drainage is in place?	Grated pit(s)
Are drains, pits or other infrastructure provided within the court enclosure?	yes
Are drains, pits or other infrastructure provided within the run-off areas?	yes
Drainage rating	Good Issues/Observations:
Drainage notes	A grated pit is located inside the enclosure in the south eastern corner, although this court would be expected to drain effectively directly through the surface. There are no signs of dirt and silt build up which would suggest there is no pooling on the surface.

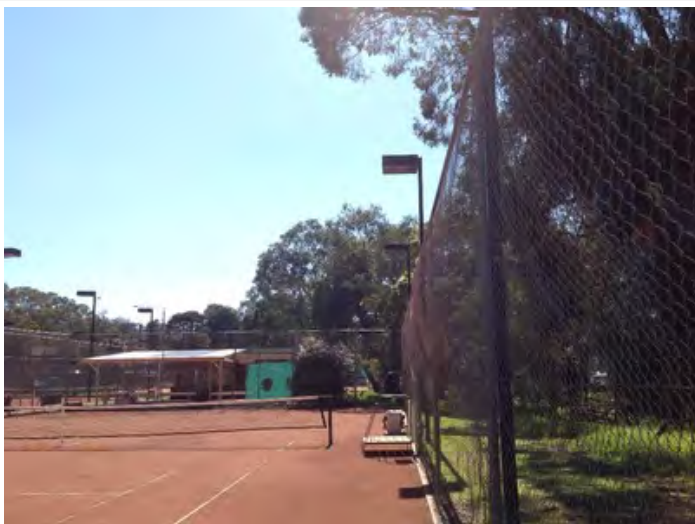
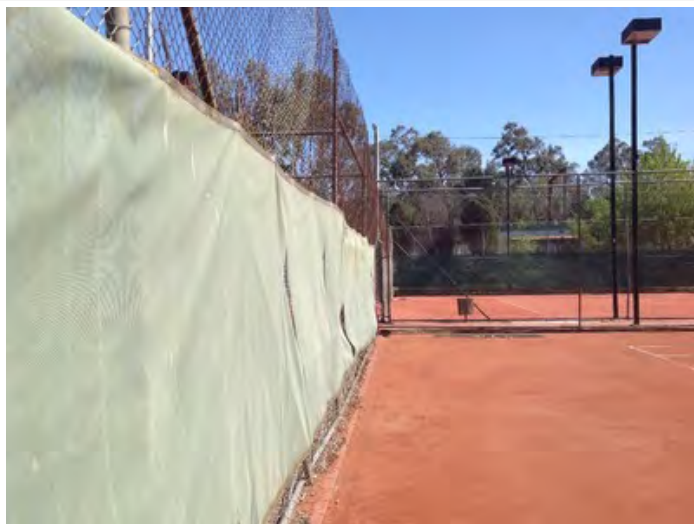
Fencing photos

Fence type	Galvanised chain mesh
Fence Rails	Fence rail top: yes Fence rail bottom: yes
Fence height	3.6m and over Low level side fencing installed: no
Fence attachments	There are no fence attachments.
Fence condition rating	Moderate Issues/Observations: Slack mesh Rusted mesh
Fencing life span	4-5 years
Fence notes	The fencing is in average condition, with multiple issues identified.

Court	Remove weed growth from court enclosure Trim trees/shrubs away from court enclosure and fencing
Drainage	
Infrastructure	Repair damaged fencing Trim vegetation away from fencing
Lighting	Conduct a lighting lux level test

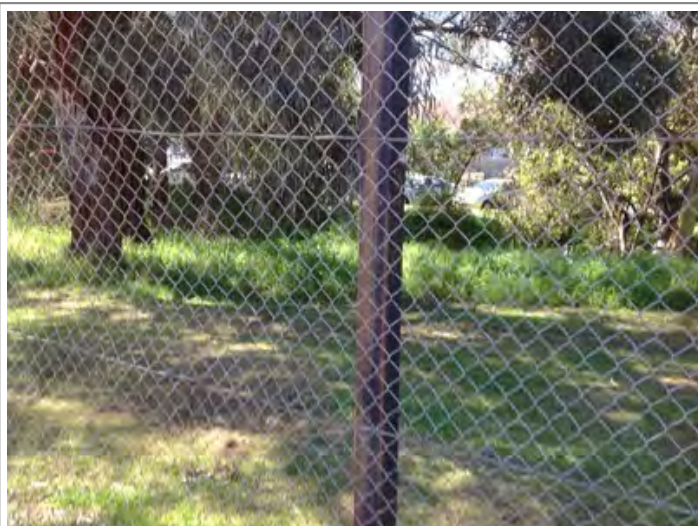
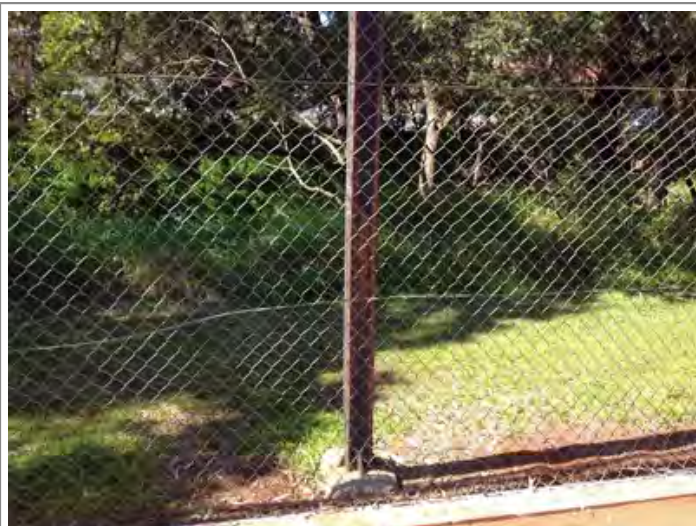
Lighting photos

Total number of lit courts per enclosure	1
Lighting infrastructure type	Black powder coated low level - Steel poles
Lighting infrastructure position	Side
Light fittings	One per tower
Lighting infrastructure design	Standard
Lighting infrastructure rating	Good Issues/Observations: Rusted infrastructure Infrastructure and fittings in very good condition - likely to achieve required lux standards
Lighting life span	10+ years
Lighting notes	The lighting appears to be in very good condition, except with some rusting on some posts.

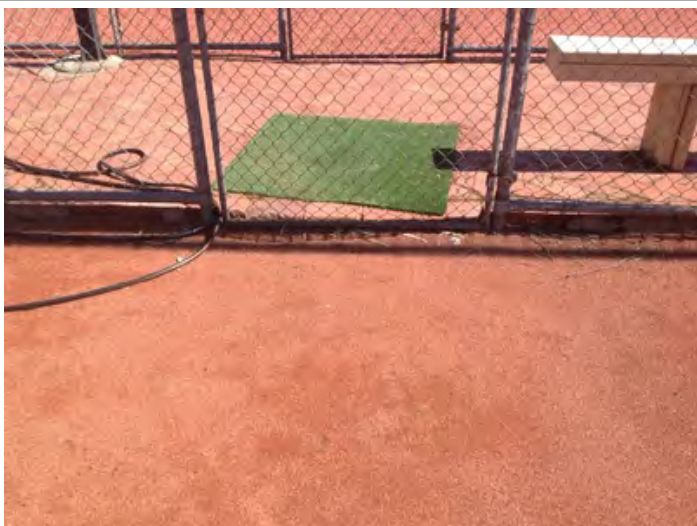
Accessibility photos

Court enclosure accessibility	Formed paths Trip hazards identified: yes Ramped access provided: no
Path material(s)	Concrete
Main gate dimensions	Standard pedestrian gate 1000mm x 2100mm
Accessibility notes	A row of pavers forms a tripping hazard entering the enclosure.

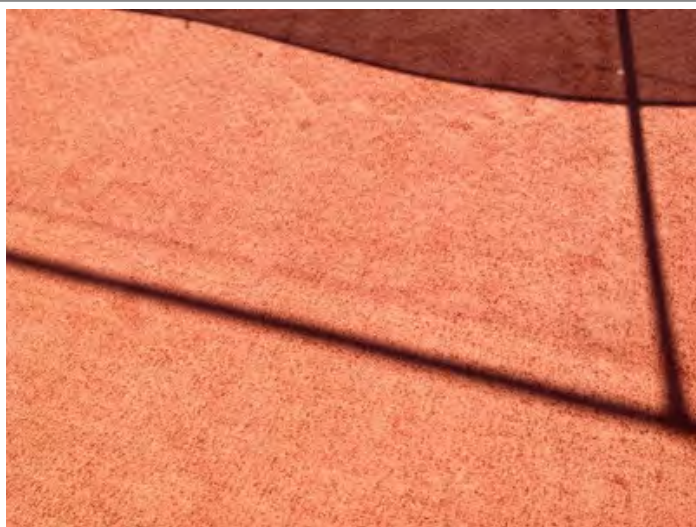
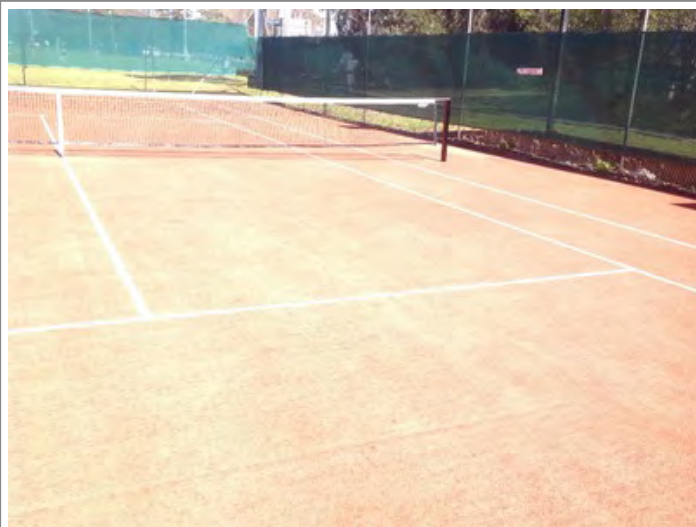
Court condition photos

Unique court number	6
Surface condition rating	Very Good
	Issues/Observations:
Surface type	Synthetic Clay
Surface life span	6-10 years
Court condition notes	This court appears to be very new and no issues are identified. The pile height remains quite high, and these courts would be less likely to be slippery when wet than courts one and two.

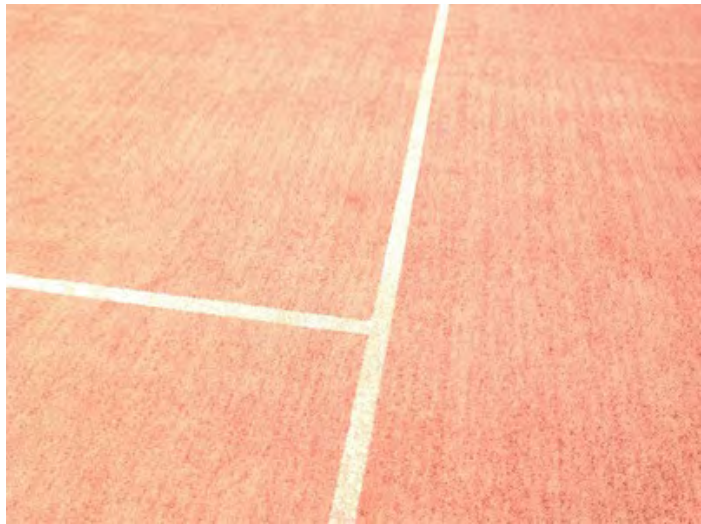
Line marking condition notes	The lines are in the same condition as the rest of the court.
Line marking condition photos
