Macleod Park Facility Audit

Document number	000219
Client / Site	Tennis Victoria
Location	Aberdeen Road Macleod VIC 3085
Auditor	Andrew Sodomaco
Audit date	11 Sep 2015

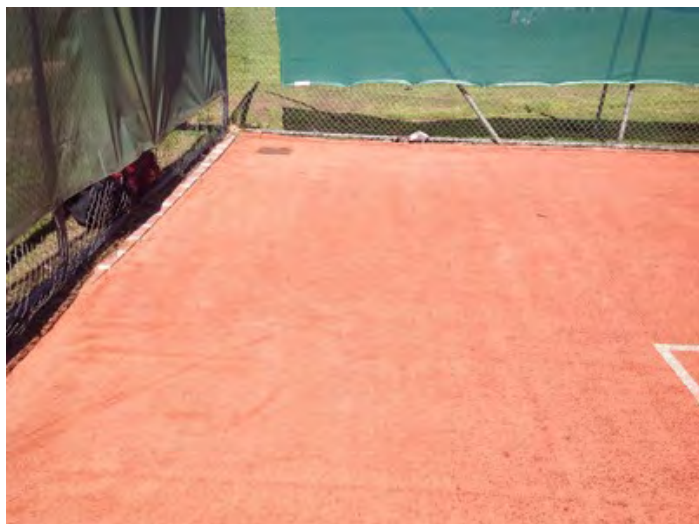
Drainage photos

Drainage infrastructure	Formed
What type of drainage is in place?	Grated pit(s)
Are drains, pits or other infrastructure provided within the court enclosure?	yes
Are drains, pits or other infrastructure provided within the run-off areas?	yes
Drainage rating	Good
	Issues/Observations:
Drainage notes	A grated pit is located inside the enclosure in the south eastern corner, although this court would be expected to drain effectively directly through the surface. There are no signs of dirt and silt build up which would suggest there is no pooling on the surface.

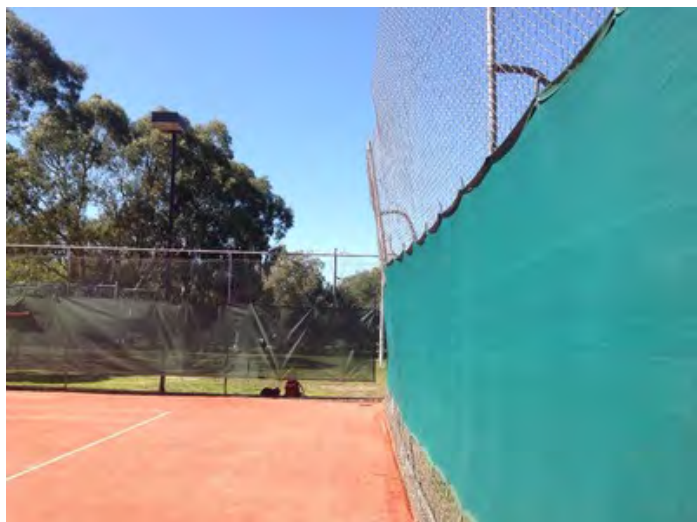
Fencing photos

Fence attachments	Windbreaks
Fence condition rating	Moderate Issues/Observations: Slack mesh Rusted mesh
Fencing life span	4-5 years
Fence notes	The fencing is in average condition, with multiple issues identified.

Court	Hang drag mats on fencing
Drainage	
Infrastructure	Repair damaged fencing
Lighting	Conduct a lighting lux level test

Are there any critical safety issues?	No
Enclosure recommendations	Plan for fencing upgrade.

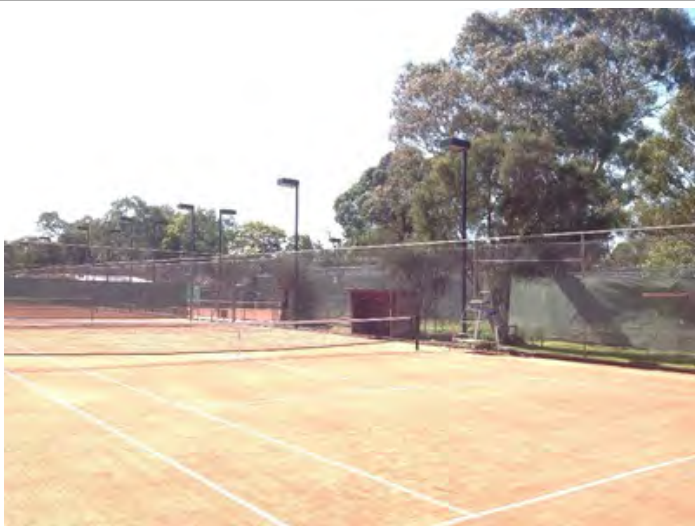
Lighting photos

Does this enclosure have lighting	Yes
Total number of lit courts per enclosure	1
Lighting infrastructure type	Black powder coated low level - Steel poles
Lighting infrastructure position	Side
Light fittings	One per tower
Lighting infrastructure design	Standard
Lighting infrastructure rating	Very Good Issues/Observations: Infrastructure and fittings in very good condition - likely to achieve required lux standards
Lighting life span	10+ years
Lighting notes	The lighting appears to be in very good condition.

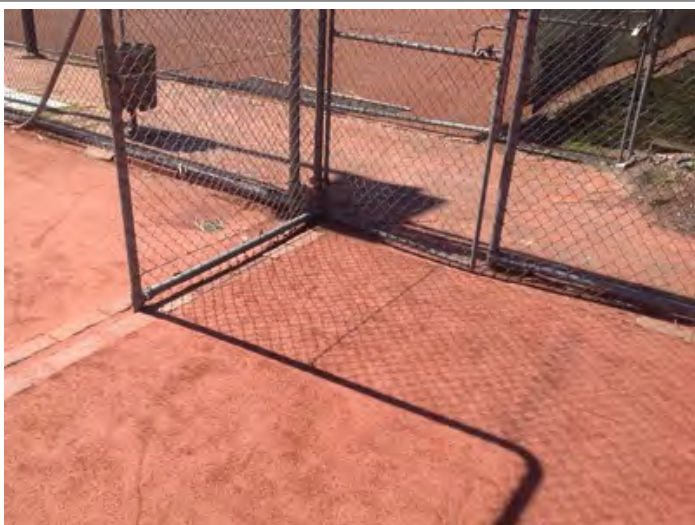
Accessibility photos

Court enclosure accessibility	Formed paths Trip hazards identified: yes Ramped access provided: no
Path material(s)	Concrete
Main gate dimensions	Standard pedestrian gate 1000mm x 2100mm
Accessibility notes	A row of pavers forms a tripping hazard entering the enclosure.

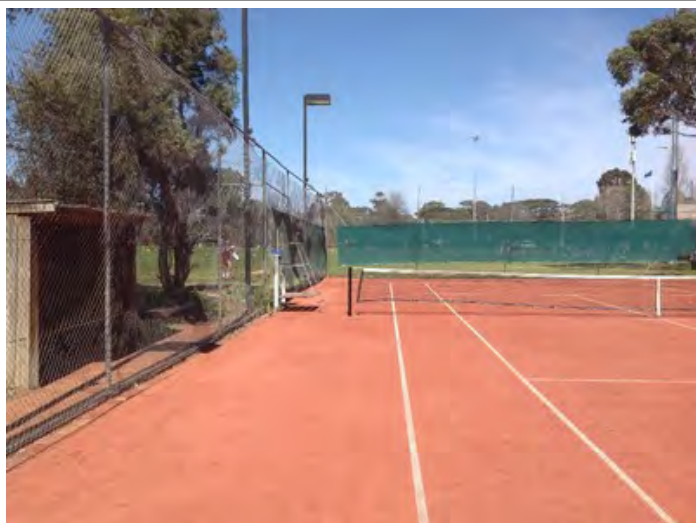
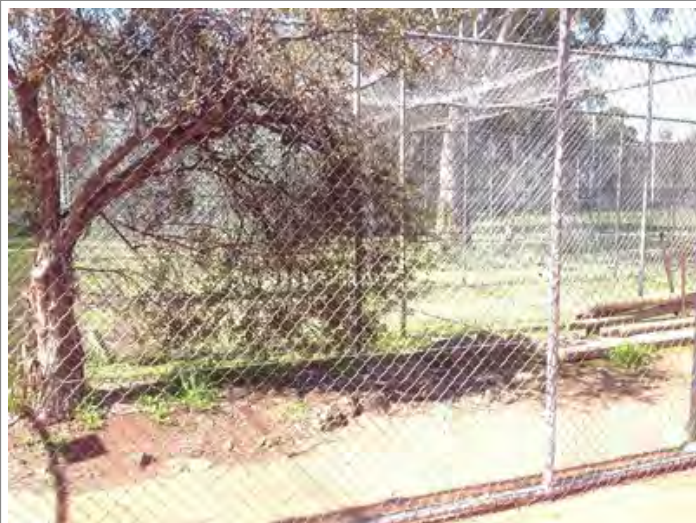
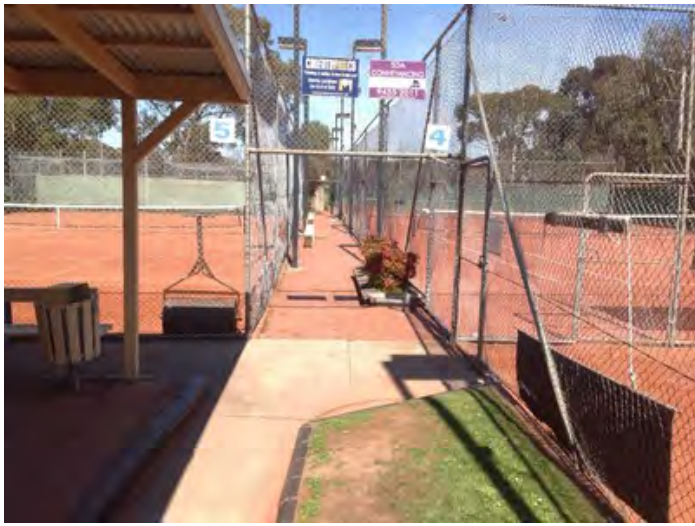
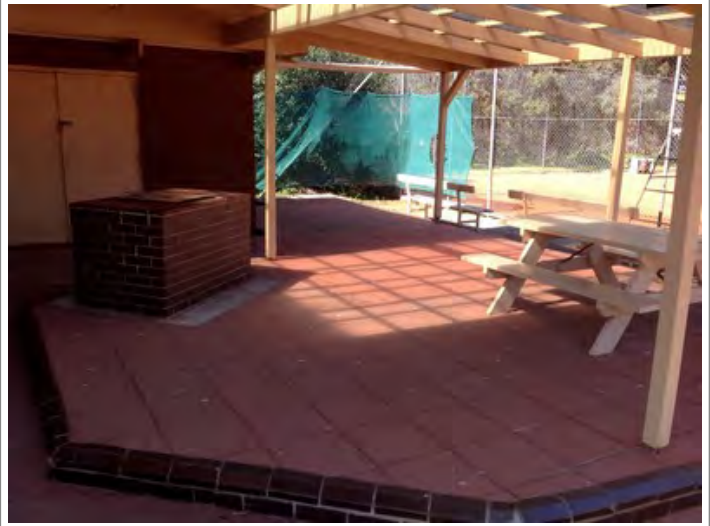
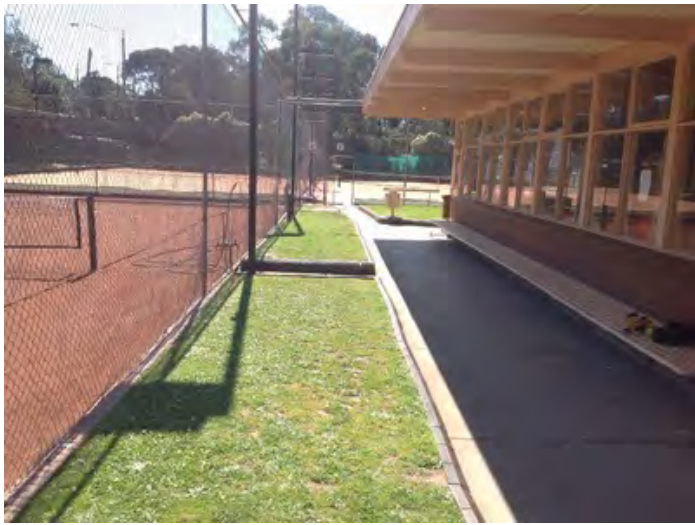
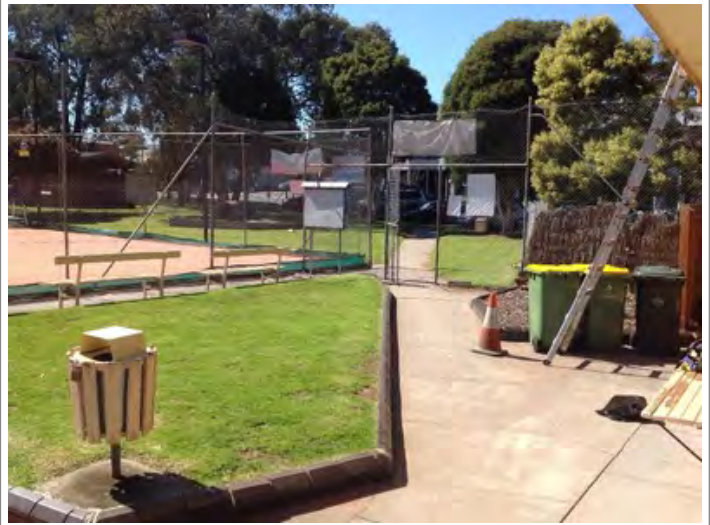
Grounds and surrounds photos

Condition of ground and court surrounds	Good
Court surround notes	Court surrounds are in between court enclosures and are relatively well maintained. A covered bbq area is provided adjacent to the clubhouse. A football ground is located to the south of facility, and train station to the north.
Water supply	Potable
Water notes	
Natural Shade	No natural shade
Man made Shade	Clubhouse veranda
Shade notes	
Car parking	On street: 61-80 spaces Off street: Overflow:
Does the site have any hit up walls	no
Car park notes	Car parking is shared with a local shopping centre and train station.
Adjacent facilities	Oval/playing field
Does the site have any potential expansion oppotunities?	no

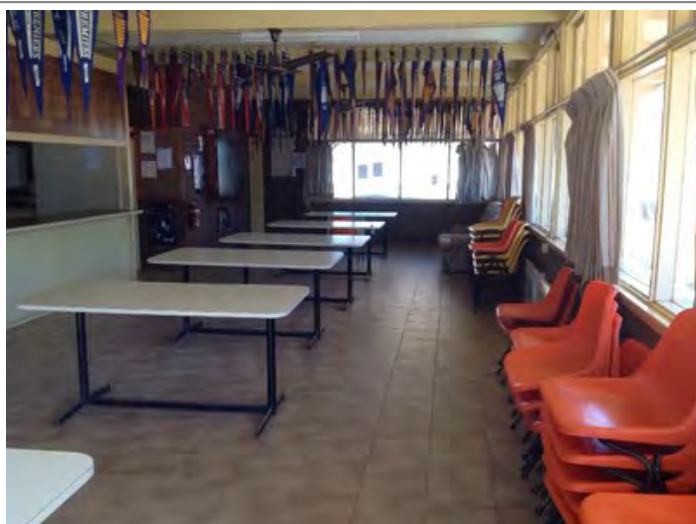
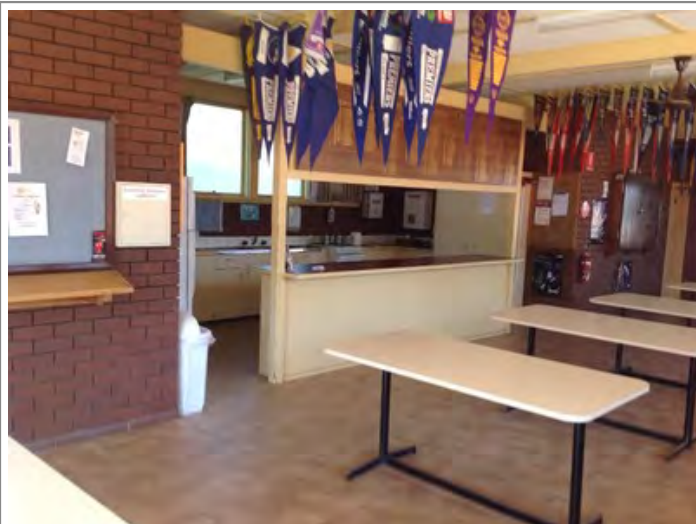
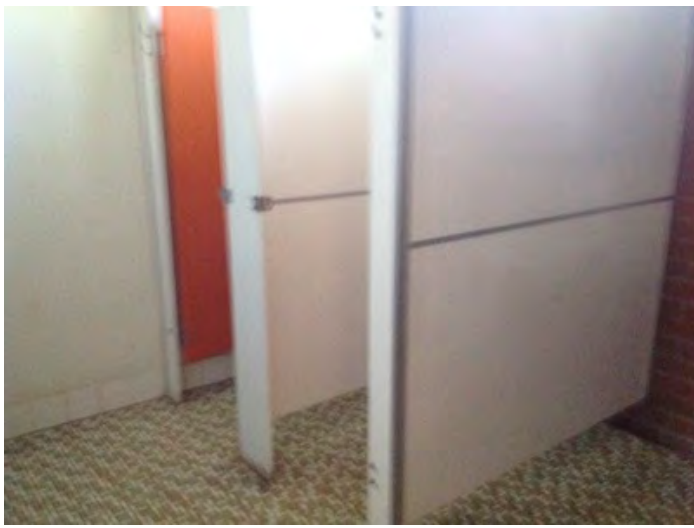
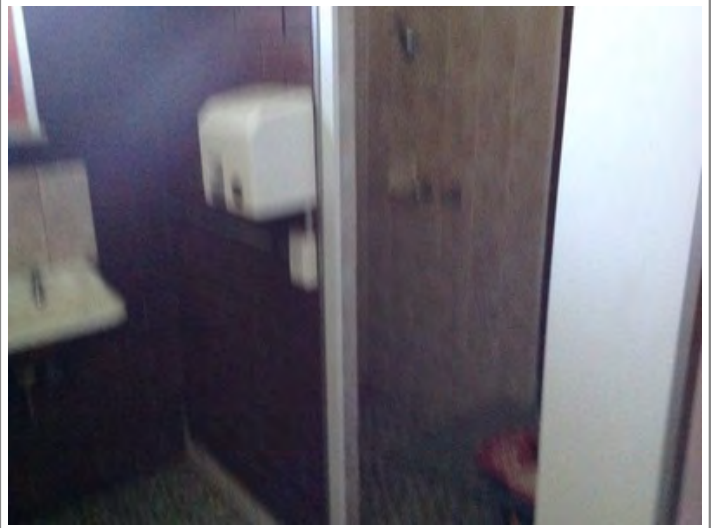
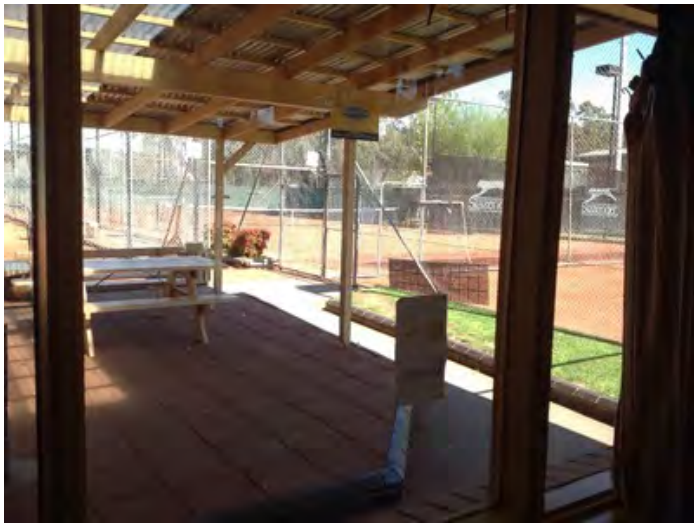
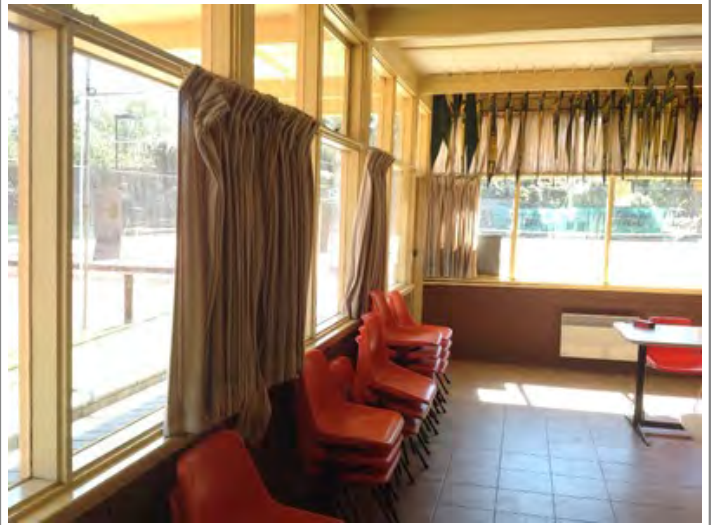
Clubroom condition photos

Building Condition	Moderate
Estimated building age	30+ years
Building materials	Brick
Accessible entry to building	no
Kitchen	Standard
Bar	
Player change rooms	Male: 1 Female: 1 Unisex: 0
Social area	65 m2
Social area comments	
Toilets	Male: yes Female: yes Accessible: no
Clubroom condition notes	The clubhouse is aged although it is in otherwise good condition. It provides views of the enclosures and courts. The toilet and kitchen areas are also aged but likely meet the needs of the club.
Other amenities provided within or outside clubrooms	Equipment storage BBQ /outdoor seating area
Other amenities condition notes	
Are there any safety concerns within clubrooms?	no

Classification	-
Overall Facility recommendation(s)	Plan for upgrade of the enclosure fencing, and in the process consider opportunities to increase the run offs on all courts. Treat weed growth on courts three and five. Plan for upgrade of court surface on courts one and two. Consider upgrades to club house to modernise in the future.
