Ivanhoe Park Facility Audit

Document number	000212
Client / Site	Tennis Victoria
Location	John Street Ivanhoe VIC 3079
Auditor	Andrew Sodomaco
Audit date	30 Aug 2015

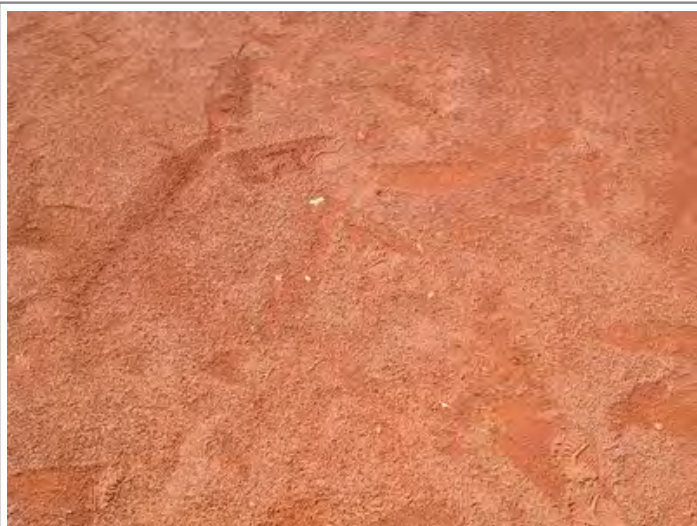
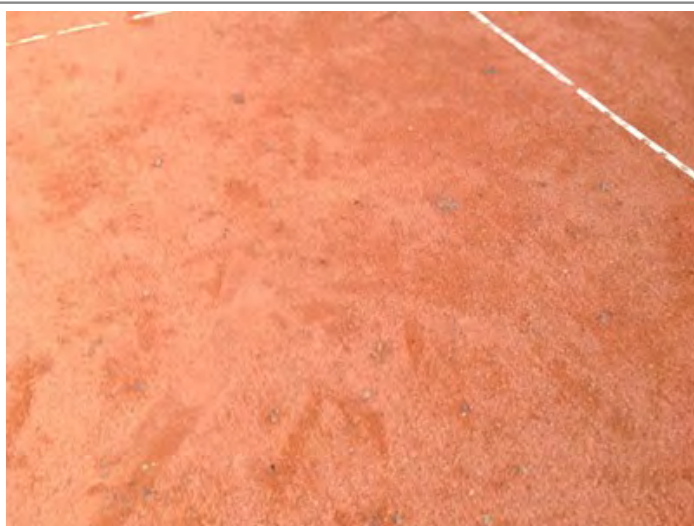
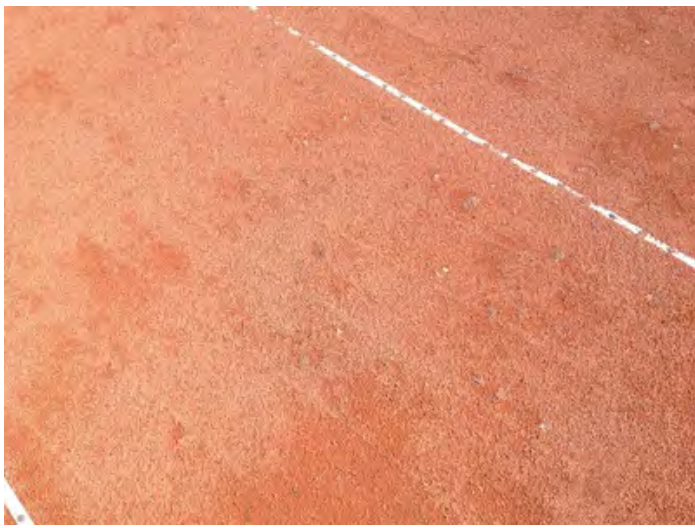
Unique court number	1
Surface condition rating	Moderate Issues/Observations: Aged surface Excessively worn surface in high wear areas
Surface type	Red Porous
Surface life span	6-10 years
Court condition notes	This is the eastern most court of the enclosure. Aggregate from the court base is showing through in high wear areas in the service boxes and other areas. Top dressing has not provided good coverage in places.

Are there any critical safety issues?	No
Enclosure recommendations	Plan for the refurbishment of court bases which are showing significant signs of age with aggregate evident throughout all courts. Trim vegetation from fence lines.

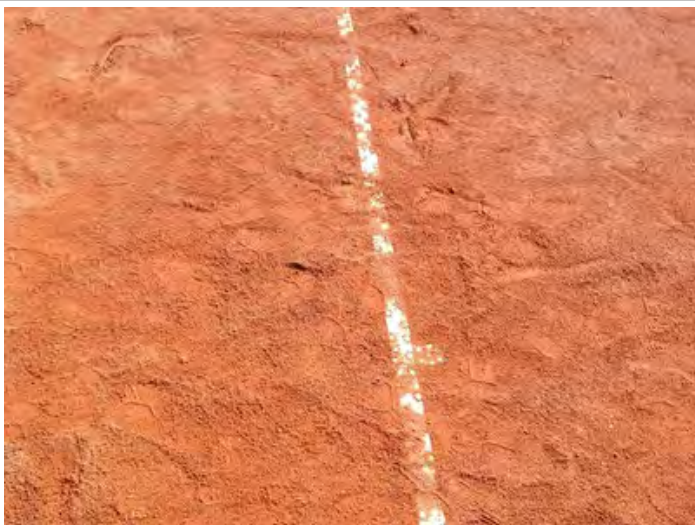
Line marking description	Tennis only lines
Line marking rating	Good Issues/Observations: Inconsistent bounce likely
Line marking condition notes	The lines are standard for this surface and appear to be in reasonable condition.

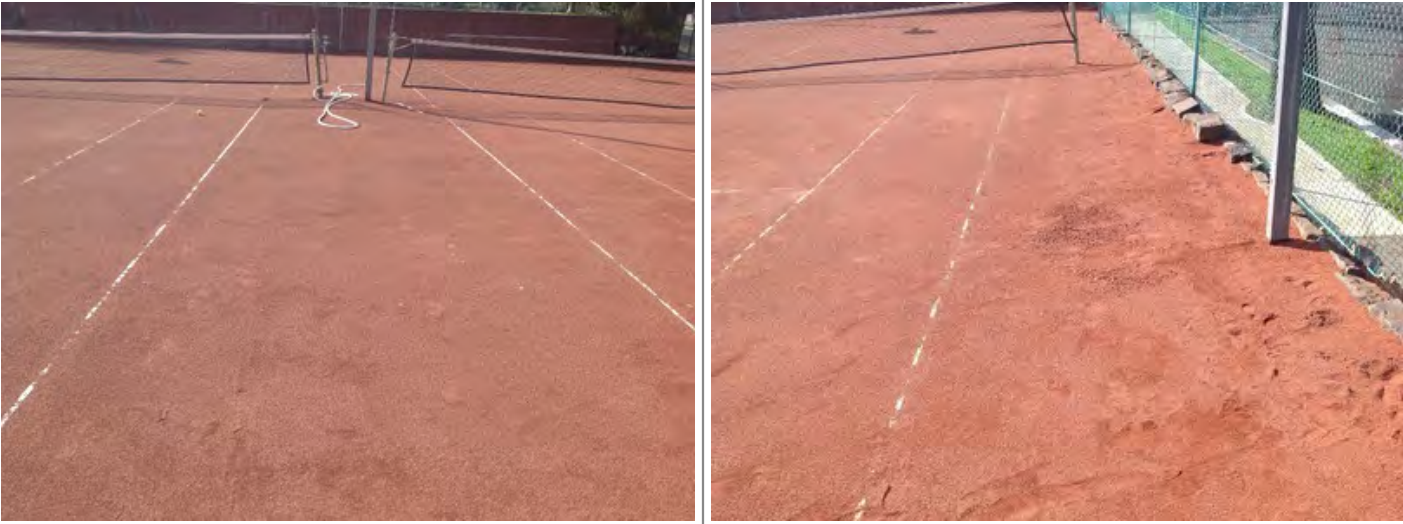
Net post life span	10+ years
Net life span	6-10 years
Net / post notes	
Net / post photos	
No photos taken	
Court compliance	
Is the court run off compliant?	no Runoffs North: 5900m South: 6000m East: 1800m West: 2800m
Could the court be made compliant?	no
Is the court to the standard dimensions?	yes
Court orientation	North-south
Are netball goal posts outside tennis court run off areas?	no
Are lockable post hole covers fitted and safe?	no
Compliance notes	The court does not meet run off distances to the east and west along sidelines.
Compliance photos

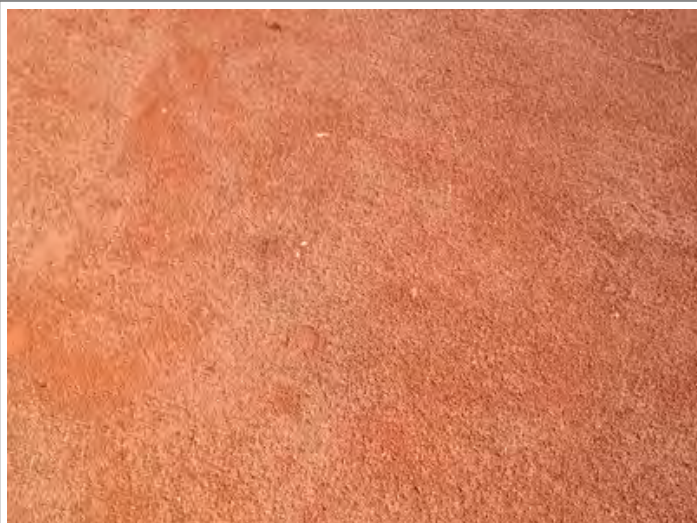
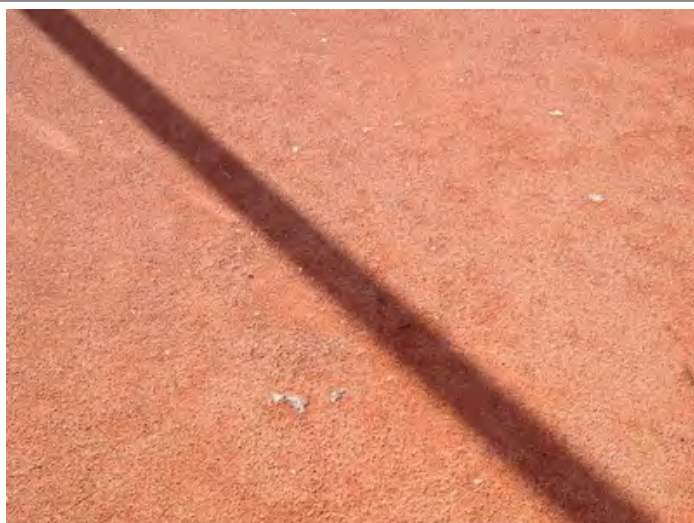
Surface condition rating	Moderate Issues/Observations: Aged surface Excessively worn surface in high wear areas
Surface type	Red Porous
Surface life span	6-10 years
Court condition notes	Aggregate from the court base is showing through in high wear areas in the service boxes and other areas. Top dressing has not provided a good coverage in places.

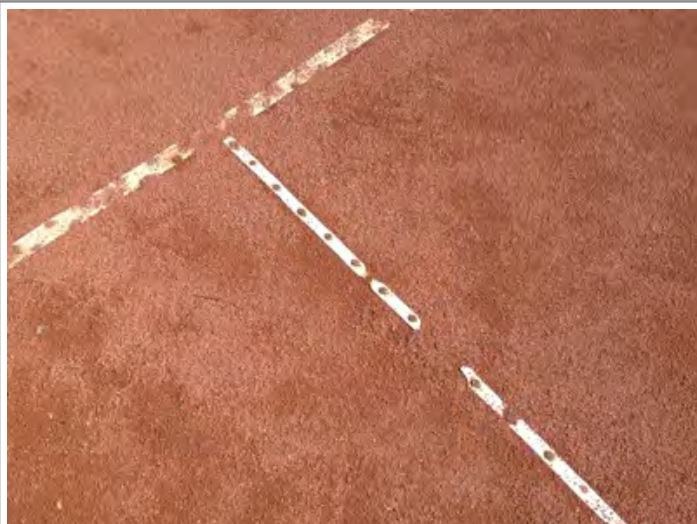
Line marking description	Tennis only lines
Line marking rating	Good Issues/Observations: Inconsistent bounce likely
Line marking condition notes	The lines are standard for this surface and appear to be in reasonable condition.

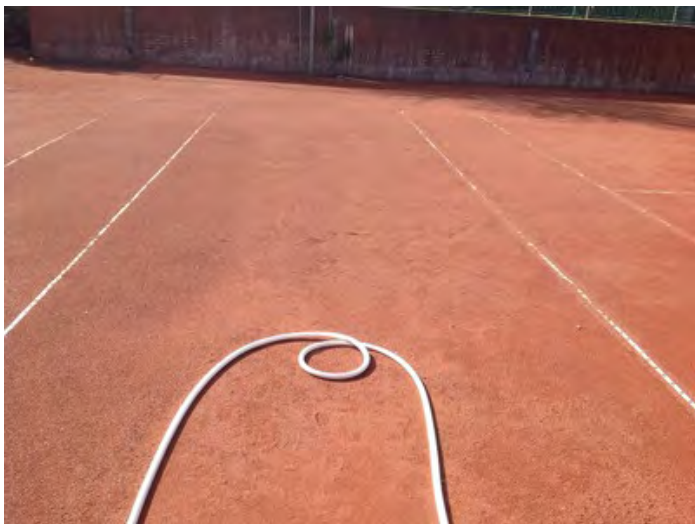
Net posts	
Net post type	Round galvanised - Installed directly into pavement
Net post condition	Good Issues/Observations: Straight
Net post winders	Protruding winders
Net condition	Good
Net structure	Tethered to the posts : yes Centre strap fitted: yes
Net post life span	10+ years
Net life span	6-10 years
Net / post notes	
Net / post photos	
No photos taken	
Court compliance	
Is the court run off compliant?	no Runoffs North: 5900m South: 6000m East: 2800m West: 2900m
Could the court be made compliant?	no
Is the court to the standard dimensions?	yes
Court orientation	North-south
Are netball goal posts outside tennis court run off areas?	no
Are lockable post hole covers fitted and safe?	no
Compliance notes	The court does not meet run off distances to the east and west along sidelines.
Compliance photos

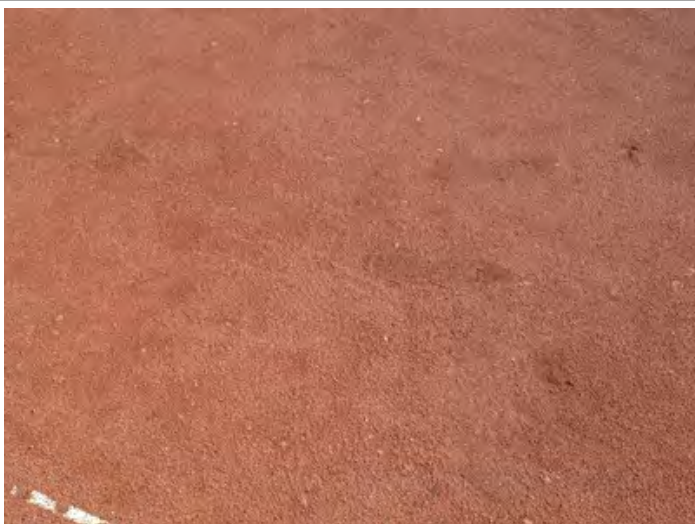
Unique court number	3
Surface condition rating	Moderate Issues/Observations: Aged surface Excessively worn surface in high wear areas
Surface type	Red Porous
Surface life span	6-10 years
Court condition notes	Aggregate from the court base is showing through in high wear areas in the service boxes and other areas.

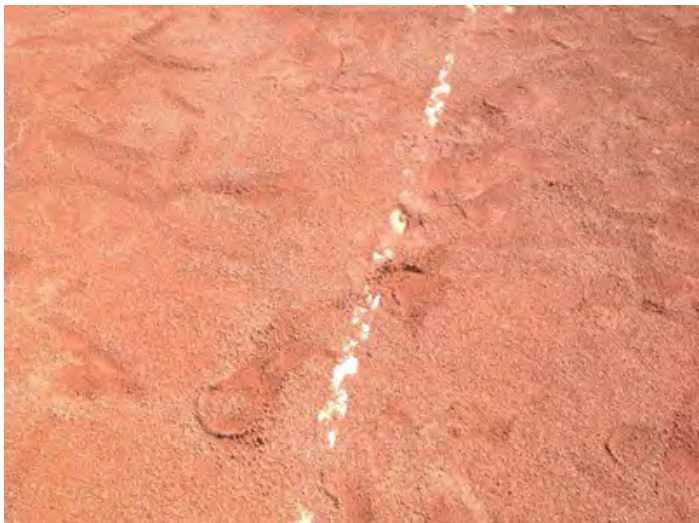
Line marking rating	Good
	Issues/Observations: Inconsistent bounce likely
Line marking condition notes	The lines are standard for this surface and appear to be in reasonable condition.
Line marking condition photos

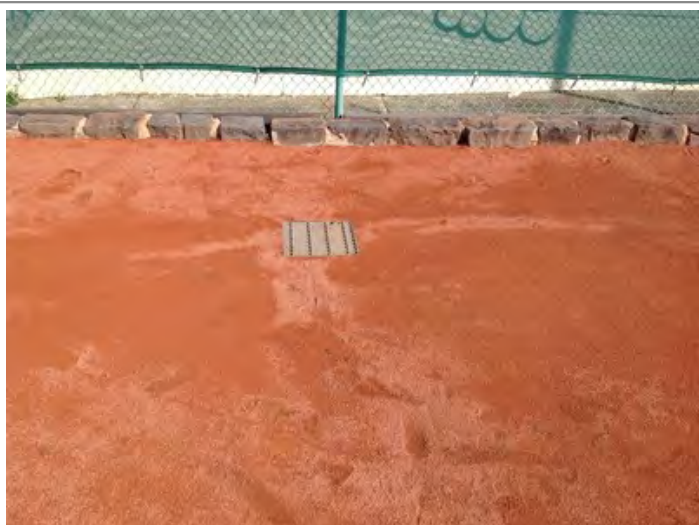
Drainage infrastructure	Formed
What type of drainage is in place?	Grated pit(s)
Are drains, pits or other infrastructure provided within the court enclosure?	yes
Are drains, pits or other infrastructure provided within the run-off areas?	yes
Drainage rating	Good
	Issues/Observations: Inadequate pit size
Drainage notes	A small grated pit is located behind the baseline at the southern end of court one. No other infrastructure is evident but there is no signs of pooling or silt build across any of the courts.

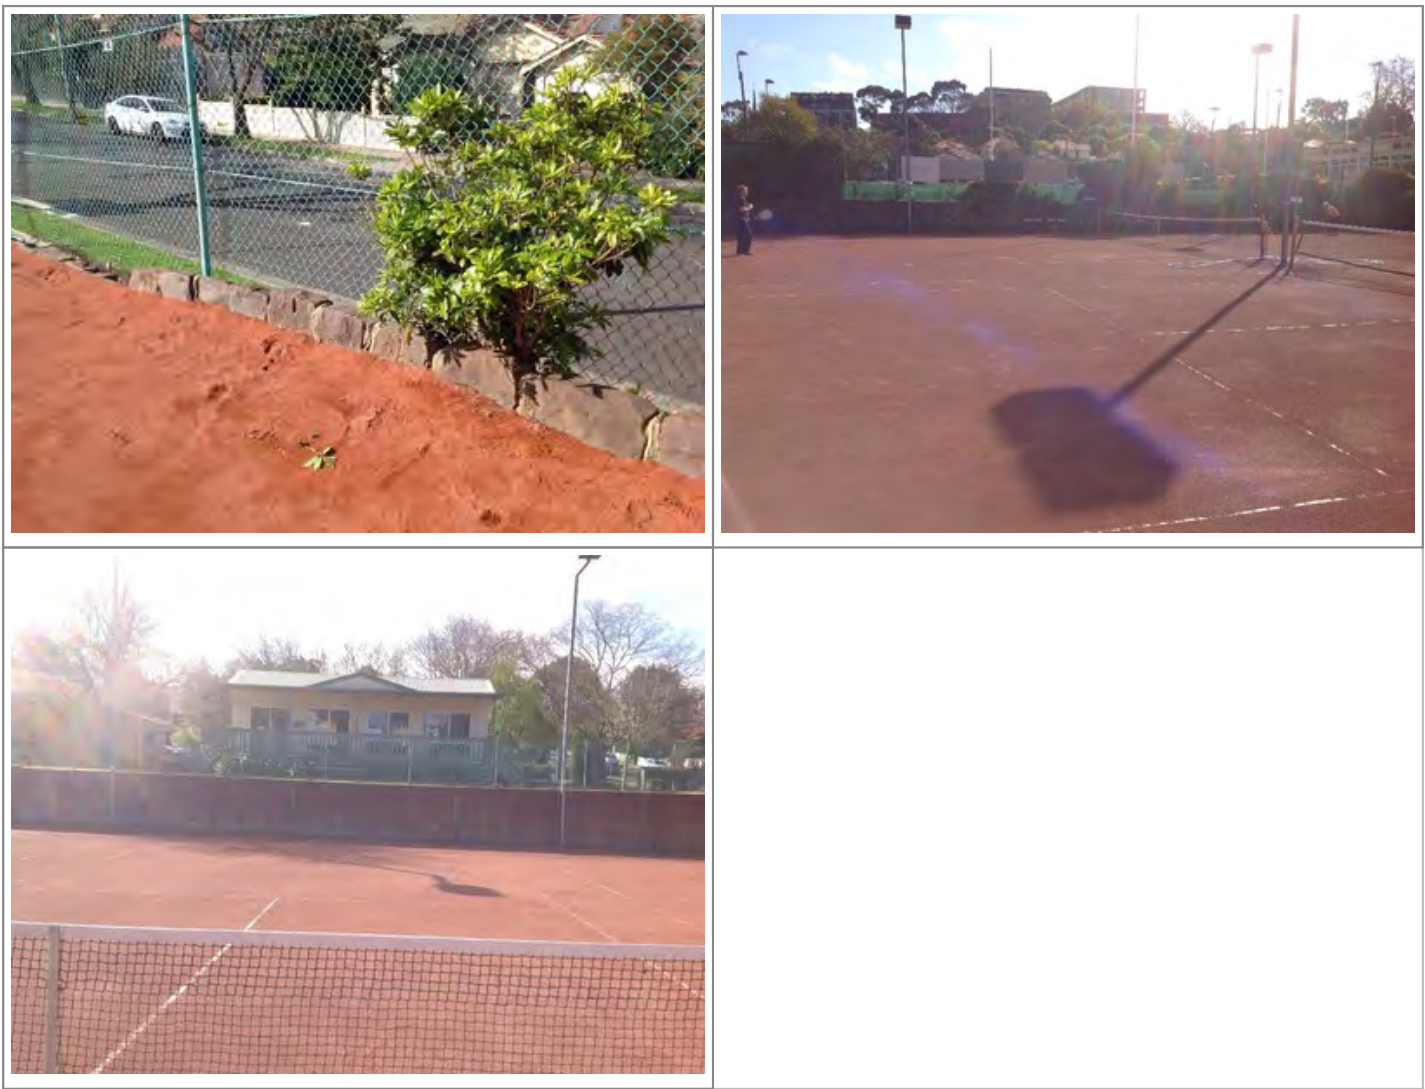
Fence type	Green PVC chain mesh
Fence Rails	Fence rail top: no Fence rail bottom: no
Fence height	3m to 3.5m Low level side fencing installed: no
Fence attachments	Sightscreens Windbreaks Sponsor advertising
Fence condition rating	Good Issues/Observations: Trees overhanging enclosure Trees/shrubs growing through mesh
Fencing life span	10+ years
Fence notes	The fence is in good condition, although there are some shrubs which are growing through and will cause damage in time. Low level fencing is located at the northern end, on top of a large brick retaining wall.

Court	Trim trees/shrubs away from court enclosure and fencing Hang drag mats on fencing Repair lines
Drainage	
Infrastructure	Trim vegetation away from fencing
Lighting	Conduct a lighting lux level test

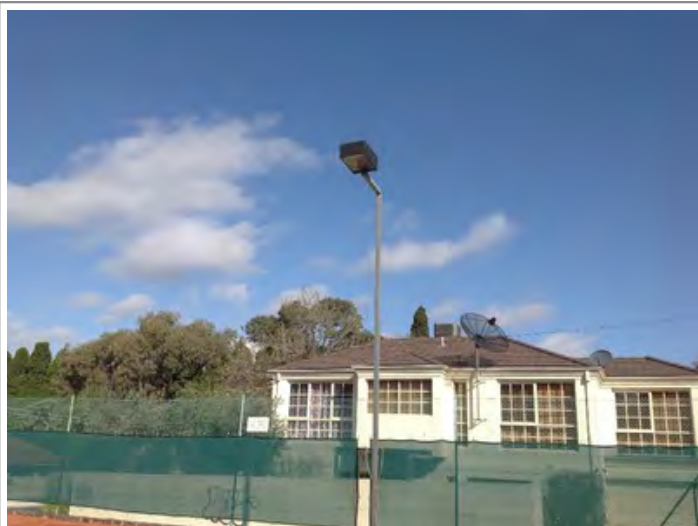
Does this enclosure have lighting	Yes
Total number of lit courts per enclosure	3
Lighting infrastructure type	Black powder coated low level - Steel poles
Lighting infrastructure position	Corner
Light fittings	One per tower
Lighting infrastructure design	Standard
Lighting infrastructure rating	Very Good
	Issues/Observations: Infrastructure and fittings in very good condition - likely to achieve required lux standards
Lighting life span	10+ years
Lighting notes	All lighting appears to be in very good condition.
Lighting photos

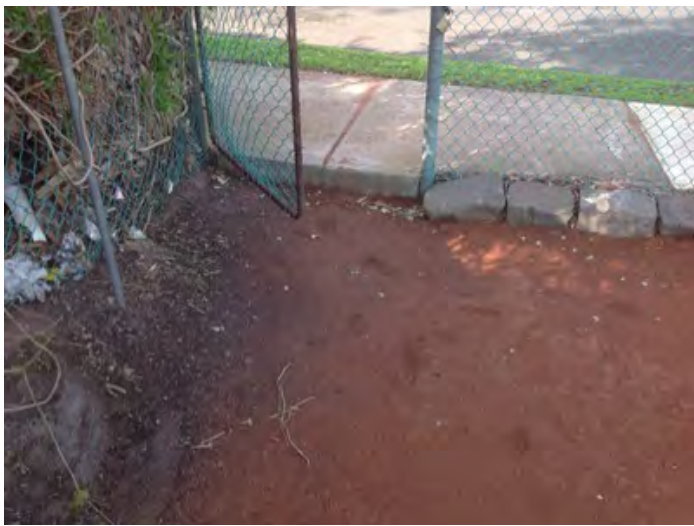
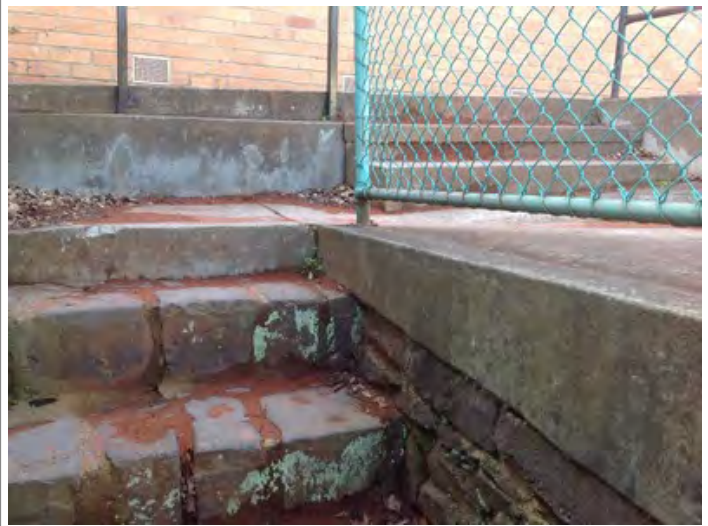
Court enclosure accessibility	Formed paths Trip hazards identified: yes Ramped access provided: no
Path material(s)	Concrete
Main gate dimensions	Standard pedestrian gate 1000mm x 2100mm
Accessibility notes	Two entrances to the enclosure both require the participants to step down on to the court. One in particular has a large set of stairs leading down the courts.

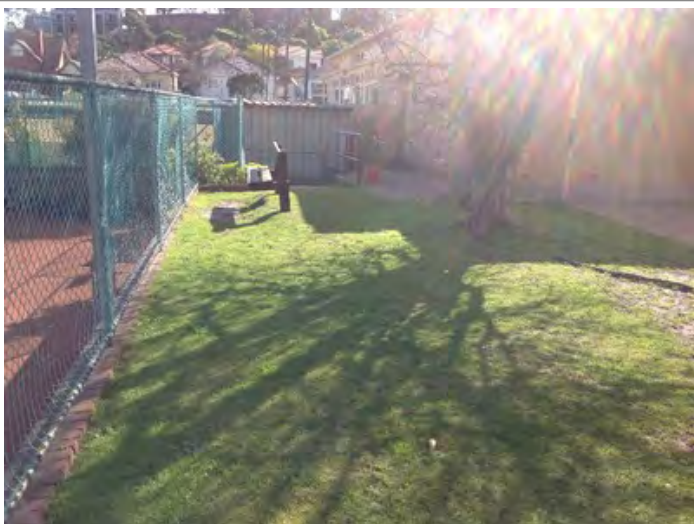
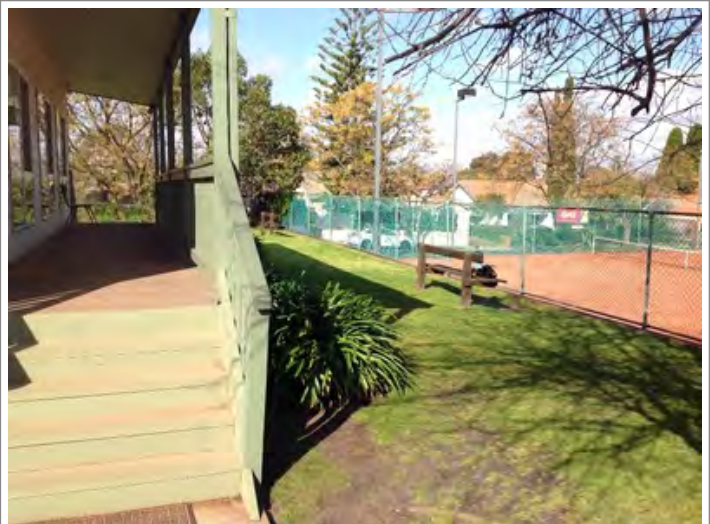
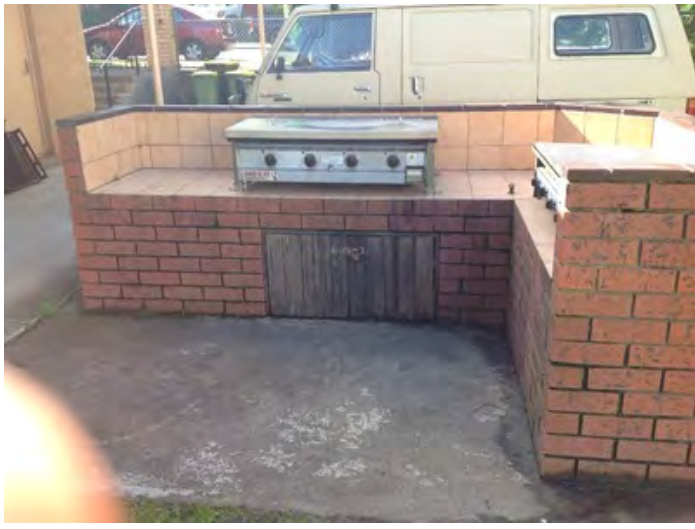
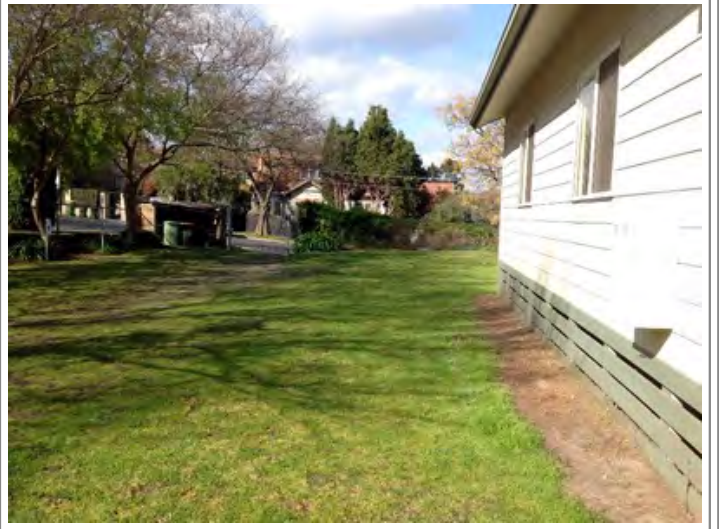
Condition of ground and court surrounds	Very Good
Court surround notes	Court surrounds are well kept and include grassy areas with trees and sitting areas. A clubhouse verandah is offered.
Water supply	Potable
Water notes	
Natural Shade	Sufficient shade available within viewing range
Man made Shade	Clubhouse veranda
Shade notes	
Car parking	On street: 0-20 spaces Off street: Overflow:
Does the site have any hit up walls	yes
Hit up wall brickwork type	Double-skin
is there any cracking in the hit up wall/s	no
Hit up wall notes	The retaining wall on court one has been painted for use as a hit up wall.
Car park notes	Most parks in the area appear to be permit zones, and a small number of disabled car parks are offered on the grassy areas behind the clubhouse.
Adjacent facilities	Other sports facility
Does the site have any potential expansion opportunities?	no

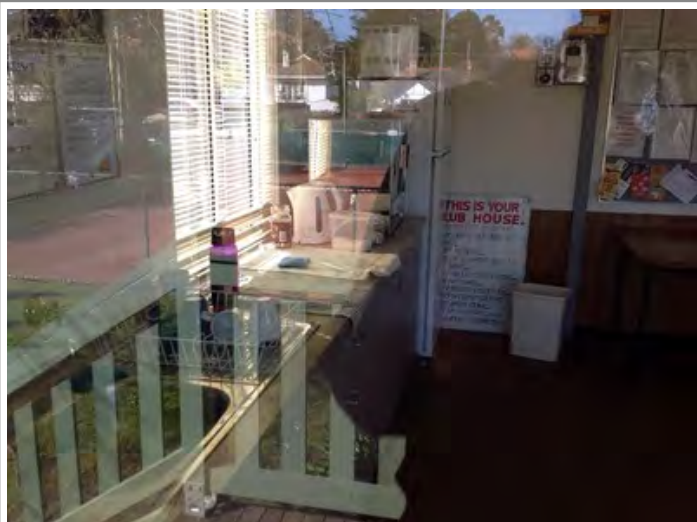
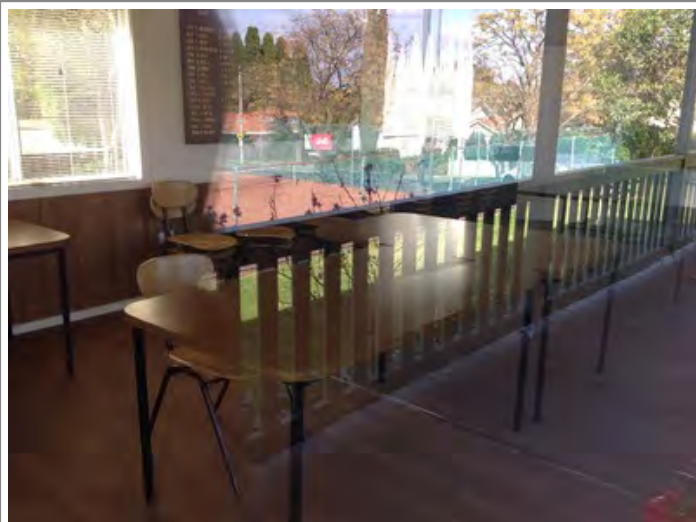
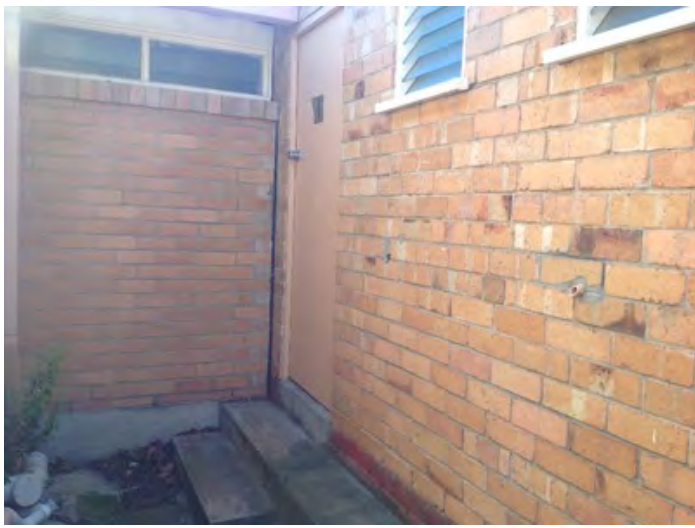
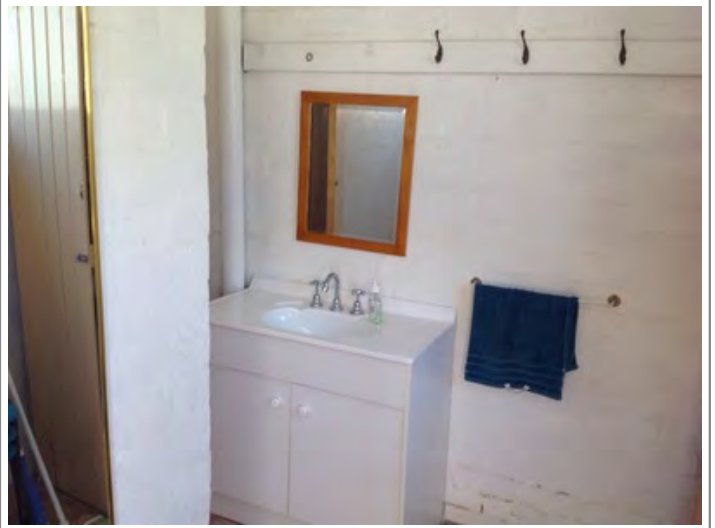
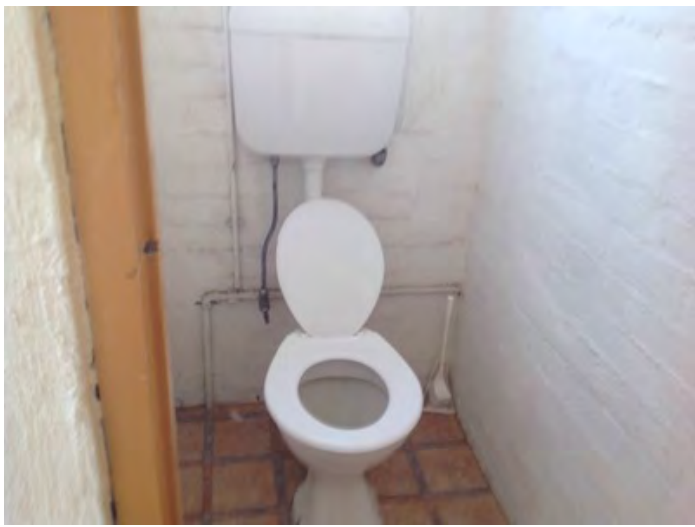
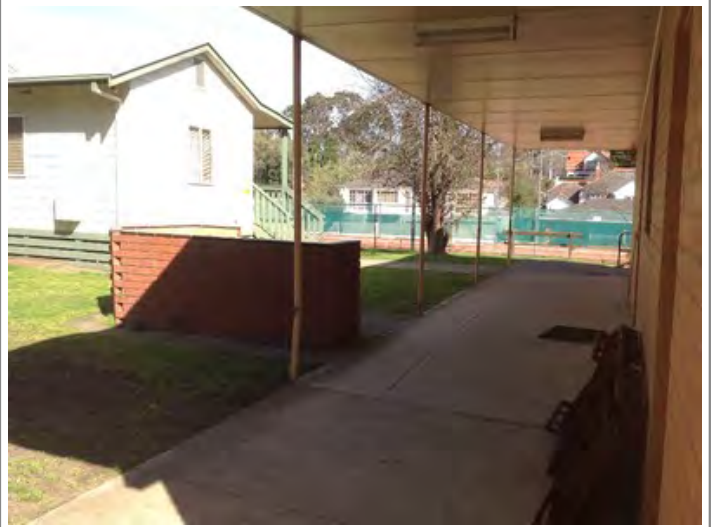
Building Condition	Good
Estimated building age	21-30 years
Building materials	Weatherboard
Accessible entry to building	no
Kitchen	Standard
Bar	no
Player change rooms	Male: 0 Female: 0 Unisex: 0
Social area	40 m2
Social area comments	
Toilets	Male: no Female: no Accessible: no
Clubroom condition notes	The clubhouse is a simple weatherboard room with a kitchenette and sitting areas. No toilets or showers are provided, although these can be accessed in the neighbouring bowls club clubhouse.
Other amenities provided within or outside clubrooms	no options selected
Other amenities condition notes	
Are there any safety concerns within clubrooms?	no

Classification	-
Overall Facility recommendation(s)	Plan for upgrade of courts given the signs of age they are showing. Remove vegetation from fence lines. Investigate the cost of addition of toilets and change facilities to the clubhouse.
