Greensborough Park Facility Audit

Document number	000213
Client / Site	Tennis Victoria
Location	Diamond Creek Greensborough VIC 3088
Auditor	Andrew Sodomaco
Audit date	04 Sep 2015

Site summary	
Total number of enclosures	2
Total number of courts	6
Total number of floodlit courts	4
Total number of enclosed mini courts	0
Hierarchy	Local

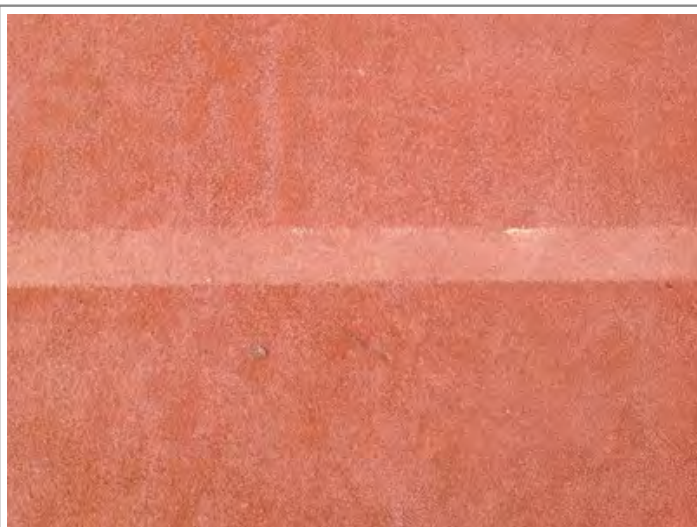
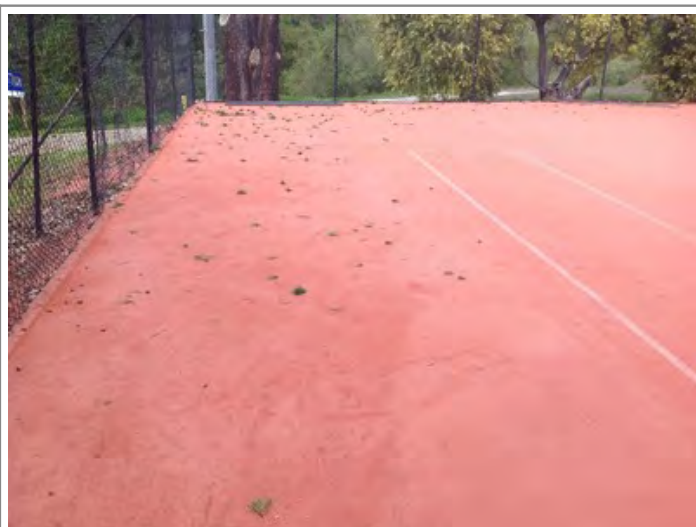
Unique court number	1
Surface condition rating	Good Issues/Observations: Debris present mainly around the perimeter Seam stress Excessively worn surface in high wear areas
Surface type	Synthetic Clay
Surface life span	4-5 years
Court condition notes	The court appears to be in quite good condition, although a small patch of seam stress is evident at the northern baseline. Some leaf litter is present around the perimeter, caused by trees in close proximity.

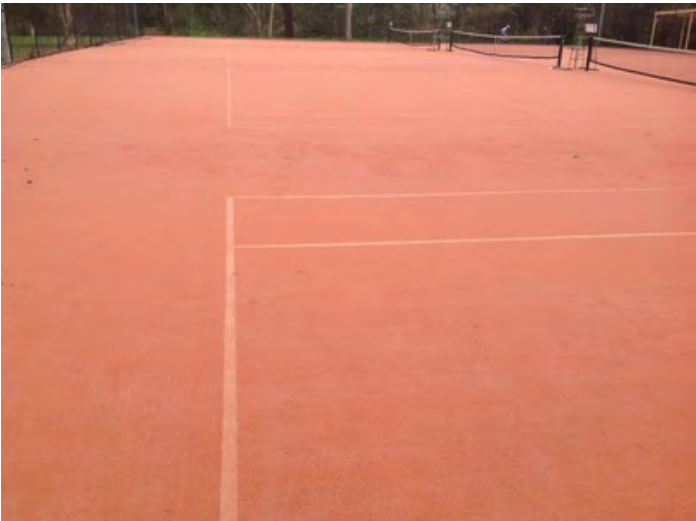
Line marking rating	Very Good
	Issues/Observations: Clear and bright Straight and clean
Line marking condition notes	The lines are in the same condition as the rest of the court.
Line marking condition photos

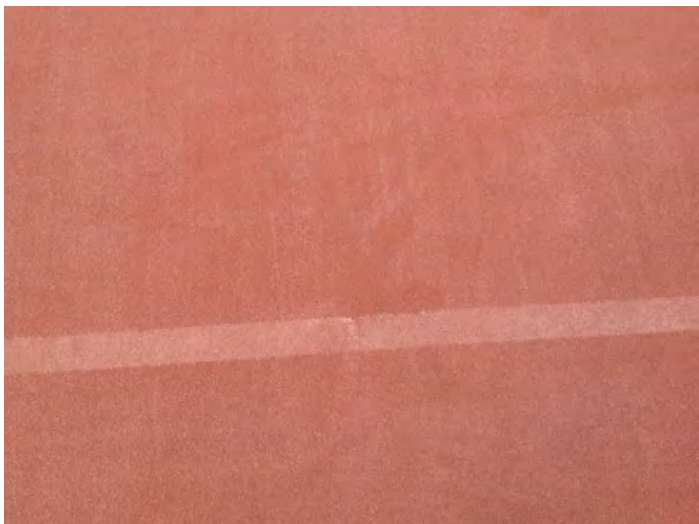
Could the court be made compliant?	n/a
Is the court to the standard dimensions?	yes
Court orientation	North-south
Are netball goal posts outside tennis court run off areas?	no
Are lockable post hole covers fitted and safe?	no
Compliance notes	The court meets run off requirements in each direction.
Compliance photos	
No photos taken	
Courts	
Condition	
Unique court number	2
Surface condition rating	Good Issues/Observations: Seam stress Excessively worn surface in high wear areas
Surface type	Synthetic Clay
Surface life span	4-5 years
Court condition notes	The court appears to be in quite good condition, although a small patch of seam stress is evident at the northern baseline.
Court condition photos

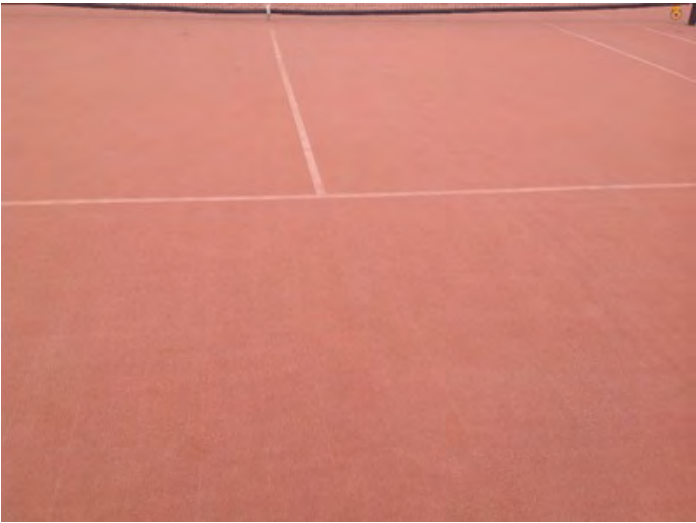
Line marking rating	Very Good
	Issues/Observations: Clear and bright Straight and clean
Line marking condition notes	The lines are in the same condition as the rest of the court.
Line marking condition photos

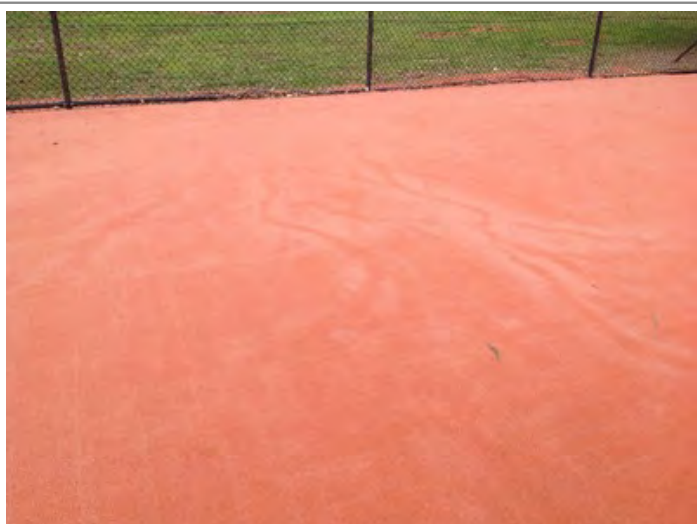
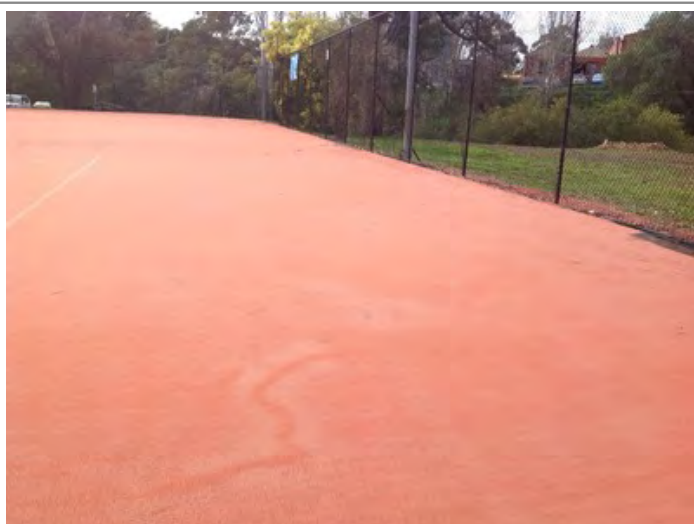
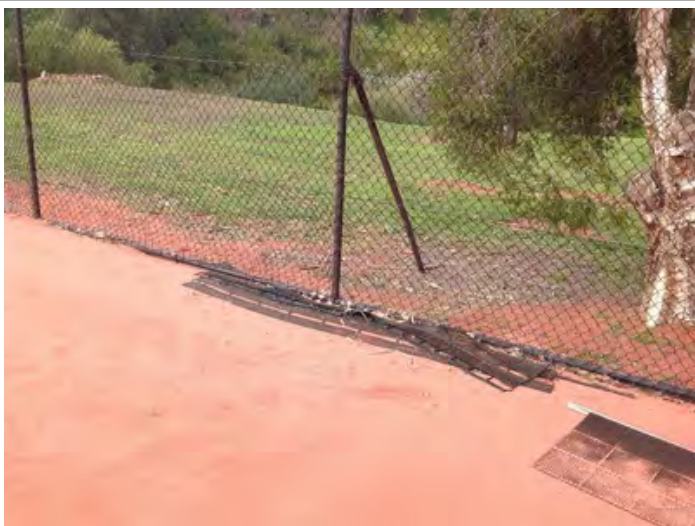
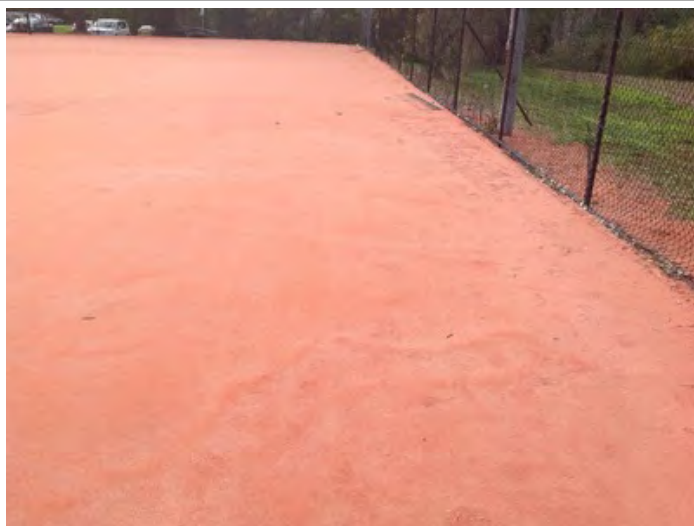
Unique court number	3
Surface condition rating	Good Issues/Observations: Seam stress Excessively worn surface in high wear areas
Surface type	Synthetic Clay
Surface life span	4-5 years
Court condition notes	The court appears to be in quite good condition, with some small patches of seam stress. At the southern end there is significant heaving of the court base. The movement looks like it is caused by tree roots, although this can not be verified.

Are there any critical safety issues?	No
Enclosure recommendations	Investigate and rectify the heaving of the court at the southern end of court three. Trim all vegetation from fence lines. Repair any areas of seam stress on the courts. Plan for replacement of court surfaces.

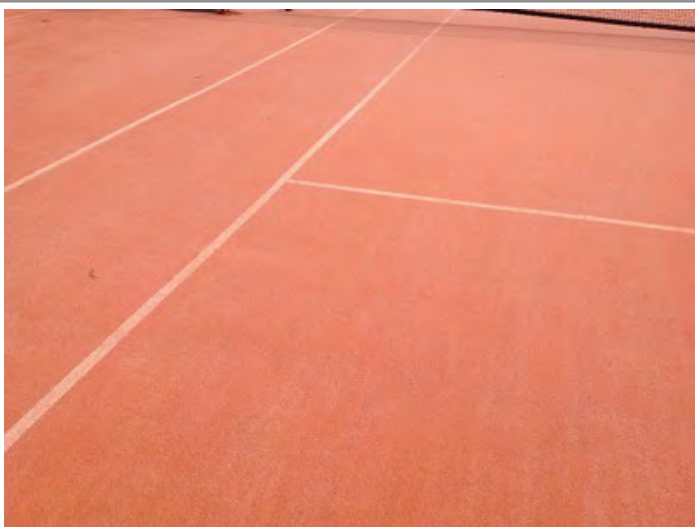
Line marking description	Tennis only lines
Line marking rating	Very Good
	Issues/Observations: Straight and clean
Line marking condition notes	The lines are in the same condition as the rest of the court.

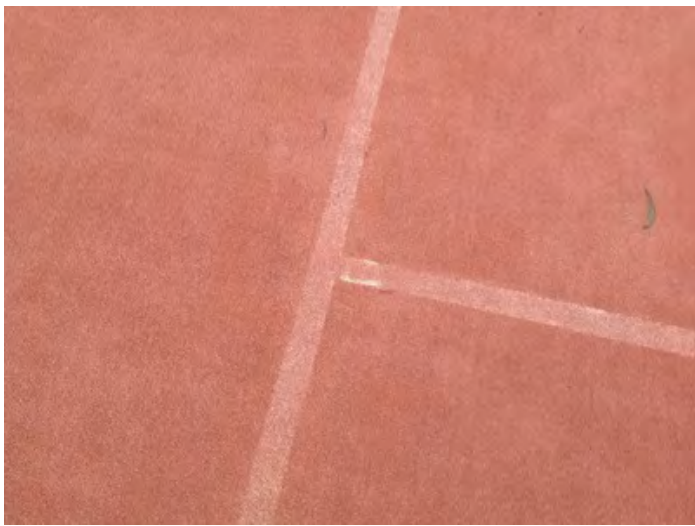
Net post life span	10+ years
Net life span	6-10 years
Net / post notes	
Net / post photos	
No photos taken	
Court compliance	
Is the court run off compliant?	yes Runoffs North: 6000m South: 5800m East: 3900m West: 3900m
Could the court be made compliant?	n/a
Is the court to the standard dimensions?	yes
Court orientation	North-south
Are netball goal posts outside tennis court run off areas?	no
Are lockable post hole covers fitted and safe?	no
Compliance notes	The court meets run off requirements in each direction.
Compliance photos	
No photos taken	
Courts	
Condition	
Unique court number	4
Surface condition rating	Good Issues/Observations: Debris present mainly around the perimeter Seam stress Excessively worn surface in high wear areas
Surface type	Synthetic Clay
Surface life span	4-5 years
Court condition notes	The court appears to be in quite good condition, with some patches of seam stress evident. Some leaf litter is present around the perimeter, caused by trees in close proximity.

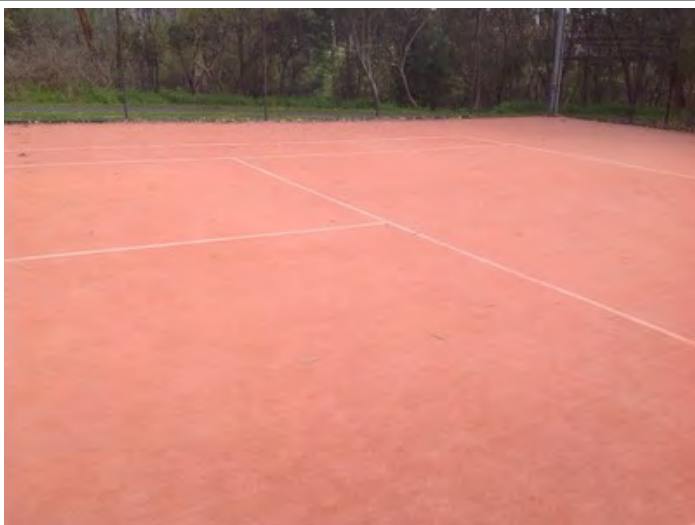
Line marking description	Tennis only lines
Line marking rating	Very Good Issues/Observations: Straight and clean
Line marking condition notes	The lines are in the same condition as the rest of the court.

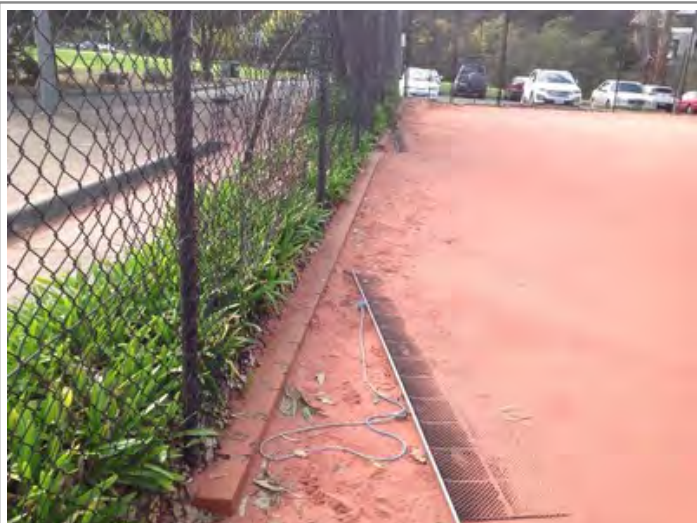
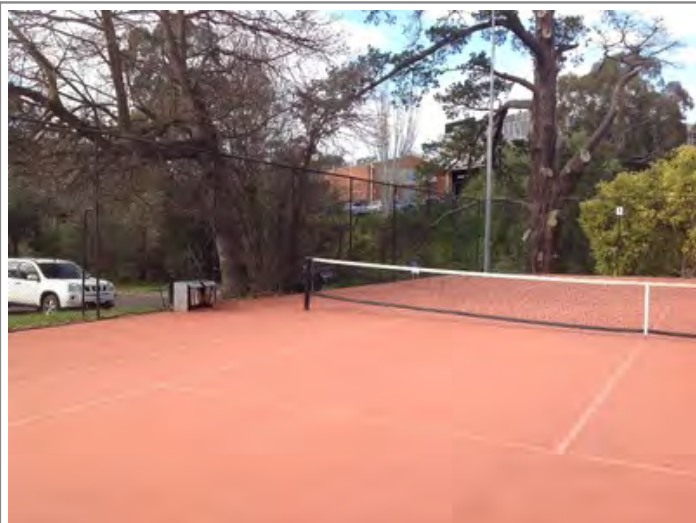
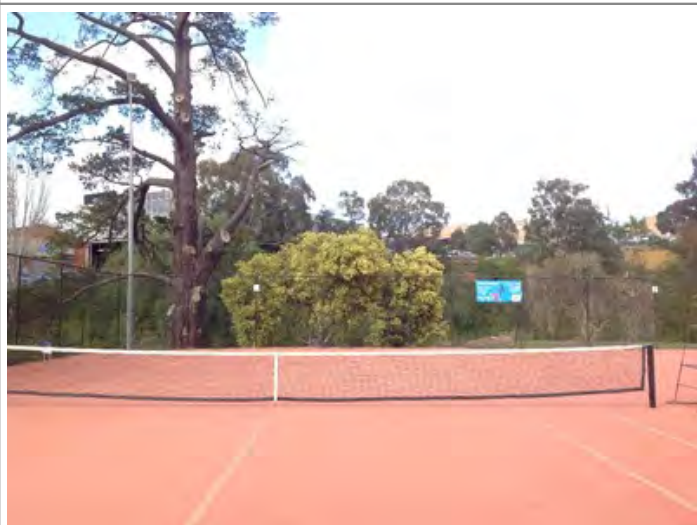
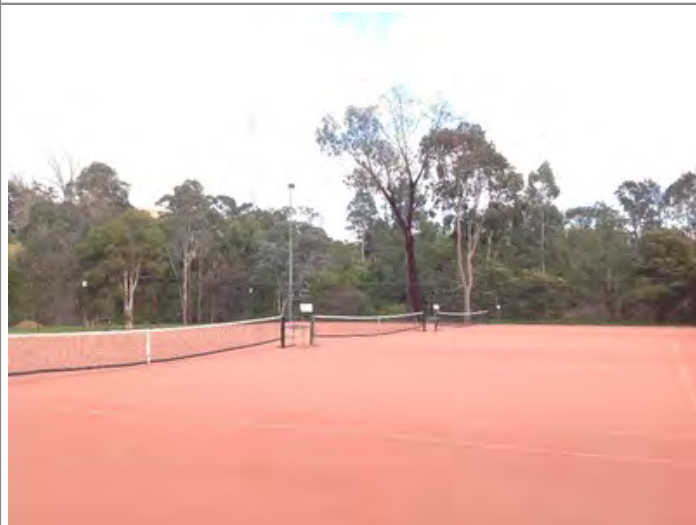
Fence type	Black PVC chain mesh
Fence Rails	Fence rail top: yes Fence rail bottom: yes
Fence height	3m to 3.5m Low level side fencing installed: no
Fence attachments	Sponsor advertising
Fence condition rating	Good Issues/Observations: Slack mesh Mesh curling at base Trees overhanging enclosure Trees/shrubs growing through mesh
Fencing life span	10+ years
Fence notes	The fencing is in good condition, although will require trimming of the tresses and bushes growing through and over it to maintain its good condition.

Court	Remove debris from court surface and enclosure Trim trees/shrubs away from court enclosure and fencing Hang drag mats on fencing Repair lines
Drainage	
Infrastructure	Trim vegetation away from fencing
Lighting	Conduct a lighting lux level test

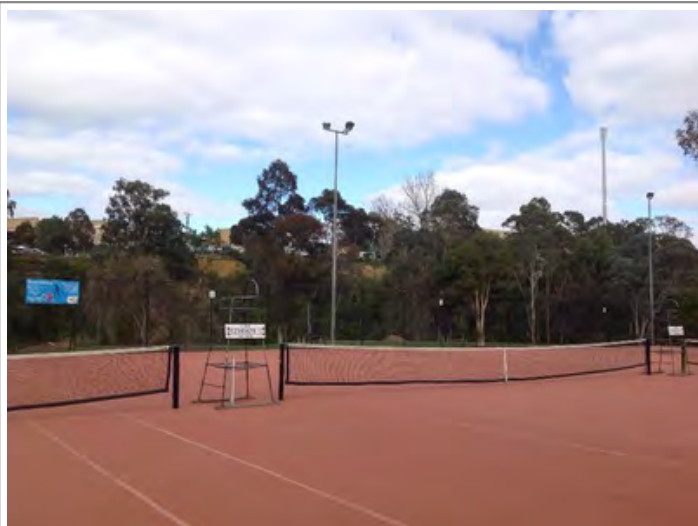
Does this enclosure have lighting	Yes
Total number of lit courts per enclosure	4
Lighting infrastructure type	High tower - Steel poles
Lighting infrastructure position	Corner
Light fittings	One per tower
Lighting infrastructure design	Standard
Lighting infrastructure rating	Moderate Issues/Observations: Old, insufficient infrastructure & fittings Old however in good condition - potential upgrade required
Lighting life span	10+ years
Lighting notes	The lighting infrastructure is likely to be sub optimal for night tennis, although it is in otherwise good condition.

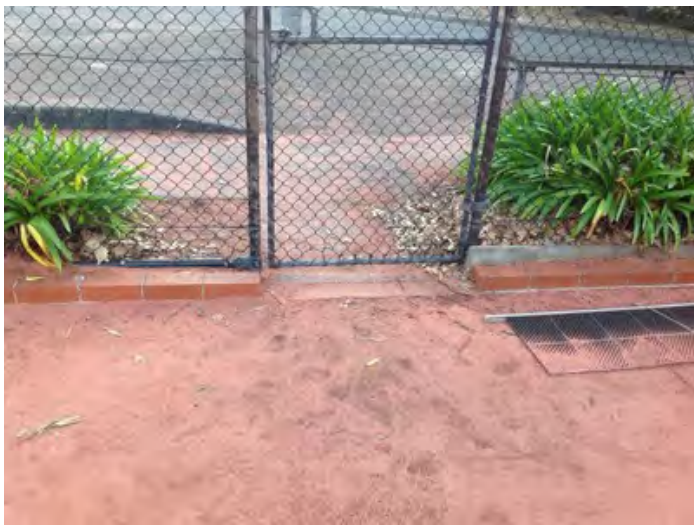
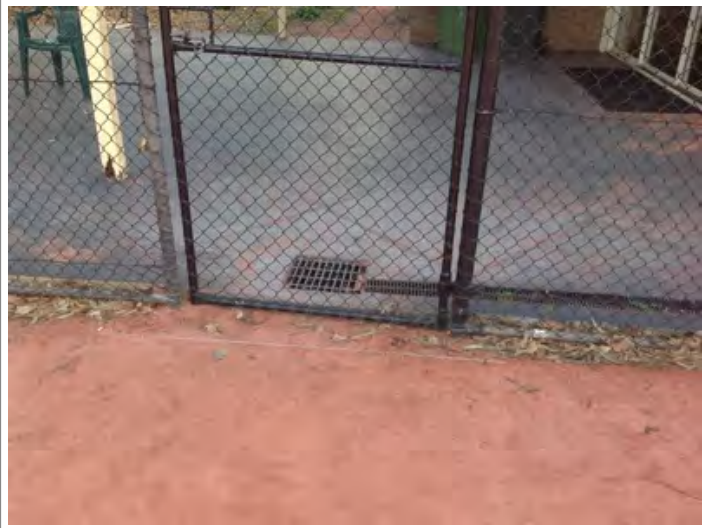
Court enclosure accessibility	Formed paths Trip hazards identified: yes Ramped access provided: yes
Path material(s)	Concrete
Main gate dimensions	Standard pedestrian gate 1000mm x 2100mm
Accessibility notes	Participants are required to step down from the paths to the court.

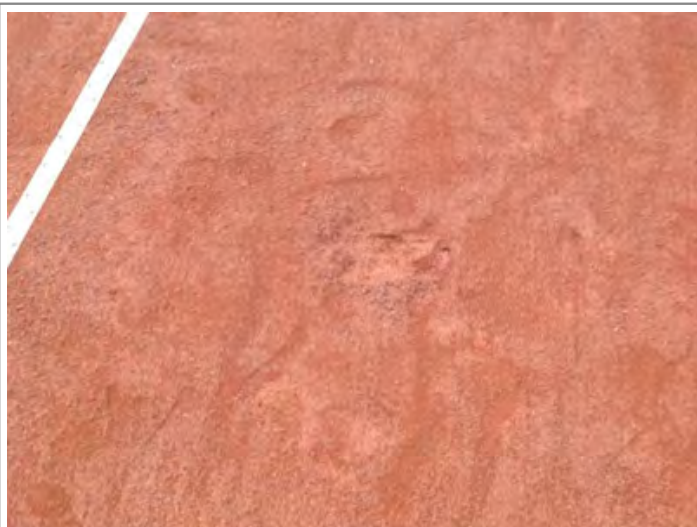
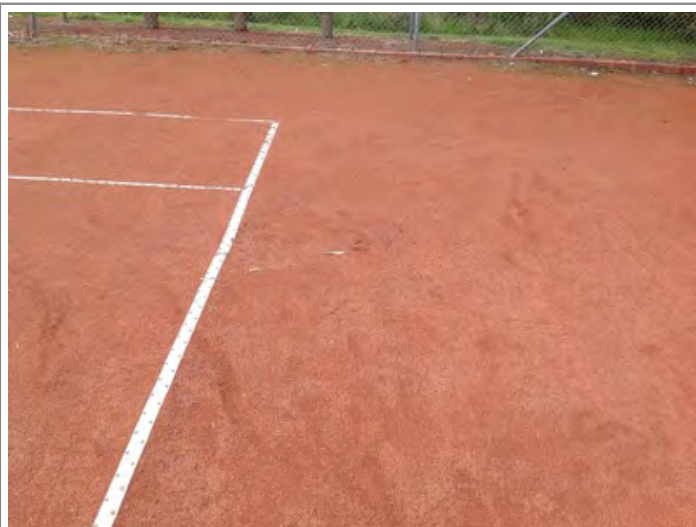
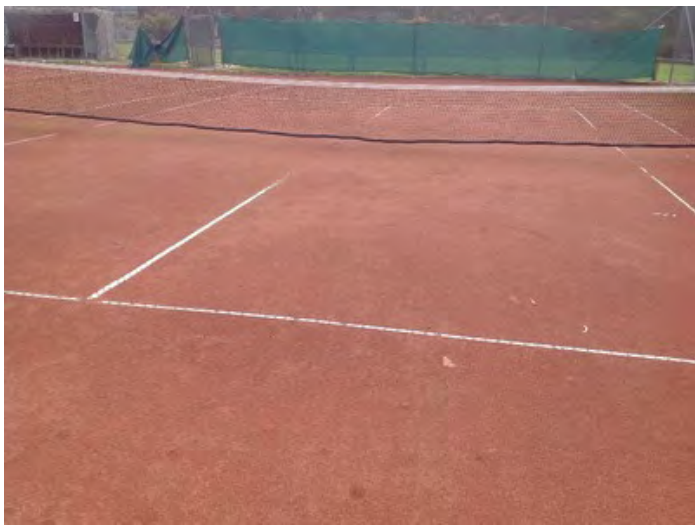
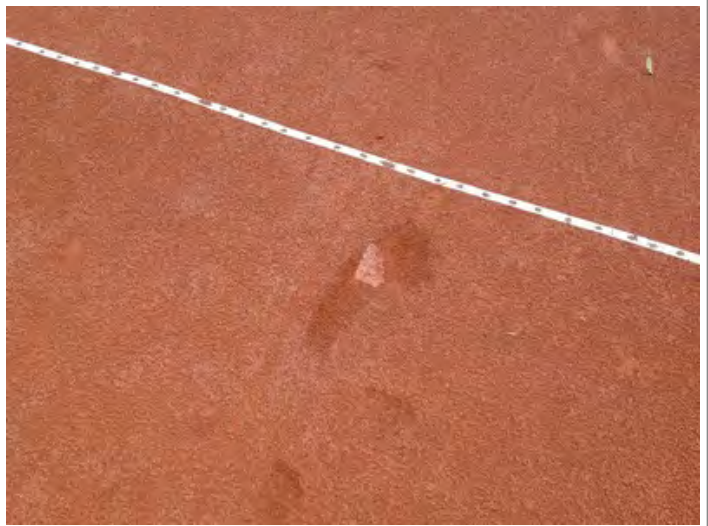
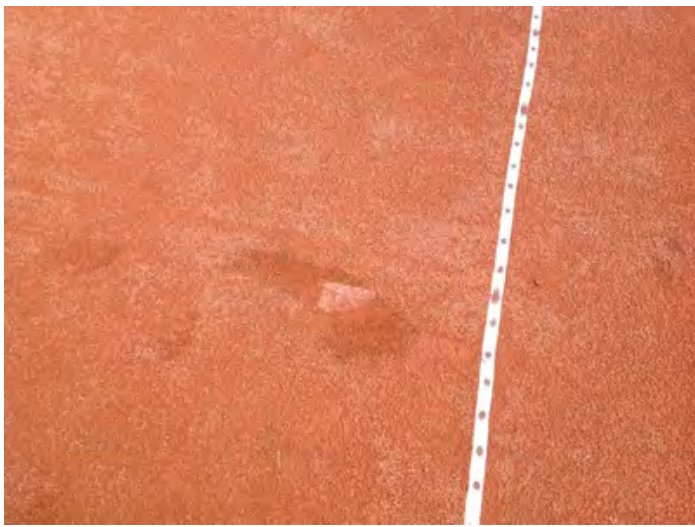
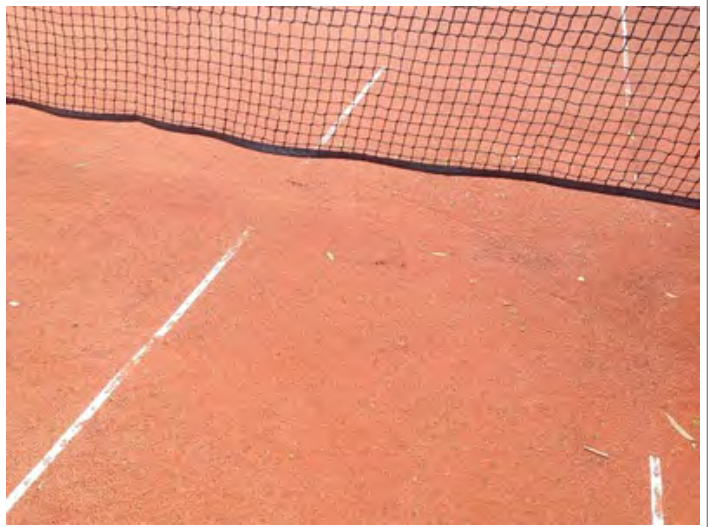
Unique court number	5
Surface condition rating	Moderate Issues/Observations: Leaf litter Debris present mainly around the perimeter Weed growth Aged surface Excessively worn surface in high wear areas
Surface type	Red Porous
Surface life span	4-5 years
Court condition notes	This court has extensive weed growth around the outside if it, and holes along the base line. Top dressing appears to be a little light and the court base is visible in many places. Something resembling a brick is embedded into the court at the southern end on the right hand side behind the service line.

Are there any critical safety issues?	No
Enclosure recommendations	Rectify dangerous holes along baselines of both courts. Weed courts. Place more top dressing on courts. Repair or replace fencing. Repair lines.

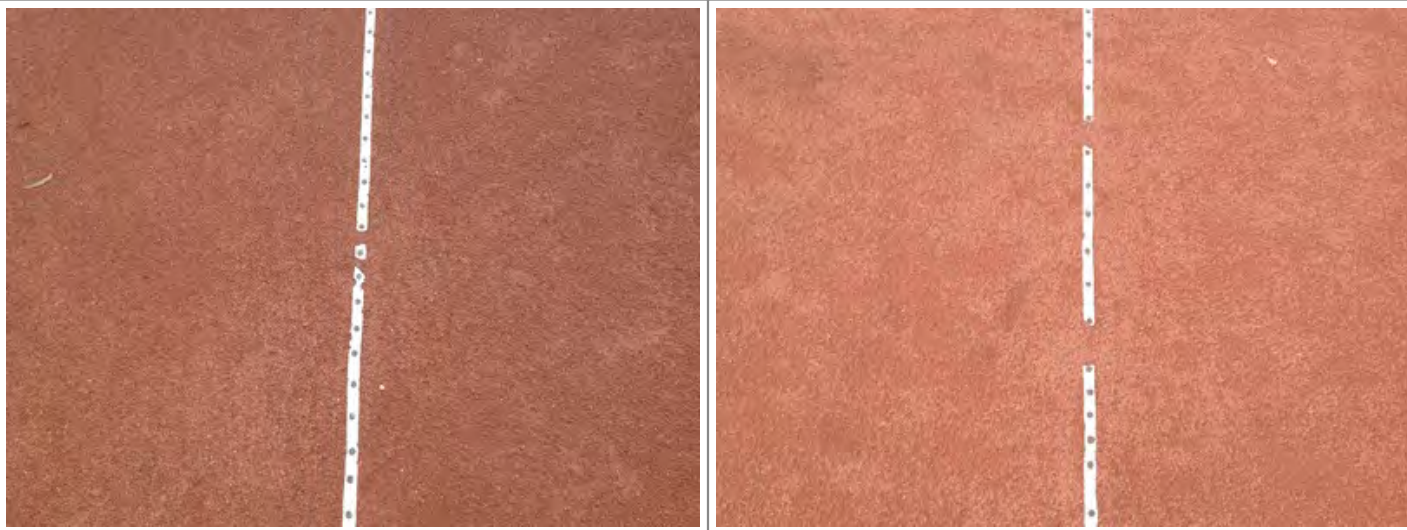
Line marking description	Tennis only lines
Line marking rating	Poor Issues/Observations: Cracked Torn Trip hazard Inconsistent bounce likely
Line marking condition notes	The lines are standard for red porous courts. They are cracked, raised and torn in places.

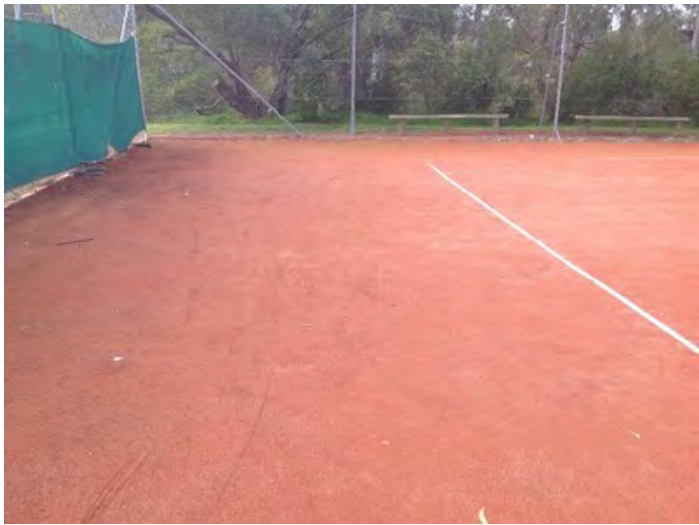
Compliance notes	The court does not meet run off distance requirements to the north or south behind the baselines, or to the eastern fence line.
------------------	---

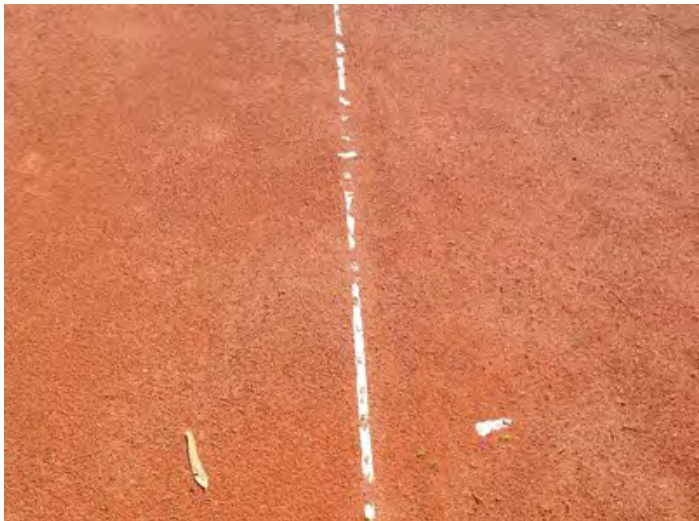
Line marking condition notes	The lines are standard for red porous courts. They are cracked, raised and torn in places.
Line marking condition photos

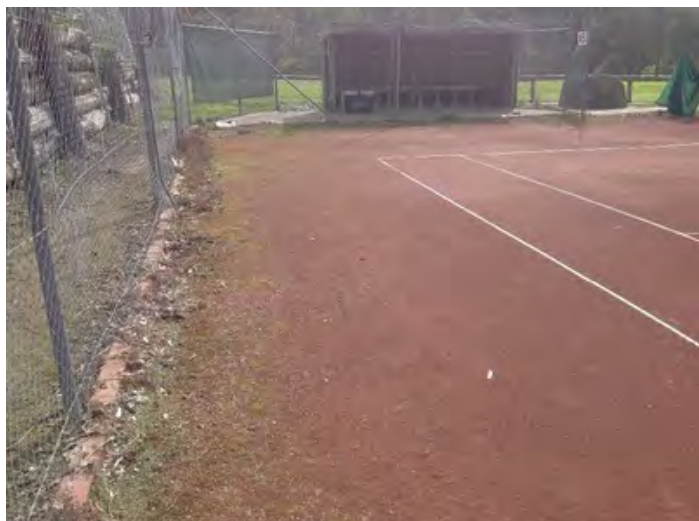
Are netball goal posts outside tennis court run off areas?	no
Are lockable post hole covers fitted and safe?	no
Compliance notes	The court does not meet run off distance requirements to the north or south behind the baselines, or to the western fence line.

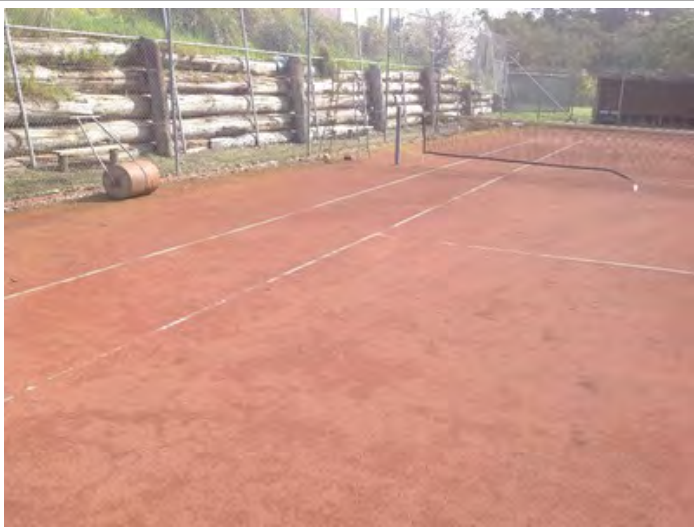
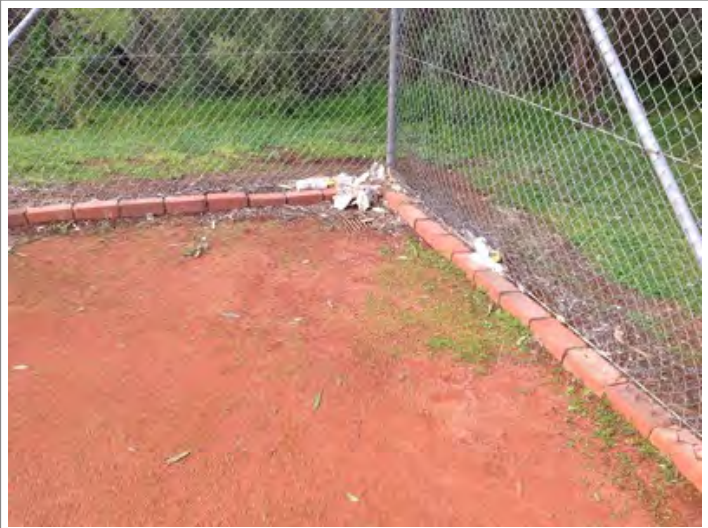
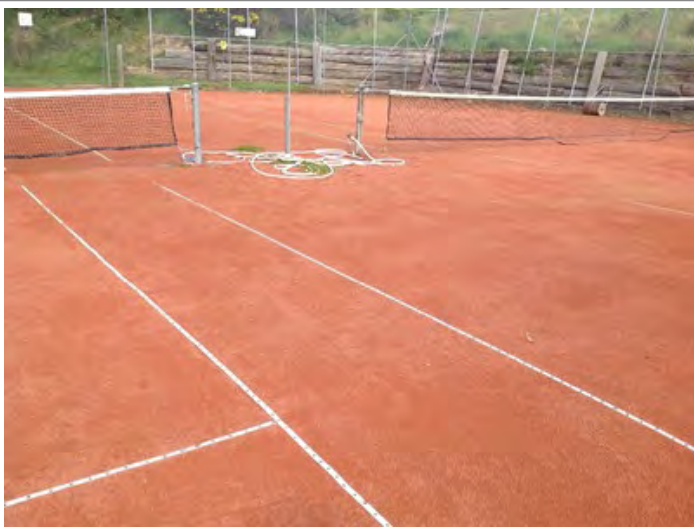
Drainage infrastructure	Formed
What type of drainage is in place?	Grated pit(s)
Are drains, pits or other infrastructure provided within the court enclosure?	yes
Are drains, pits or other infrastructure provided within the run-off areas?	yes
Drainage rating	Moderate Issues/Observations: Ponding evident Leaf litter build up
Drainage notes	A grated pit is in the south eastern corner. The holes along the baseline are showing signs that they pool with water, as expected. The outsides of the court enclosure are very damp.

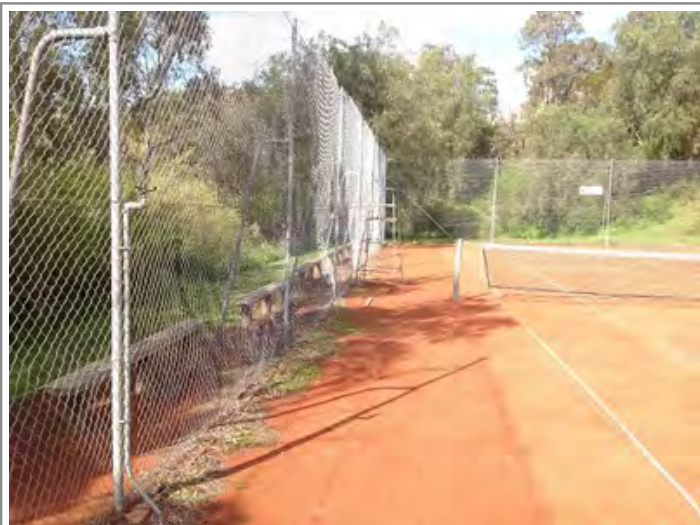
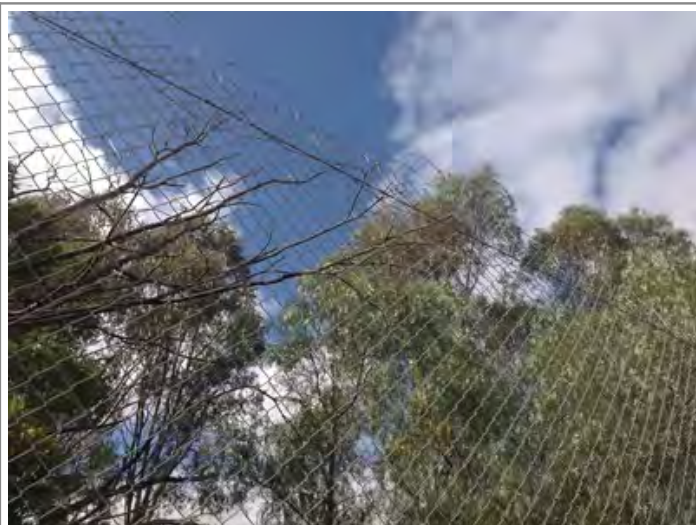
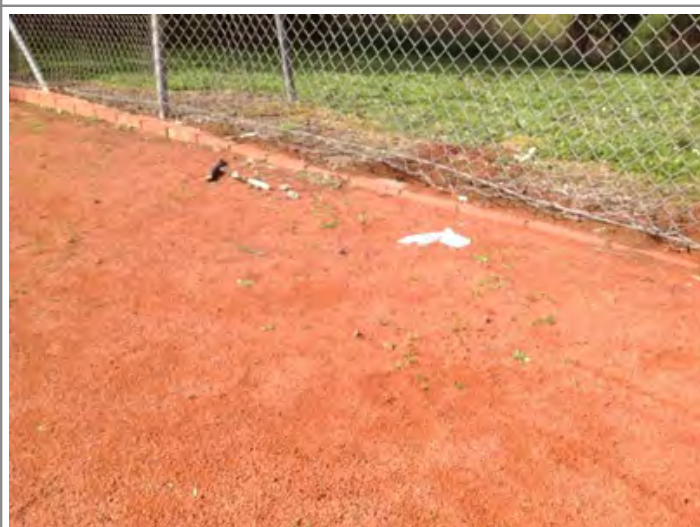
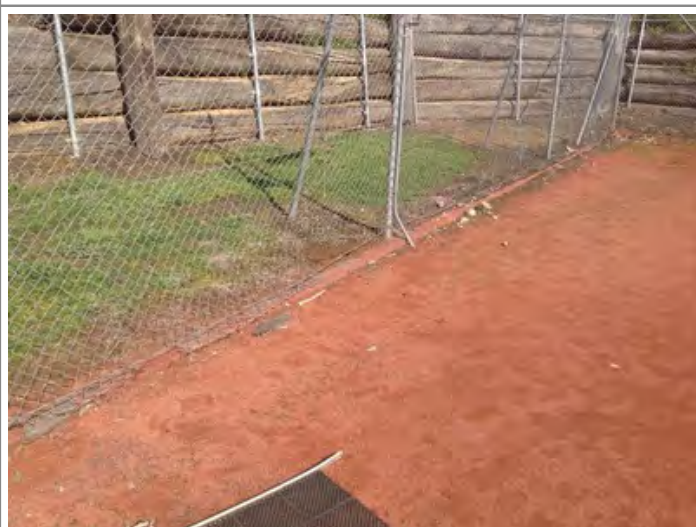
Fence type	Galvanised chain mesh
Fence Rails	Fence rail top: no Fence rail bottom: no
Fence height	3m to 3.5m Low level side fencing installed: no
Fence attachments	Sightscreens Windbreaks
Fence condition rating	Moderate Issues/Observations: Slack mesh Mesh curling at base Damaged mesh Excessive gap under fencing - allows balls to escape enclosure Trees overhanging enclosure Trees/shrubs growing through mesh
Fencing life span	6-10 years

Fence notes	There are large holes in the fence particularly on the southern fence line. Barbed wire has been installed along the top of the fence around the perimeter.
--------------------	---

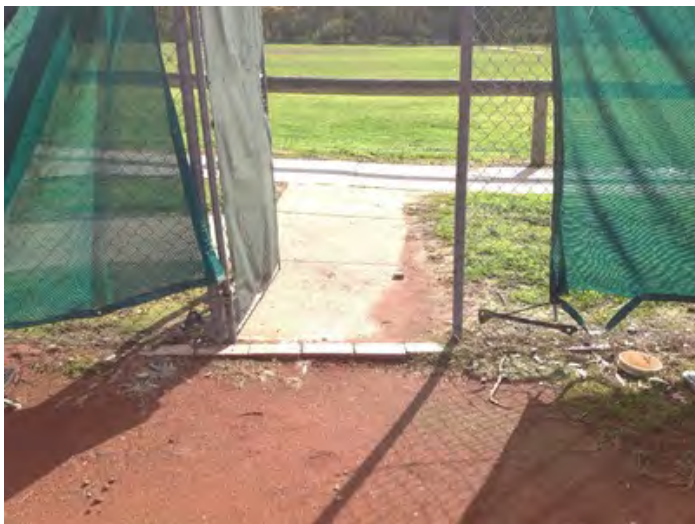
Court enclosure accessibility	Formed paths Trip hazards identified: yes Ramped access provided: yes
Path material(s)	Concrete
Main gate dimensions	Standard pedestrian gate 1000mm x 2100mm
Accessibility notes	A row of bricks must be stepped over to enter the enclosure.

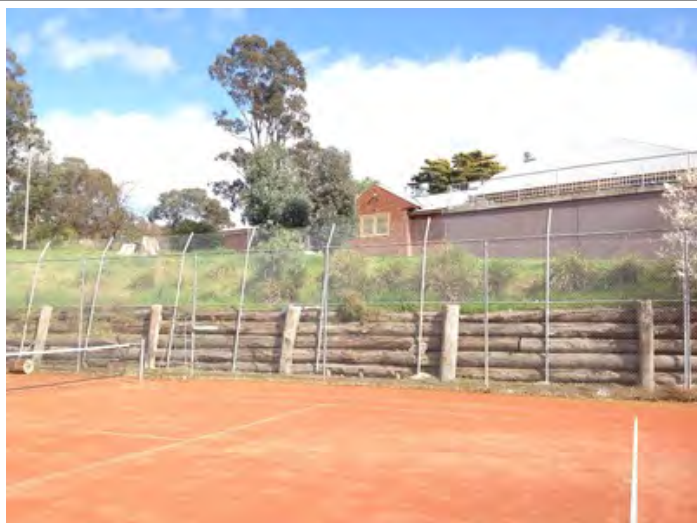
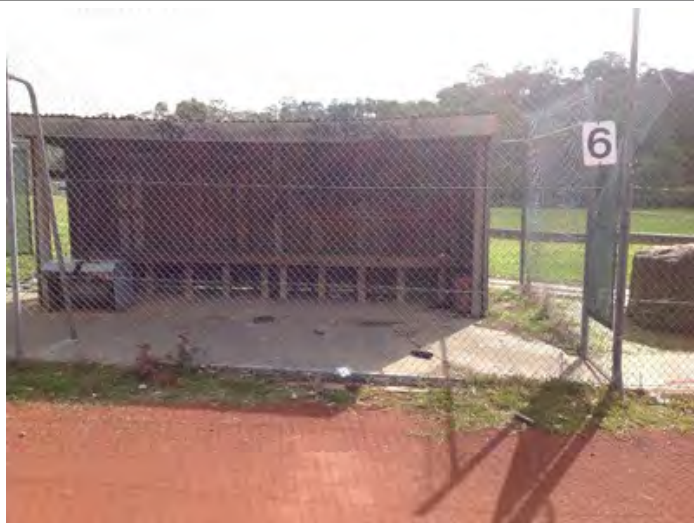
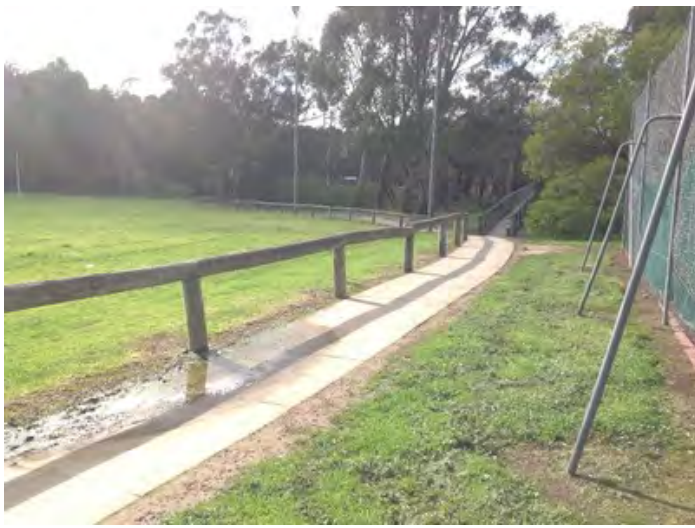
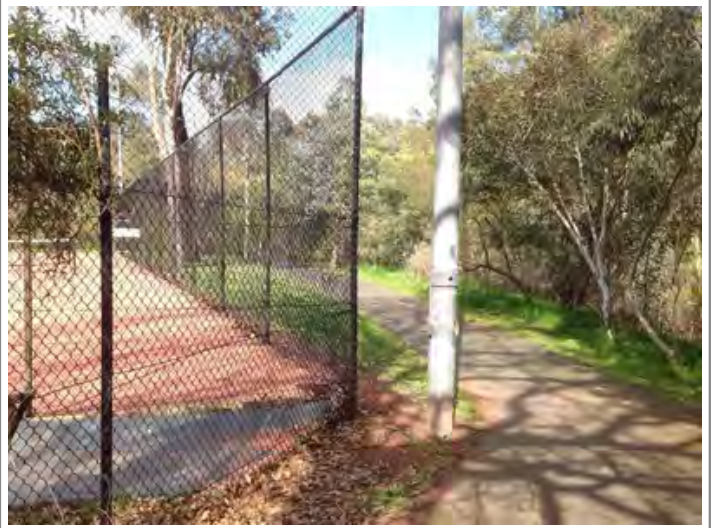
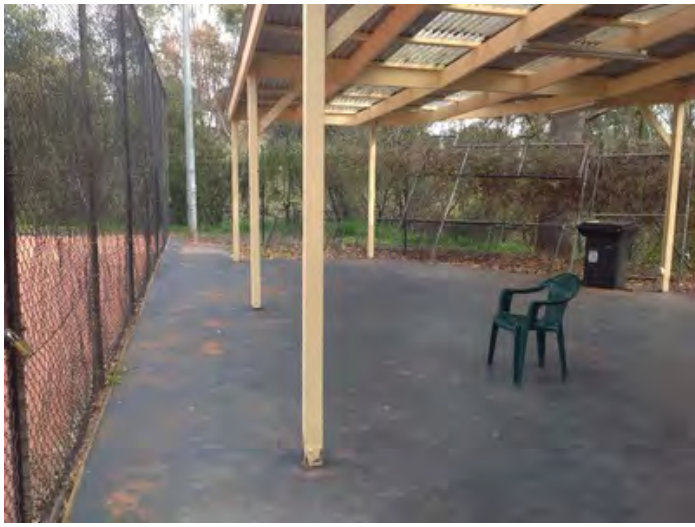
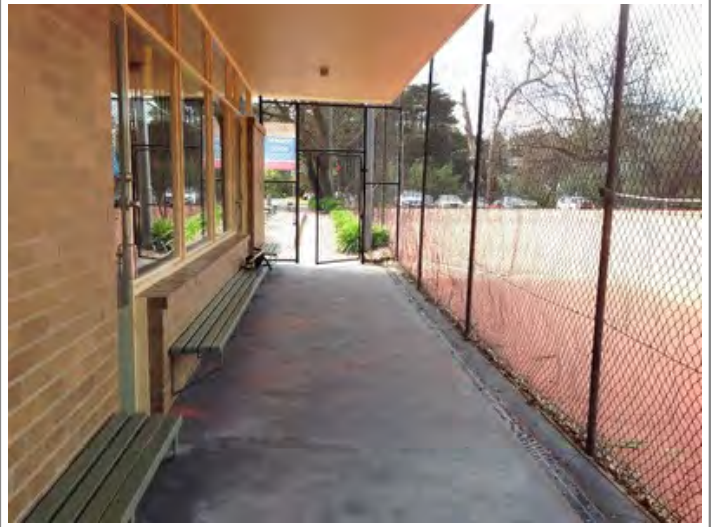
Condition of ground and court surrounds	Good
Court surround notes	Court surrounds are public space with a walking trail and creek running alongside the enclosures, and a football ground and licensed venue to the west. A footbridge connects the two court enclosures over the creek.
Water supply	Potable
Water notes	
Natural Shade	Sufficient shade available within viewing range
Man made Shade	Clubhouse veranda
Shade notes	
Car parking	On street: Off street: 41-60 spaces Overflow:
Does the site have any hit up walls	no
Car park notes	The car park is shared the football club.
Adjacent facilities	Oval/playing field
Does the site have any potential expansion oppotunities?	no

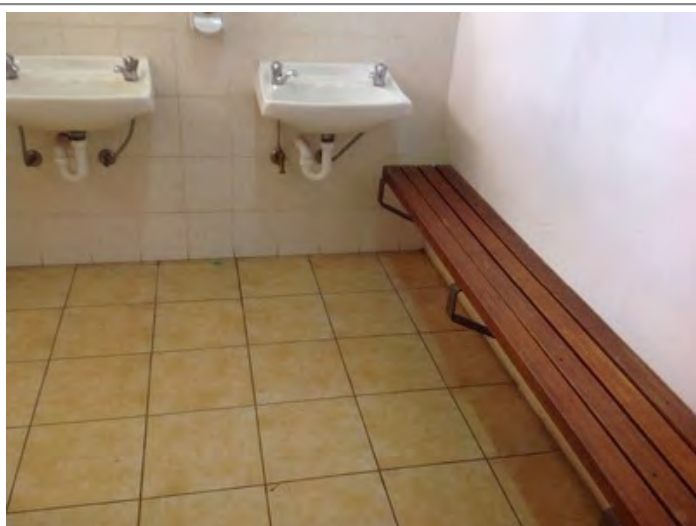
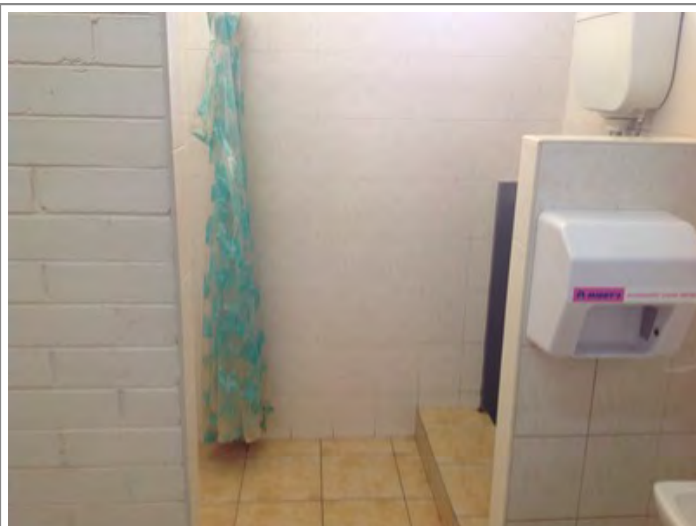
Building Condition	Moderate
Estimated building age	30+ years
Building materials	Brick
Accessible entry to building	yes
Kitchen	Standard
Bar	no
Player change rooms	Male: 1 Female: 1 Unisex: 0
Social area	66 m2
Social area comments	
Toilets	Male: yes Female: yes Accessible: no
Clubroom condition notes	The clubhouse consists of an open social area with adjacent kitchen and toilet facilities. The mens shower is quite close to the urinal which makes for a sub optimal arrangement. The kitchen is new, and there are clear views of the court enclosures. There is some paint peeling from the brick work around the interior of the clubhouse.
Other amenities provided within or outside clubrooms	BBQ /outdoor seating area
Other amenities condition notes	
Are there any safety concerns within clubrooms?	no
