Elder Street Reserve Facility Audit

Document number	000217
Client / Site	Tennis Victoria
Location	Elder Street Watsonia VIC 3088
Auditor	Andrew Sodomaco
Audit date	04 Sep 2015

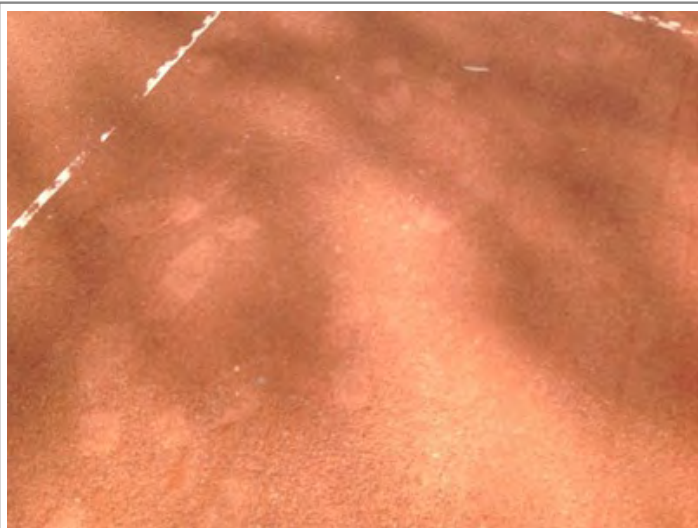
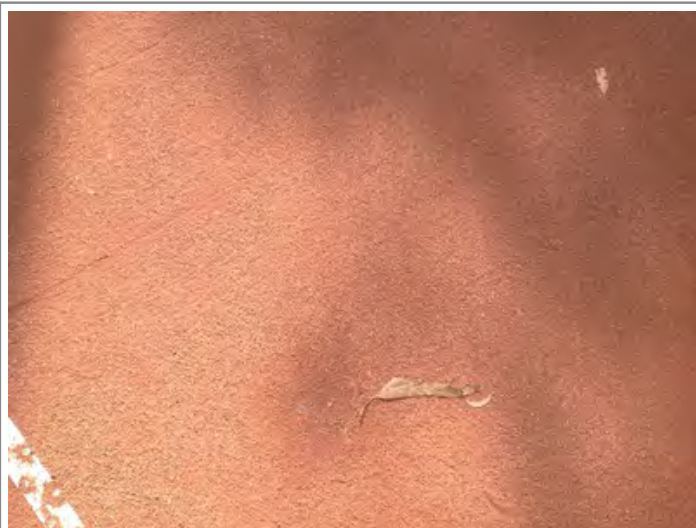
Unique court number	1
Surface condition rating	Moderate Issues/Observations: Leaf litter Aged surface Excessively worn surface in high wear areas
Surface type	Red Porous
Surface life span	10+ years
Court condition notes	Multiple areas of aggregate are showing through the court surface, although there is a good covering of top dressing.

Are there any critical safety issues?	No
Enclosure recommendations	Plan for refurbishment of court one in the long term, which appears to have much more wear than court two. Plan for fencing upgrade. Trim vegetation from fence line. Consider lighting upgrade.

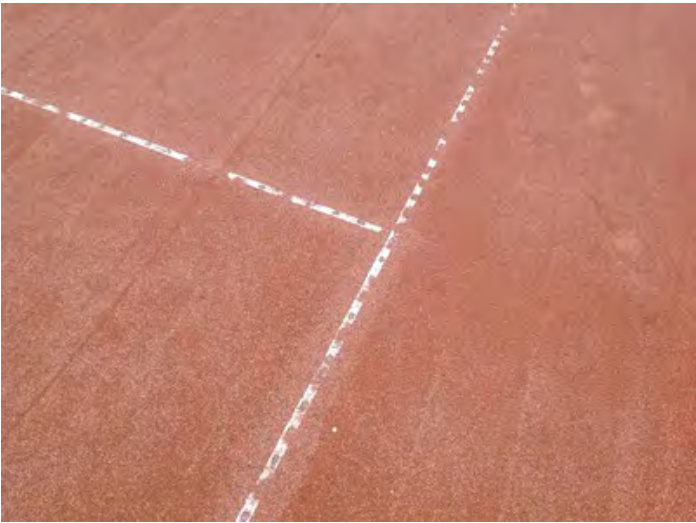
Line marking rating	Good
	Issues/Observations: Inconsistent bounce likely
Line marking condition notes	The lines are standard for this surface and do not have obvious breaks or cracks.
Line marking condition photos

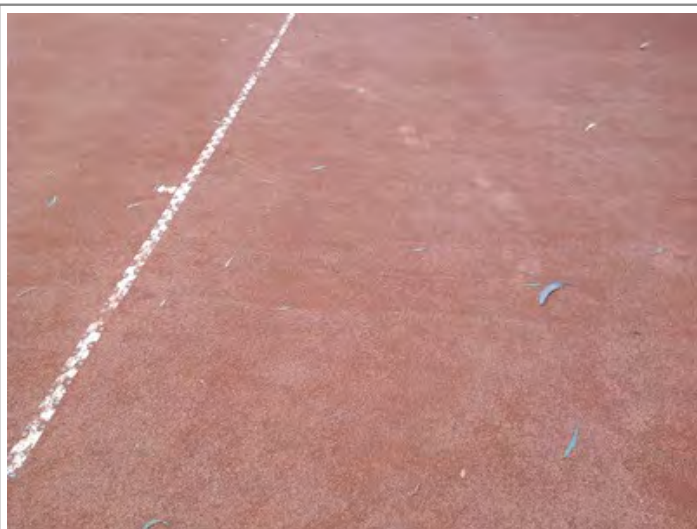
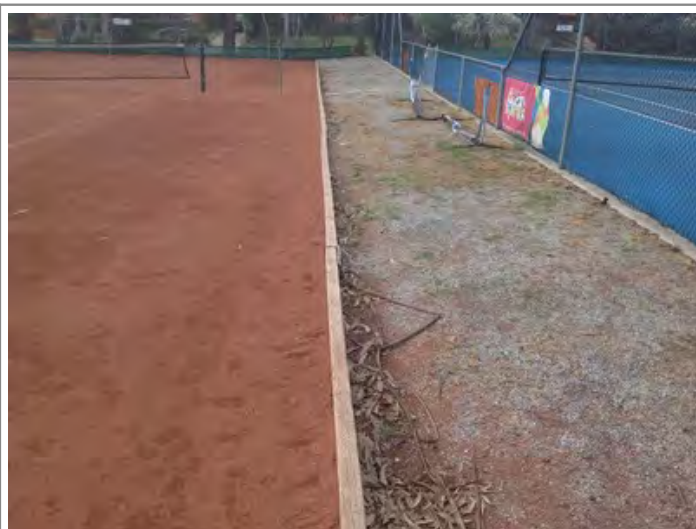
Unique court number	2
Surface condition rating	Good Issues/Observations: Leaf litter
Surface type	Red Porous
Surface life span	10+ years
Court condition notes	This court appears to be less worn than court one, with a good covering of top dressing and little aggregate showing through. There is a step down over a wooden plinth on the eastern side of the court and this represents a trip hazard.

Classification	-
Overall Facility recommendation(s)	Plan for lighting upgrade in both enclosures. Upgrade the fencing in enclosure one. Trim vegetation from fencing in enclosure one. Investigate cracking issues in enclosure two. Consider alternative solutions to the wooden plinth adjacent to court two, which is currently a tripping hazard.

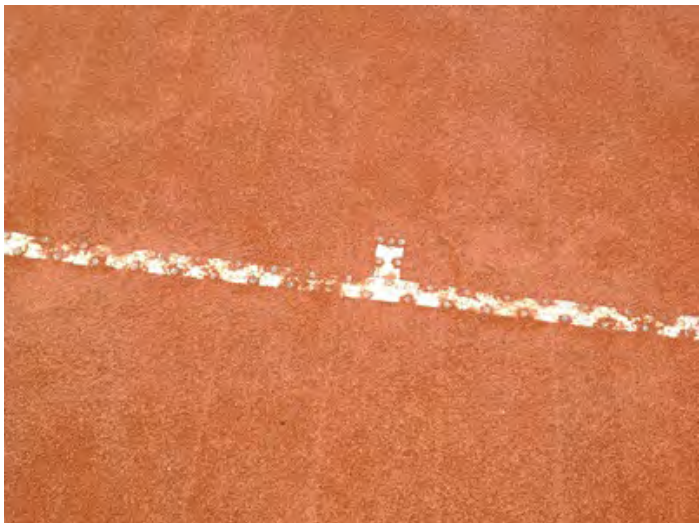
Line marking rating	Good
	Issues/Observations: Inconsistent bounce likely
Line marking condition notes	The lines are standard for this surface and do not have obvious breaks or cracks.
Line marking condition photos

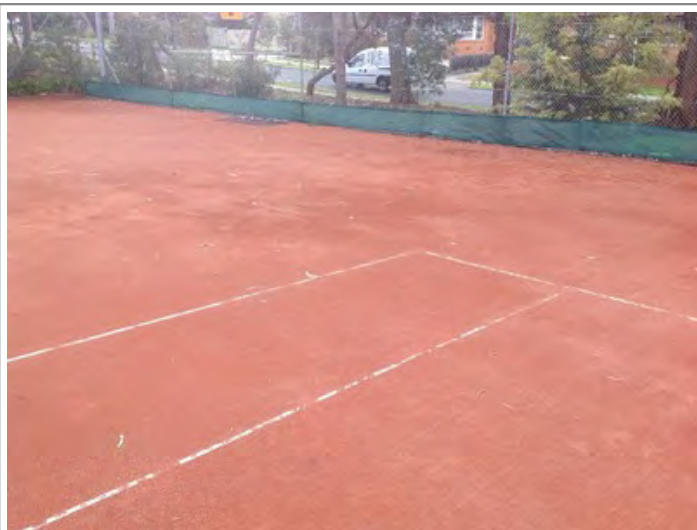
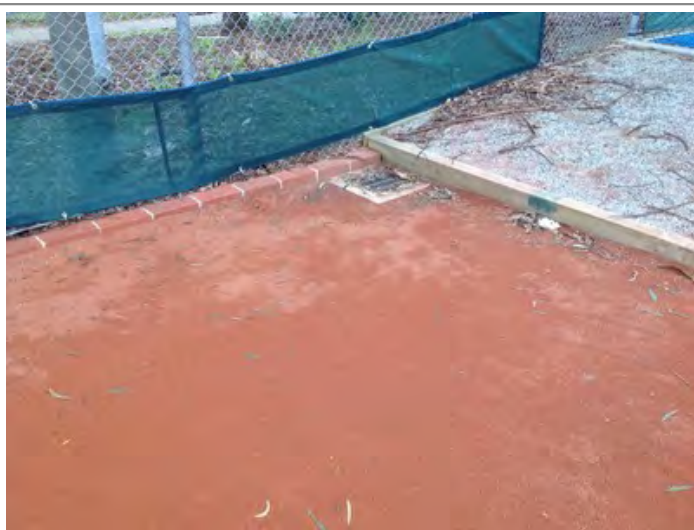
Drainage infrastructure	Formed
What type of drainage is in place?	Grated pit(s)
Are drains, pits or other infrastructure provided within the court enclosure?	yes
Are drains, pits or other infrastructure provided within the run-off areas?	no
Drainage rating	Good
	Issues/Observations: Ponding evident
Drainage notes	A grated pit is located in the northern eastern corner. The courts are quite damp between the baselines at the northern end, possibly due to shade at that end of the court.

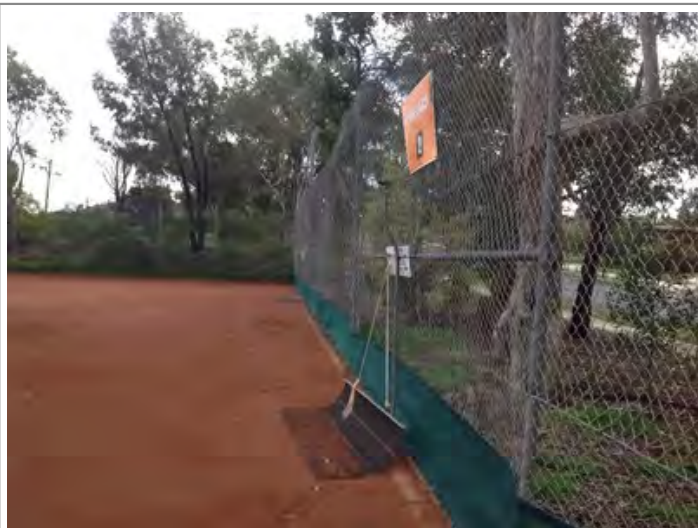
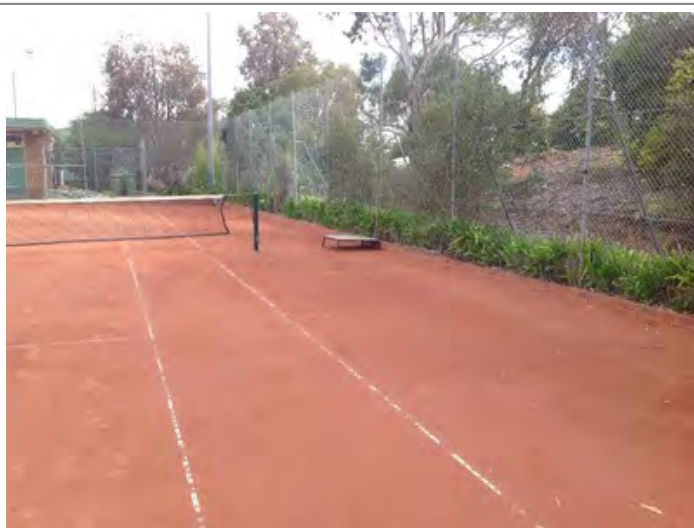
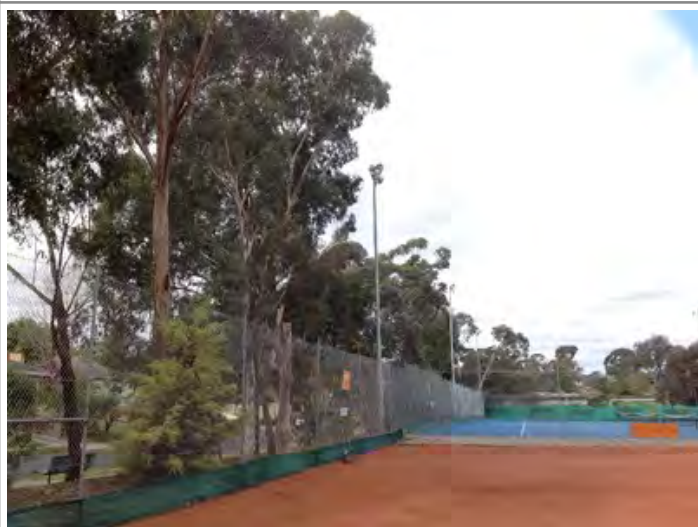
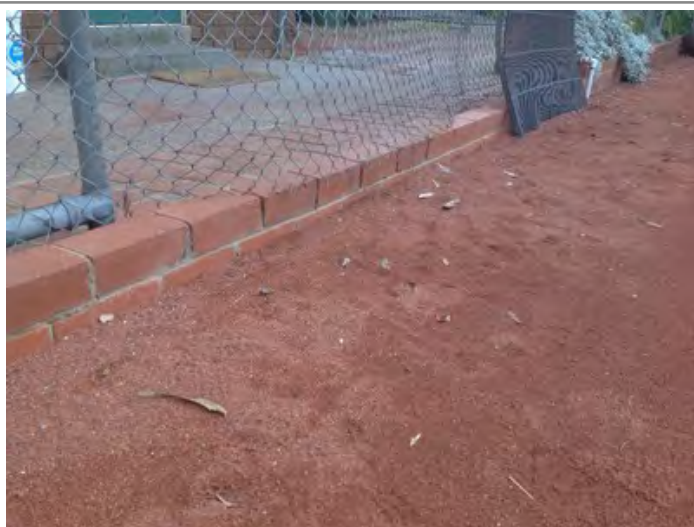
Fence Rails	Fence rail top: no Fence rail bottom: no
Fence height	3.6m and over Low level side fencing installed: no
Fence attachments	There are no fence attachments.
Fence condition rating	Moderate Issues/Observations: Slack mesh Mesh curling at base Excessive gap under fencing - allows balls to escape enclosure Trees overhanging enclosure Trees/shrubs growing through mesh
Fencing life span	10+ years
Fence notes	The fencing is in moderate condition, although multiple areas of vegetation are causing issues and should be rectified.

Court	Remove debris from court surface and enclosure Trim trees/shrubs away from court enclosure and fencing Hang drag mats on fencing
Drainage	
Infrastructure	Repair damaged fencing Trim vegetation away from fencing
Lighting	Conduct a lighting lux level test Structural Engineer required to assess integrity of lighting poles

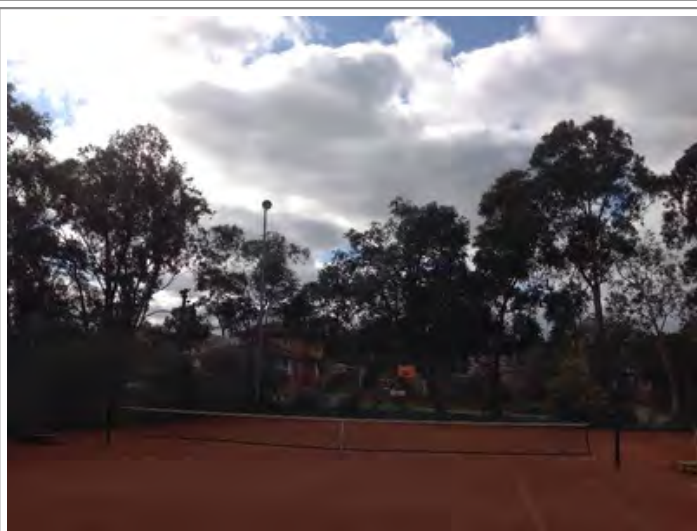
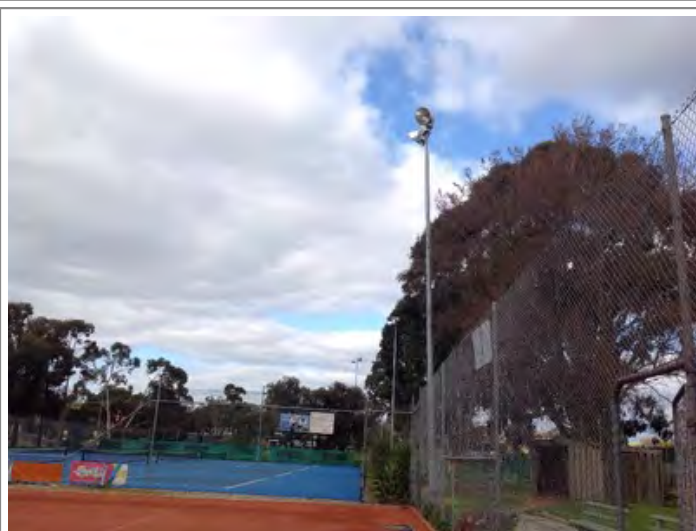
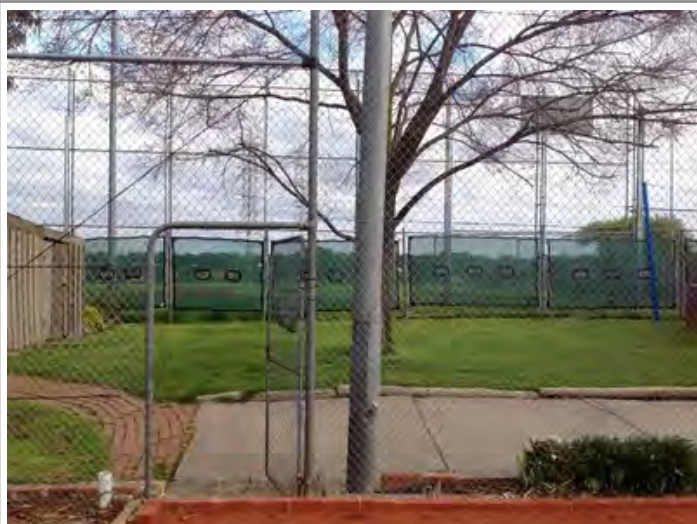
Total number of lit courts per enclosure	2
Lighting infrastructure type	High tower - Steel poles
Lighting infrastructure position	Corner
Light fittings	One per tower
Lighting infrastructure design	Standard
Lighting infrastructure rating	Moderate
	Issues/Observations: Leaning poles Old however in good condition - potential upgrade required
Lighting life span	10+ years
Lighting notes	Although the lighting is old and may not meet required lux levels, it is in otherwise good condition. One of the bolts on the light tower in the south eastern corner is missing and the post is leaning.

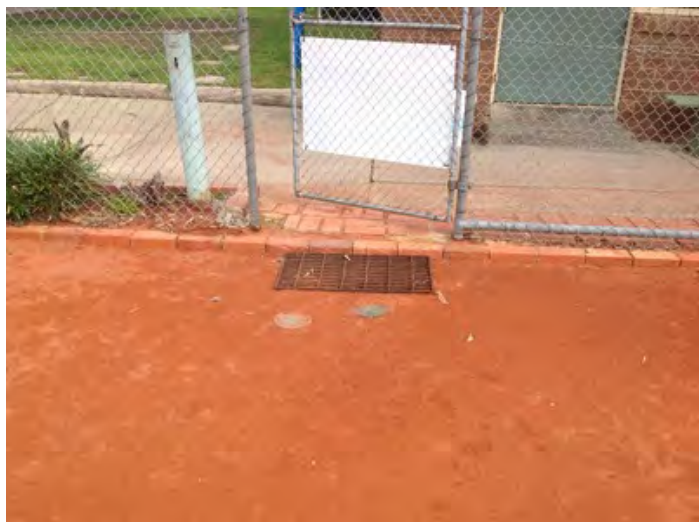
Court enclosure accessibility	Formed paths Trip hazards identified: yes Ramped access provided: no
Path material(s)	Other material?
Main gate dimensions	Standard pedestrian gate 1000mm x 2100mm
Accessibility notes	Users are required to step over pavers to enter the enclosure.
Accessibility photos

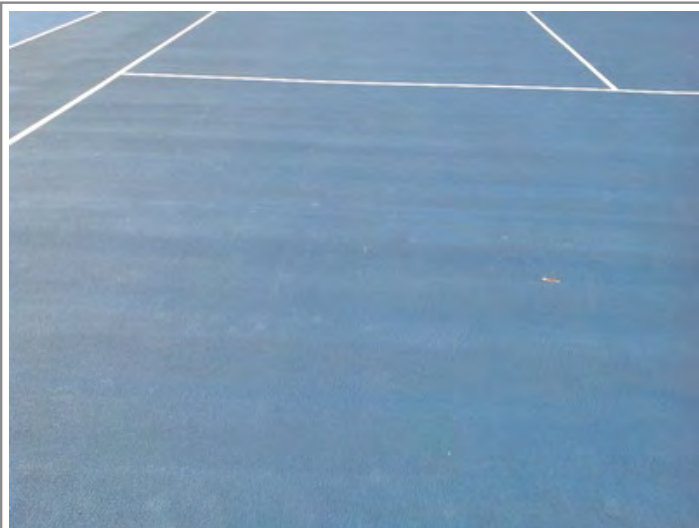
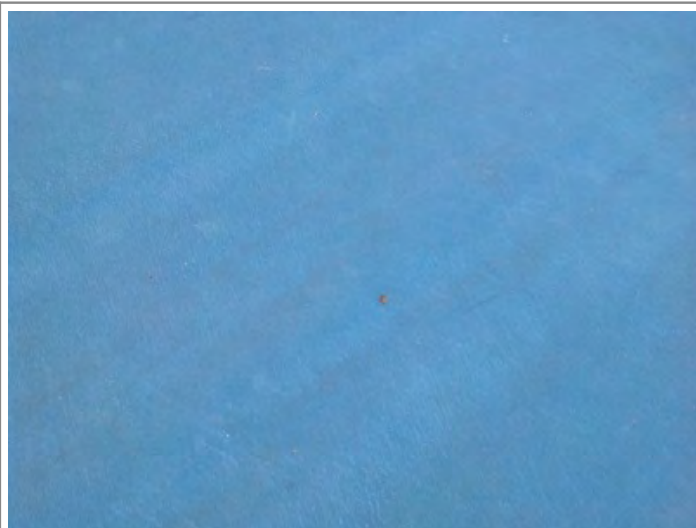
Unique court number	3
Surface condition rating	Good Issues/Observations: Surface pitting Dirt/silt on surface
Surface type	Cushioned Acrylic
Surface life span	6-10 years
Court condition notes	This court appears quite new and has few signs of wear. There are no obvious signs of cracking in the surface, although there is a little dirt over the court. There is a hole in the middle of the court, where the surface has pitted.

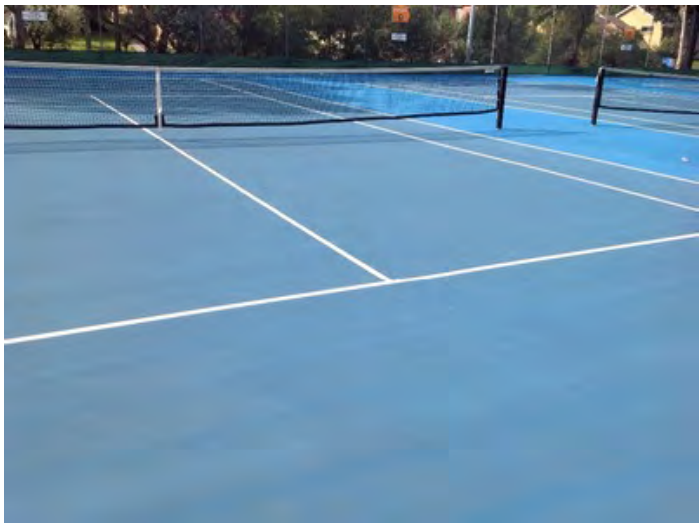
Line marking rating	Good
	Issues/Observations: Clear and bright Straight and clean
Line marking condition notes	The lines are in the same condition as the rest of the court.
Line marking condition photos

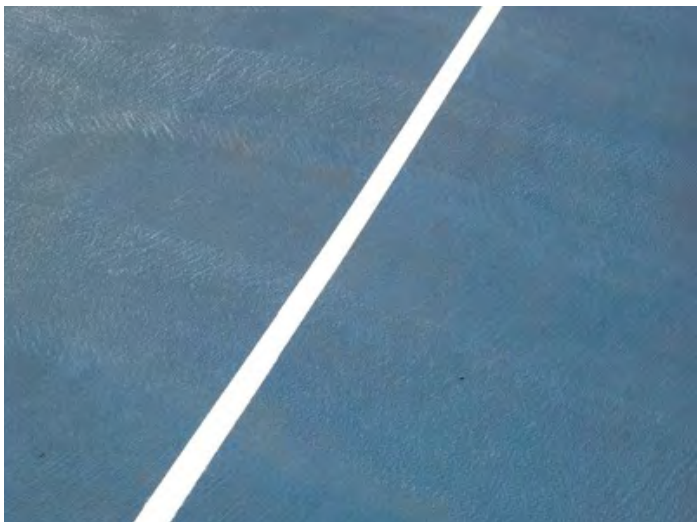
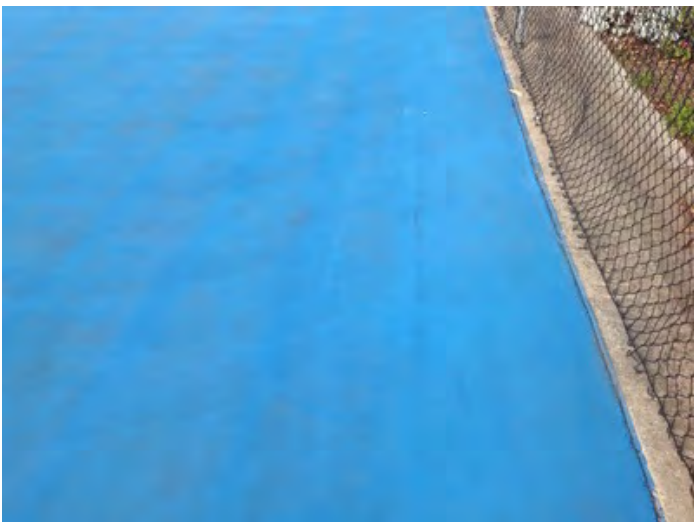
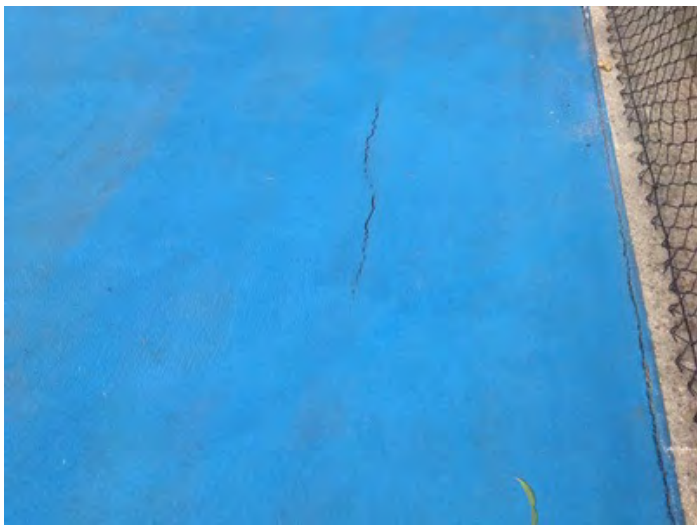
Could the court be made compliant?	n/a
Is the court to the standard dimensions?	yes
Court orientation	North-south
Are netball goal posts outside tennis court run off areas?	no
Are lockable post hole covers fitted and safe?	no
Compliance notes	The court meets run off compliance to all directions.
Compliance photos	
No photos taken	
Courts	
Condition	
Unique court number	4
Surface condition rating	Good Issues/Observations: Minor surface cracking Dirt/silt on surface
Surface type	Cushioned Acrylic
Surface life span	6-10 years
Court condition notes	This court appears quite new and has few signs of wear. There are no obvious signs of cracking or pitting in the surface, although there is a little dirt over the court. There is some cracking along the southern baseline close to the fence line however.
Court condition photos

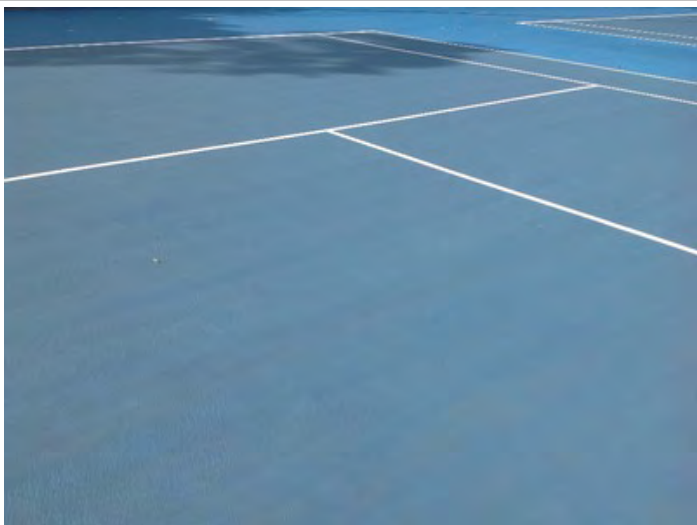
Line marking description	Tennis only lines
Line marking rating	Good Issues/Observations: Clear and bright Straight and clean
Line marking condition notes	The lines are in the same condition as the rest of the court.

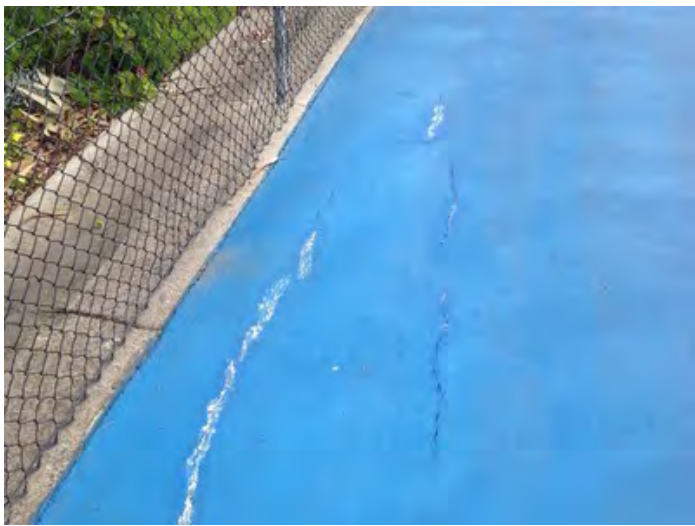
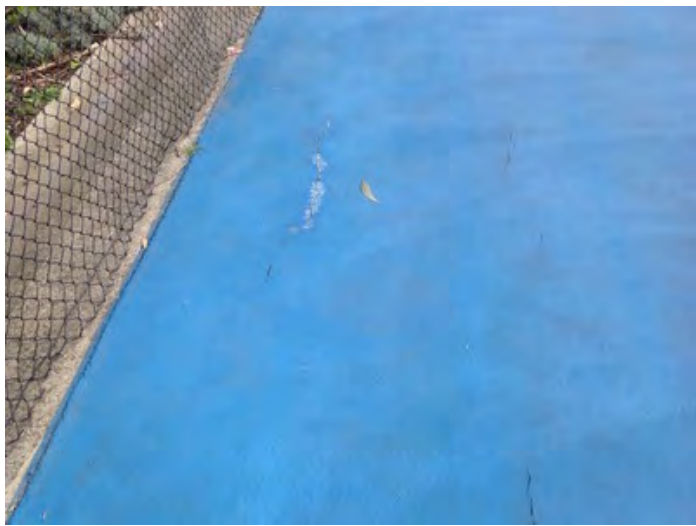
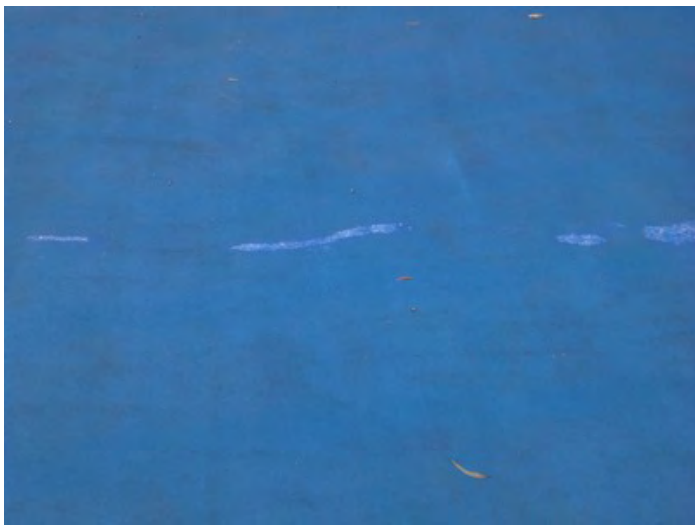
Net post life span	10+ years
Net life span	6-10 years
Net / post notes	
Net / post photos	
No photos taken	
Court compliance	
Is the court run off compliant?	yes Runoffs North: 5500m South: 5500m East: 4300m West: 4300m
Could the court be made compliant?	n/a
Is the court to the standard dimensions?	yes
Court orientation	North-south
Are netball goal posts outside tennis court run off areas?	no
Are lockable post hole covers fitted and safe?	no
Compliance notes	The court meets run off compliance to all directions.
Compliance photos	
No photos taken	
Courts	
Condition	
Unique court number	5
Surface condition rating	Good Issues/Observations: Minor surface cracking Major surface cracking Dirt/silt on surface
Surface type	Acrylic
Surface life span	6-10 years
Court condition notes	This court appears quite new and has few signs of wear. There are no obvious signs of pitting in the surface, although there is a little dirt over the court. There are large cracks which have opened up at the southern end near the fence line. Some of these have been attempted to be repaired. Some cracks also exist at the northern end between courts five and six.

Investigate cracking of courts behind court five. Consider lighting upgrade.

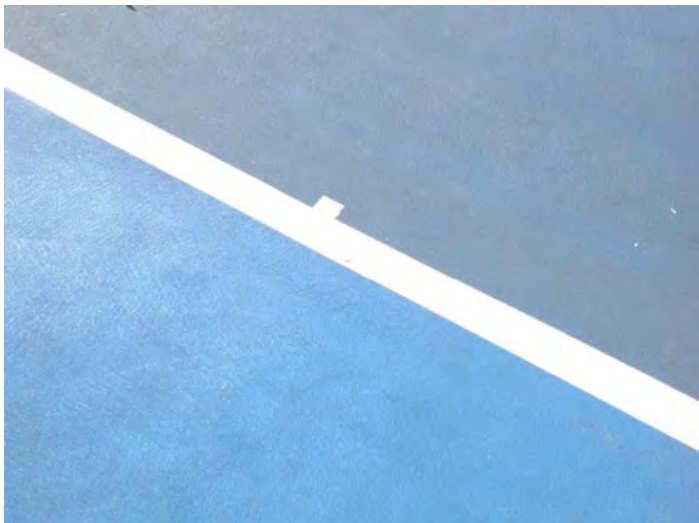
Line marking description	Tennis only lines
Line marking rating	Good Issues/Observations: Clear and bright Straight and clean
Line marking condition notes	The lines are in the same condition as the rest of the court.
Line marking condition photos

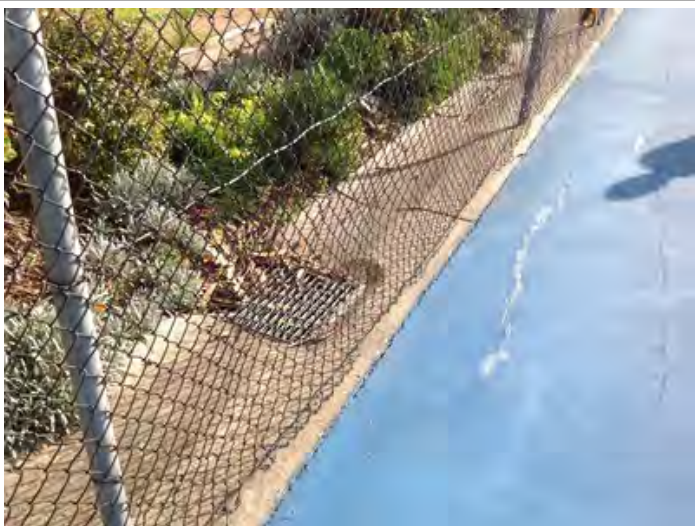
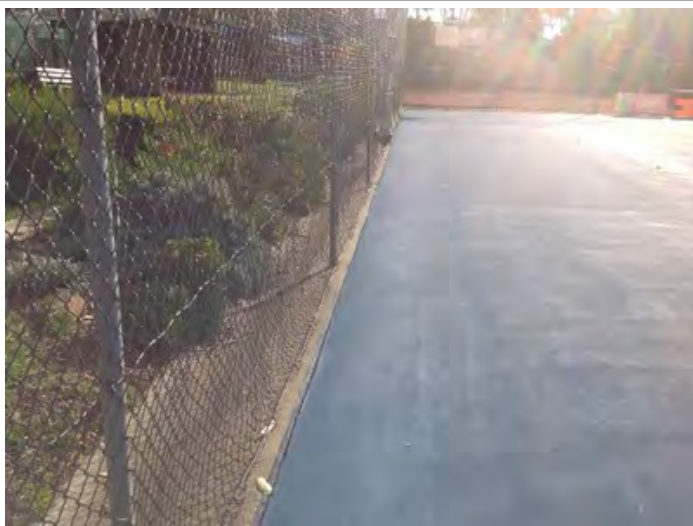
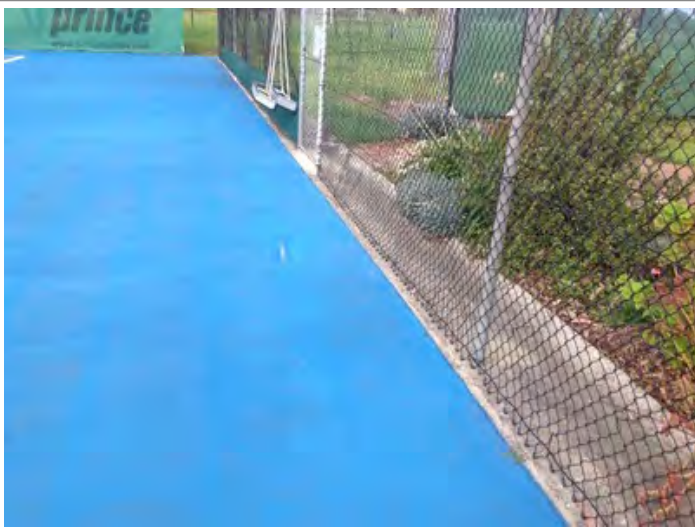
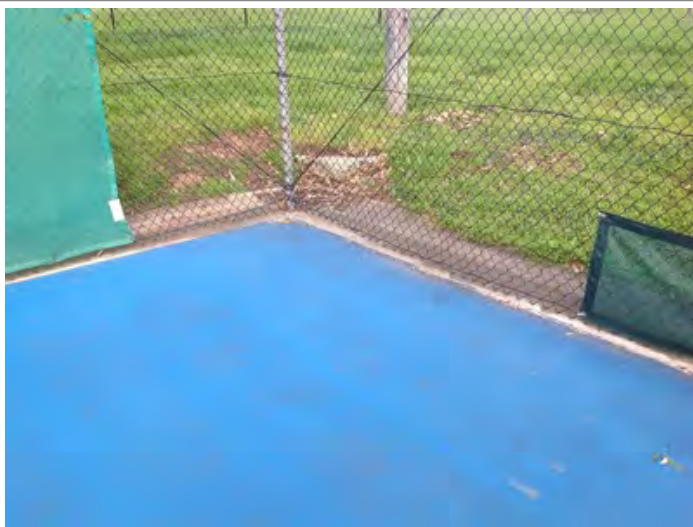
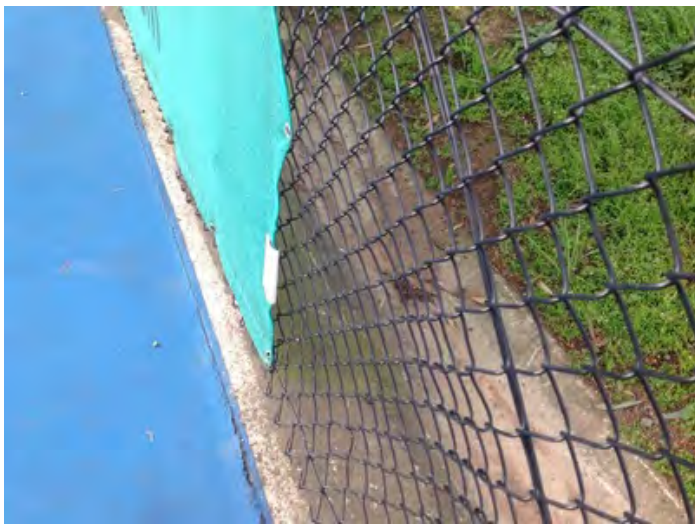
Could the court be made compliant?	n/a
Is the court to the standard dimensions?	yes
Court orientation	North-south
Are netball goal posts outside tennis court run off areas?	no
Are lockable post hole covers fitted and safe?	no
Compliance notes	The court meets run off compliance to all directions.
Compliance photos	
No photos taken	
Drainage	
Drainage infrastructure	Formed
What type of drainage is in place?	Grated pit(s)
Are drains, pits or other infrastructure provided within the court enclosure?	yes
Are drains, pits or other infrastructure provided within the run-off areas?	no
Drainage rating	Good
	Issues/Observations: Ponding evident
Drainage notes	A grated pit is located in the south eastern corner. There is some dirt and silt build up in the enclosure near this pit suggesting water pools in these areas. The pit is located outside the enclosure, and concrete spoon drains run along the outside of the enclosure along the southern and eastern fence lines. Another grated pit also lies in the spoon drain on the southern side between courts four and five. Near this area the pavement has begun to crack and this may be due to water finding its way under the court surface and into the base.

Court	Remove debris from court surface and enclosure Remove dirt and high pressure clean court surface
Drainage	Qualified Engineer required to further investigate drainage issues.
Infrastructure	Repair damaged fencing
Lighting	Conduct a lighting lux level test

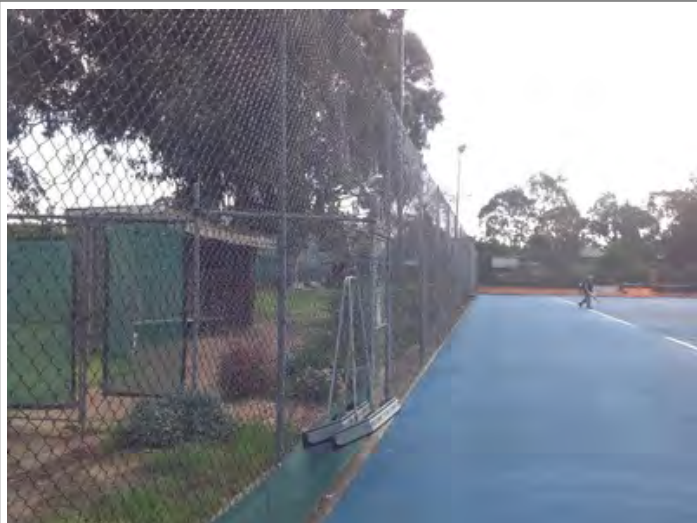
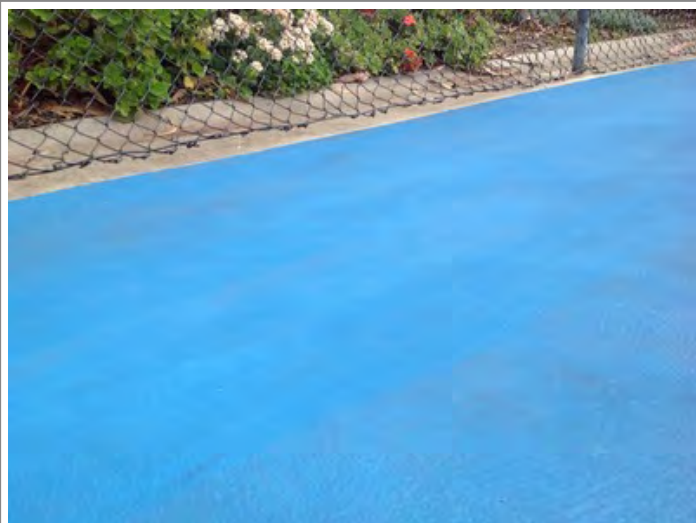
Fence attachments	There are no fence attachments.
Fence condition rating	Moderate Issues/Observations: Slack mesh Mesh curling at base Excessive gap under fencing - allows balls to escape enclosure
Fencing life span	10+ years
Fence notes	The fencing is in moderate condition. It appears existing galvanised posts have been kept and newer black PVC mesh has been installed.

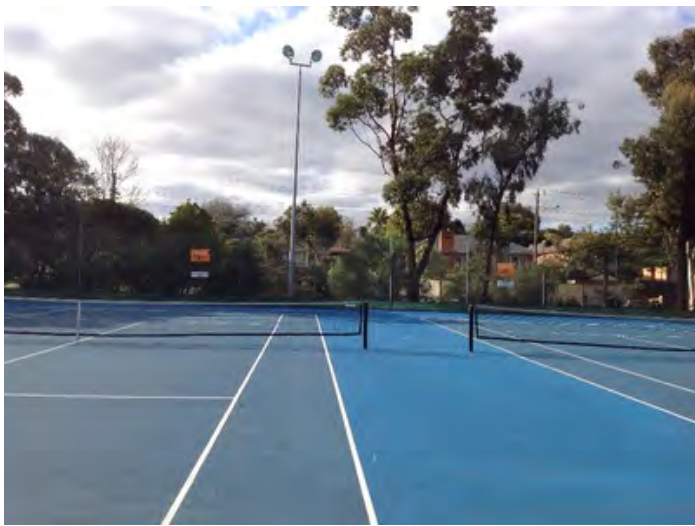
Does this enclosure have lighting	Yes
Total number of lit courts per enclosure	4
Lighting infrastructure type	High tower - Steel poles
Lighting infrastructure position	Corner
Light fittings	One per tower
Lighting infrastructure design	Standard
Lighting infrastructure rating	Good Issues/Observations: Old however in good condition - potential upgrade required
Lighting life span	10+ years
Lighting notes	Although the lighting is old and may not meet required lux levels, it is in otherwise good condition. The lights do not match up with the court configuration, leaving some areas darker than others under lights. This is due to a refurbishment of courts some years ago leaving them in a different configuration to beforehand.

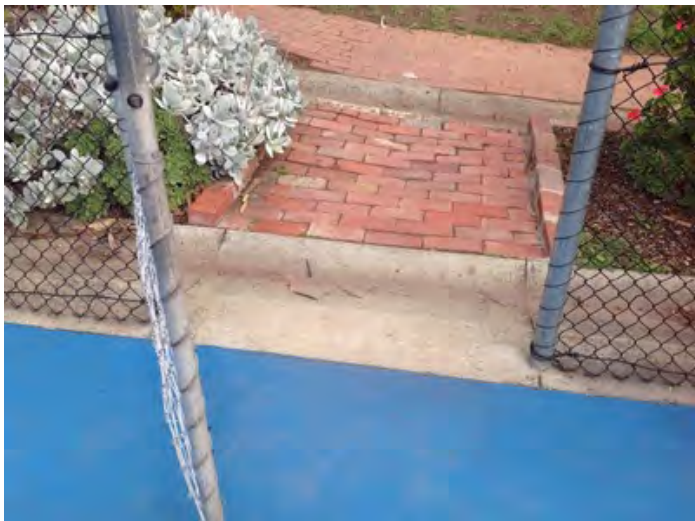
Court enclosure accessibility	Formed paths Trip hazards identified: yes Ramped access provided: no
Path material(s)	Other material?
Main gate dimensions	Standard pedestrian gate 1000mm x 2100mm
Accessibility notes	Users are required to step over pavers to enter the enclosure.

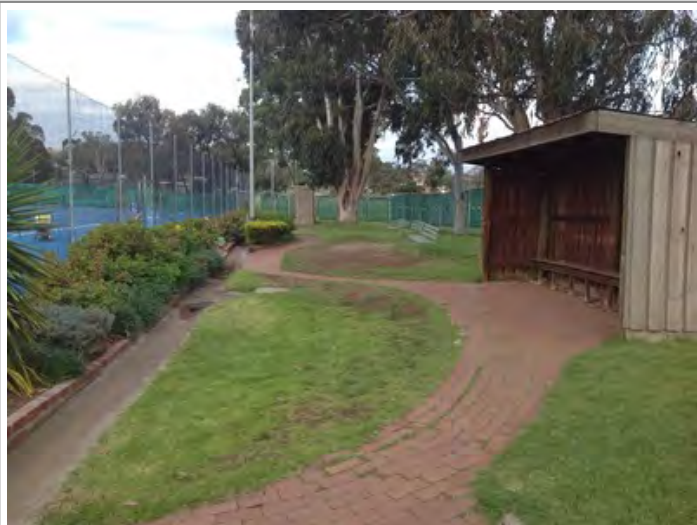
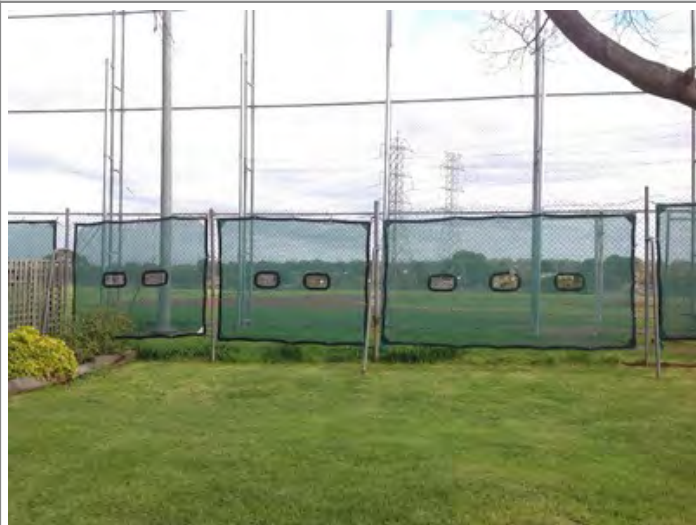
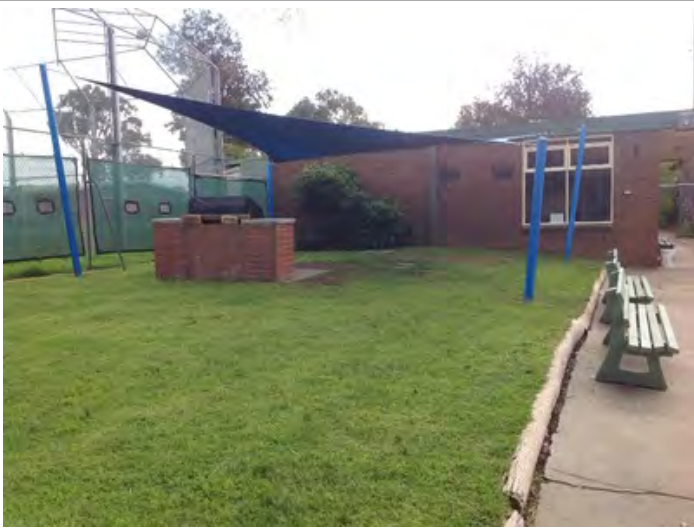
Condition of ground and court surrounds	Moderate
Court surround notes	Paths around the venue have numerous trip hazards, but gardens and lawns are well maintained.
Water supply	Potable
Water notes	
Natural Shade	Sufficient shade available within viewing range
Man made Shade	Shade sail(s)
Shade notes	
Car parking	On street: Off street: 41-60 spaces Overflow:
Does the site have any hit up walls	no
Car park notes	
Adjacent facilities	Oval/playing field
Does the site have any potential expansion opportunities?	no

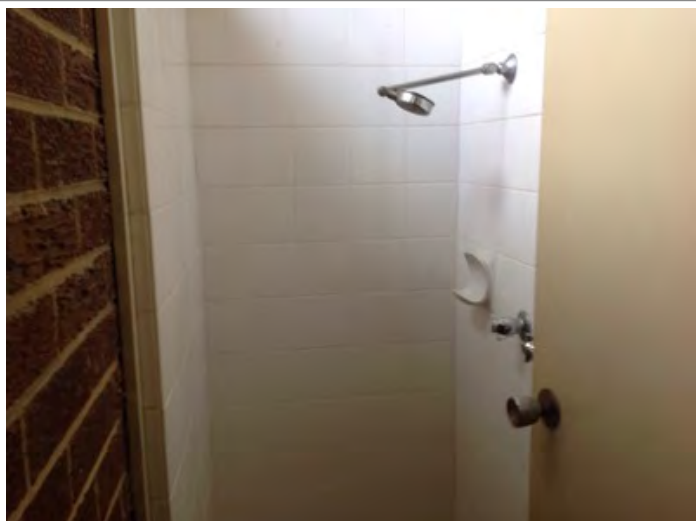
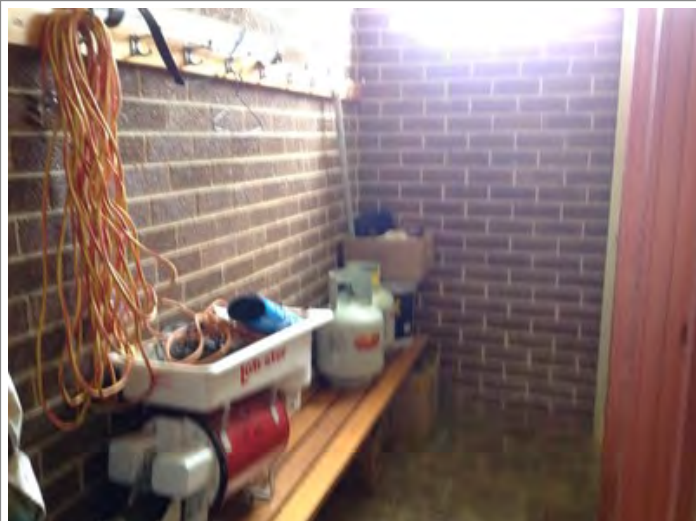
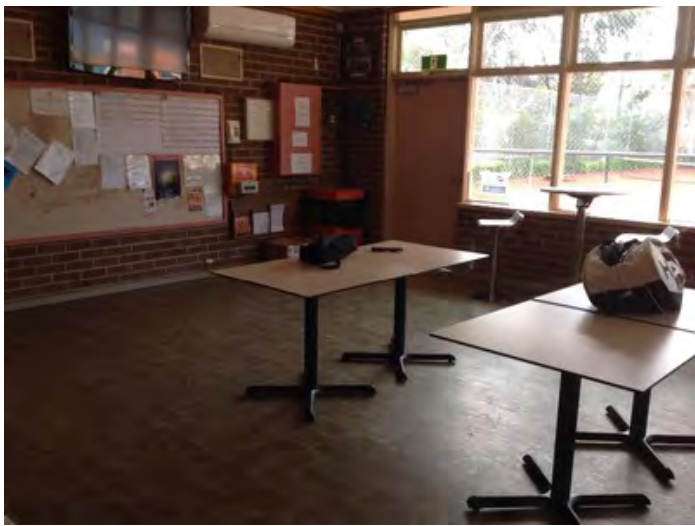
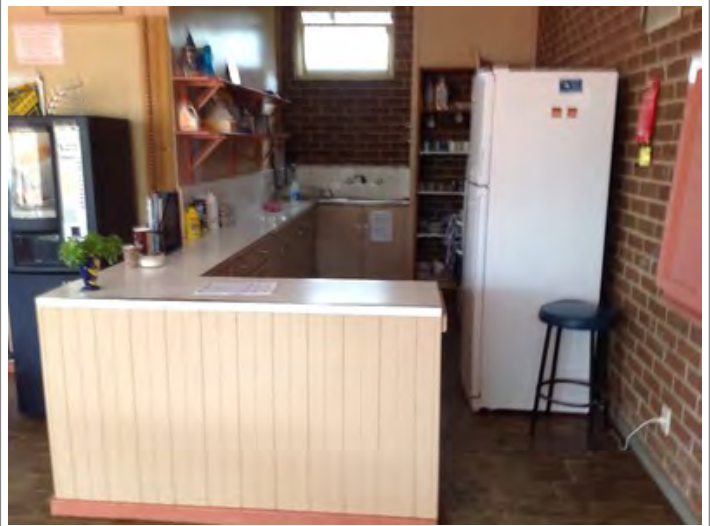
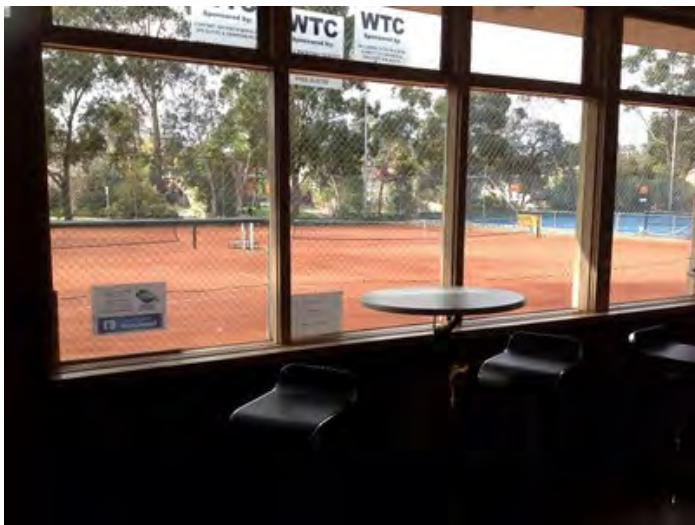
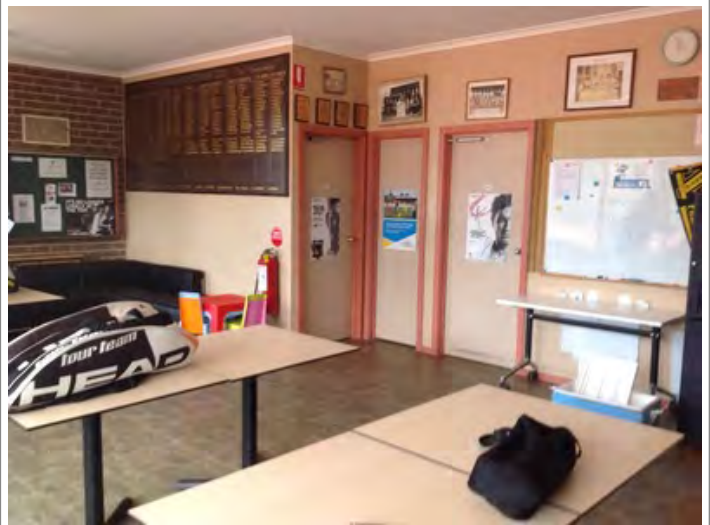
Building Condition	Moderate
Estimated building age	30+ years
Building materials	Brick
Accessible entry to building	no
Kitchen	Standard
Bar	no
Player change rooms	Male: 1 Female: 1 Unisex: 0
Social area	61 m2
Social area comments	
Toilets	Male: yes Female: yes Accessible: no
Clubroom condition notes	An open social area has toilets adjacent to the space. A kitchen is adequate for the club size. The change rooms are small and have been used as a storage space which is not ideal. The clubhouse offers excellent views of the courts. It is somewhat aged but has been kept clean inside.
Other amenities provided within or outside clubrooms	Equipment storage BBQ /outdoor seating area
Other amenities condition notes	
Are there any safety concerns within clubrooms?	no
