De Winton Park Facility Audit

Document number	000220
Client / Site	Tennis Victoria
Location	12 Turnham Avenue Rosanna VIC 3084
Auditor	Andrew Sodomaco
Audit date	11 Sep 2015

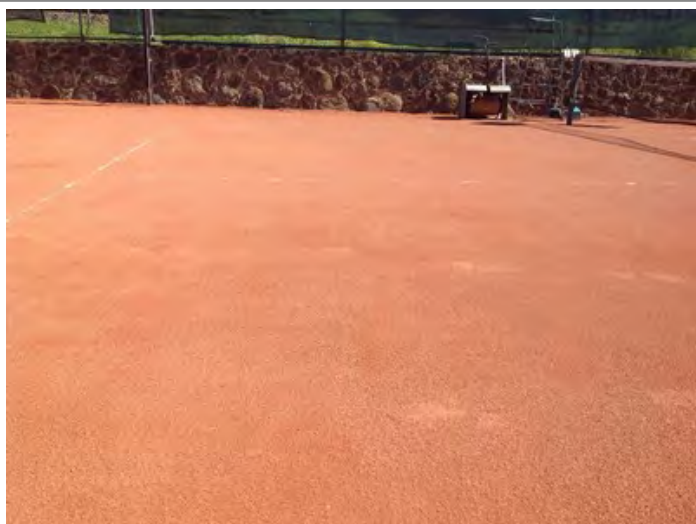
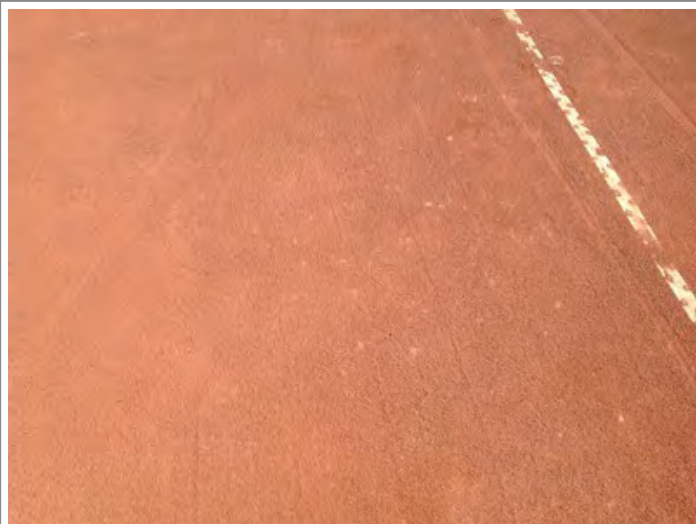
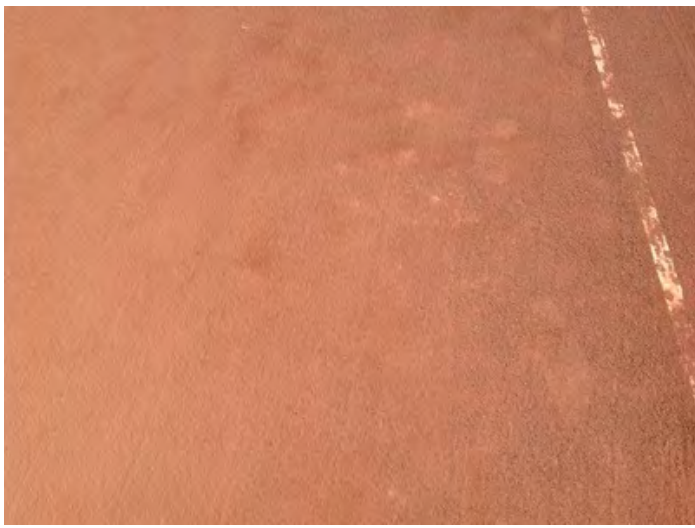
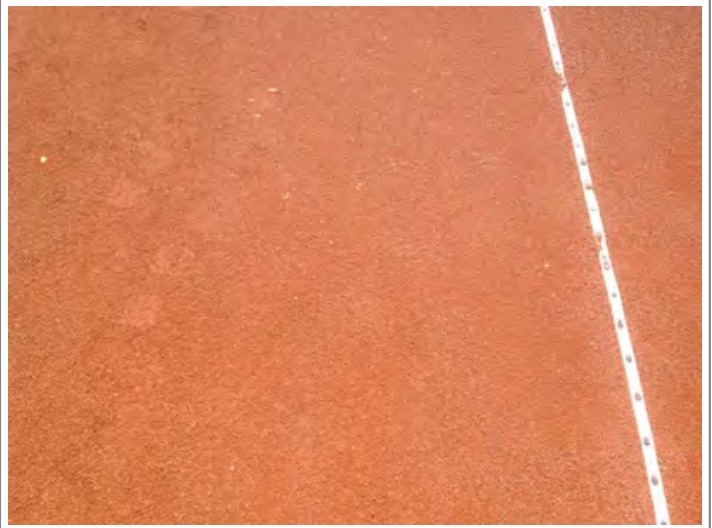
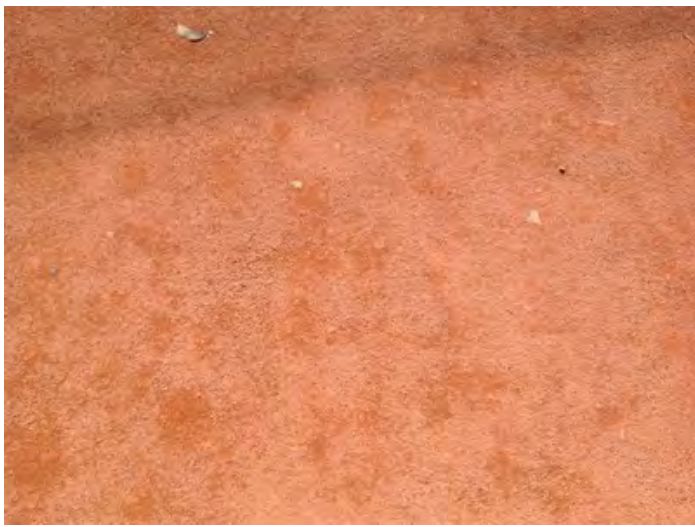
Unique court number	1
Surface condition rating	Moderate Issues/Observations: Aged surface Excessively worn surface in high wear areas
Surface type	Red Porous
Surface life span	10+ years
Court condition notes	This court is well worn with aggregate showing through the base. Top dressing is thin in some parts.

Are there any critical safety issues?	No
Enclosure recommendations	Plan for renewal of surface and court base. Plan for fencing upgrade. Add additional top dressing as required.

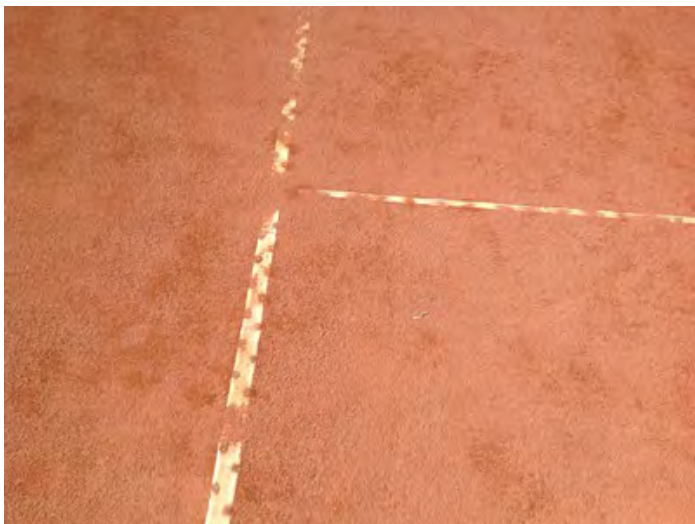
Line marking description	Tennis only lines
Line marking rating	Good
	Issues/Observations: Inconsistent bounce likely
Line marking condition notes	These are standard lines for this surface and there are no obvious signs of breakage.

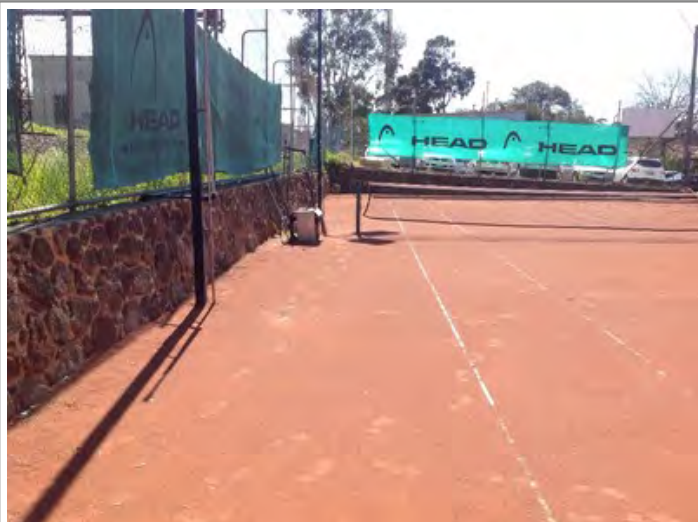
Compliance notes	The court does not meet run off requirements to any direction. The stone retaining wall is dangerous given the short distance to the court.
------------------	---

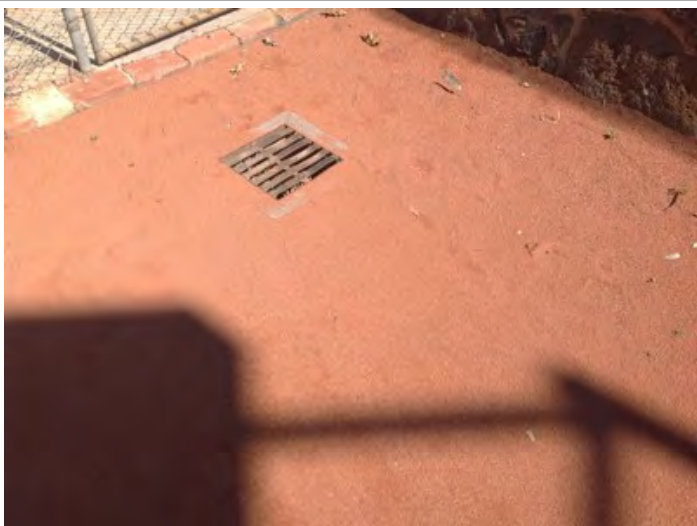
Drainage infrastructure	Formed
What type of drainage is in place?	Grated pit(s)
Are drains, pits or other infrastructure provided within the court enclosure?	yes
Are drains, pits or other infrastructure provided within the run-off areas?	yes
Drainage rating	Good
	Issues/Observations:
Drainage notes	A grated pit is located in the south western corner of the enclosure. There is no sign of dirt and silt build up across the surfaces which suggests water does not pool on the surface. It is likely that water sits in top rather than drain through the compacted surface.

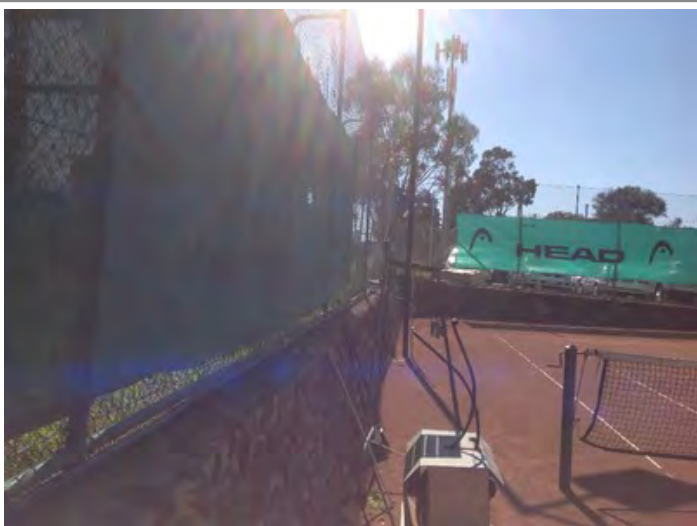
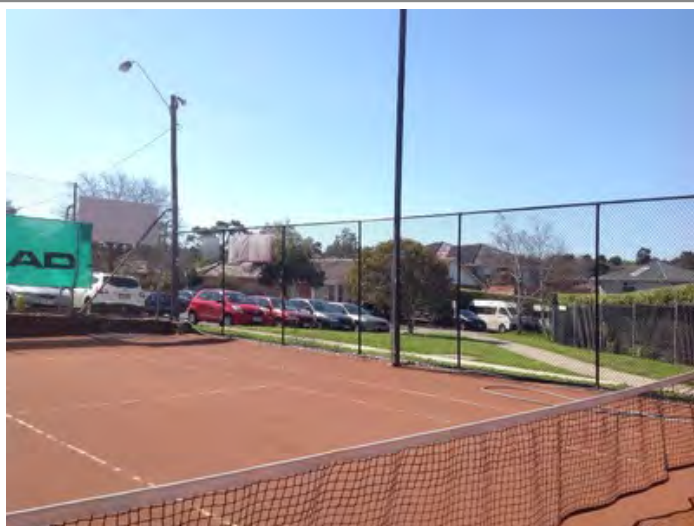
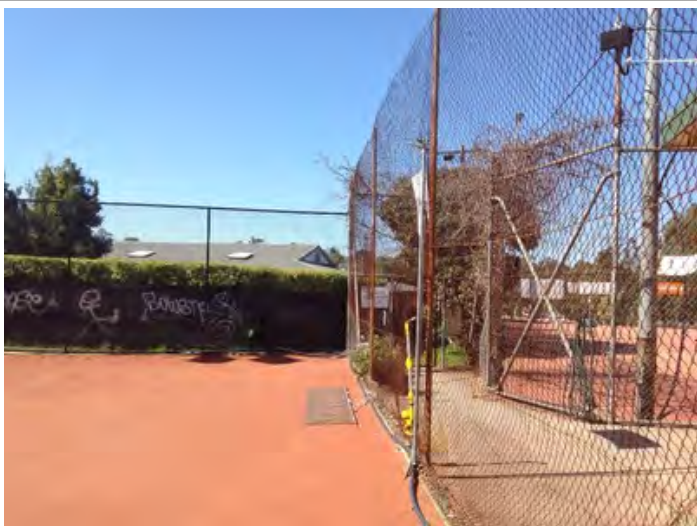
Fence type	Galvanised chain mesh
Fence Rails	Fence rail top: no Fence rail bottom: yes
Fence height	3.6m and over Low level side fencing installed: no
Fence attachments	Windbreaks Sponsor advertising
Fence condition rating	Moderate Issues/Observations: Slack mesh Rusted mesh Damaged mesh Trees/shrubs growing through mesh
Fencing life span	6-10 years
Fence notes	The eastern fence line is new and in good condition while the western and northern fencelines are older and have some issues. The southern fence is heavily rusted with a tree growing through it.

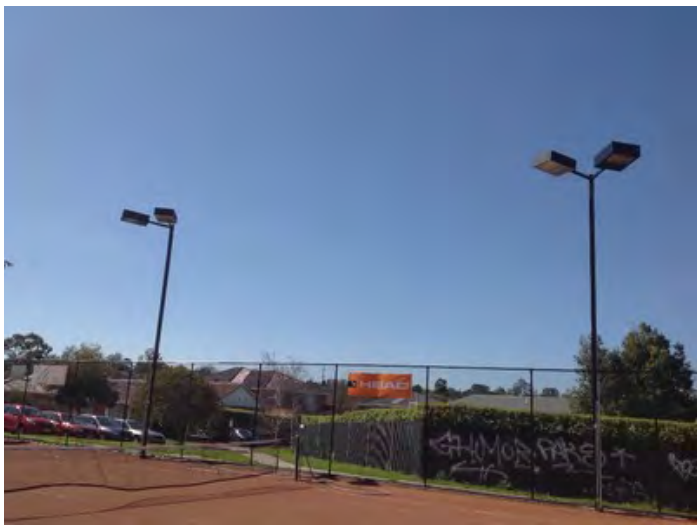
Does this enclosure have lighting	Yes
Total number of lit courts per enclosure	1
Lighting infrastructure type	Black powder coated low level - Steel poles
Lighting infrastructure position	Side
Light fittings	Two per tower
Lighting infrastructure design	Non standard
Lighting infrastructure rating	Very Good
	Issues/Observations: Infrastructure and fittings in very good condition - likely to achieve required lux standards
Lighting life span	10+ years
Lighting notes	The lighting appears to be in very good condition. It is in a slightly different configuration, with two lights on each pole covering one quadrant of the court each.

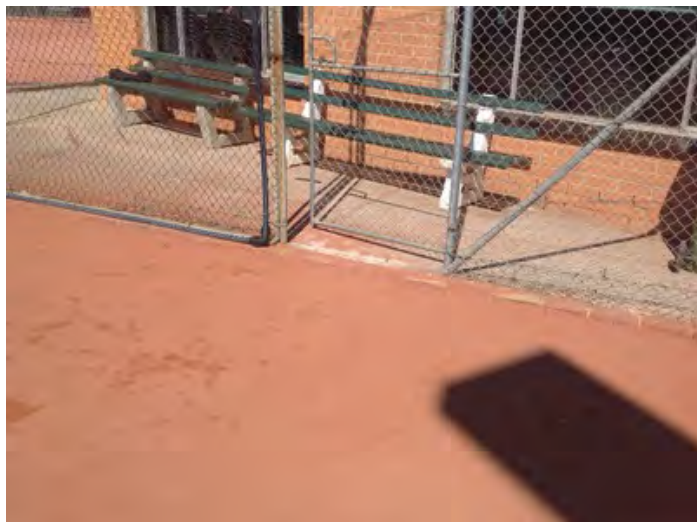
Court enclosure accessibility	Formed paths Trip hazards identified: yes Ramped access provided: no
Path material(s)	Concrete
Main gate dimensions	Standard pedestrian gate 1000mm x 2100mm
Accessibility notes	Participants are required to step over pavers to enter the enclosure.

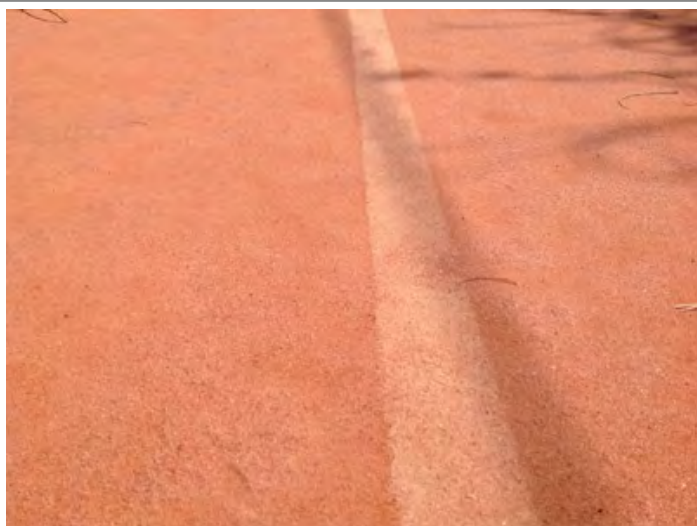
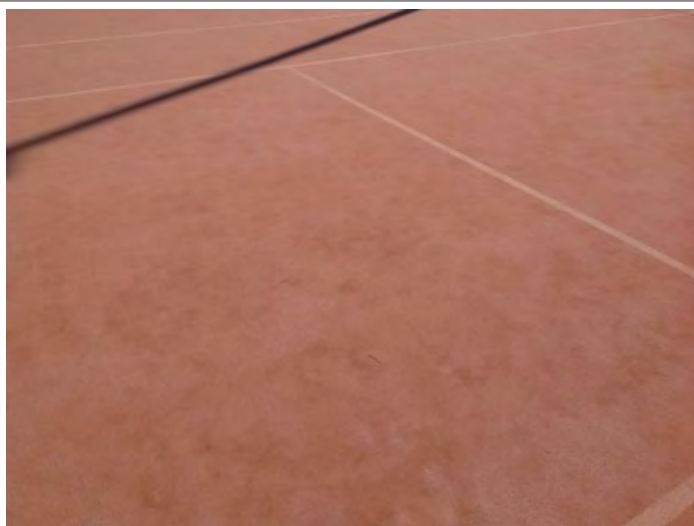
Unique court number	2
Surface condition rating	Moderate Issues/Observations: Seam stress Aged surface Excessively worn surface in high wear areas
Surface type	Synthetic Clay
Surface life span	2-3 years
Court condition notes	The surface is very worn and there is almost no pile left in the carpet. It would be likely to be very slippery when wet.

Court	Trim trees/shrubs away from court enclosure and fencing Hang drag mats on fencing Remove and replace sand/surface material Rejuvenate synthetic pile
Drainage	
Infrastructure	Repair damaged fencing Trim vegetation away from fencing
Lighting	Conduct a lighting lux level test
Safety Issues	
Are there any critical safety issues?	No
Enclosure recommendations	Plan for upgrade to court surface. Trim vegetation from fence lines. Plan for upgrade of older fences.

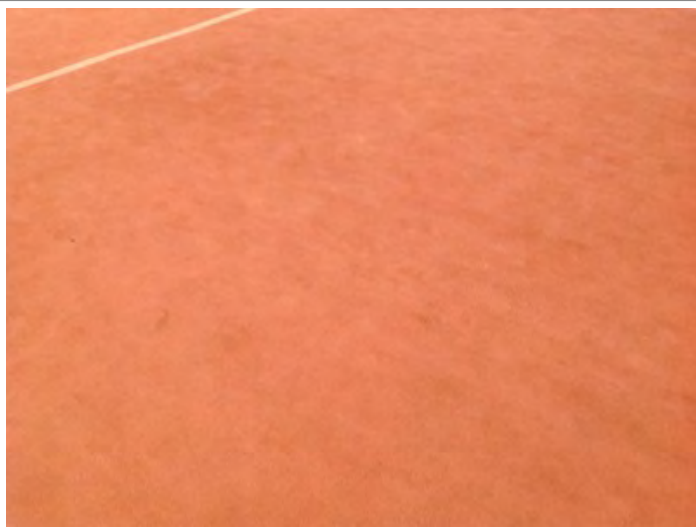
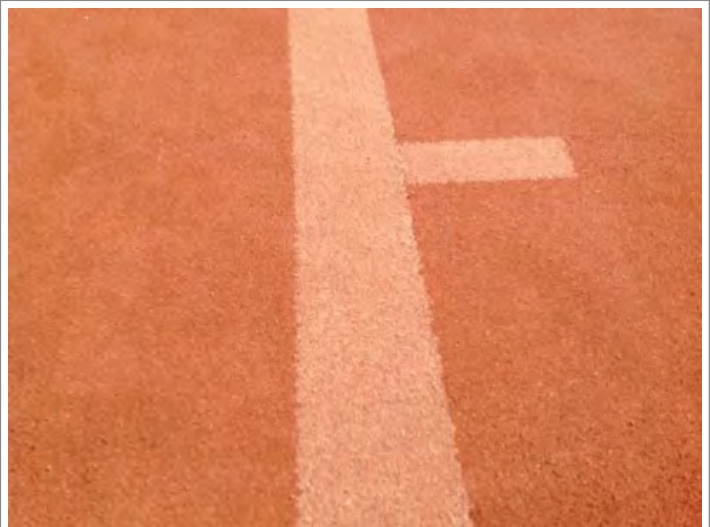
Unique court number	3
Surface condition rating	Moderate Issues/Observations: Seam stress Aged surface Excessively worn surface in high wear areas
Surface type	Synthetic Clay
Surface life span	2-3 years
Court condition notes	The surface is very worn and there is almost no pile left in the carpet. It would be likely to be very slippery when wet.

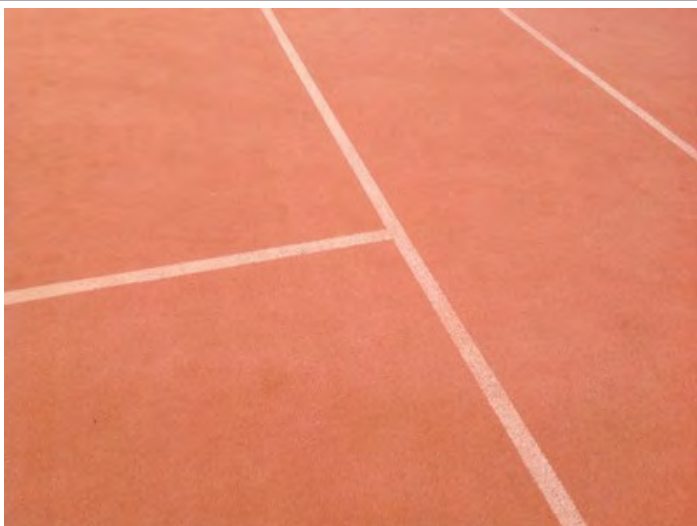
Line marking description	Tennis only lines
Line marking rating	Good Issues/Observations: Clear and bright Straight and clean
Line marking condition notes	The lines are in the same condition as the rest of the court.

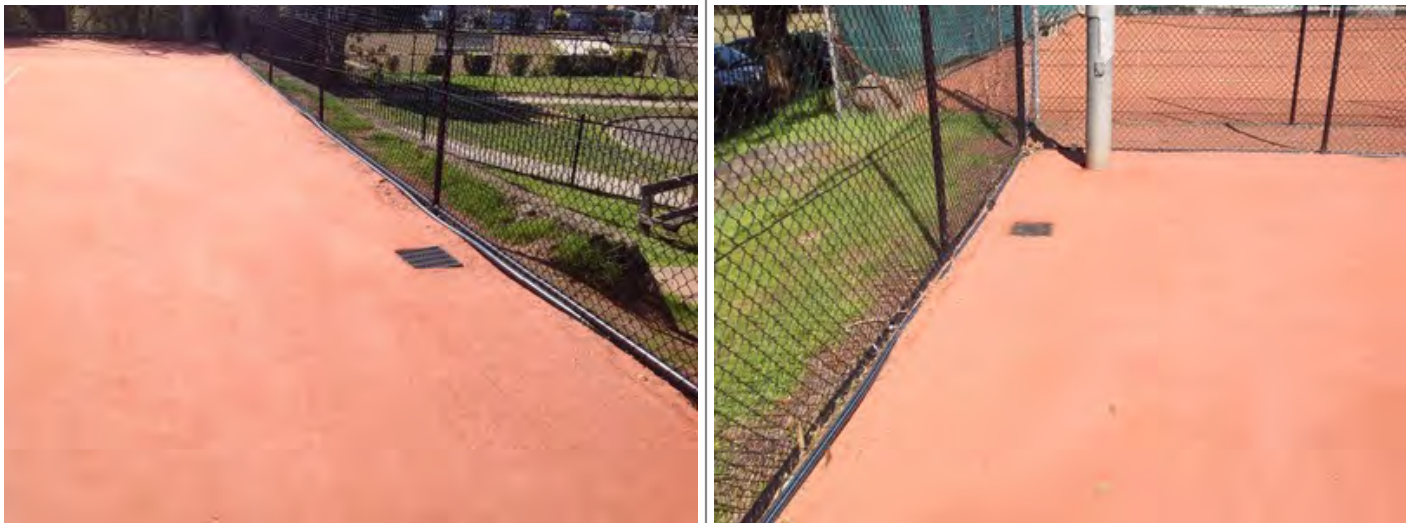
Compliance notes	The court does not meet run off requirements to the north and south behind the baselines.
Compliance photos	
No photos taken	
Drainage	
Drainage infrastructure	Formed
What type of drainage is in place?	Grated pit(s)
Are drains, pits or other infrastructure provided within the court enclosure?	yes
Are drains, pits or other infrastructure provided within the run-off areas?	yes
Drainage rating	Good
	Issues/Observations:
Drainage notes	Two drainage pits are located along the eastern fence line, with a natural fall from the north west to the south eastern corner. This surface is likely to drain effectively through the court and into the base.
Drainage photos

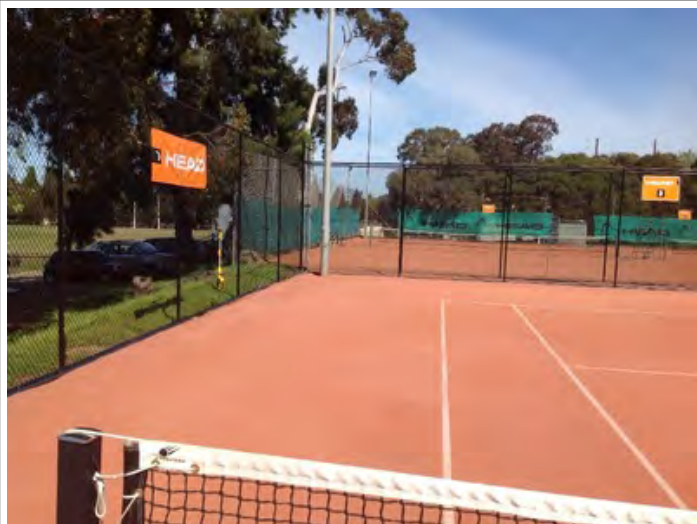
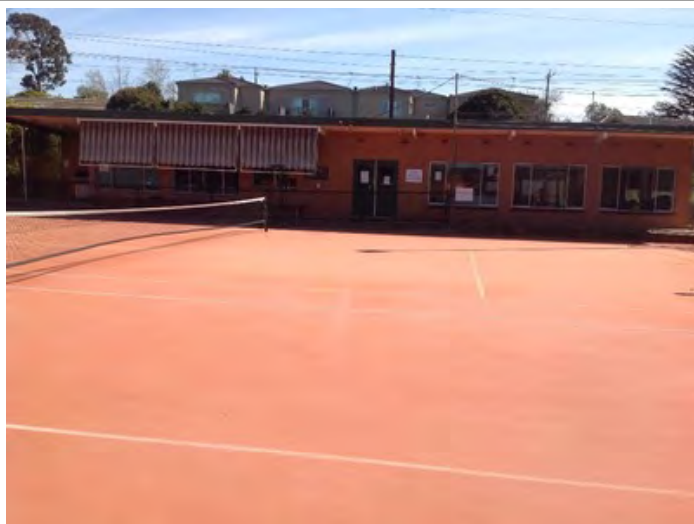
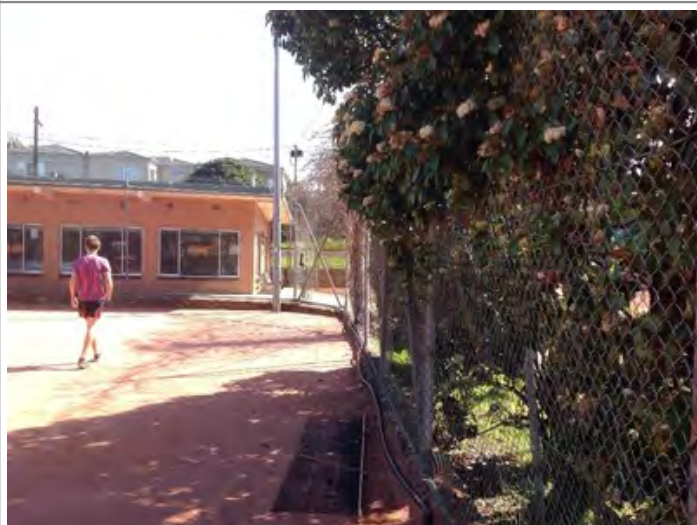
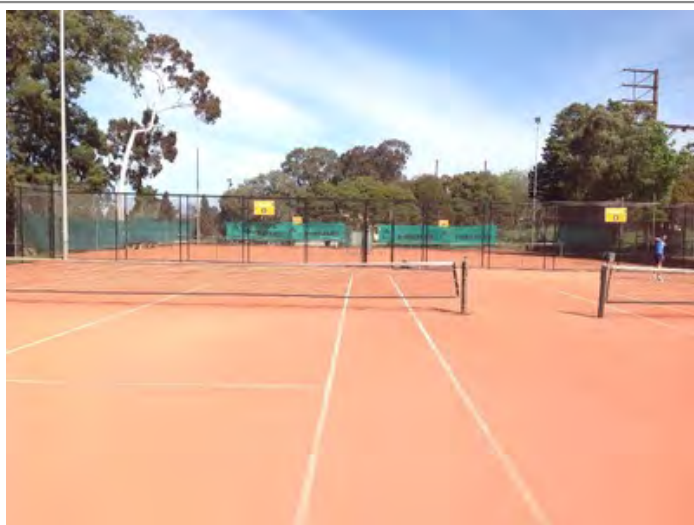
Fence condition rating	Very Good Issues/Observations: Trees overhanging enclosure Trees/shrubs growing through mesh
Fencing life span	10+ years
Fence notes	The southern, eastern and low fencing on western sideline is very new and in good condition. The high fencing to the west, and northern fencing is old and in average condition, with trees growing through it.

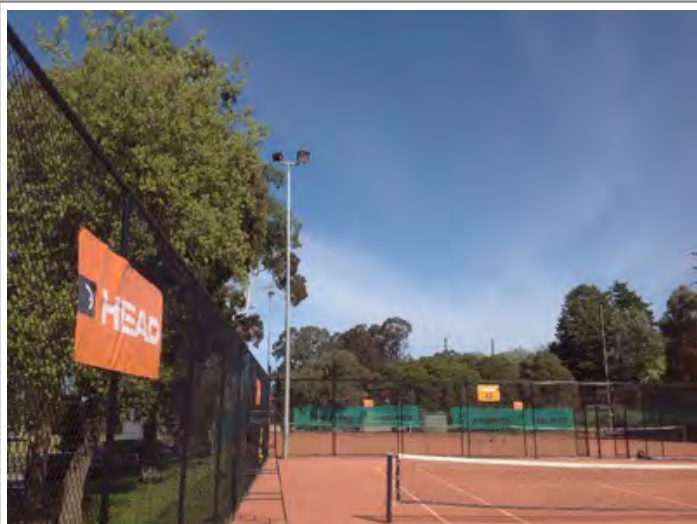
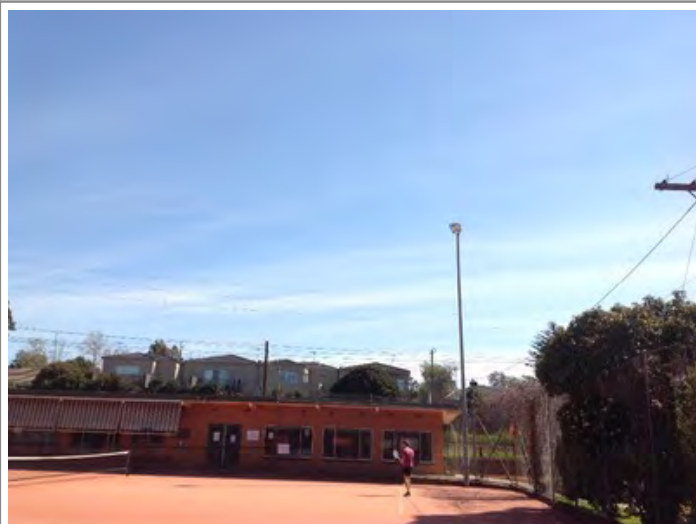
Lighting infrastructure rating	Moderate Issues/Observations: Old however in good condition - potential upgrade required
Lighting life span	10+ years
Lighting notes	Lighting is quite old and would likely not meet required lux levels for night play.

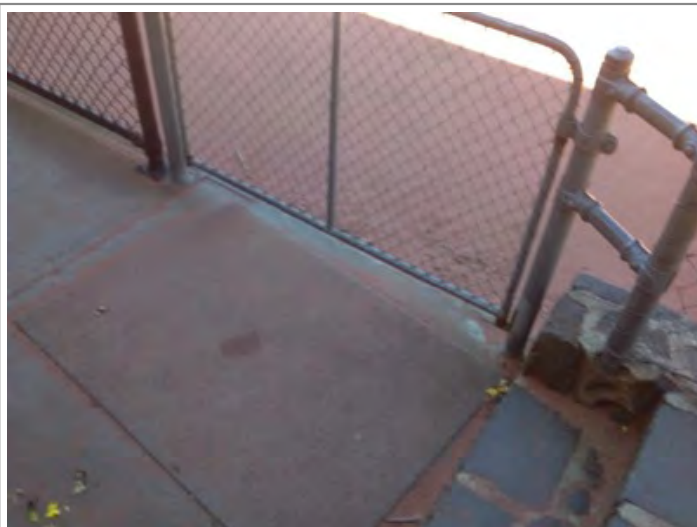
Court enclosure accessibility	Formed paths Trip hazards identified: yes Ramped access provided: no
Path material(s)	Concrete
Main gate dimensions	Accessible gate 1200mm x 2100mm
Accessibility notes	There is a step down on to the court surface.

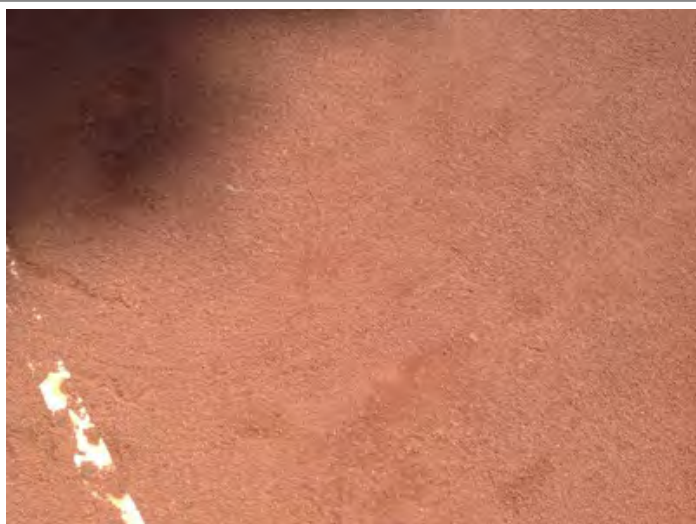
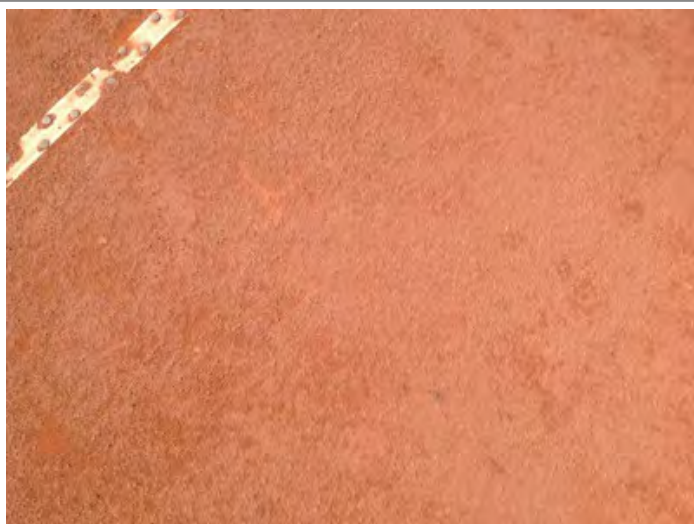
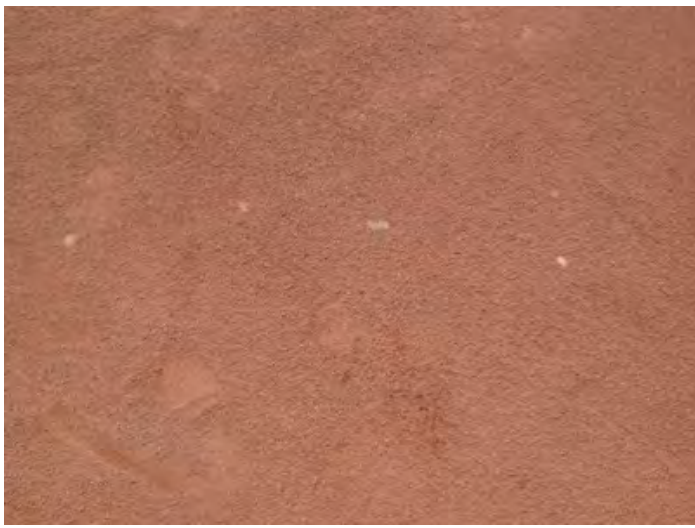
Unique court number	4
Surface condition rating	Moderate Issues/Observations: Debris present mainly around the perimeter Aged surface Excessively worn surface in high wear areas
Surface type	Red Porous
Surface life span	10+ years
Court condition notes	The surface is well worn with multiple areas of aggregate showing through the base. The top dressing is quite thin across the surface.

Are there any critical safety issues?	No
Enclosure recommendations	Plan for upgrade to court surface. Trim vegetation from fence lines. Plan for upgrade of older fences.

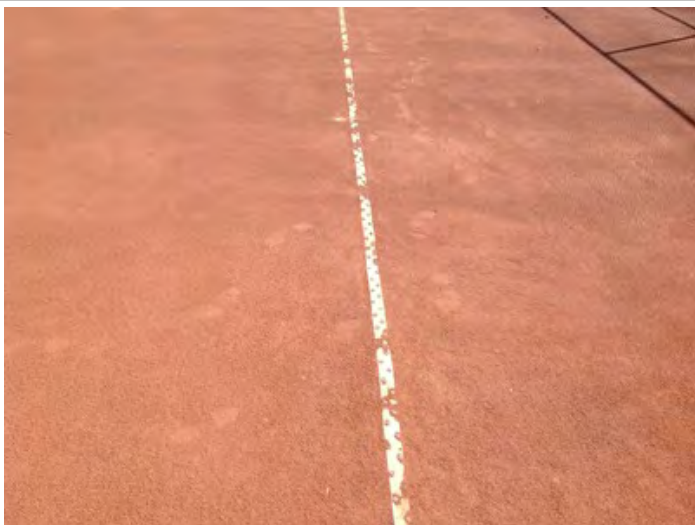
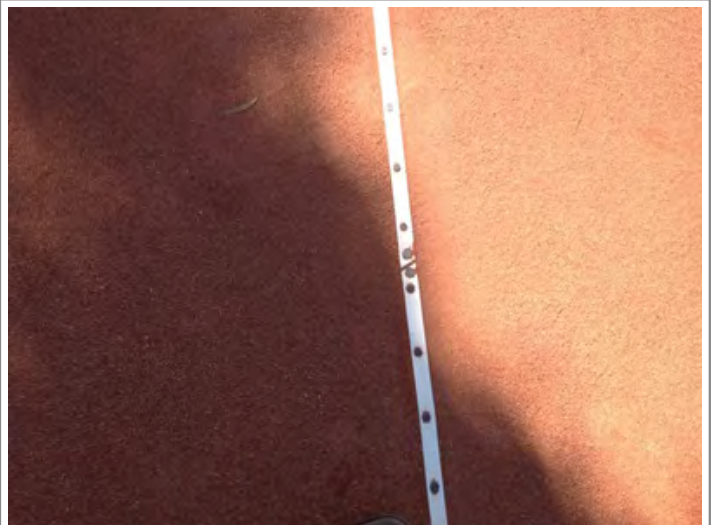
Line marking description	Tennis only lines
Line marking rating	Good Issues/Observations: Cracked Inconsistent bounce likely
Line marking condition notes	The lines are standard for this surface, with a few signs of cracks and breaks.

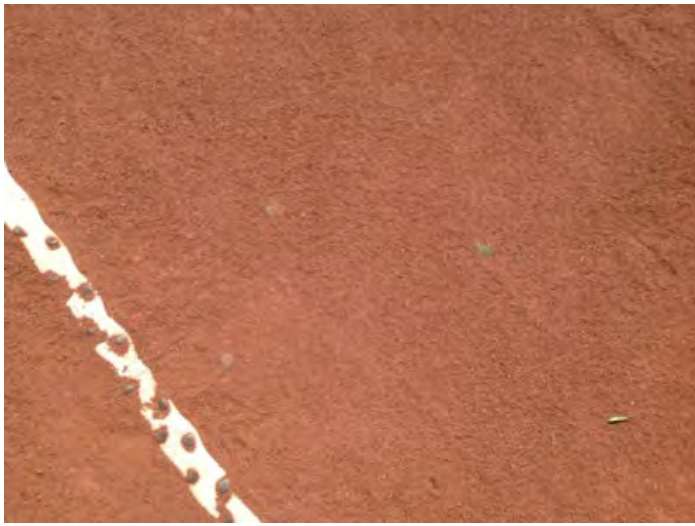
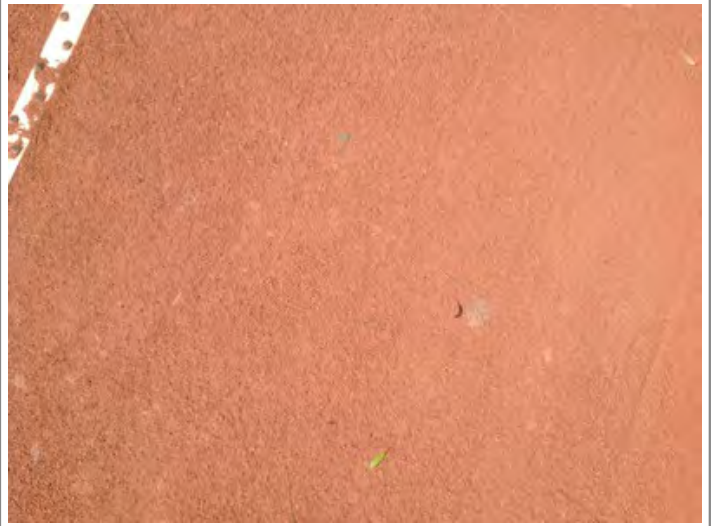
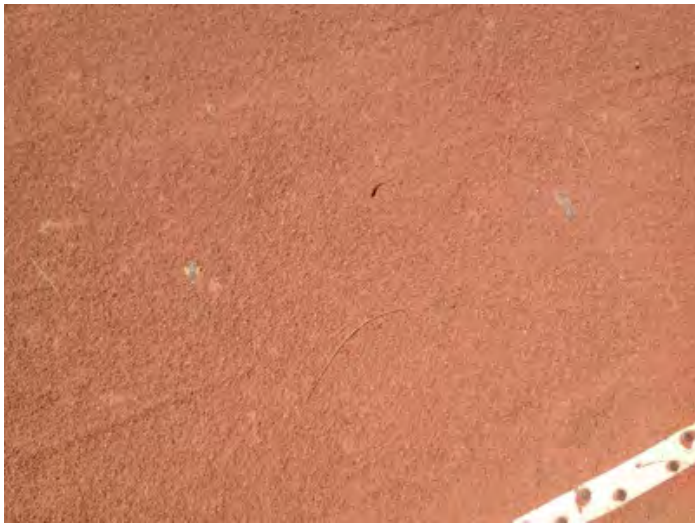
Net post life span	10+ years
Net life span	6-10 years
Net / post notes	
Net / post photos	
No photos taken	
Court compliance	
Is the court run off compliant?	no Runoffs North: 4600m South: 4800m East: 4100m West: 3500m
Could the court be made compliant?	no
Is the court to the standard dimensions?	yes
Court orientation	North-south
Are netball goal posts outside tennis court run off areas?	no
Are lockable post hole covers fitted and safe?	no
Compliance notes	The court does not meet run off requirements to the north and south behind the baselines.
Compliance photos	
No photos taken	
Courts	
Condition	
Unique court number	5
Surface condition rating	Moderate Issues/Observations: Debris present mainly around the perimeter Aged surface Excessively worn surface in high wear areas
Surface type	Red Porous
Surface life span	10+ years
Court condition notes	The surface is well worn with multiple areas of aggregate showing through the base. The top dressing is quite thin across the surface.

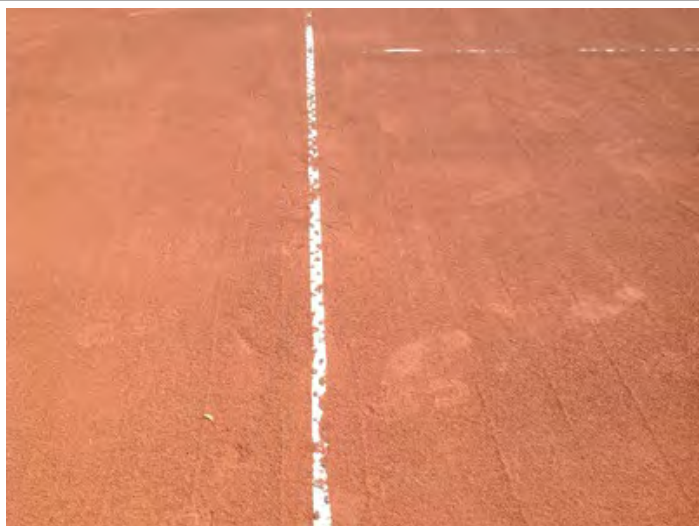
Line marking condition notes	The lines are standard for this surface, with a few signs of cracks and breaks.
-------------------------------------	---

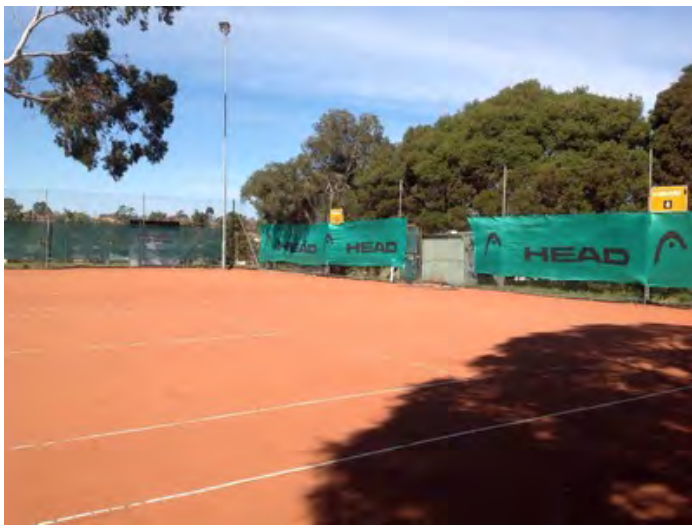
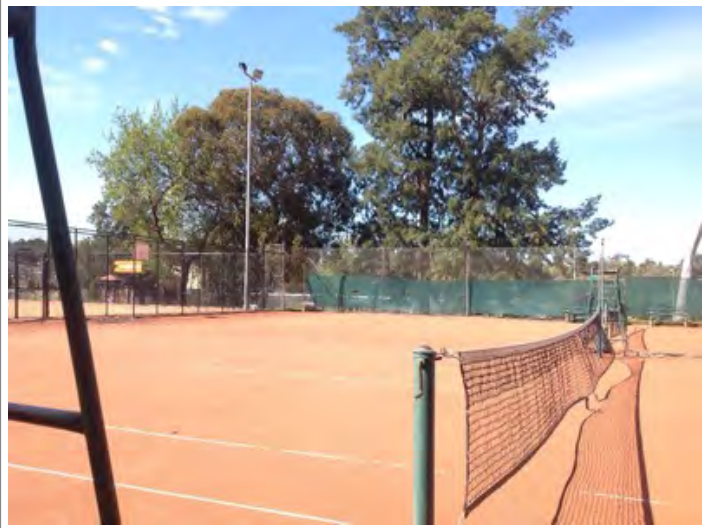
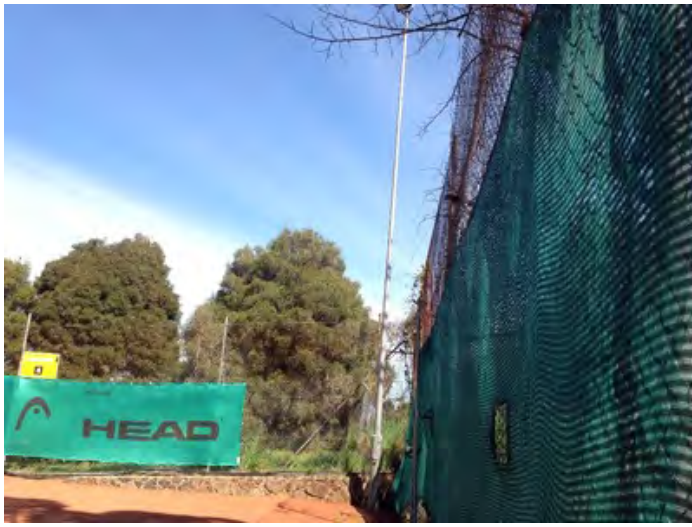
Fencing life span	10+ years
Fence notes	The eastern, western and southern fences are old with multiple issues identified. The northern fence line is quite new and in good condition.
Fencing photos	
<div></div>

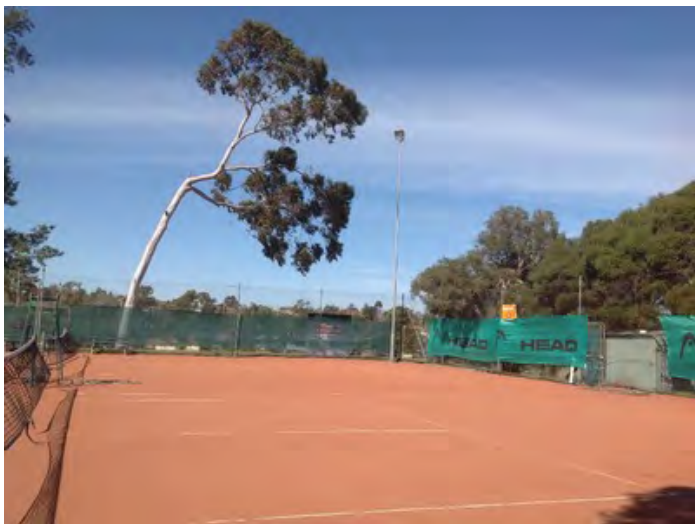
Does this enclosure have lighting	Yes
Total number of lit courts per enclosure	2
Lighting infrastructure type	High tower - Steel poles
Lighting infrastructure position	Corner
Light fittings	One per tower
Lighting infrastructure design	Standard
Lighting infrastructure rating	Moderate
	Issues/Observations: Old however in good condition - potential upgrade required
Lighting life span	10+ years
Lighting notes	Lighting is quite old and would likely not meet required lux levels for night play.
Lighting photos

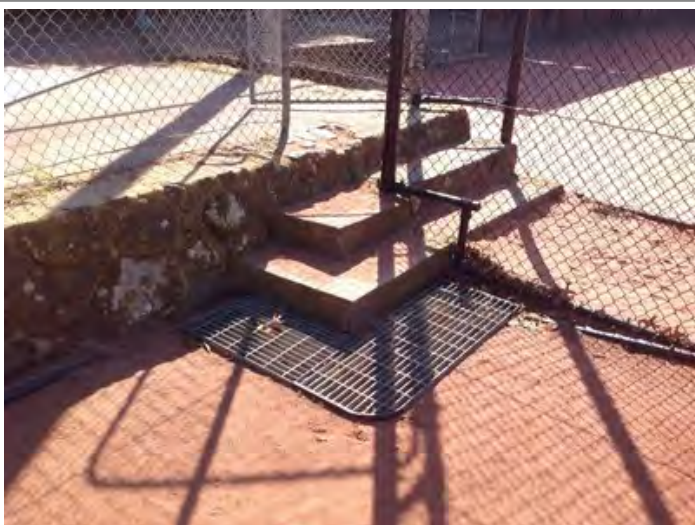
Court enclosure accessibility	Formed paths Trip hazards identified: yes Ramped access provided: no
Path material(s)	Concrete
Main gate dimensions	Accessible gate 1200mm x 2100mm
Accessibility notes	There is a set of steps down on to the court surface.

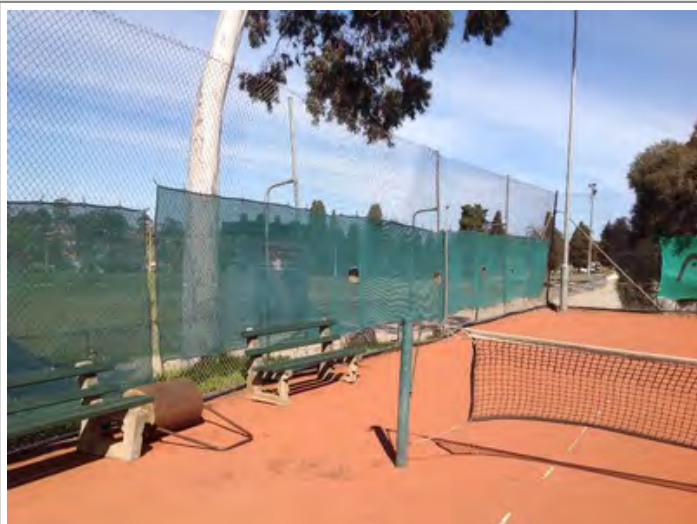
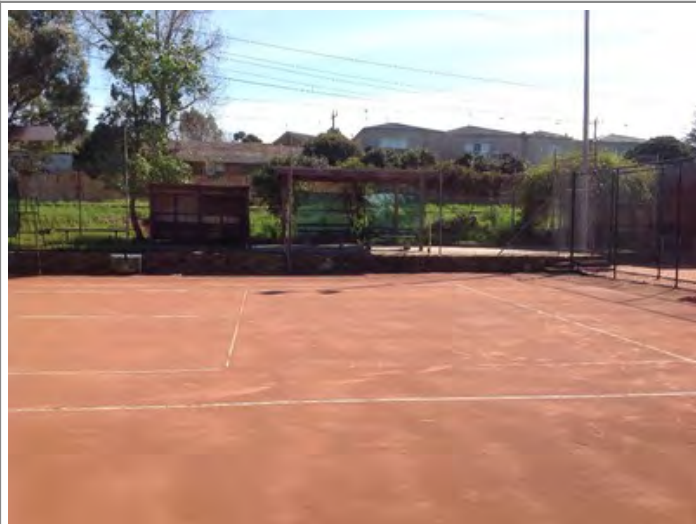
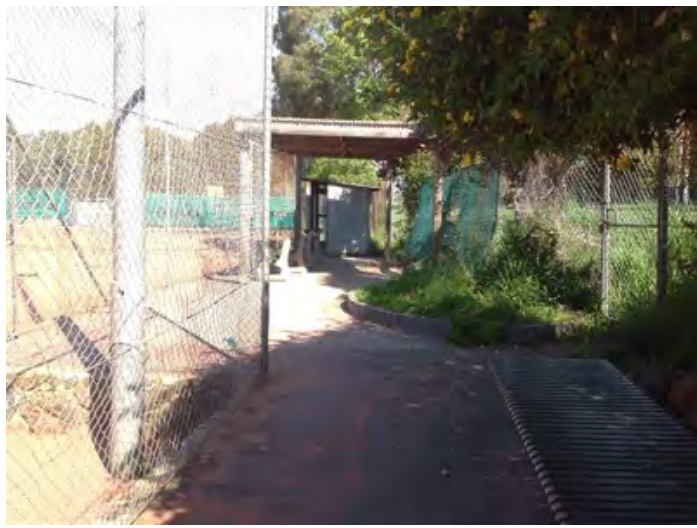
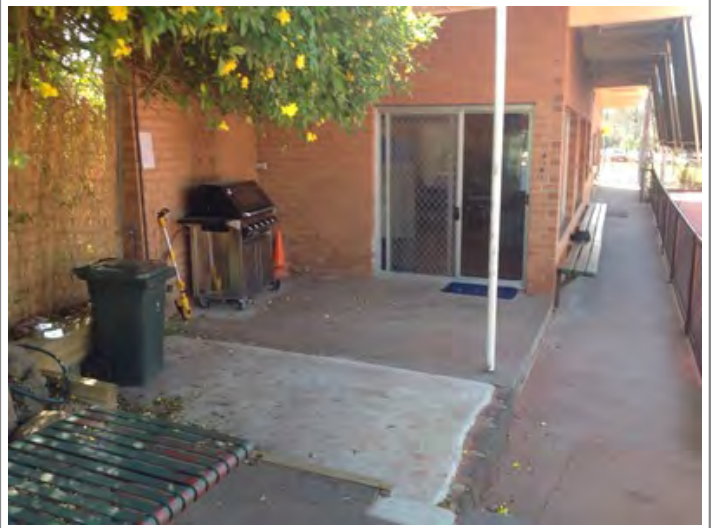
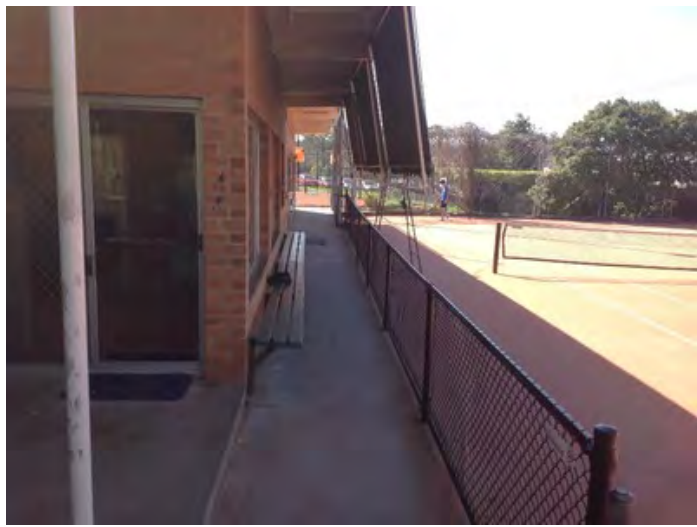
Condition of ground and court surrounds	Good
Court surround notes	Court surrounds consist of a paved area connecting the clubhouse to a bbq area and viewing shelters. A football club and train station are adjacent to the facility. The court surrounds appear to be well maintained.
Water supply	Potable
Water notes	Water pipes connect all porous courts with sprinklers which appear to water the courts
Natural Shade	Sufficient shade available within viewing range
Man made Shade	Purpose built shelter
Shade notes	
Car parking	On street: 21-40 spaces Off street: Overflow:
Does the site have any hit up walls	no
Car park notes	Car parking is near train station and was almost full at the time of inspection.
Adjacent facilities	Oval/playing field Community centre
Does the site have any potential expansion opportunities?	no

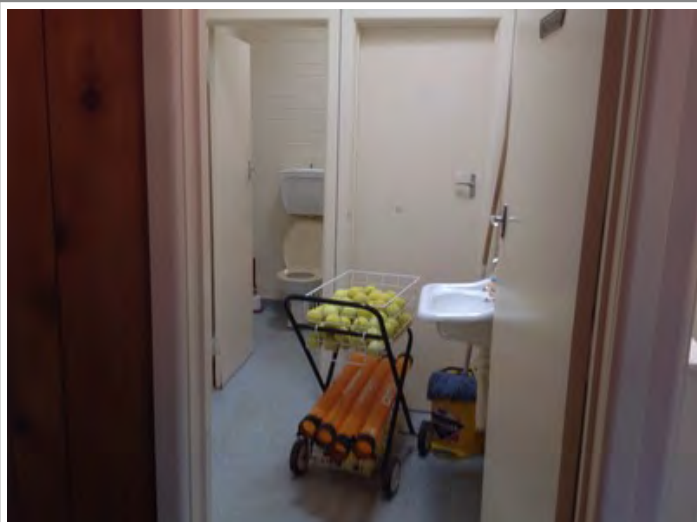
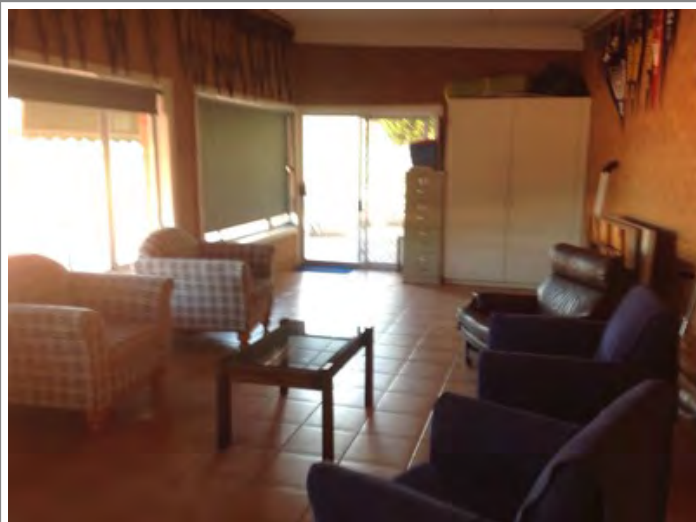
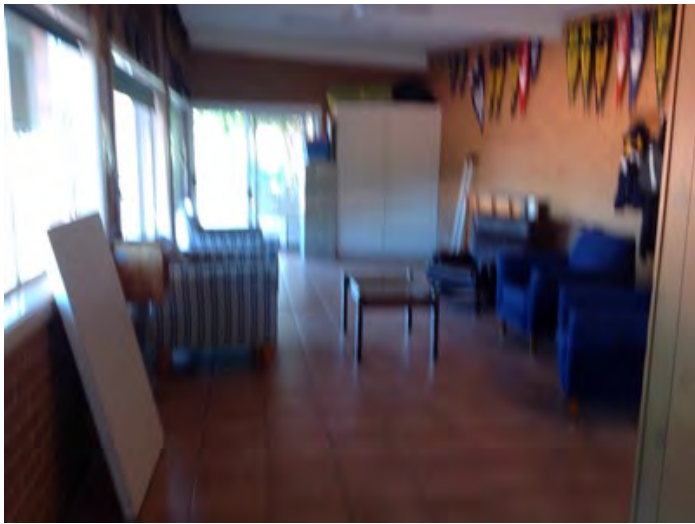
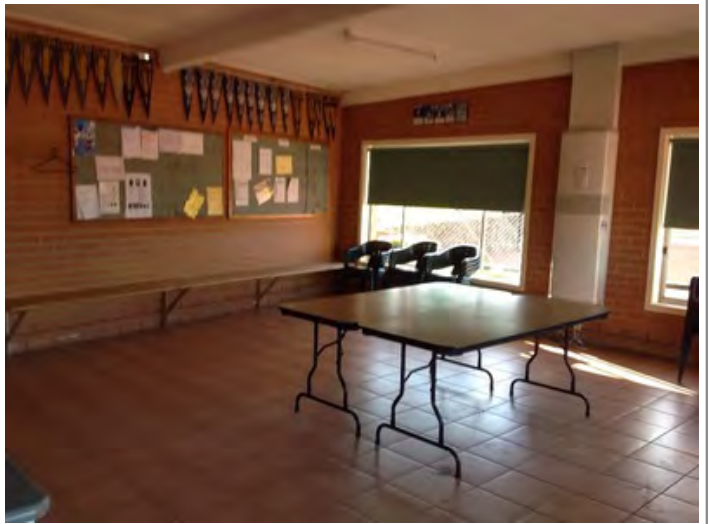
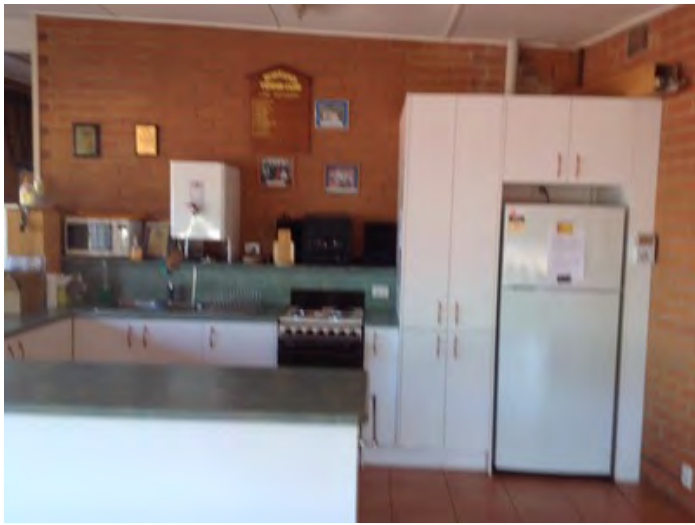
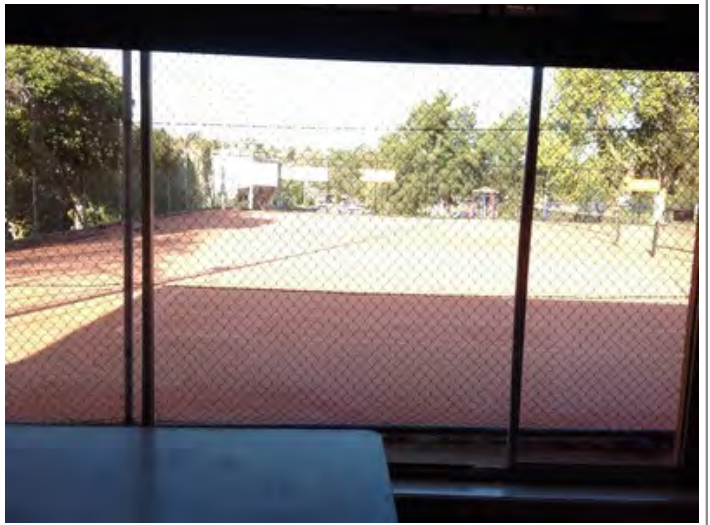
Building Condition	Good
Estimated building age	30+ years
Building materials	Brick
Accessible entry to building	no
Kitchen	
Bar	no
Player change rooms	Male: 0 Female: 0 Unisex: 0
Social area	110 m2
Social area comments	
Toilets	Male: yes Female: yes Accessible:
Clubroom condition notes	The clubhouse offers views over enclosure two and appears to be in good condition. The toilet area is small and contains coach storage which is not ideal. There is ample seating available for spectators.
Other amenities provided within or outside clubrooms	BBQ /outdoor seating area
Other amenities condition notes	
Are there any safety concerns within clubrooms?	no
