Cyril Cummins Reserve Facility Audit

Document number	000211
Client / Site	Tennis Victoria
Location	67 Liberty Parade Bellfield VIC 3081
Auditor	Andrew Sodomaco
Audit date	30 Aug 2015

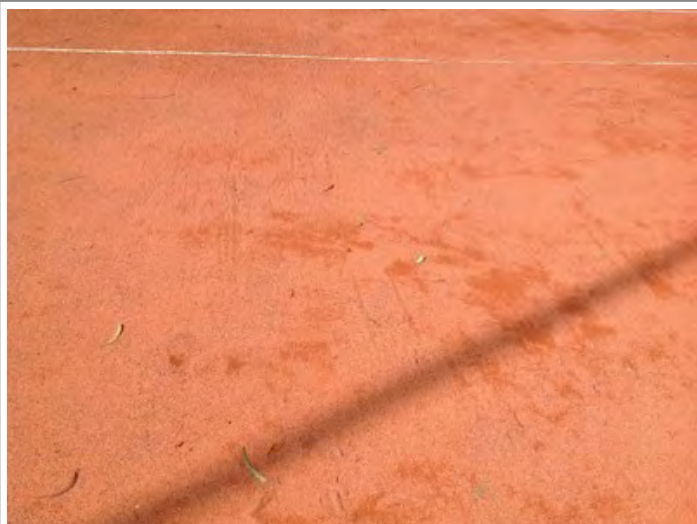
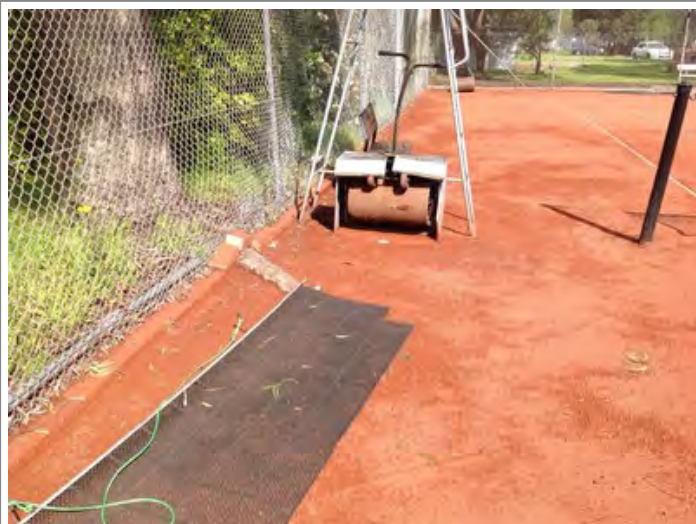
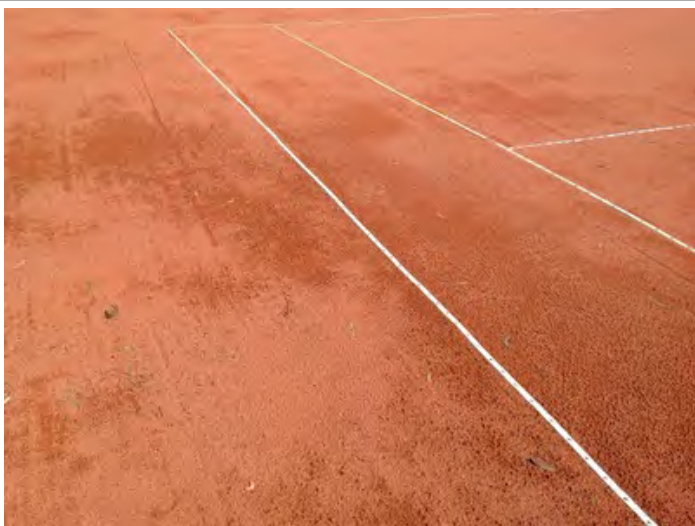
Unique court number	1
Surface condition rating	Good Issues/Observations: Leaf litter
Surface type	Red Porous
Surface life span	10+ years
Court condition notes	The surface is in good condition, although adjacent trees have resulted in quite a lot of litter throughout the court. A large tree root has invaded the court. There is a good covering of top dressing on the surface.

Classification	-
Overall Facility recommendation(s)	Replace dangerous concrete pad on court two. Trim vegetation that is growing through the fence lines. Plan for the long term refurbishment of all courts as they age and more aggregate from the court base begins to show through. Assess treatment of root invasion on court one.

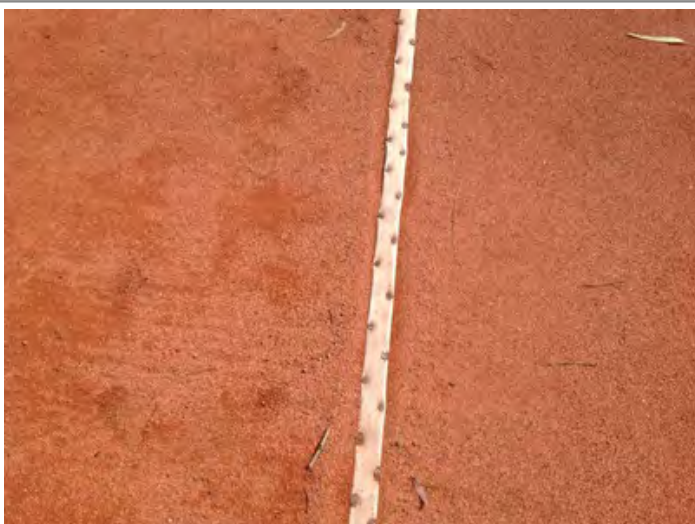
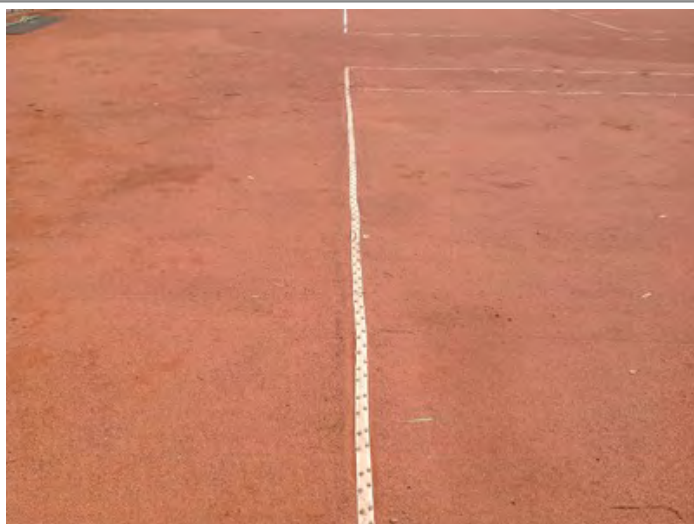
Line marking description	Tennis only lines
Line marking rating	Moderate Issues/Observations: Raised Inconsistent bounce likely Slip hazard
Line marking condition notes	The lines are standard for this surface but they are not straight in places and a little raised, posing a trip hazard.

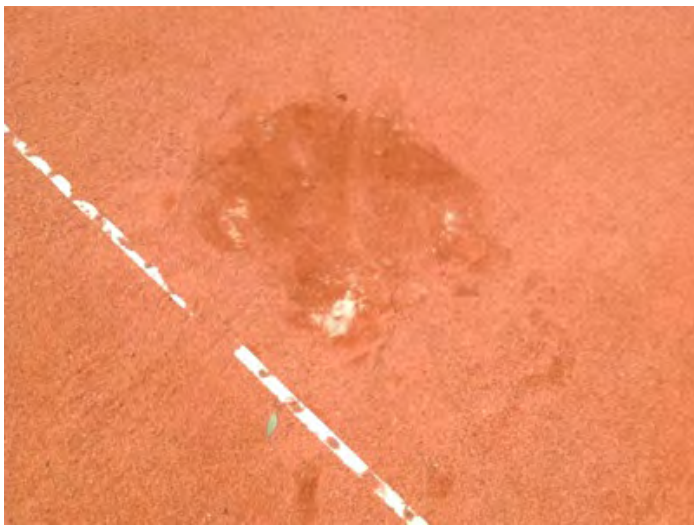
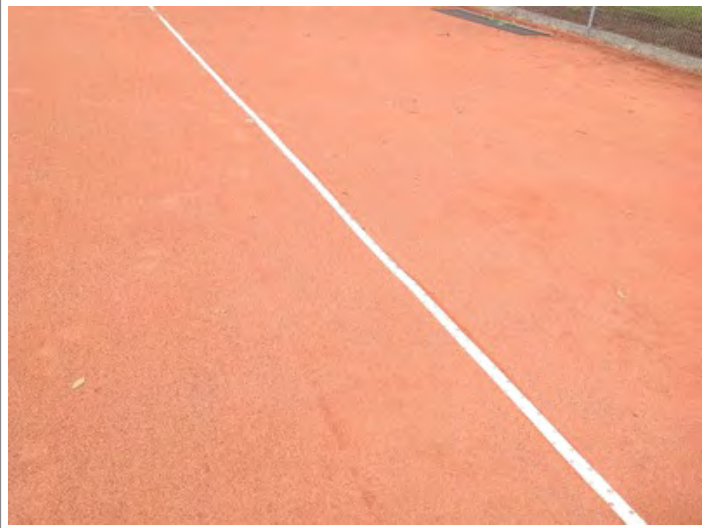
Net structure	Tethered to the posts : yes Centre strap fitted: no
Net post life span	10+ years
Net life span	6-10 years
Net / post notes	
Net / post photos	
No photos taken	
Court compliance	
Is the court run off compliant?	yes Runoffs North: 6200m South: 6200m East: 3500m West: 3600m
Could the court be made compliant?	n/a
Is the court to the standard dimensions?	yes
Court orientation	North-south
Are netball goal posts outside tennis court run off areas?	no
Are lockable post hole covers fitted and safe?	no
Compliance notes	The court is likely to be compliant to all directions, although it is borderline to the west to the adjacent court.
Compliance photos	
No photos taken	
Courts	
Condition	
Unique court number	2
Surface condition rating	Good Issues/Observations: Leaf litter
Surface type	Red Porous
Surface life span	10+ years
Court condition notes	The surface is in good condition. There is a good covering of top dressing on the surface. In the south western corner of the court is a concrete pad which presumably had been used to fill a hole. This is a significant slip hazard.

Are there any critical safety issues?	No
Enclosure recommendations	Plan for lighting upgrade. Trim vegetation from fence line. Remove concrete pad on court two and repair court so it is safe. Remove leaf litter from courts.

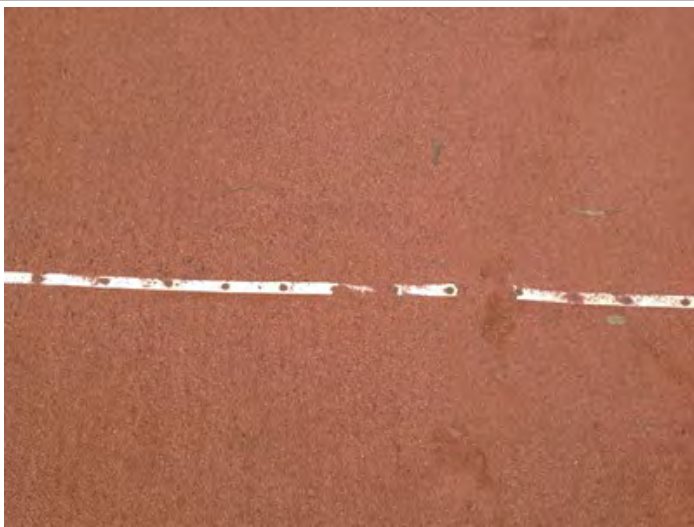
Line marking description	Tennis only lines
Line marking rating	Moderate Issues/Observations: Cracked Raised Torn Inconsistent bounce likely Slip hazard
Line marking condition notes	The lines are standard for this surface but they are not straight in places and a little raised, posing a trip hazard. In some places they have broken.

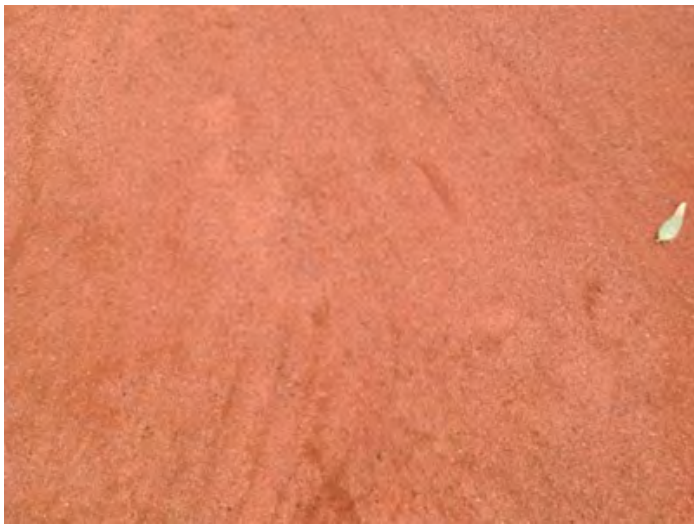
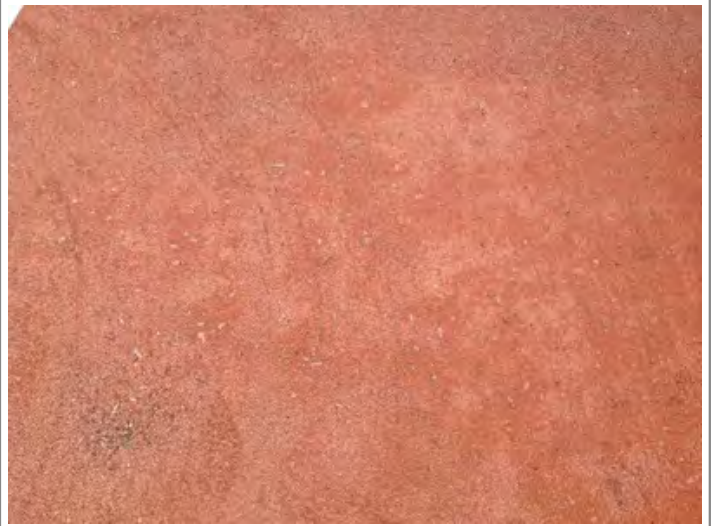
Court condition notes	The surface is in good condition. There is a good covering of top dressing on the surface. Some aggregate has begun to show through the top dressing.
Court condition photos

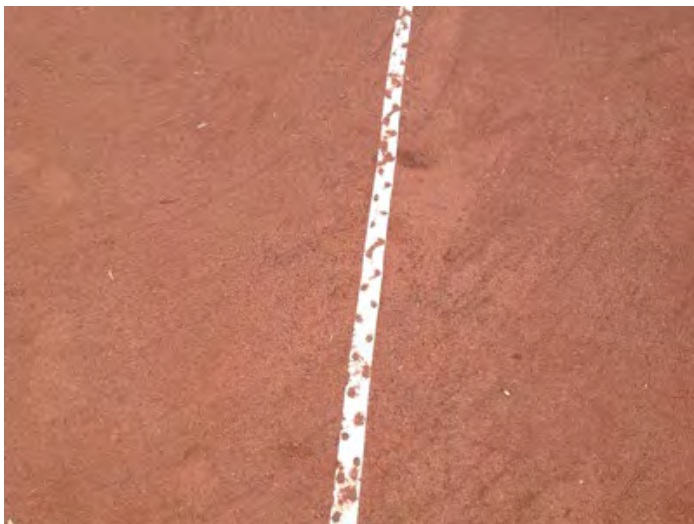
Line marking description	Tennis only lines
Line marking rating	Moderate Issues/Observations: Raised Inconsistent bounce likely Slip hazard
Line marking condition notes	The lines are standard for this surface but they are not straight in places and a little raised, posing a trip hazard.

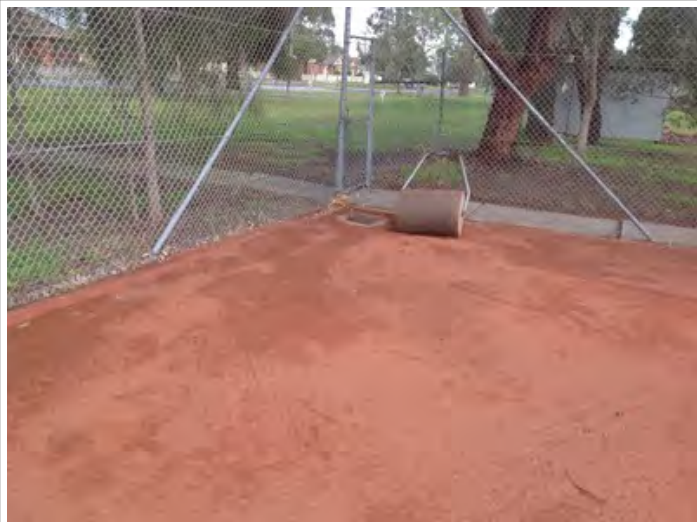
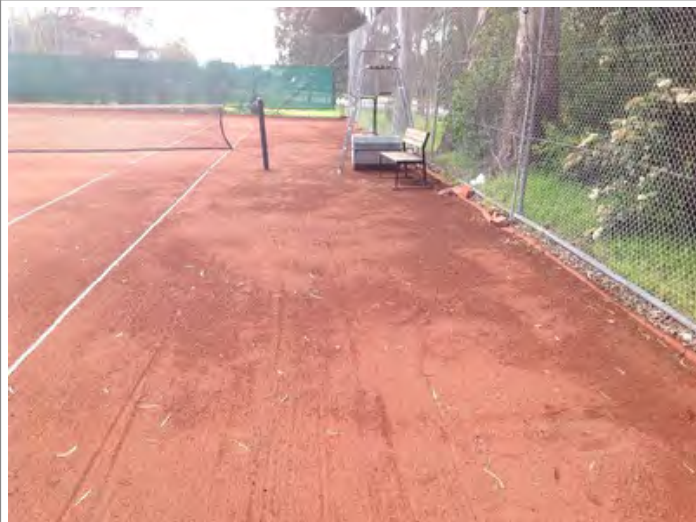
Drainage rating	Good Issues/Observations:
Drainage notes	A small grated pit is located in the south eastern corner of the enclosure. There is little sign of leaf litter build up around it, or of pooling around the enclosure. There is some dampness around the perimeter fencing of the eastern boundary, under a large block of trees.

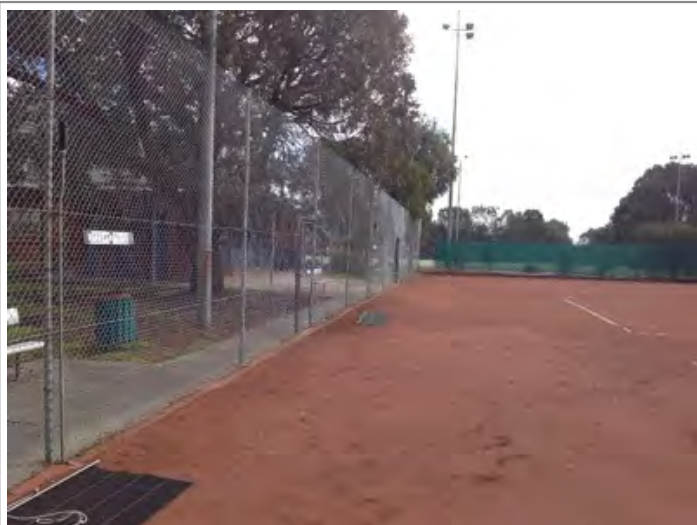
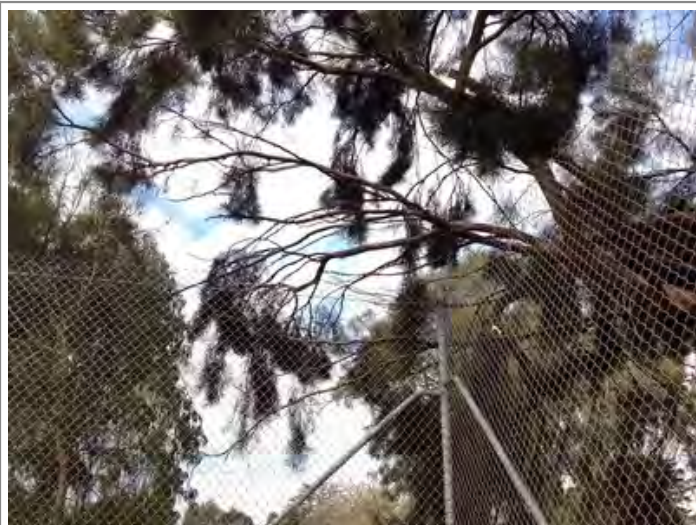
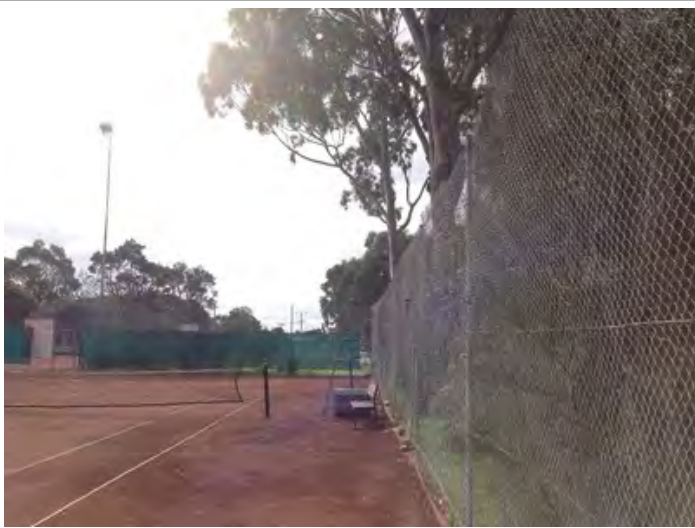
Fence type	Galvanised chain mesh
Fence Rails	Fence rail top: no Fence rail bottom: yes
Fence height	3m to 3.5m Low level side fencing installed: no
Fence attachments	Sightscreens
Fence condition rating	Moderate Issues/Observations: Slack mesh Trees overhanging enclosure Trees/shrubs growing through mesh
Fencing life span	6-10 years
Fence notes	The fence appears to be quite old but still in reasonable condition. Some trees need to be trimmed from the fence line.

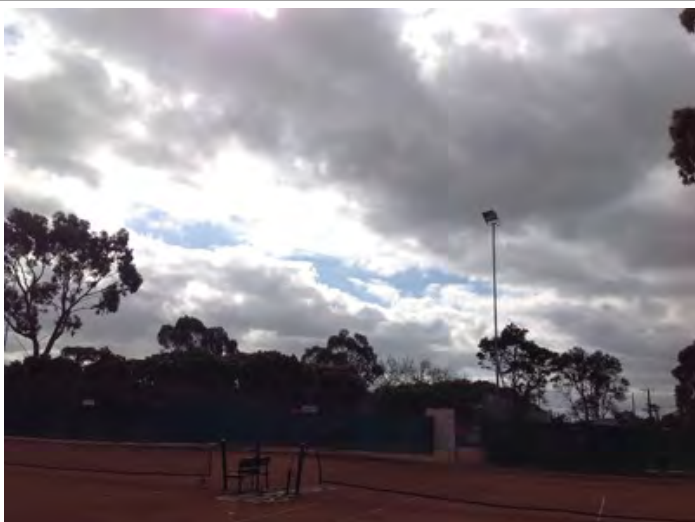
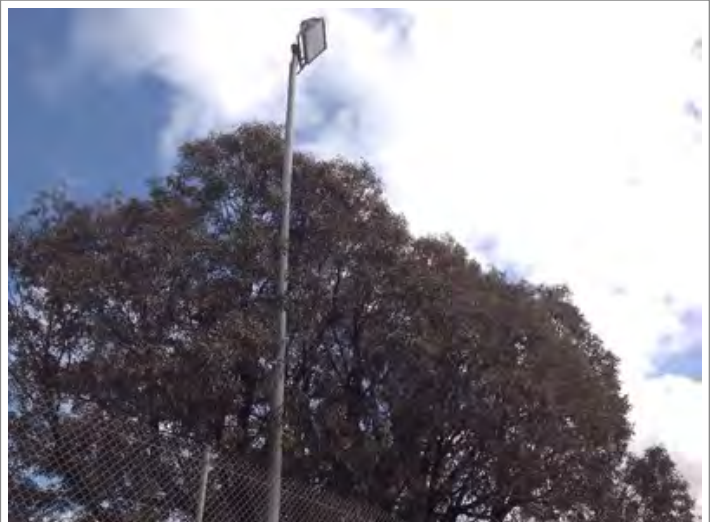
Does this enclosure have lighting	Yes
Total number of lit courts per enclosure	2
Lighting infrastructure type	Low level - Steel poles
Lighting infrastructure position	Corner
Light fittings	One per tower
Lighting infrastructure design	Non standard
Lighting infrastructure rating	Moderate Issues/Observations: Old however in good condition - potential upgrade required Infrastructure and fittings in very good condition - likely to achieve required lux standards
Lighting life span	10+ years
Lighting notes	This lighting may not reach required lux levels for night tennis and should be examined. Although likely to be inadequate, they are in otherwise good condition.

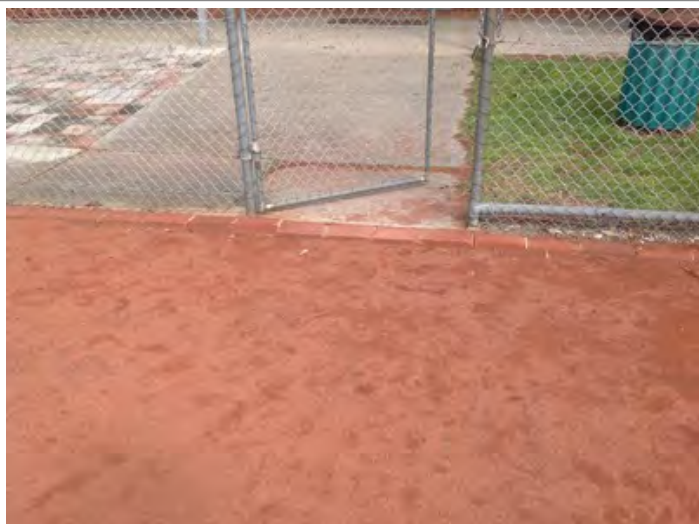
Court enclosure accessibility	Formed paths Trip hazards identified: yes Ramped access provided: no
Path material(s)	Concrete
Main gate dimensions	Standard pedestrian gate 1000mm x 2100mm
Accessibility notes	There is a small step down on to the court surface.

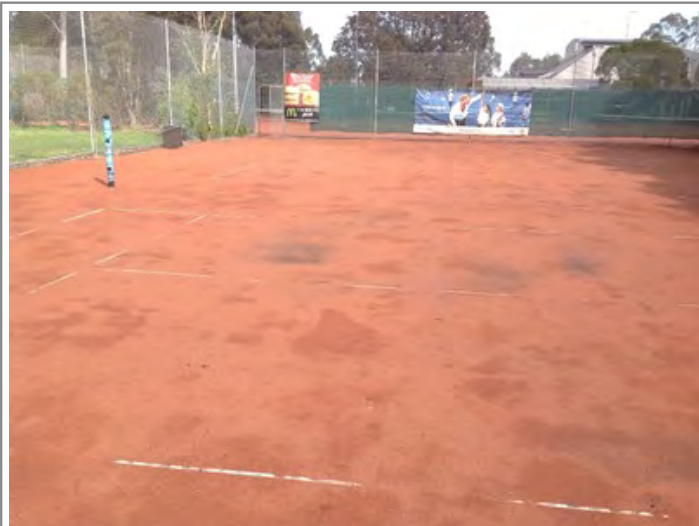
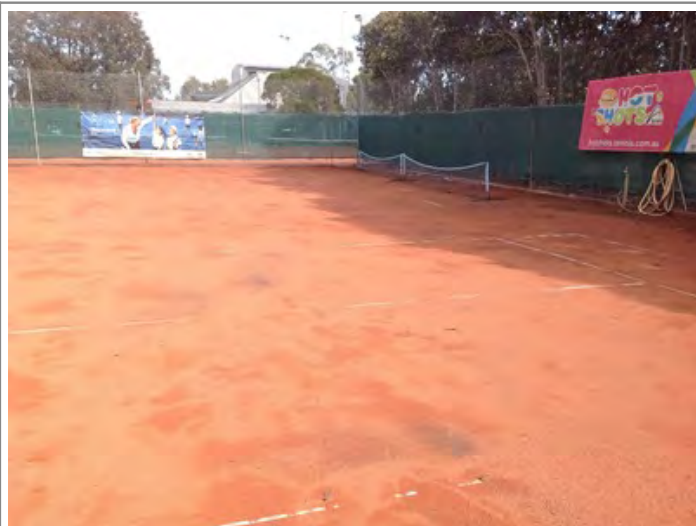
Unique court number	4
Surface condition rating	Moderate Issues/Observations: Dirt/silt on surface Aged surface Excessively worn surface in high wear areas
Surface type	Red Porous
Surface life span	10+ years
Court condition notes	This court is not a full size court but four mini hot shots courts in one enclosure. The surface does not appear to as well maintained as the other enclosure, and there is numerous patches of silt build up suggesting puddling.

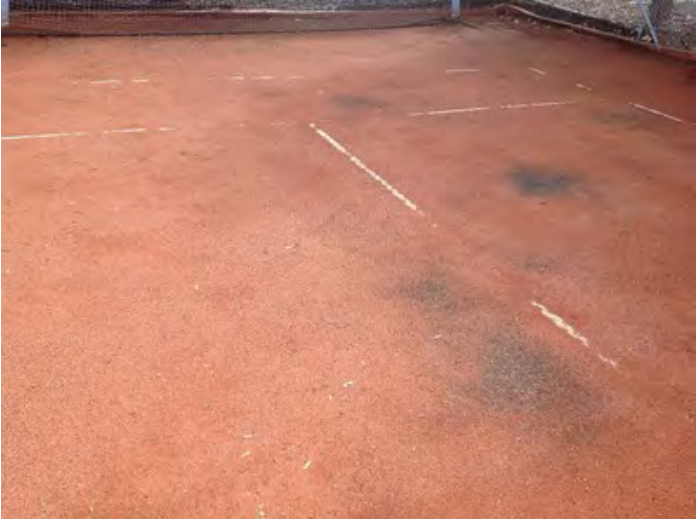
Line marking rating	Moderate
	Issues/Observations: Raised Inconsistent bounce likely Slip hazard
Line marking condition notes	The lines are standard for this surface but they are not straight in places and a little raised, posing a trip hazard. All lines for the mini courts are the same types as those for a full sized court.
Line marking condition photos

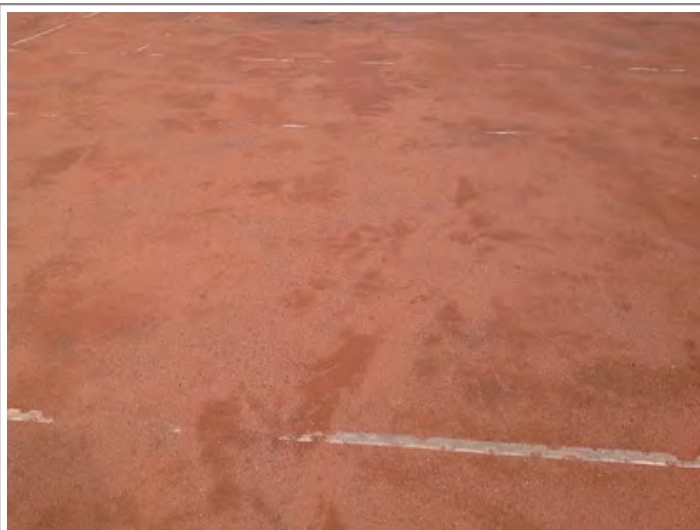
Drainage infrastructure	Unformed
What type of drainage is in place?	No drainage infrastructure
Are drains, pits or other infrastructure provided within the court enclosure?	yes
Are drains, pits or other infrastructure provided within the run-off areas?	no
Drainage rating	Poor
	Issues/Observations: Drainage infrastructure requires maintenance or repair
Drainage notes	There is no drainage infrastructure present, although the silt build up across the surface suggests what is in place is not effective.

Are there any critical safety issues?	No
Enclosure recommendations	Trim vegetation from fence line. Consider improvements to drainage infrastructure. Ensure future expenditure is consistent with the future use of the court. For example, if the court will remain for use by juniors and coaching only, some compromises can be made on quality.

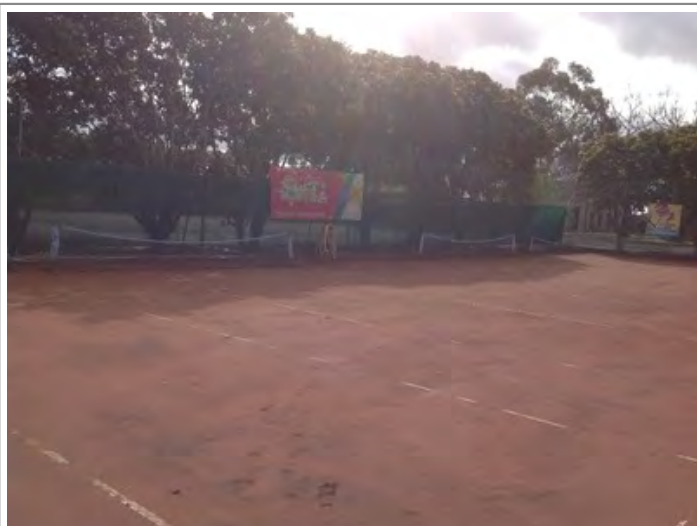
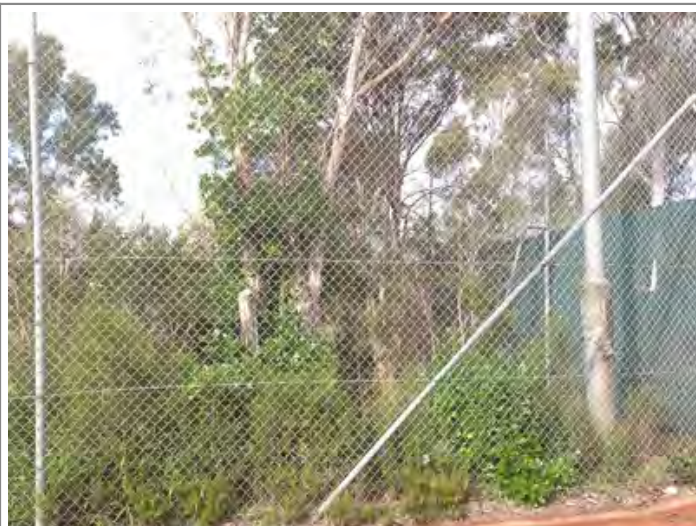
Fence Rails	Fence rail top: no Fence rail bottom: yes
Fence height	3m to 3.5m Low level side fencing installed: no
Fence attachments	Sightscreens Windbreaks Sponsor advertising
Fence condition rating	Moderate Issues/Observations: Slack mesh Trees overhanging enclosure Trees/shrubs growing through mesh
Fencing life span	6-10 years
Fence notes	The fence appears to be quite old but still in reasonable condition. Some trees need to be trimmed from the fence line.

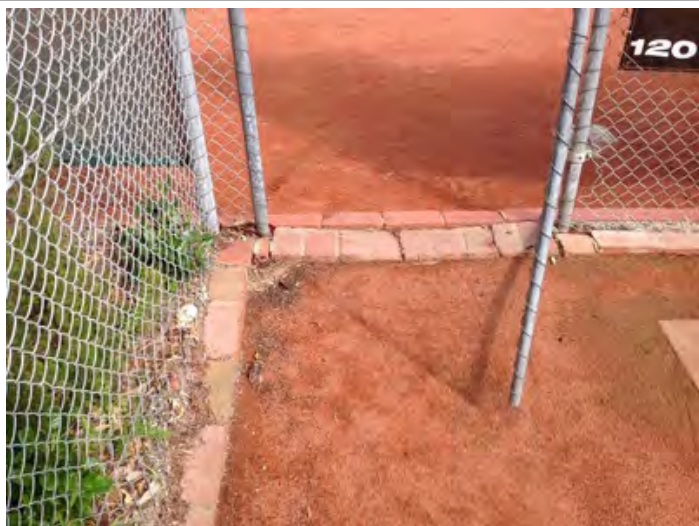
Court enclosure accessibility	Unformed paths Trip hazards identified: yes Ramped access provided: no
Path material(s)	Other material?
Main gate dimensions	Standard pedestrian gate 1000mm x 2100mm
Accessibility notes	Users are required to step over bricks to access the enclosure from enclosure one.

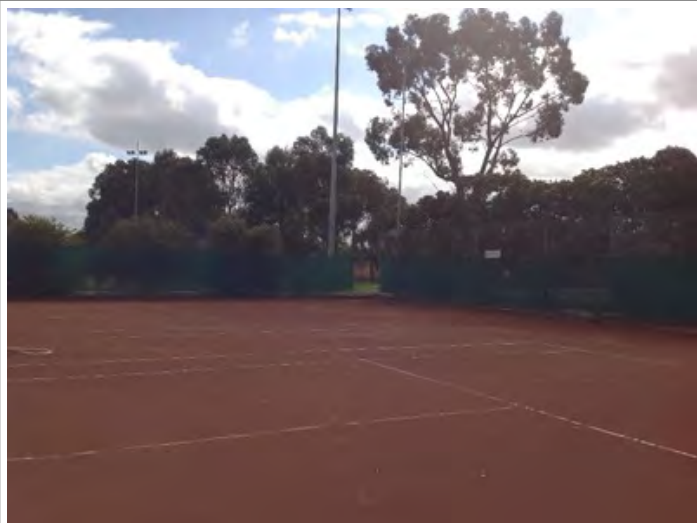
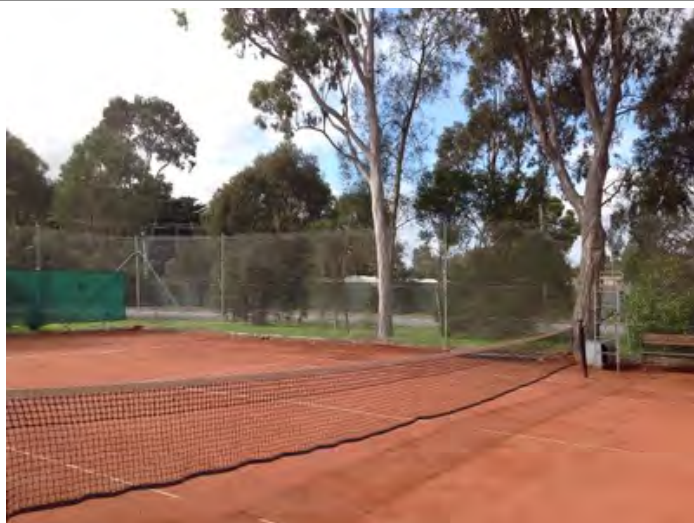
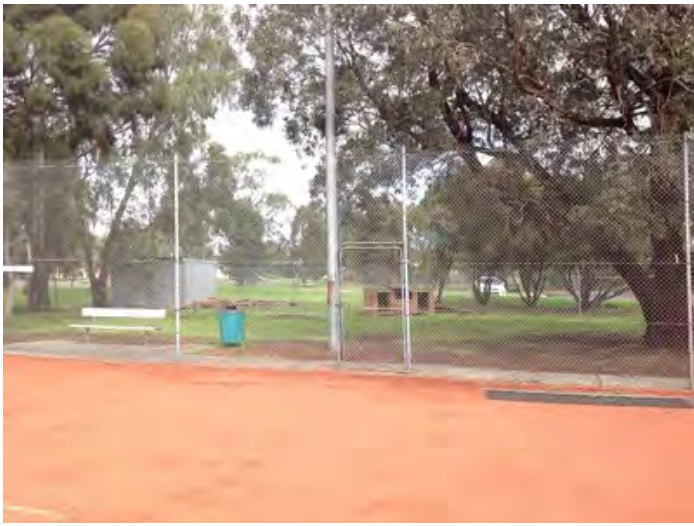
Condition of ground and court surrounds	Moderate
Court surround notes	Banks of trees and grassed areas are located around the court enclosures. Seating is offered adjacent to enclosure one. A hockey club is located to the west of the facility.
Water supply	Potable
Water notes	
Natural Shade	Sufficient shade available within viewing range
Man made Shade	Clubhouse veranda
Shade notes	
Car parking	On street: Off street: 41-60 spaces Overflow:
Does the site have any hit up walls	no
Car park notes	The car park is shared with the hockey club adjacent.
Adjacent facilities	Other sports facility
Does the site have any potential expansion oppotunities?	no

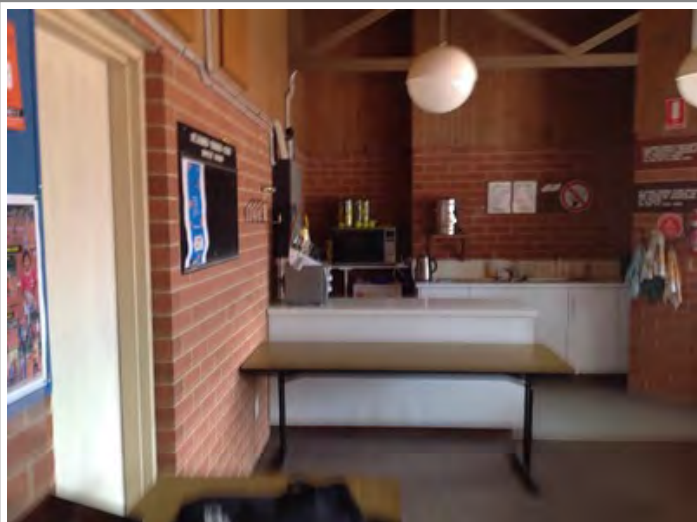
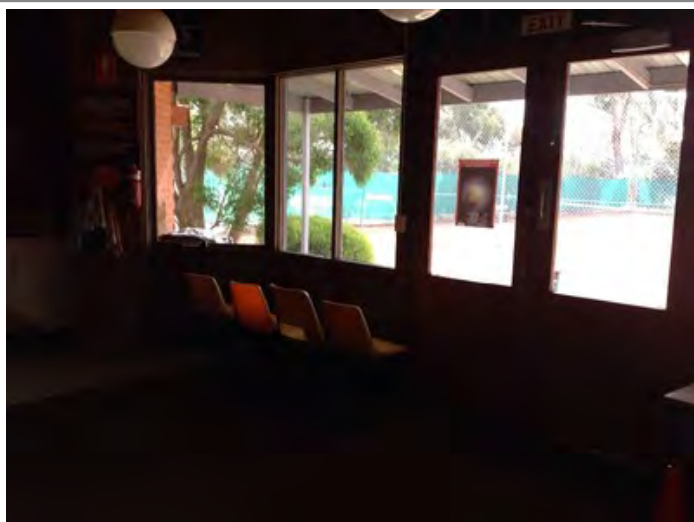
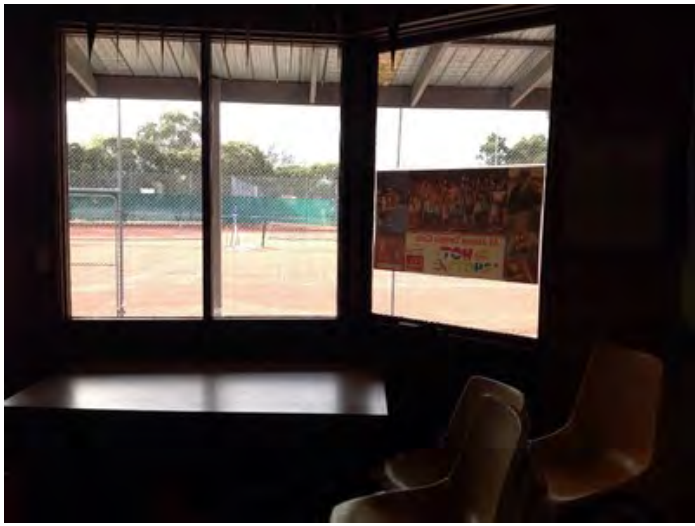
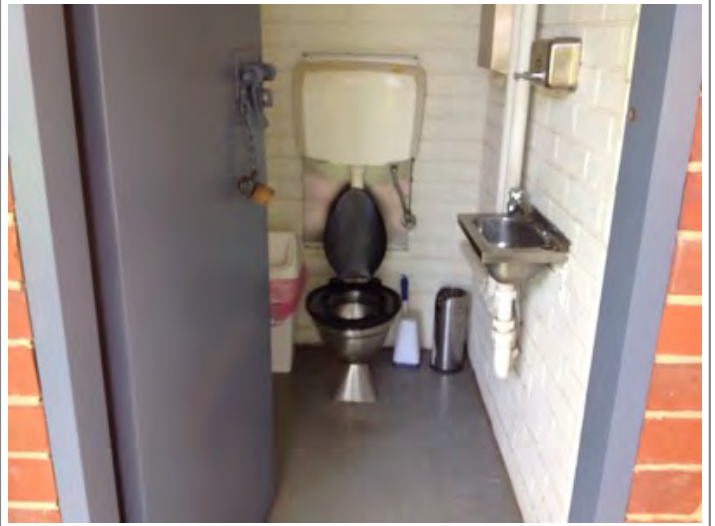
Building Condition	Good
Estimated building age	30+ years
Building materials	Brick
Accessible entry to building	yes
Kitchen	Standard
Bar	no
Player change rooms	Male: 0 Female: 0 Unisex: 0
Social area	33 m2
Social area comments	
Toilets	Male: yes Female: yes Accessible: no
Clubroom condition notes	The clubhouse is a simple area with a kitchen and viewing areas of the courts. Toilets are accessible from the outside, although can be accessed by walking under the verandah.
Other amenities provided within or outside clubrooms	BBQ /outdoor seating area
Other amenities condition notes	
Are there any safety concerns within clubrooms?	no
