## Chelsworth Park Facility Audit

Document number	000210
Client / Site	Tennis Victoria
Location	130 The Boulevard Ivanhoe VIC 3079
Auditor	Andrew Sodomaco
Audit date	30 Aug 2015

Site summary	
Total number of enclosures	2
Total number of courts	7
Total number of floodlit courts	2
Total number of enclosed mini courts	0
Hierarchy	Local

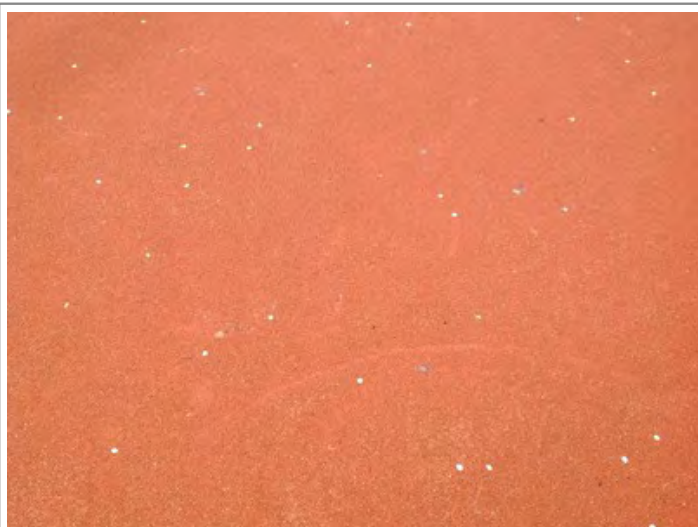
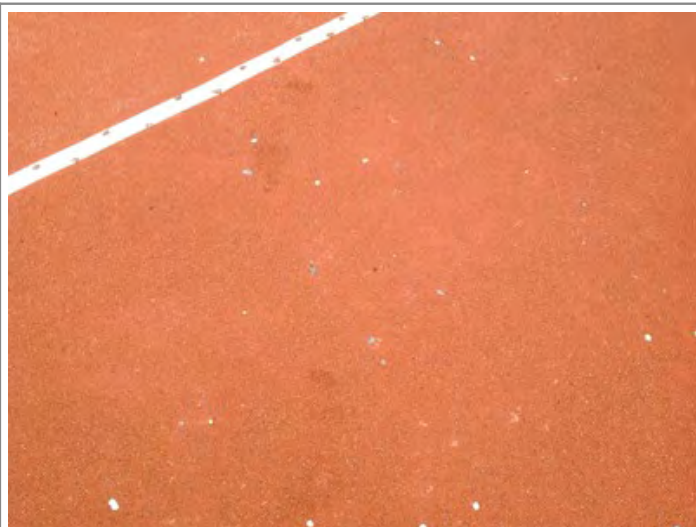
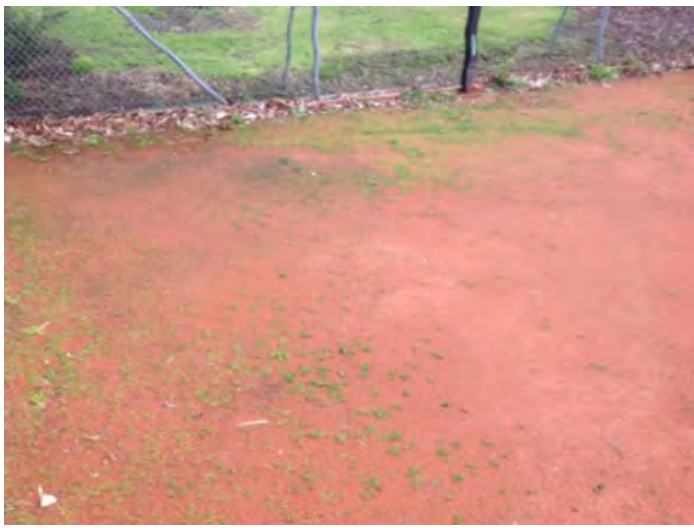
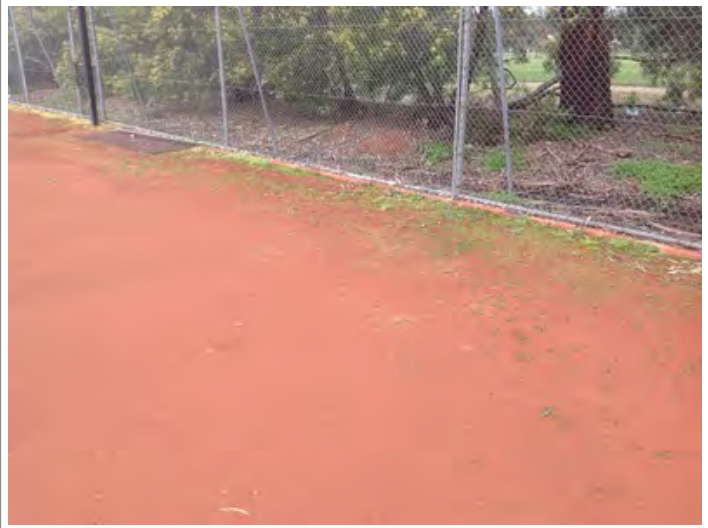
Unique court number	1
Surface condition rating	Poor  <b>Issues/Observations:</b> Leaf litter Minor ponding evident Algae Weed growth Aged surface
Surface type	Red Porous
Surface life span	2-3 years
Court condition notes	This court is the western most of the enclosure. There is extensive areas of weed growth throughout the court and the aggregate base is showing through in a number of places. Blossom from an adjacent tree is spread across the court.

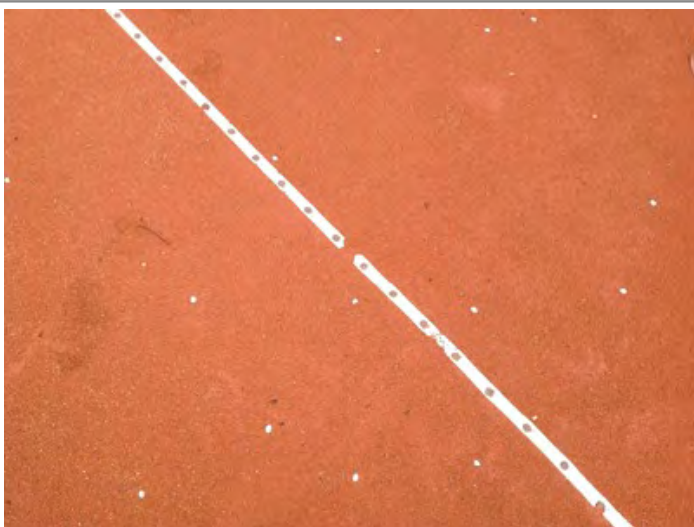
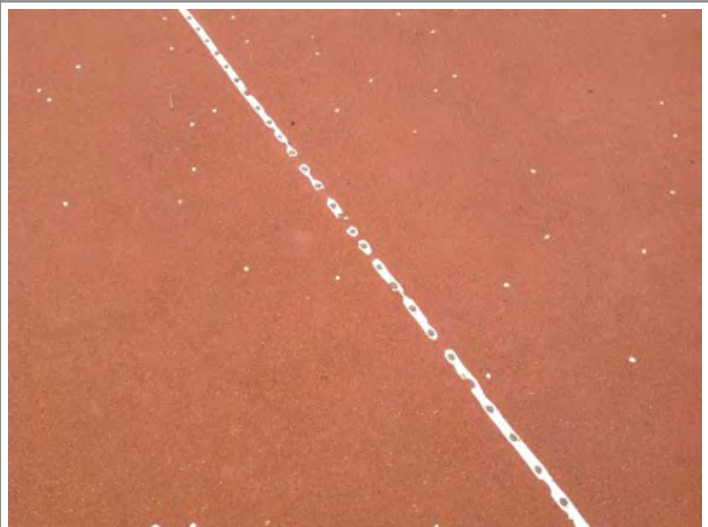
Line marking description	Tennis only lines
Line marking rating	Moderate  <b>Issues/Observations:</b> Cracked Raised Inconsistent bounce likely
Line marking condition notes	The lines are standard for this court surface but are aged, cracked and have broken completely in places.

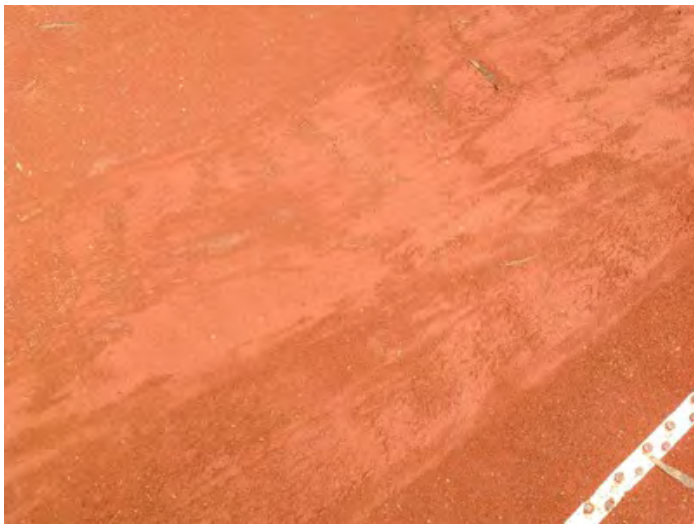
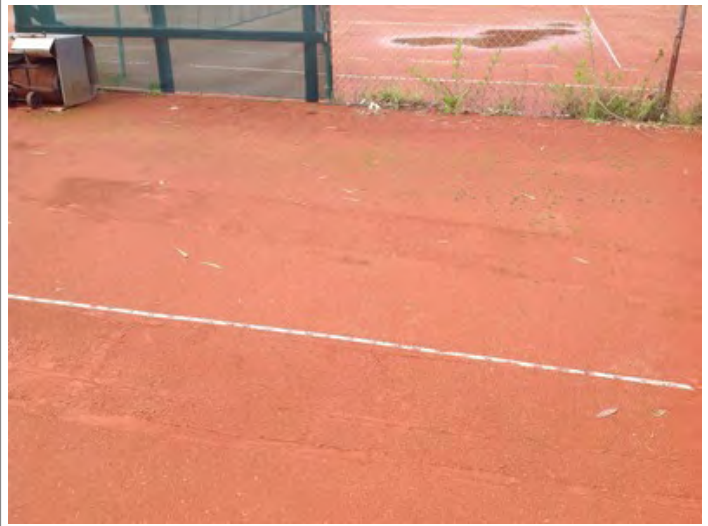
Net structure	Tethered to the posts : yes Centre strap fitted: no
Net post life span	6-10 years
Net life span	4-5 years
Net / post notes	
Net / post photos	
No photos taken	
Court compliance	
Is the court run off compliant?	no  <b>Runoffs</b> North: 5100m South: 5500m East: 4000m West: 3400m
Could the court be made compliant?	no
Is the court to the standard dimensions?	yes
Court orientation	North-south
Are netball goal posts outside tennis court run off areas?	no
Are lockable post hole covers fitted and safe?	no
Compliance notes	The court is not run off compliant to the north behind the baseline.
Compliance photos	
No photos taken	
Courts	
Condition	
Unique court number	2
Surface condition rating	Poor  <b>Issues/Observations:</b> Leaf litter Minor ponding evident Algae Weed growth Aged surface
Surface type	Red Porous
Surface life span	4-5 years
Court condition notes	This court is in better condition than court one, with less weed growth across the surface. There is aggregate showing through from the court base and leaf litter present on the court.

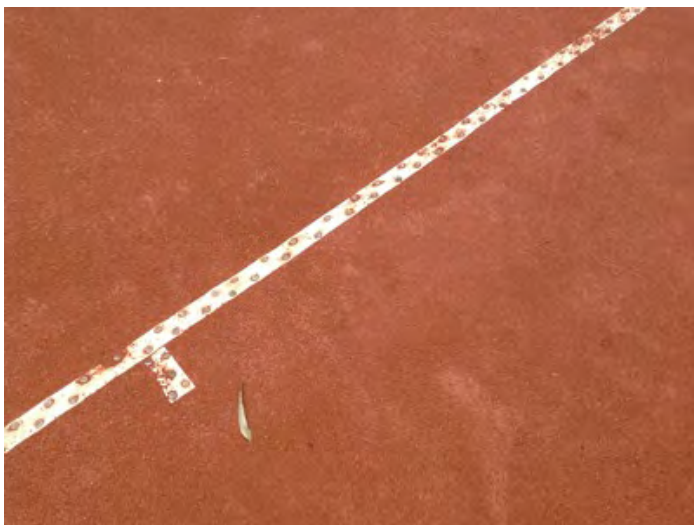
Line marking description	Tennis only lines
Line marking rating	Moderate  <b>Issues/Observations:</b> Cracked Raised
Line marking condition notes	The lines are standard for this court surface and there are no obvious signs of cracking.

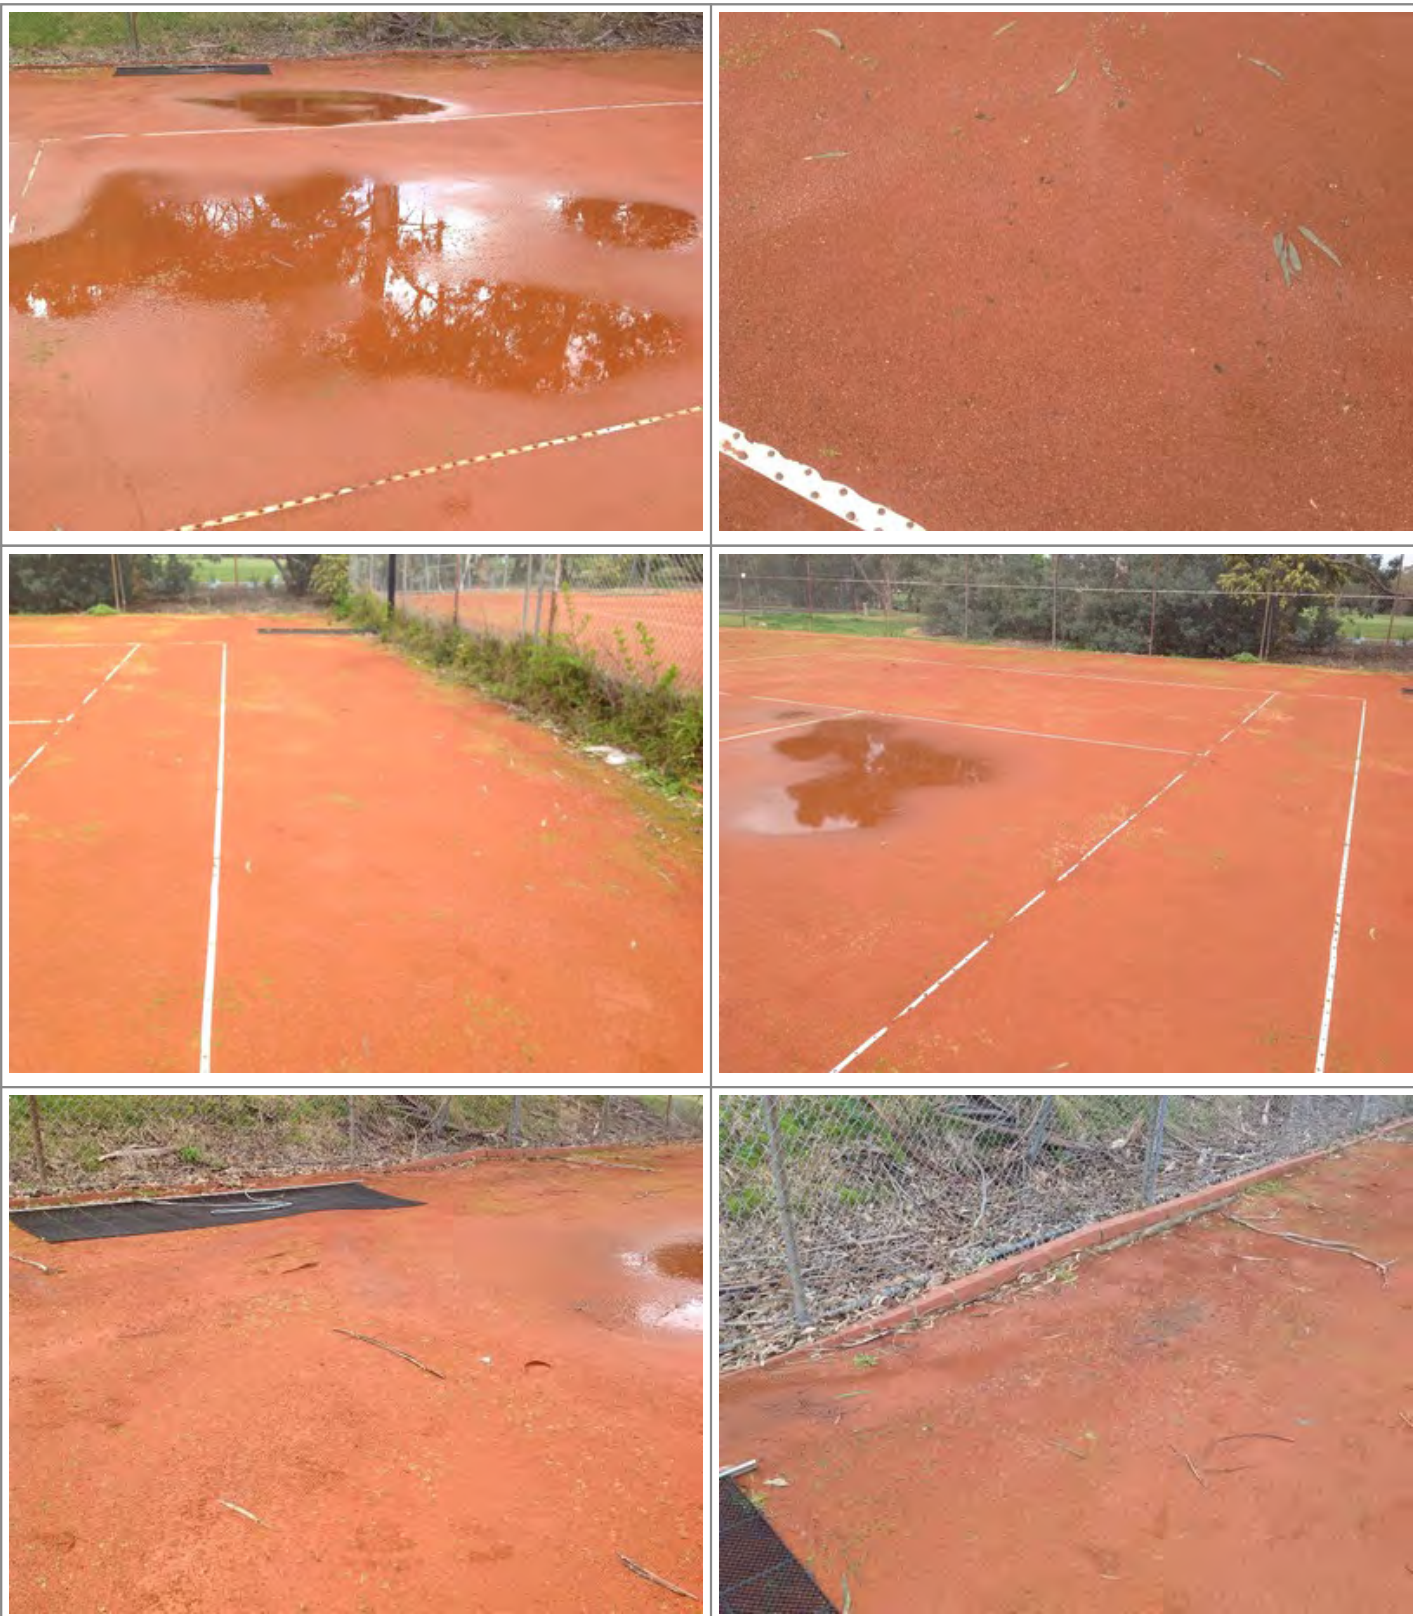
Net structure	Tethered to the posts : no Centre strap fitted: no
Net post life span	6-10 years
Net life span	4-5 years
Net / post notes	
Net / post photos	
No photos taken	
<b>Court compliance</b>	
Is the court run off compliant?	no  <b>Runoffs</b> North: 5400m South: 5200m East: 3900m West: 4400m
Could the court be made compliant?	no
Is the court to the standard dimensions?	yes
Court orientation	North-south
Are netball goal posts outside tennis court run off areas?	no
Are lockable post hole covers fitted and safe?	no
Compliance notes	The court is not run off compliant behind the north and south baselines.
Compliance photos	
No photos taken	
<b>Courts</b>	
<b>Condition</b>	
Unique court number	3
Surface condition rating	Poor  <b>Issues/Observations:</b> Leaf litter Minor ponding evident Poor drainage Algae Weed growth Aged surface
Surface type	Red Porous
Surface life span	2-3 years
Court condition notes	There is extensive areas of weed growth throughout the court and the aggregate base is showing through in a number of places. Extensive puddling is also evident on this court. Tree roots have significantly invaded the northern end of the court.

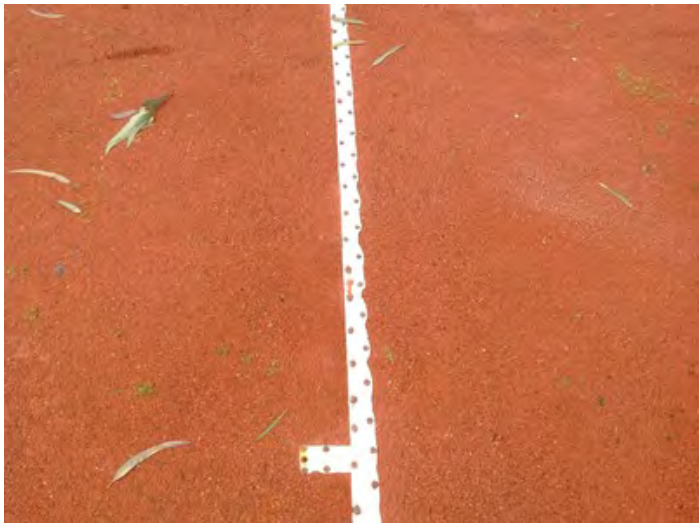
Line marking rating	Moderate
	<b>Issues/Observations:</b> Cracked Raised Inconsistent bounce likely
Line marking condition notes	The lines are standard for this court surface but are aged and cracked in places.
Line marking condition photos

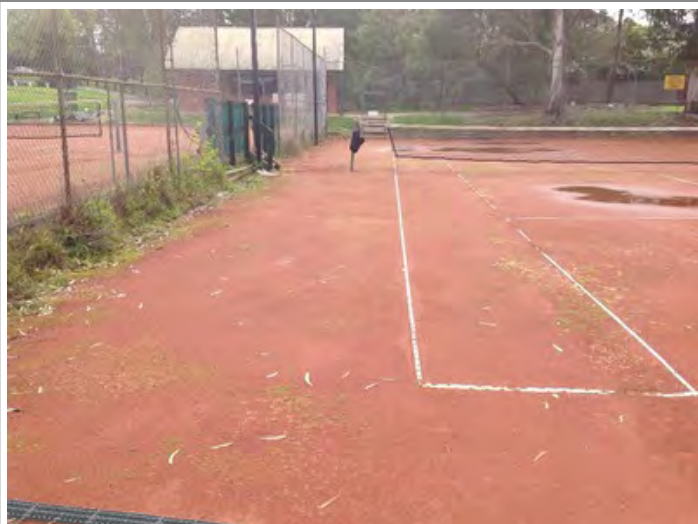
Could the court be made compliant?	yes
Is the court to the standard dimensions?	yes
Court orientation	North-south
Are netball goal posts outside tennis court run off areas?	no
Are lockable post hole covers fitted and safe?	no
Compliance notes	The court is not run off compliant to the north behind the baseline and also to the south and west to the light poles.

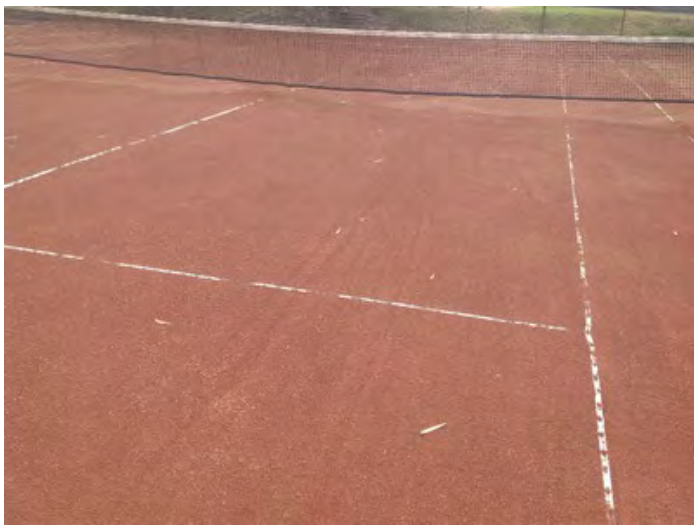
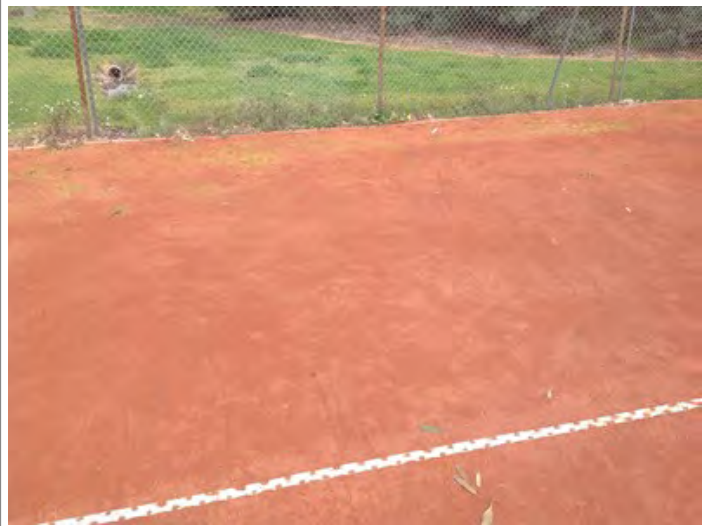
Unique court number	4
Surface condition rating	Poor  <b>Issues/Observations:</b> Leaf litter Minor ponding evident Algae Weed growth Aged surface
Surface type	Red Porous
Surface life span	4-5 years
Court condition notes	The court is the eastern most of the enclosure. There is extensive areas of weed growth throughout the court and the aggregate base is showing through in a number of places.

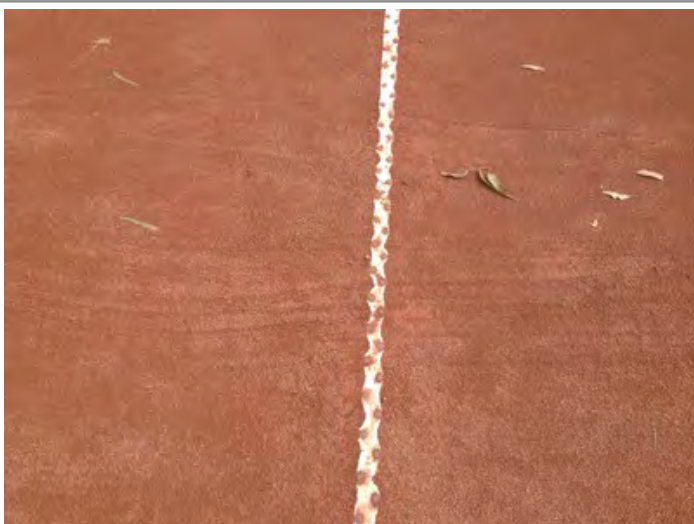
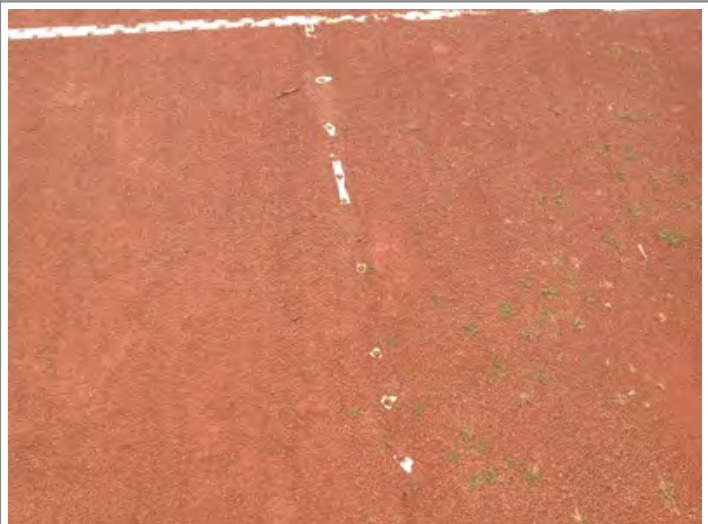
Line marking description	Tennis only lines
Line marking rating	Moderate  <b>Issues/Observations:</b> Cracked Raised Inconsistent bounce likely
Line marking condition notes	The lines are standard for this court surface but are aged, cracked and have broken completely in places.

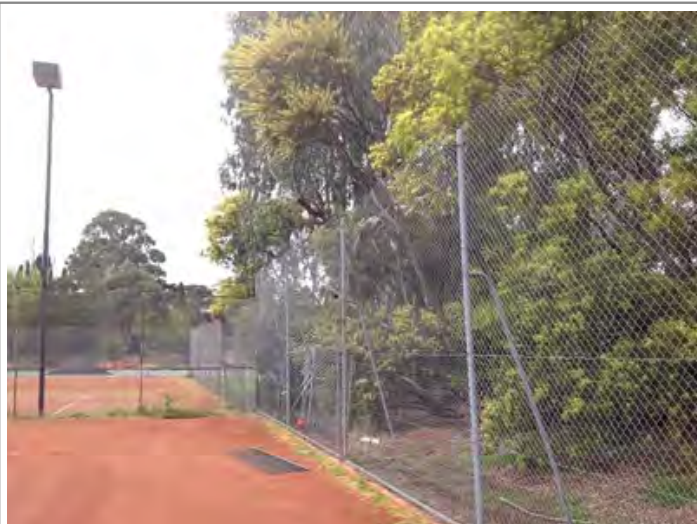
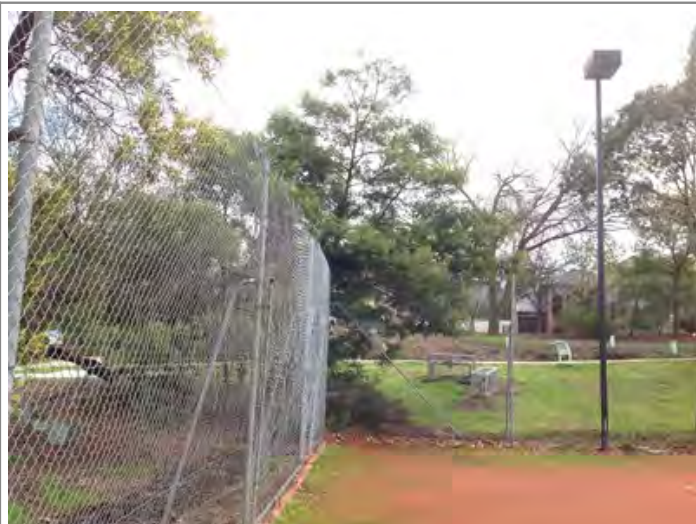
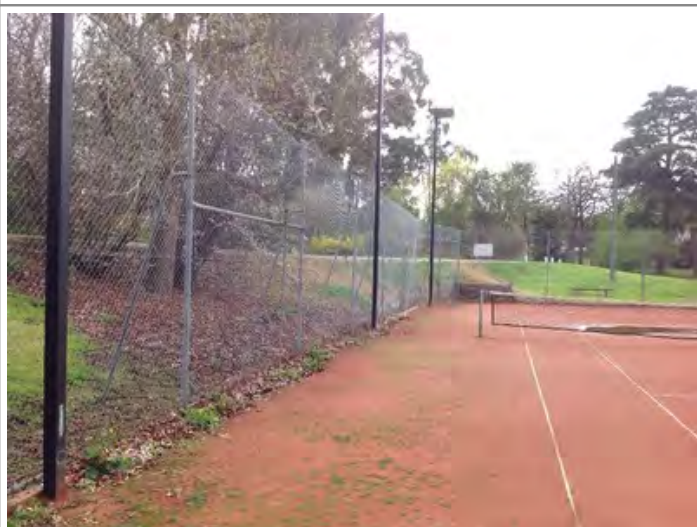
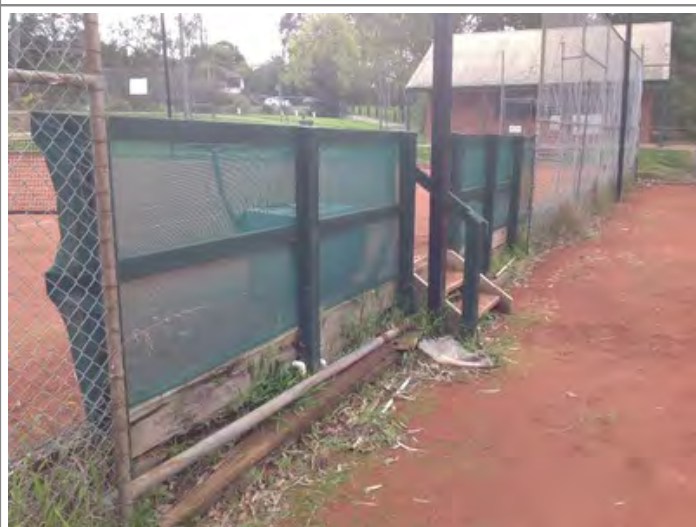
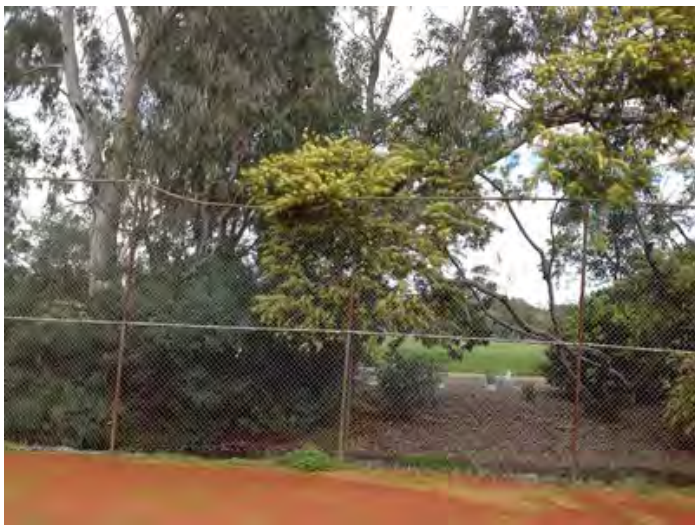
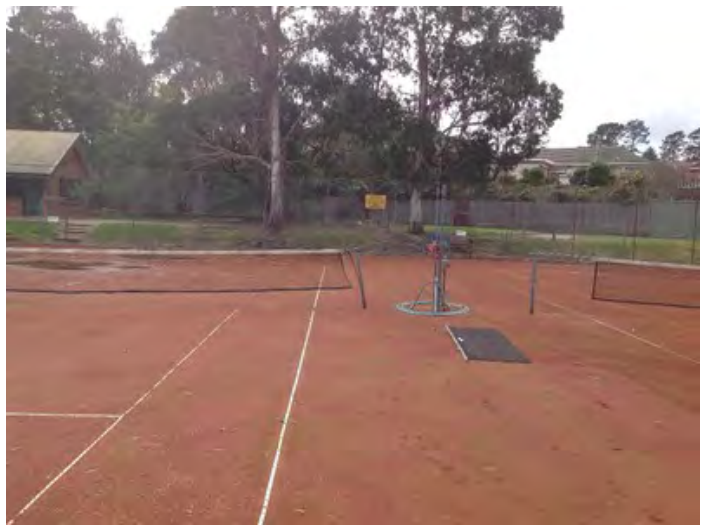
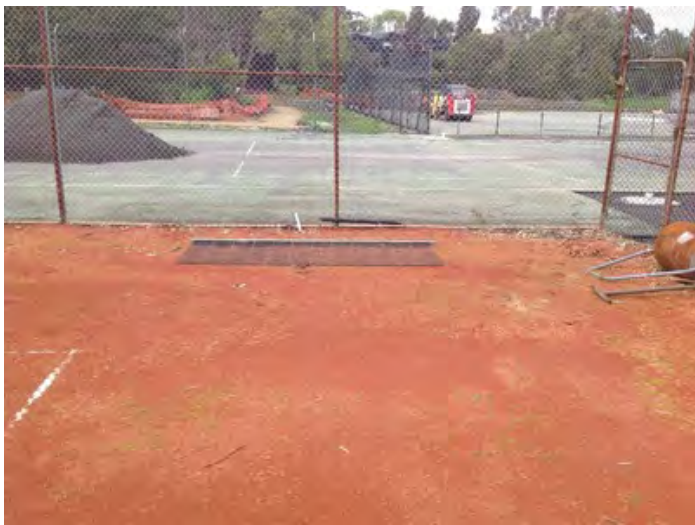
<b>Fence condition rating</b>	<p>Poor</p> <p><b>Issues/Observations:</b></p> <p>Slack mesh</p> <p>Mesh curling at base</p> <p>Rusted mesh</p> <p>Leaning posts</p> <p>Bent posts</p> <p>Damaged mesh</p> <p>Trees overhanging enclosure</p> <p>Trees/shrubs growing through mesh</p>
<b>Fencing life span</b>	2-3 years
<b>Fence notes</b>	<p>The fencing is in two different parts - the upper two courts of court one and two, and lower section of courts three and four. The upper section along the western, northern and southern borders is in respectable condition, although some trees are growing over the fence. The lower section is particularly poor, and there is extensive damage throughout. A small wooden and mesh fence has been built between the two sections.</p>

<b>Are there any critical safety issues?</b>	No
<b>Enclosure recommendations</b>	Treat all weed growth and assess drainage issues across all courts. Repair lines. Replace fencing.

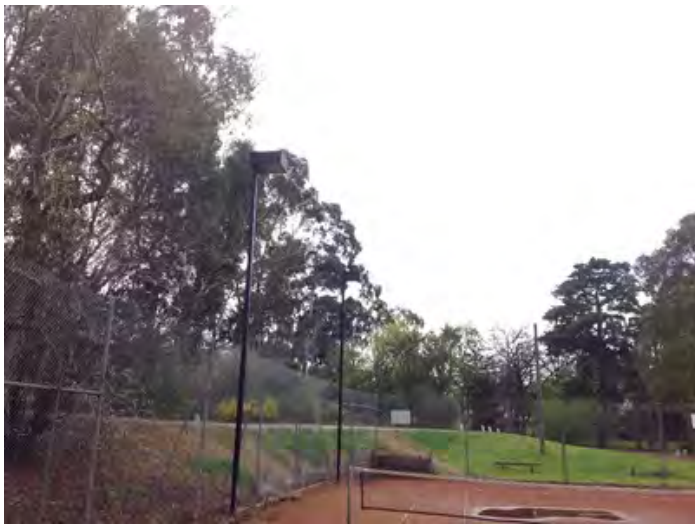
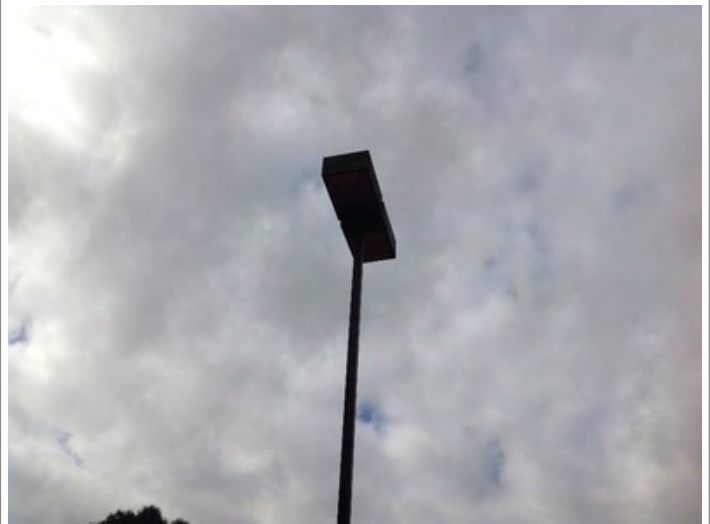
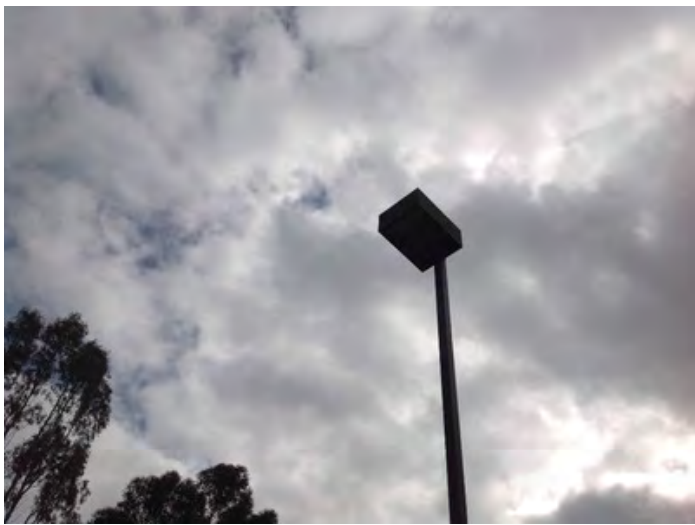
Does this enclosure have lighting	Yes
Total number of lit courts per enclosure	2
Lighting infrastructure type	Black powder coated low level - Steel poles
Lighting infrastructure position	Side
Light fittings	One per tower
Lighting infrastructure design	Standard
Lighting infrastructure rating	Good
	<b>Issues/Observations:</b> Infrastructure and fittings in very good condition - likely to achieve required lux standards
Lighting life span	10+ years
Lighting notes	The lighting appears to be in good condition and would likely meet minimum standards, however there is algae growth locate across the light boxes on some lights.

<b>Court</b>	Remove debris from court surface and enclosure Remove weed growth from court enclosure Remove and treat algae within court enclosure Trim trees/shrubs away from court enclosure and fencing Hang drag mats on fencing Repair lines
<b>Drainage</b>	Remove build-up of debris from drainage infrastructure to allow efficient water movement. Qualified Engineer required to further investigate drainage issues.
<b>Infrastructure</b>	Repair damaged fencing Trim vegetation away from fencing
<b>Lighting</b>	Conduct a lighting lux level test

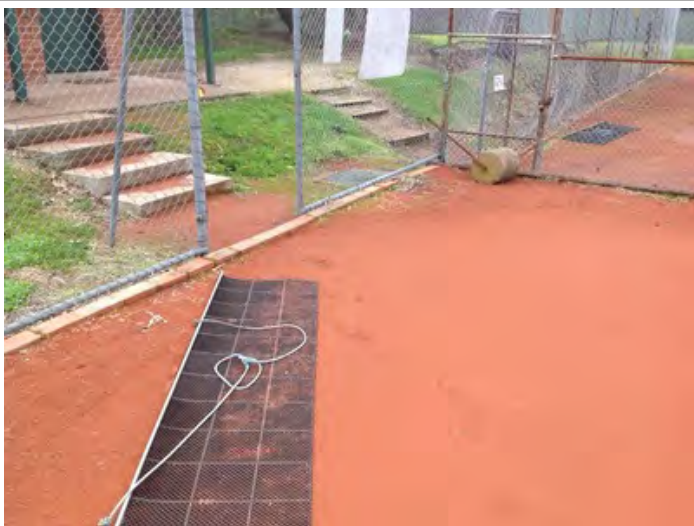
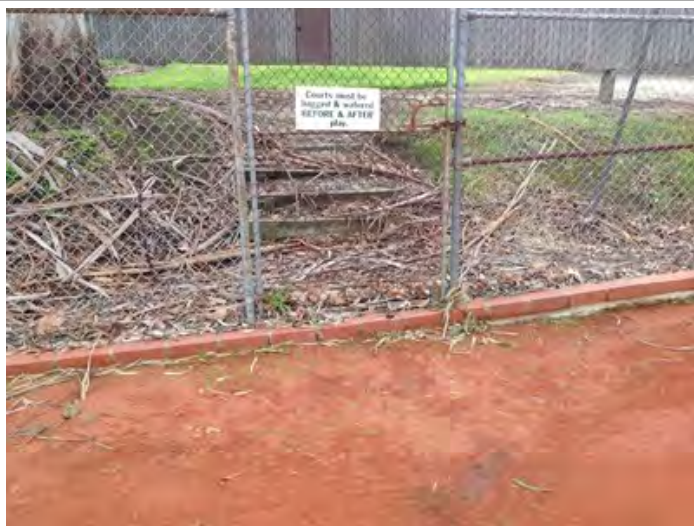
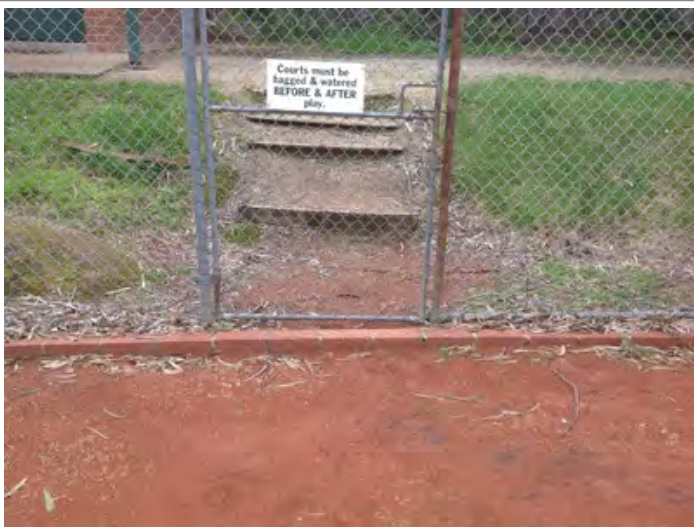
<b>Court enclosure accessibility</b>	Formed paths Trip hazards identified: yes Ramped access provided: no
<b>Path material(s)</b>	Concrete
<b>Main gate dimensions</b>	Standard pedestrian gate 1000mm x 2100mm
<b>Accessibility notes</b>	Participants are required to walk down steps to enter the enclosure.
<b>Accessibility photos</b>

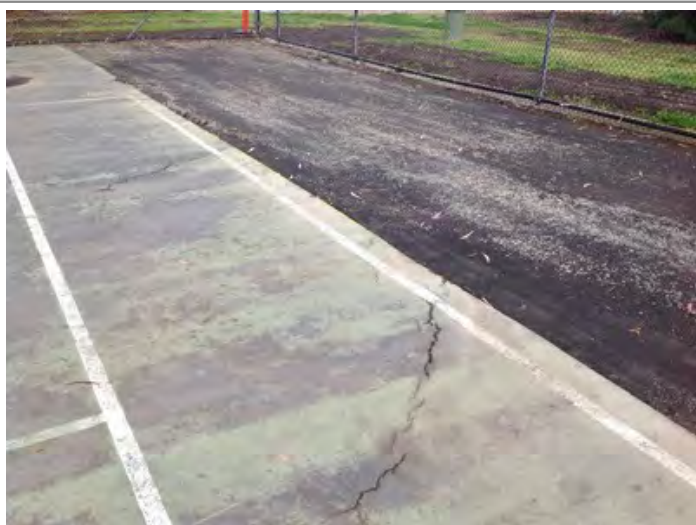
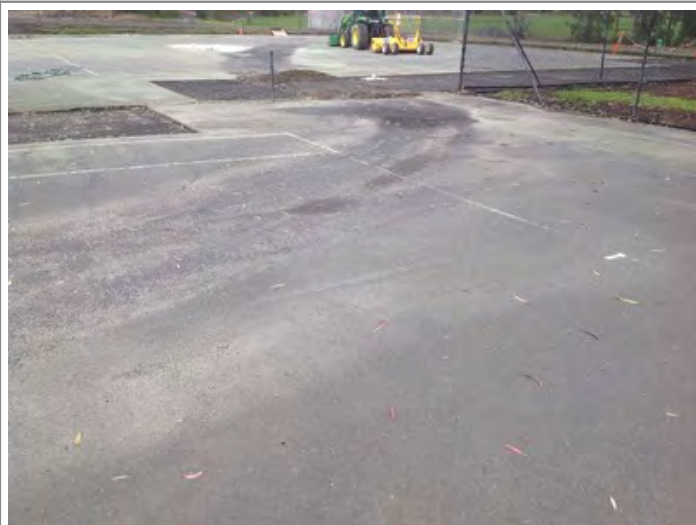
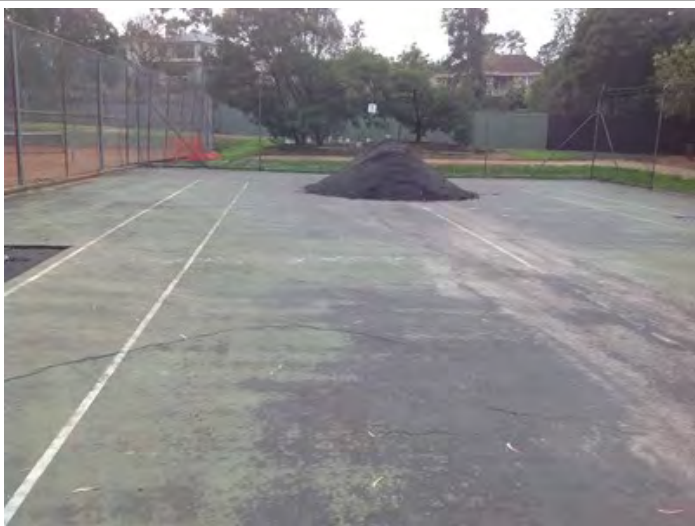
Unique court number	5
Surface condition rating	<p>Very Poor</p> <p><b>Issues/Observations:</b></p> <p>Leaf litter</p> <p>Major surface cracking</p> <p>Surface pitting</p> <p>Debris present mainly around the perimeter</p> <p>Aged surface</p> <p>Excessively worn surface in high wear areas</p>
Surface type	Acrylic
Surface life span	0-1 year
Court condition notes	The is the western most court of enclosure two. It is currently under repair, with maintenance equipment and gravel piled on the court. The old surface is in a very poor condition and suffers from extensive cracking. Much of the acrylic or painted surface has worn away to reveal the asphalt underneath.

Court	Remove debris from court surface and enclosure Remove dirt and high pressure clean court surface Remove large stones from surface Repaint lines
Drainage	
Infrastructure	Repair damaged fencing
Lighting	
Other Comments	Maintenance issues are being addressed through maintenance equipment being present at the facility at the time of inspection.

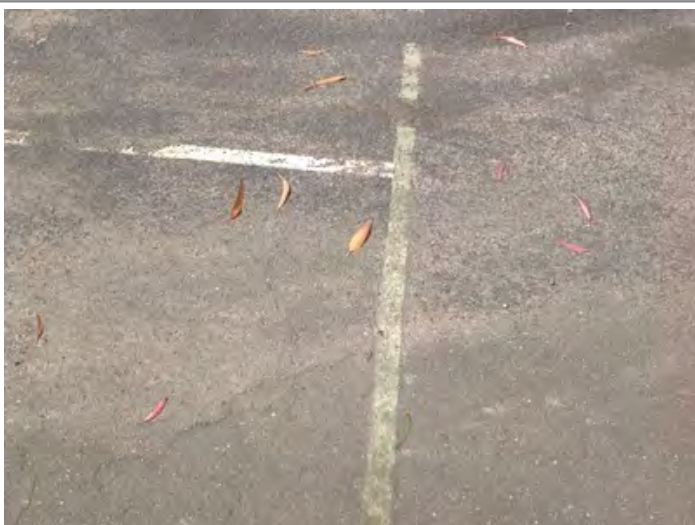
Line marking description	Tennis only lines
Line marking rating	Very Poor  <b>Issues/Observations:</b> Inconsistent / undefined Aged and dull
Line marking condition notes	The lines are in the same condition as the rest of the court.

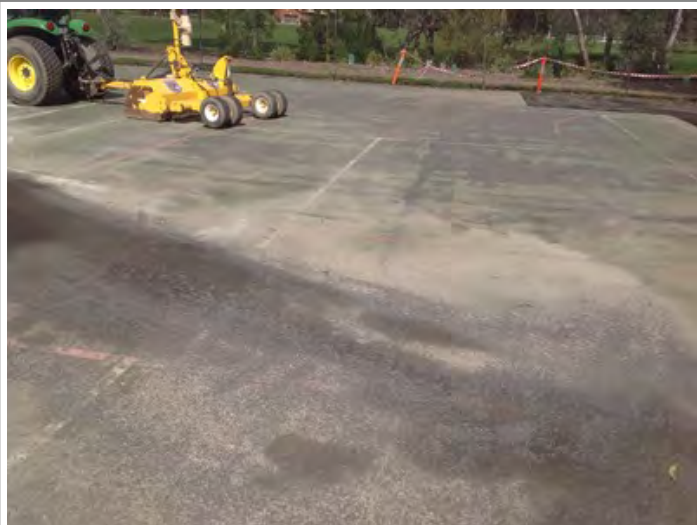
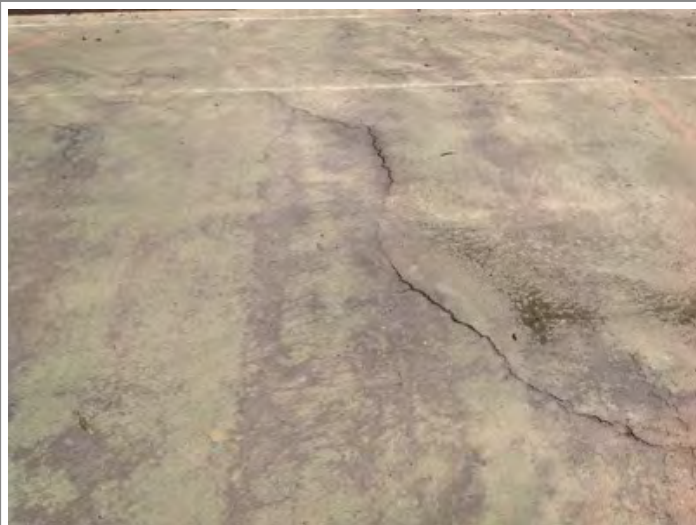
Unique court number	6
Surface condition rating	Very Poor  <b>Issues/Observations:</b> Leaf litter Major surface cracking Surface pitting Debris present mainly around the perimeter Aged surface Excessively worn surface in high wear areas
Surface type	Acrylic
Surface life span	0-1 year
Court condition notes	The is the middle court of enclosure two. It is currently under repair, with maintenance equipment and gravel piled on the court. The old surface is in a very poor condition and suffers from extensive cracking. Much of the acrylic or painted surface has worn away to reveal the asphalt underneath.

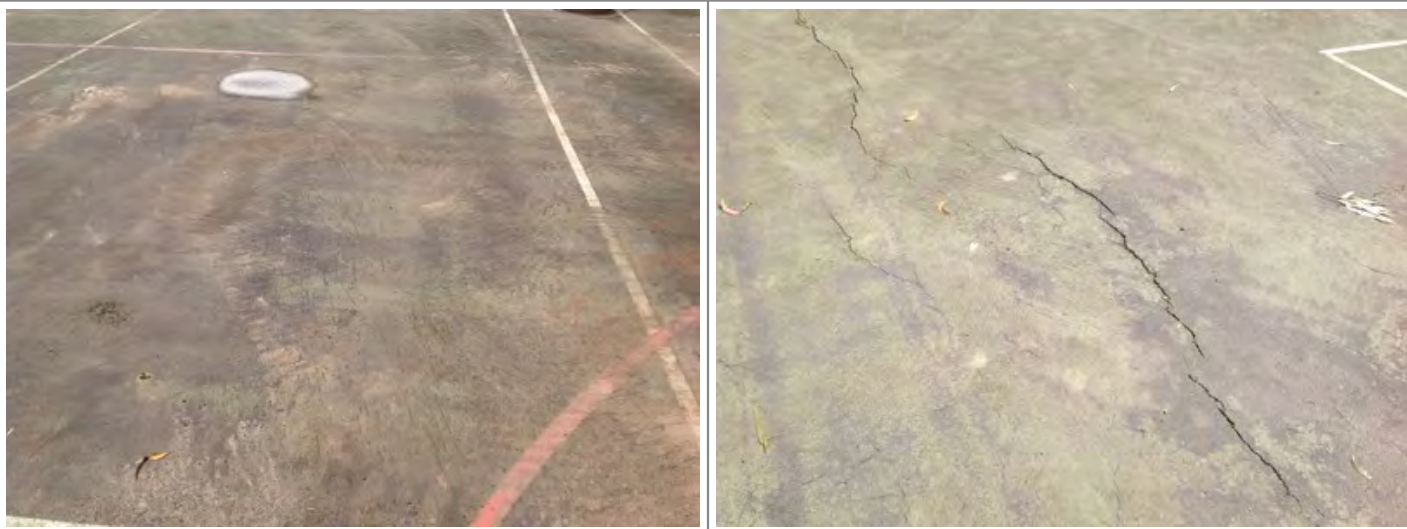
Surface life span	0-1 year
Court condition notes	The is the eastern most court of enclosure two. It is currently under repair, with maintenance equipment and gravel piled on the court. The old surface is in a very poor condition and suffers from extensive cracking. Much of the acrylic or painted surface has worn away to reveal the asphalt underneath.
Court condition photos

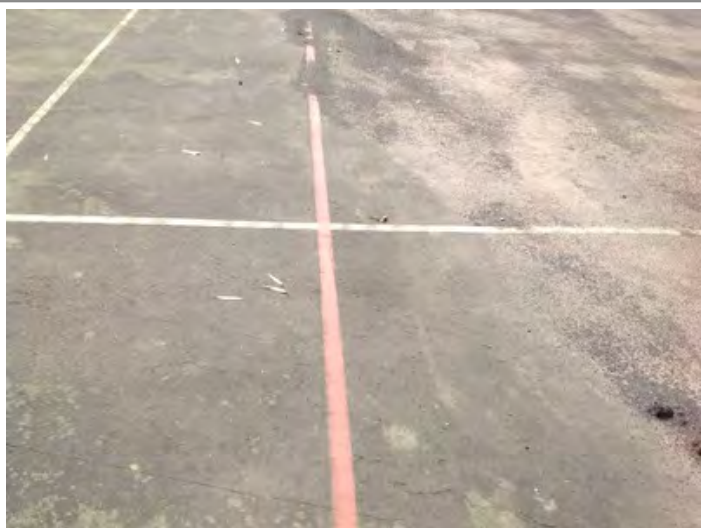
Line marking	
Line marking description	Tennis and Netball only lines
Line marking rating	Very Poor  <b>Issues/Observations:</b> Inconsistent / undefined Aged and dull
Line marking condition notes	The lines are in the same condition as the rest of the court.
Line marking condition photos

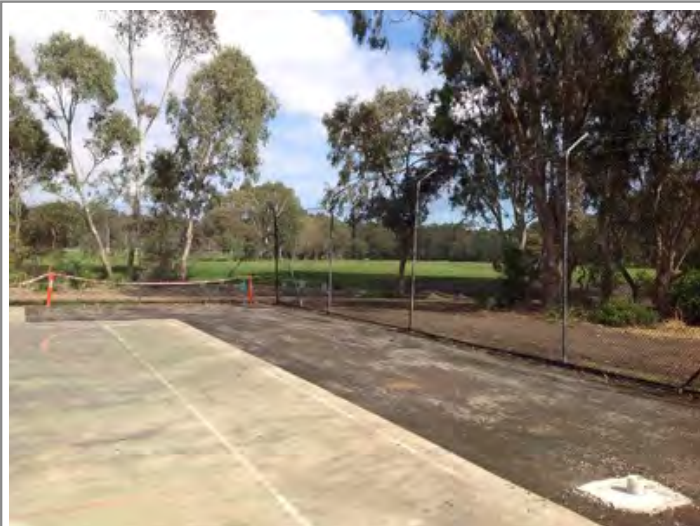
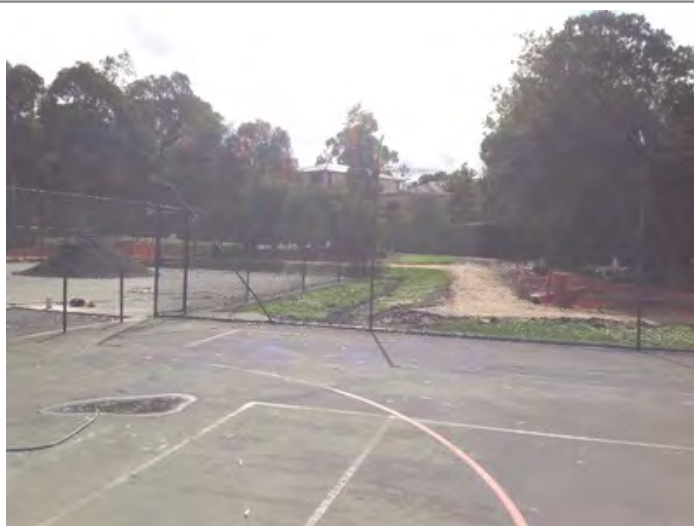
<b>Fence condition rating</b>	Poor  <b>Issues/Observations:</b> Slack mesh Leaning posts Trees overhanging enclosure
<b>Fencing life span</b>	2-3 years
<b>Fence notes</b>	The fencing has barbed wire throughout and is in poor condition.

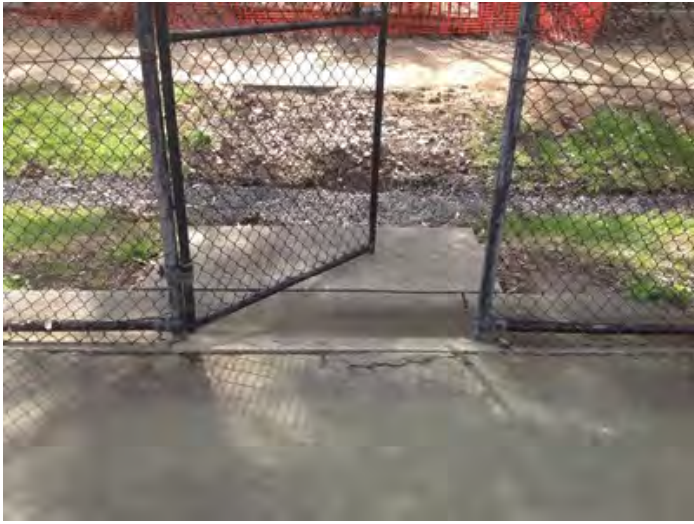
<b>Court enclosure accessibility</b>	Unformed paths Trip hazards identified: yes Ramped access provided: no
<b>Path material(s)</b>	Crushed rock
<b>Main gate dimensions</b>	Standard pedestrian gate 1000mm x 2100mm
<b>Accessibility notes</b>	The access to this enclosure is presumably compromised by the current works to the facility.

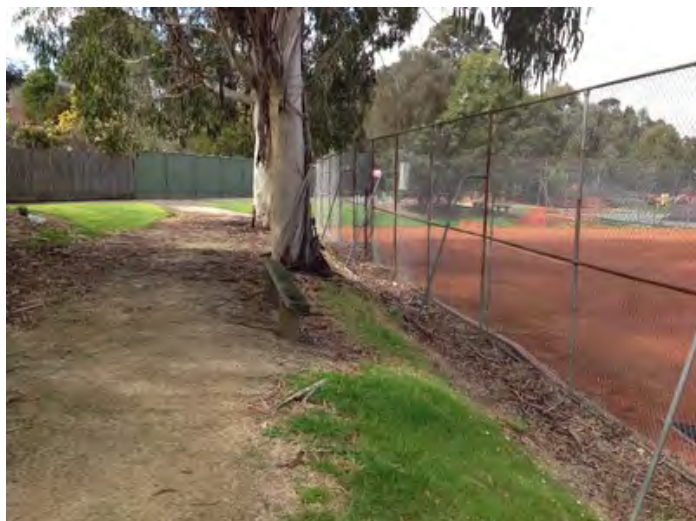
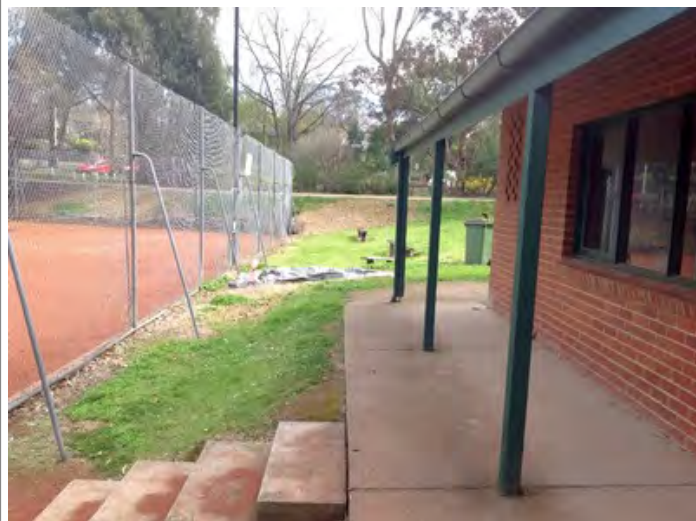
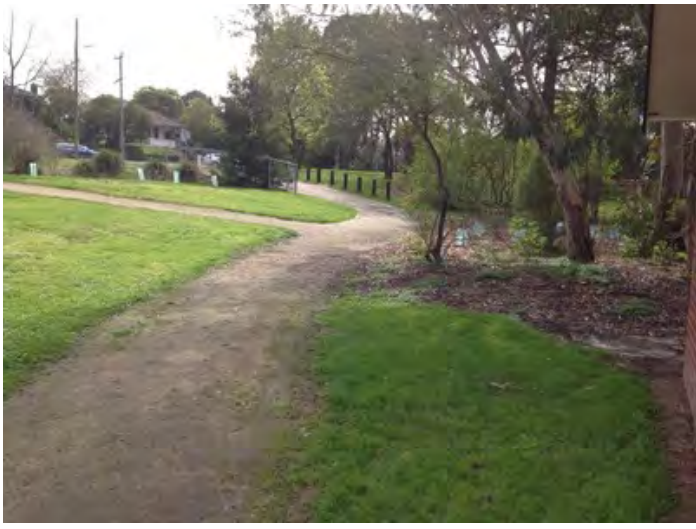
Condition of ground and court surrounds	Moderate
Court surround notes	Public pathways are adjacent to the facility, and gardens are maintained alongside court areas. A football pitch and parklands are located to the south of the facility.
Water supply	Unknown
Water notes	
Natural Shade	Sufficient shade available within viewing range
Man made Shade	Clubhouse veranda
Shade notes	
Car parking	On street: Off street: 0-20 spaces Overflow:
Does the site have any hit up walls	no
Car park notes	
Adjacent facilities	Oval/playing field  Park/playground
Does the site have any potential expansion opportunities?	no

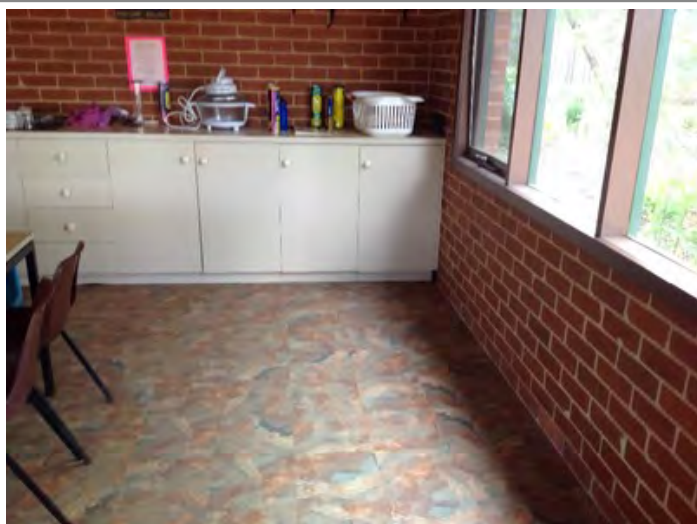
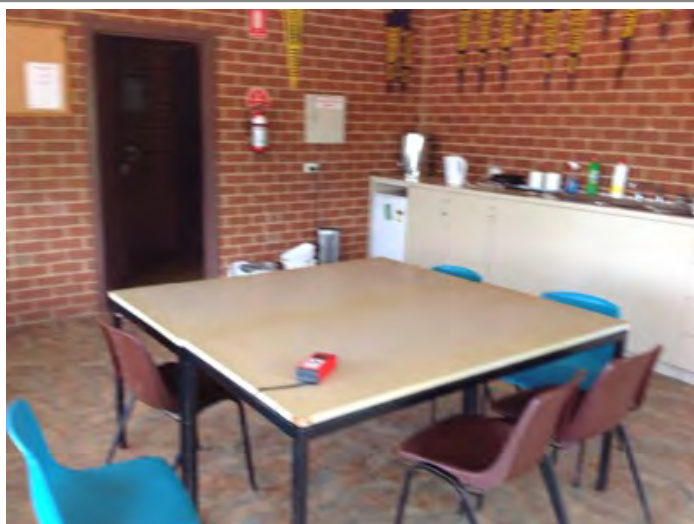
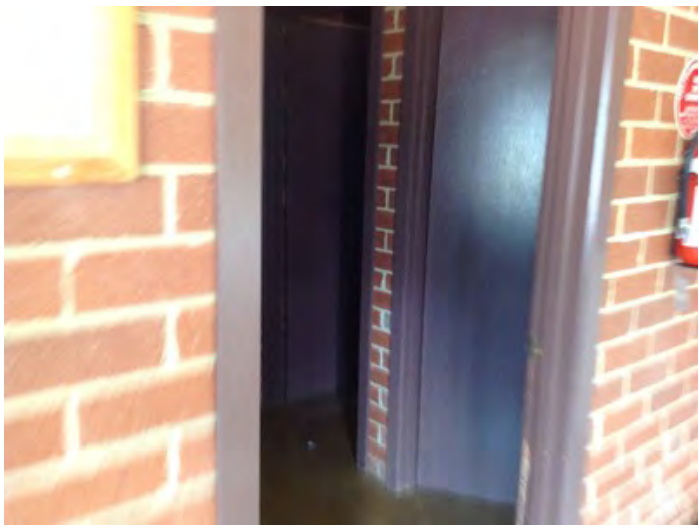
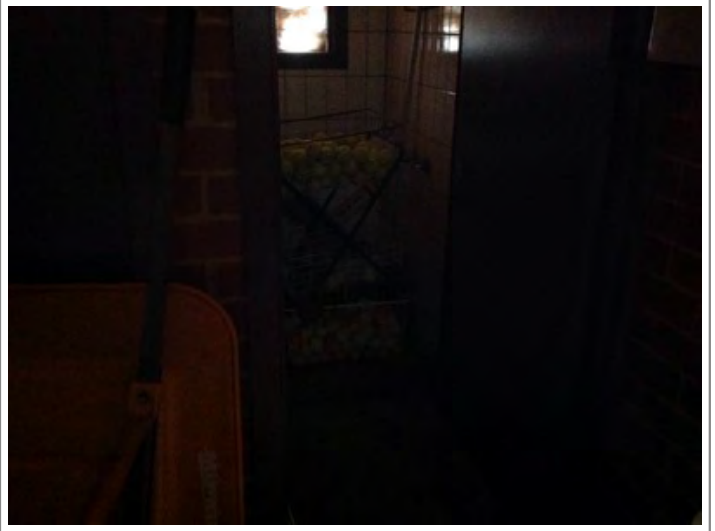
Building Condition	Good
Estimated building age	30+ years
Building materials	Brick
Accessible entry to building	no
Kitchen	Standard
Bar	no
Player change rooms	Male: 0 Female: 0 Unisex: 0
Social area	33 m2
Social area comments	The social area consists of a simple kitchen and sitting area, where toilets are adjacent to this space.
Toilets	Male: Female: Accessible:
Clubroom condition notes	A simple clubhouse is offered, with two unisex toilets and a small storage area.
Other amenities provided within or outside clubrooms	Equipment storage
Other amenities condition notes	
Are there any safety concerns within clubrooms?	no
