Central Park Facility Audit

Document number	000216
Client / Site	Tennis Victoria
Location	63 Plenty Lane Greensborough VIC 3088
Auditor	Andrew Sodomaco
Audit date	04 Sep 2015

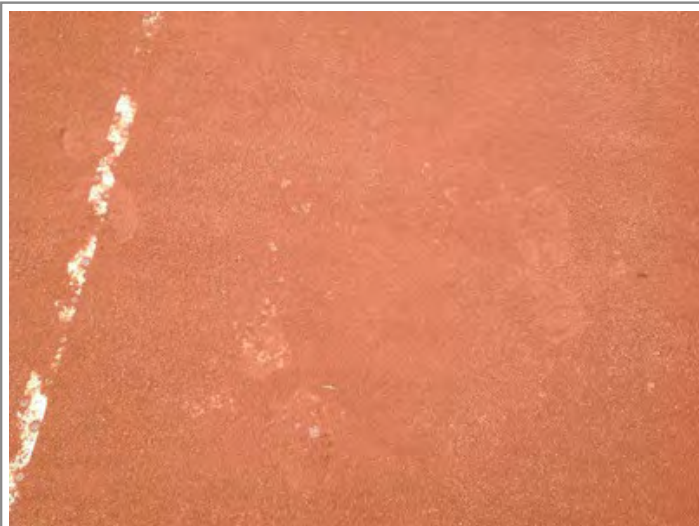
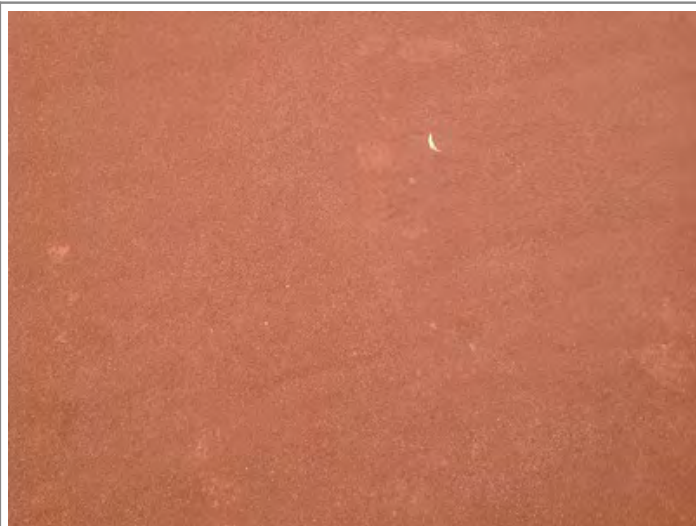
Unique court number	1
Surface condition rating	Good Issues/Observations: Aged surface Excessively worn surface in high wear areas
Surface type	Red Porous
Surface life span	10+ years
Court condition notes	This court is in good condition with a good amount of top dressing, although there are multiple areas with aggregate showing through the surface.

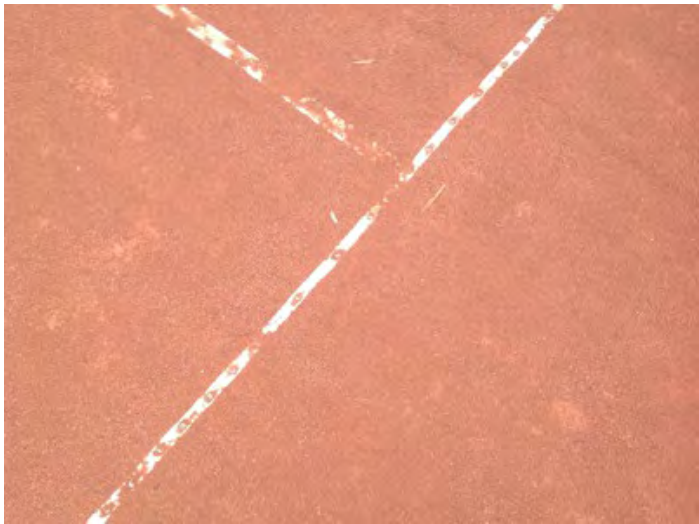
Line marking condition notes	The lines are standard for this surface and there are no obvious signs of breakage.
Line marking condition photos

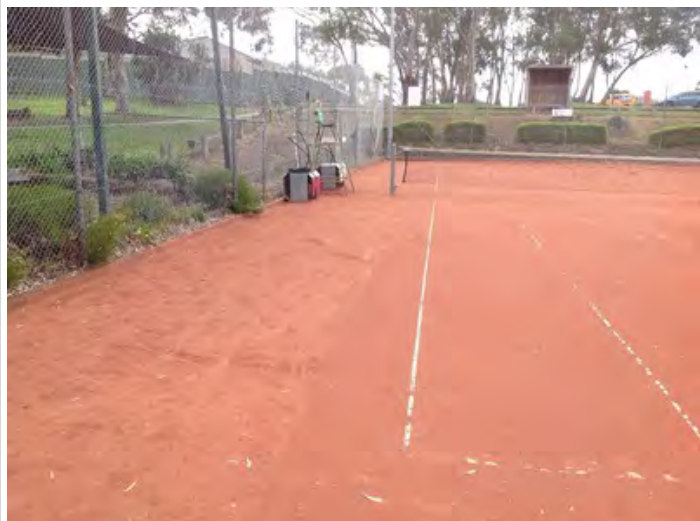
Are netball goal posts outside tennis court run off areas?	no
Are lockable post hole covers fitted and safe?	no
Compliance notes	The court does not meet run off requirements to the western sideline fence, although there is enough room to move the court east toward the adjacent court to rectify this issue.

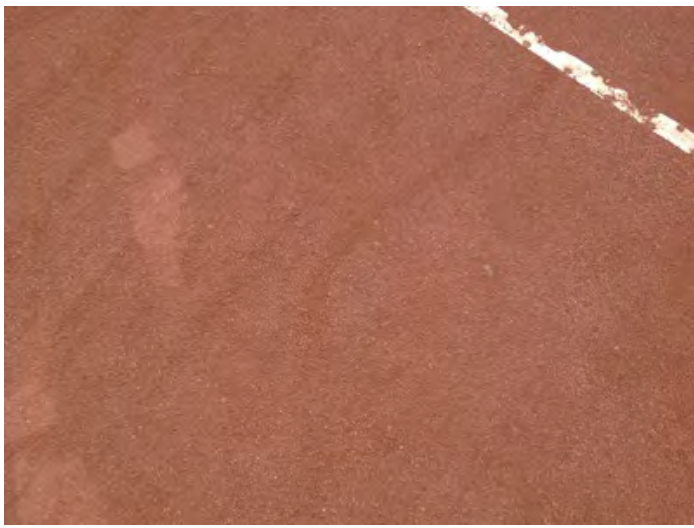
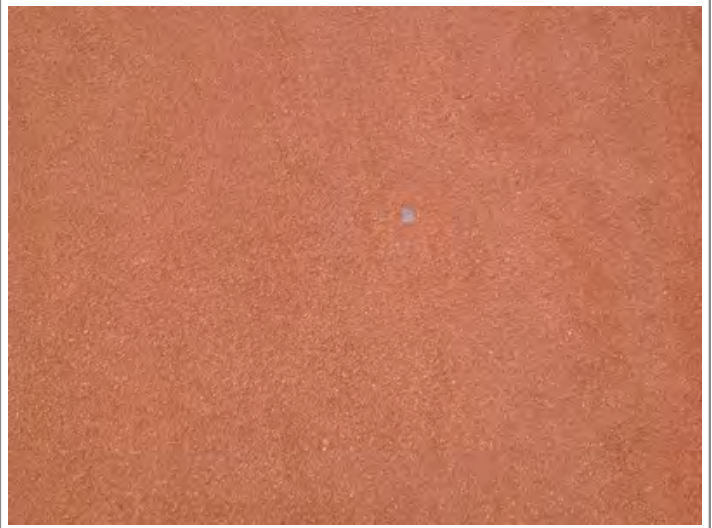
Unique court number	2
Surface condition rating	Good Issues/Observations: Aged surface Excessively worn surface in high wear areas
Surface type	Red Porous
Surface life span	10+ years
Court condition notes	This court is in good condition with a good amount of top dressing, although there are multiple areas with aggregate showing through the surface.

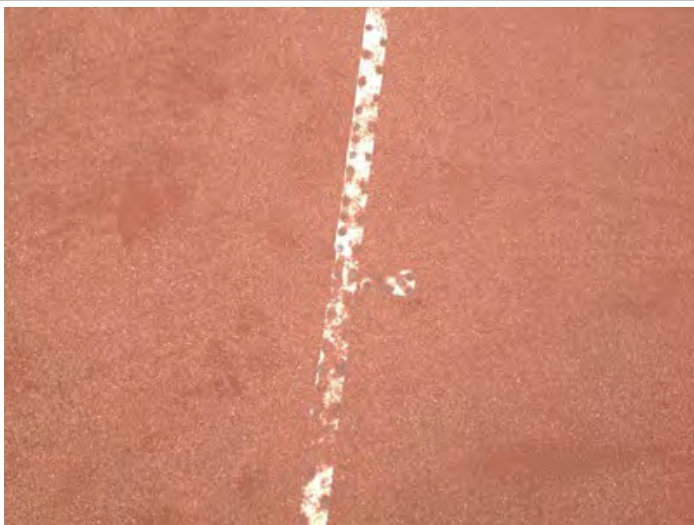
Line marking description	Tennis only lines
Line marking rating	Good Issues/Observations: Inconsistent bounce likely
Line marking condition notes	The lines are standard for this surface and there are no obvious signs of breakage.

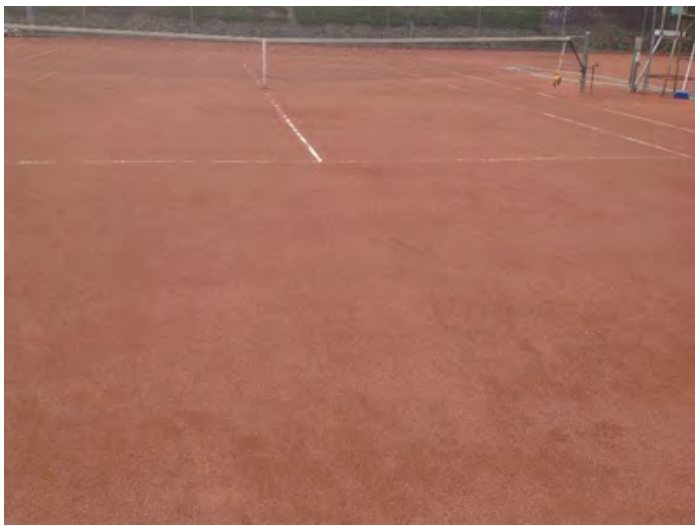
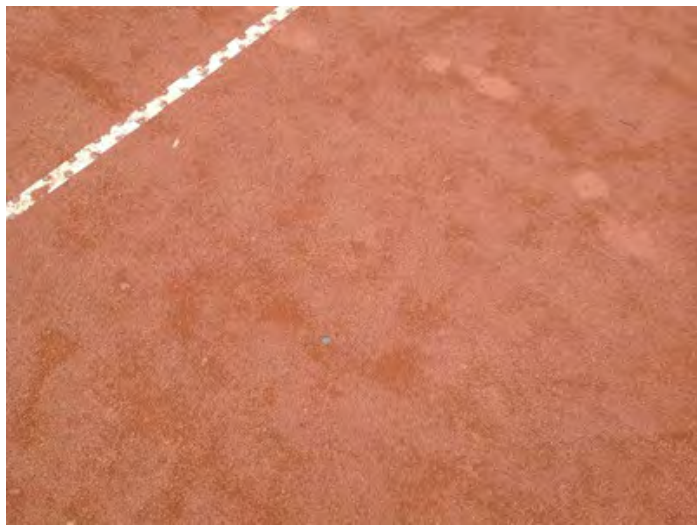
Net post life span	10+ years
Net life span	6-10 years
Net / post notes	
Net / post photos	
No photos taken	
Court compliance	
Is the court run off compliant?	yes Runoffs North: 6100m South: 6200m East: 4900m West: 4900m
Could the court be made compliant?	n/a
Is the court to the standard dimensions?	yes
Court orientation	North-south
Are netball goal posts outside tennis court run off areas?	no
Are lockable post hole covers fitted and safe?	no
Compliance notes	The court meets run off requirements to every direction.
Compliance photos	
No photos taken	
Courts	
Condition	
Unique court number	3
Surface condition rating	Good Issues/Observations: Aged surface
Surface type	Red Porous
Surface life span	10+ years
Court condition notes	This court is in good condition with a good amount of top dressing, and appears less worn than courts one and two with less aggregate showing through the top dressing.
Court condition photos

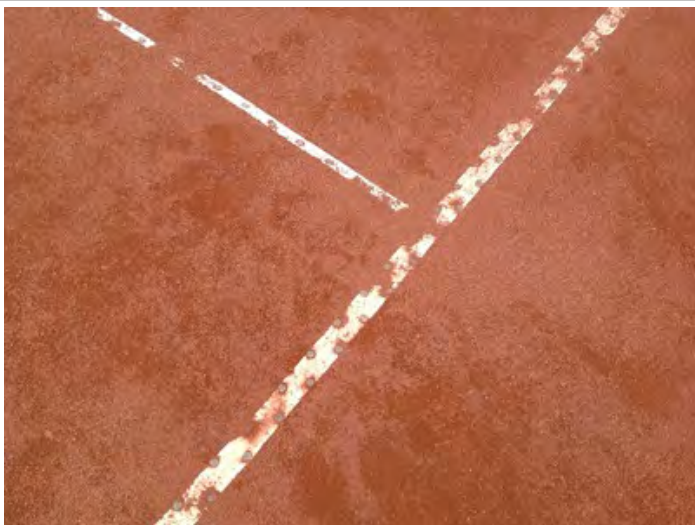
Line marking description	Tennis only lines
Line marking rating	Good Issues/Observations: Inconsistent bounce likely
Line marking condition notes	The lines are standard for this surface and there are no obvious signs of breakage.

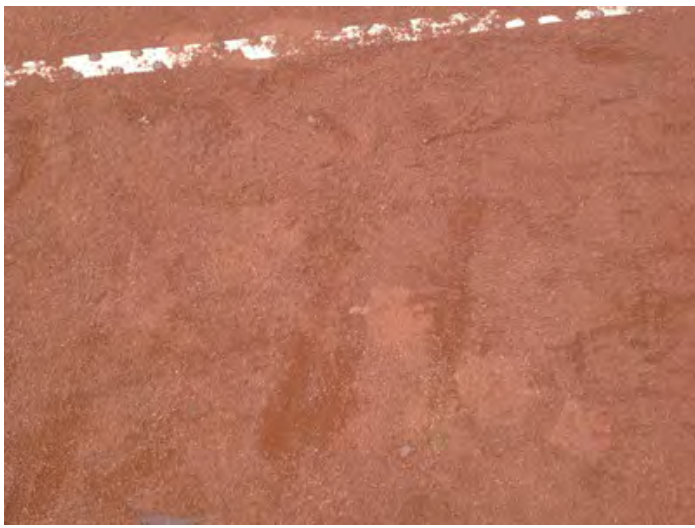
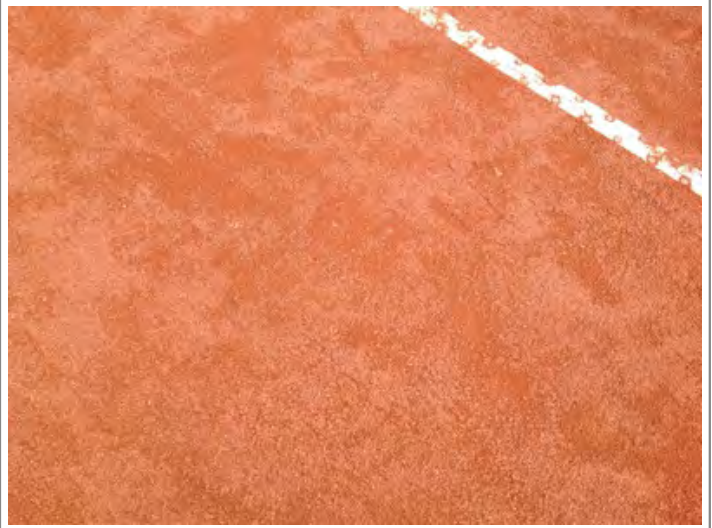
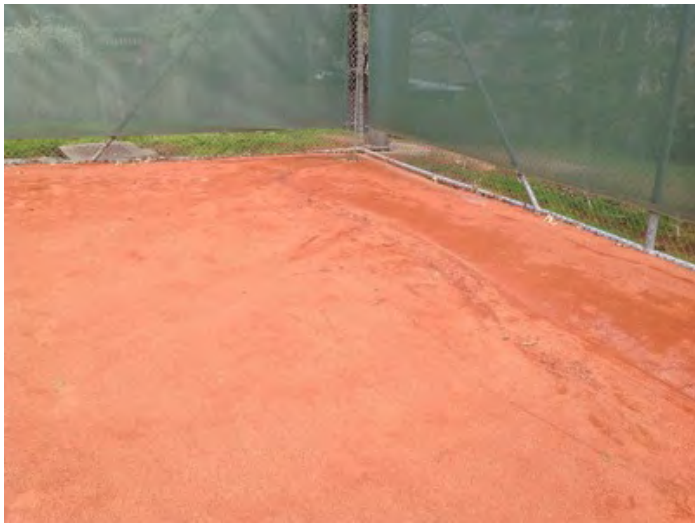
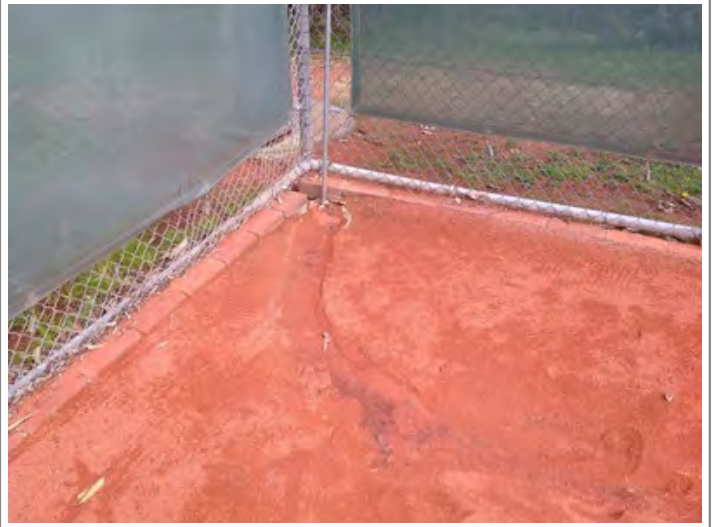
Net post life span	10+ years
Net life span	6-10 years
Net / post notes	
Net / post photos	
No photos taken	
Court compliance	
Is the court run off compliant?	yes Runoffs North: 6100m South: 6200m East: 4900m West: 4900m
Could the court be made compliant?	n/a
Is the court to the standard dimensions?	yes
Court orientation	North-south
Are netball goal posts outside tennis court run off areas?	no
Are lockable post hole covers fitted and safe?	no
Compliance notes	The court meets run off requirements to each direction.
Compliance photos	
No photos taken	
Courts	
Condition	
Unique court number	4
Surface condition rating	Good Issues/Observations: Aged surface
Surface type	Red Porous
Surface life span	10+ years
Court condition notes	This court is in good condition with a good amount of top dressing, although there are multiple areas with aggregate showing through the surface. There is a large rut at the southern end of the court where water has drained under the fence to the south eastern corner.

Plan for upgrade of all courts. Trim vegetation from fencing. Investigate solutions to large rut in the court to the south of court four.

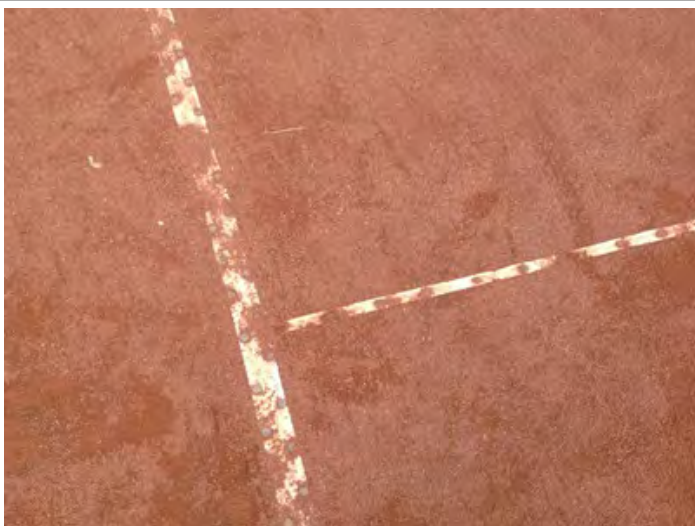
Line marking description	Tennis only lines
Line marking rating	Good
	Issues/Observations: Inconsistent bounce likely
Line marking condition notes	The lines are standard for this surface and there are no obvious signs of breakage.

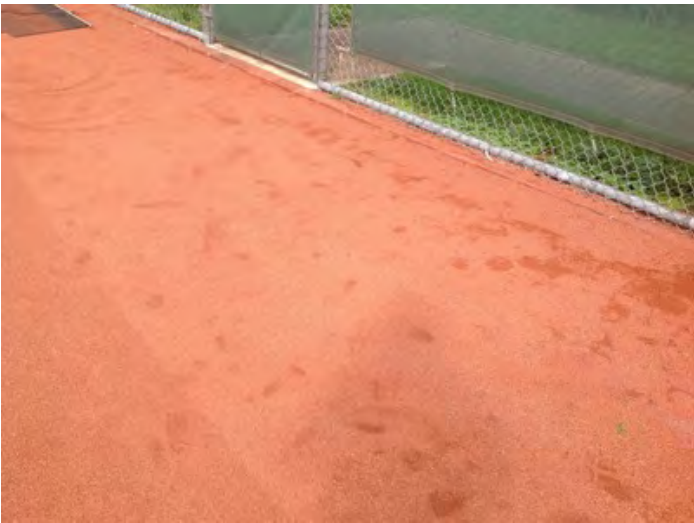
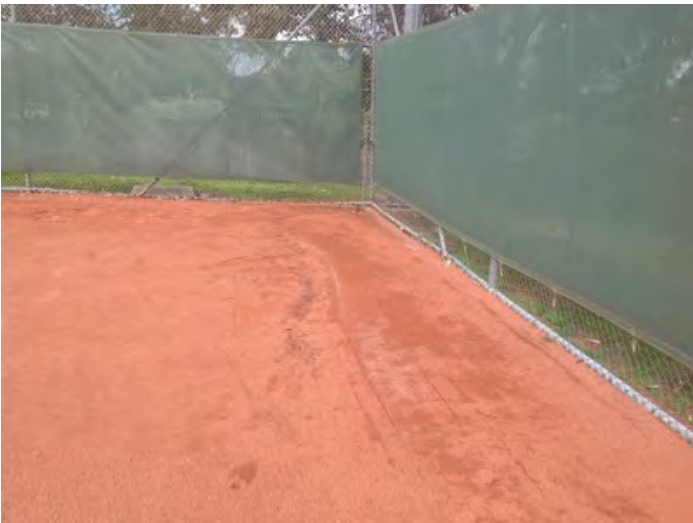
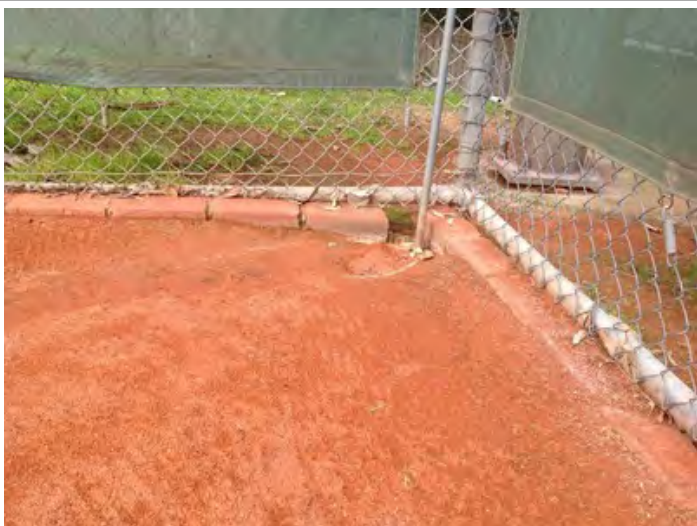
Compliance notes	The court does not meet run off requirements to the eastern sideline fence, although there is enough room to move the court west toward the adjacent court to rectify this issue.
Compliance photos	
No photos taken	
Drainage	
Drainage infrastructure	Unformed
What type of drainage is in place?	No drainage infrastructure
Are drains, pits or other infrastructure provided within the court enclosure?	no
Are drains, pits or other infrastructure provided within the run-off areas?	no
Drainage rating	Good Issues/Observations: No pits
Drainage notes	Despite no drainage infrastructure being evident within the enclosure, there is little sign of pooling of water on the courts. The enclosure is more damp around the outsides where excess top dressing has built up and can trap the moisture more easily. In the south eastern corner, water appears to run under the fence and down into a gully. This has left a rut in the court.

Court	Trim trees/shrubs away from court enclosure and fencing Hang drag mats on fencing
Drainage	Qualified Engineer required to further investigate drainage issues.
Infrastructure	Trim vegetation away from fencing
Lighting	Conduct a lighting lux level test

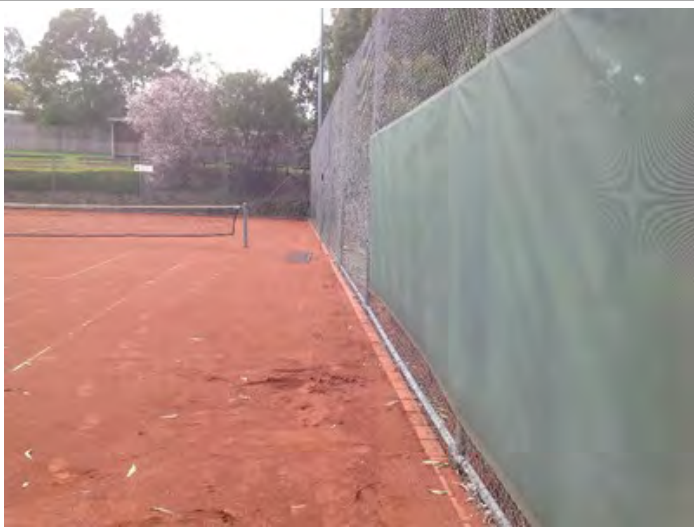
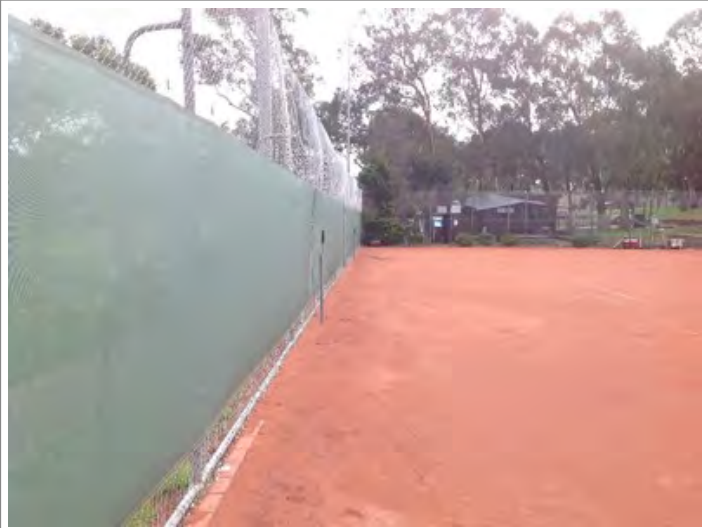
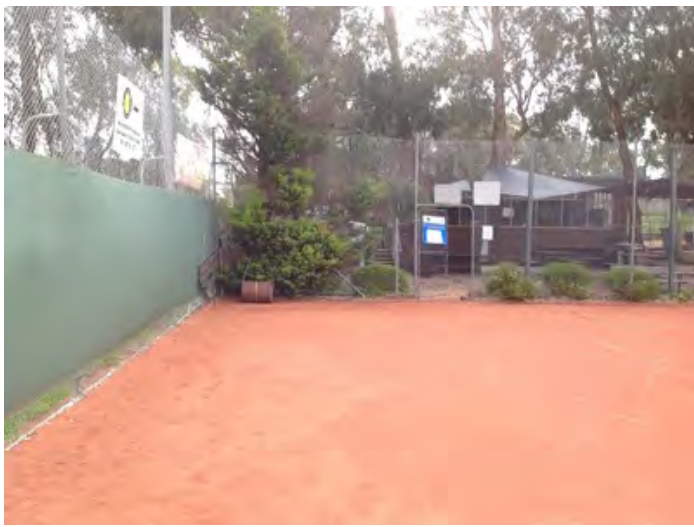
Fence type	Galvanised chain mesh
Fence Rails	Fence rail top: no Fence rail bottom: yes
Fence height	3m to 3.5m Low level side fencing installed: no
Fence attachments	Sightscreens Windbreaks Sponsor advertising
Fence condition rating	Moderate Issues/Observations: Slack mesh Mesh curling at base Trees overhanging enclosure Trees/shrubs growing through mesh
Fencing life span	10+ years
Fence notes	An older fence is provided which is still in reasonable condition although will require some trimming of trees growing through it to ensure it has a longer lifespan.

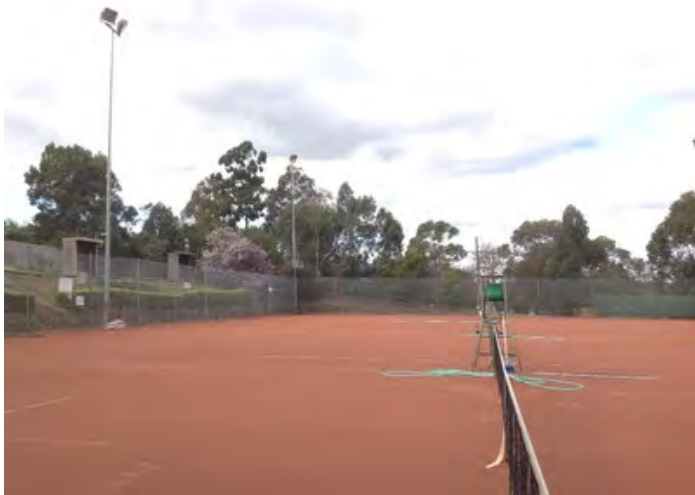
Does this enclosure have lighting	Yes
Total number of lit courts per enclosure	4
Lighting infrastructure type	High tower - Steel poles
Lighting infrastructure position	Corner
Light fittings	One per tower
Lighting infrastructure design	Standard
Lighting infrastructure rating	Good
	Issues/Observations: Old however in good condition - potential upgrade required
Lighting life span	10+ years
Lighting notes	The high tower lighting provided may potentially not meet required lux standards, although it is in otherwise good condition.
Lighting photos

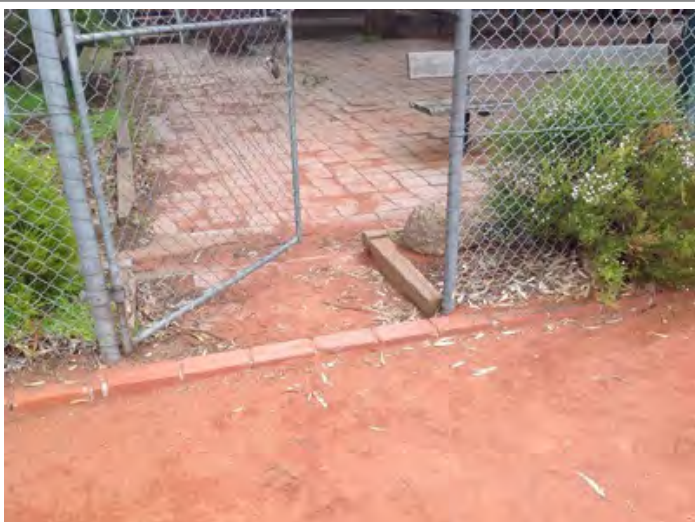
Court enclosure accessibility	Formed paths Trip hazards identified: yes Ramped access provided: no
Path material(s)	Other material?
Main gate dimensions	Accessible gate 1200mm x 2100mm
Accessibility notes	Court users are required to step over pavers to enter the enclosure.

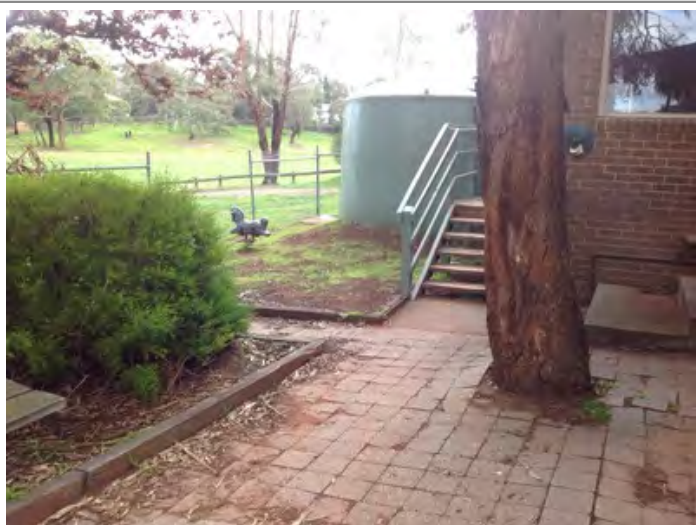
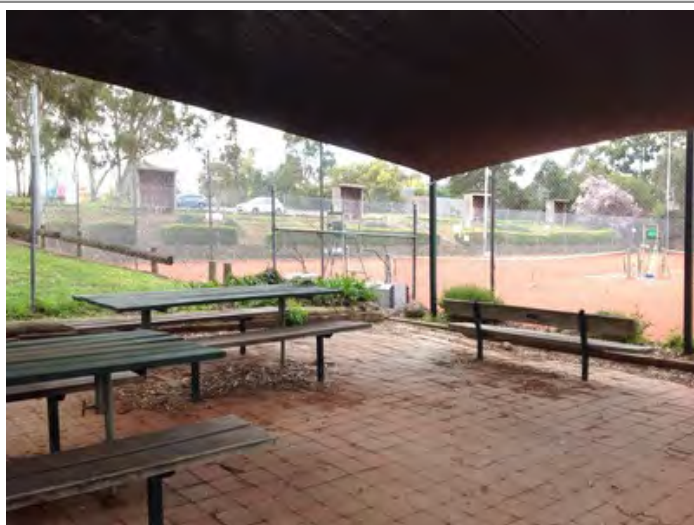
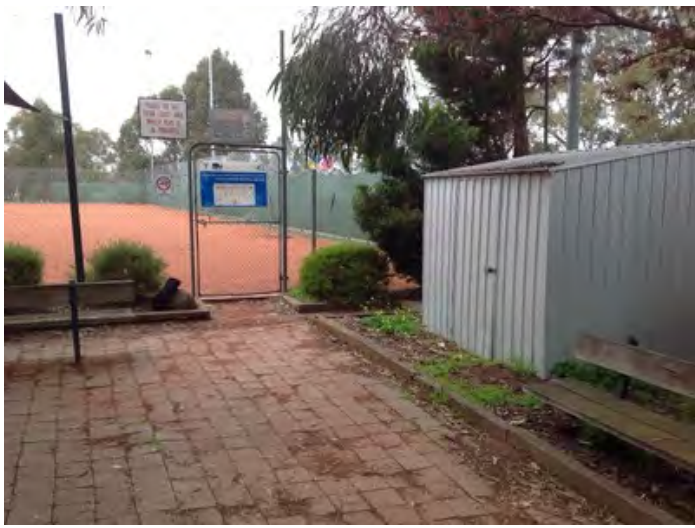
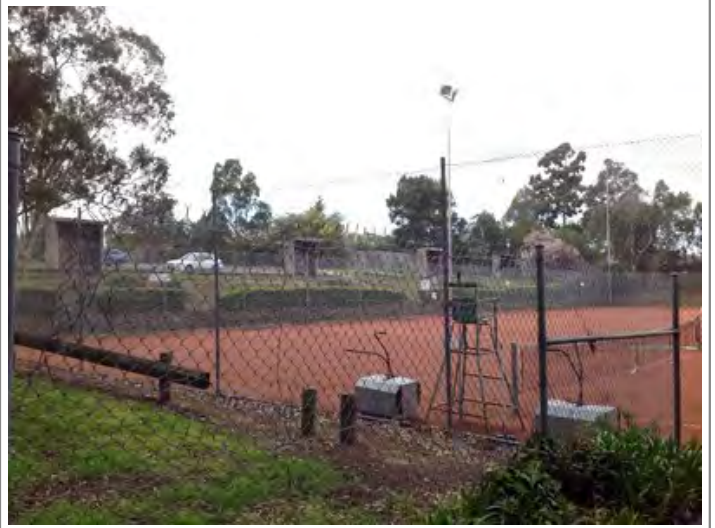
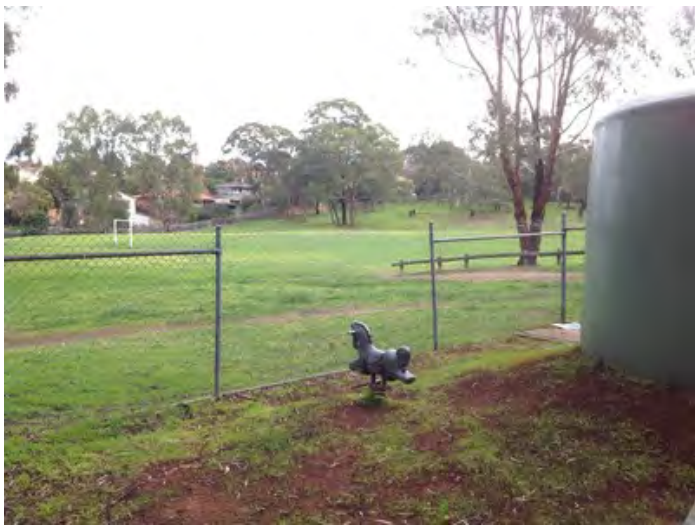
Condition of ground and court surrounds	Moderate
Court surround notes	The court surrounds are limited to a paved area adjacent to the clubhouse with some seating provided. Some viewing shelters are situated above the courts to the north in public open space areas.
Water supply	Recycled Potable
Water notes	
Natural Shade	Sufficient shade available within viewing range
Man made Shade	Shade sail(s)
Shade notes	
Car parking	On street: Off street: 21-40 spaces Overflow:
Does the site have any hit up walls	no
Car park notes	
Adjacent facilities	Park/playground
Does the site have any potential expansion oppotunities?	no

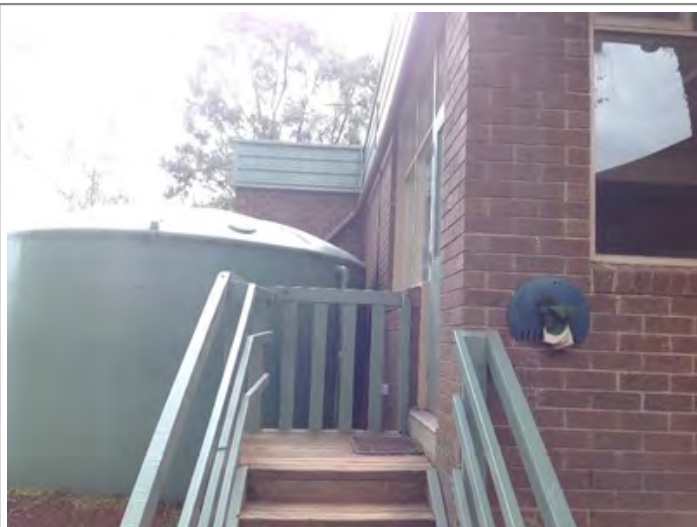
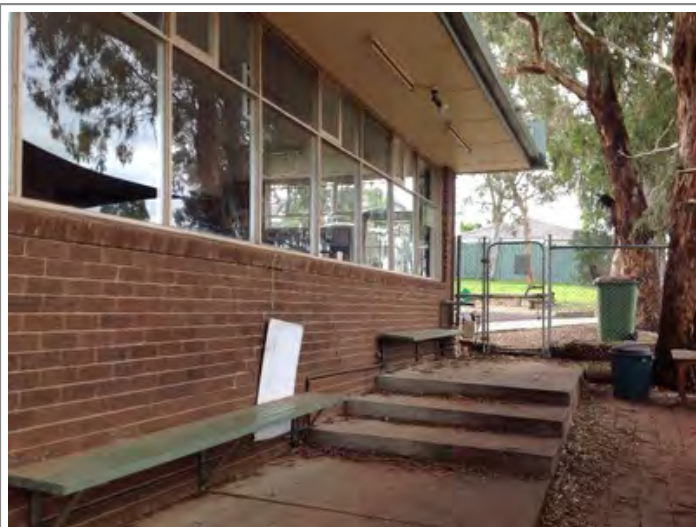
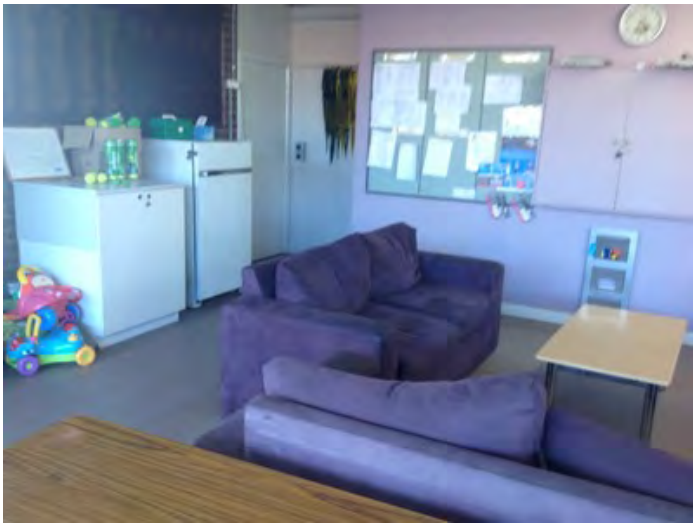
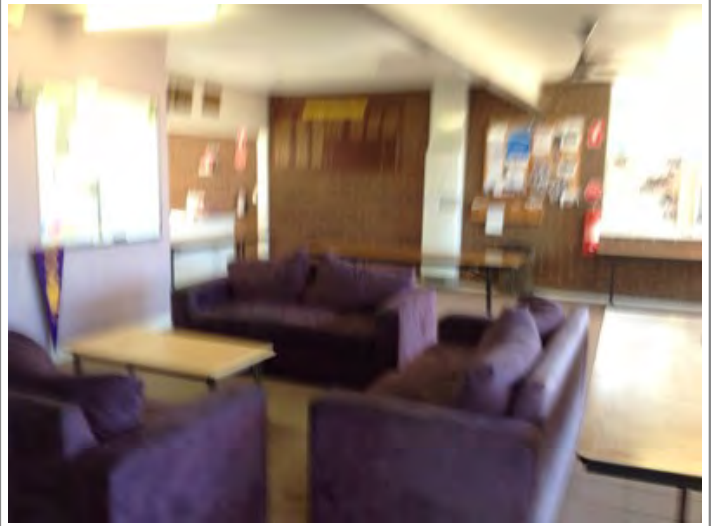
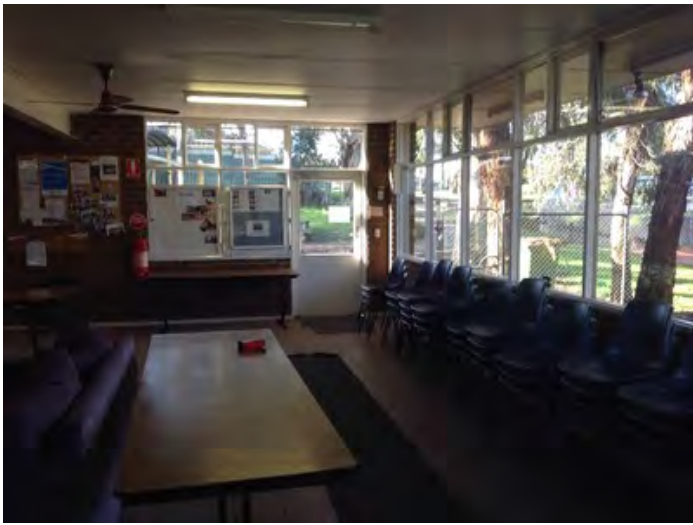
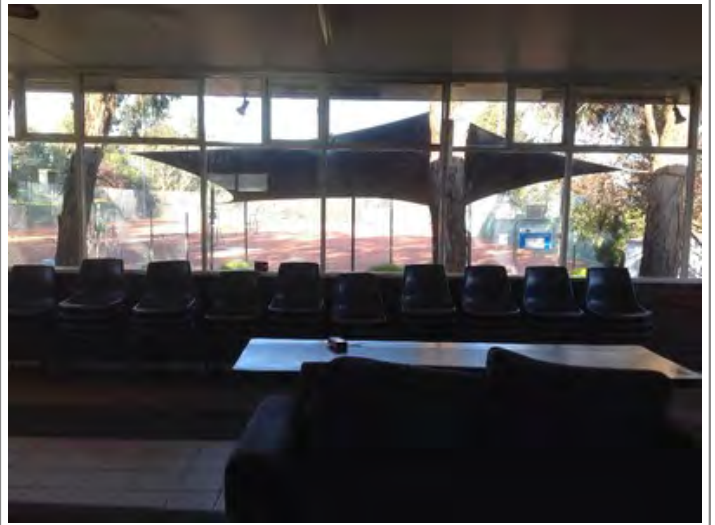
Building Condition	Moderate
Estimated building age	30+ years
Building materials	Brick
Accessible entry to building	no
Kitchen	Standard
Bar	no
Player change rooms	Male: 1 Female: 1 Unisex: 0
Social area	64 m2
Social area comments	
Toilets	Male: yes Female: yes Accessible: no
Clubroom condition notes	The clubhouse consists of an open social area which looks out on to the courts and outdoor shaded area. Couches and seating is provided for spectators. There are no obvious signs of damage on the inside of the clubhouse. Change facilities are provided for both males and females.
Other amenities provided within or outside clubrooms	BBQ /outdoor seating area
Other amenities condition notes	
Are there any safety concerns within clubrooms?	no
