Burke Road North Tennis Facility Audit

Document number	000209
Client / Site	Tennis Victoria
Location	Off the Boulevard East Ivanhoe VIC 3079
Auditor	Andrew Sodomaco
Audit date	30 Aug 2015

Site summary	
Total number of enclosures	5
Total number of courts	10
Total number of floodlit courts	4
Total number of enclosed mini courts	0
Hierarchy	District

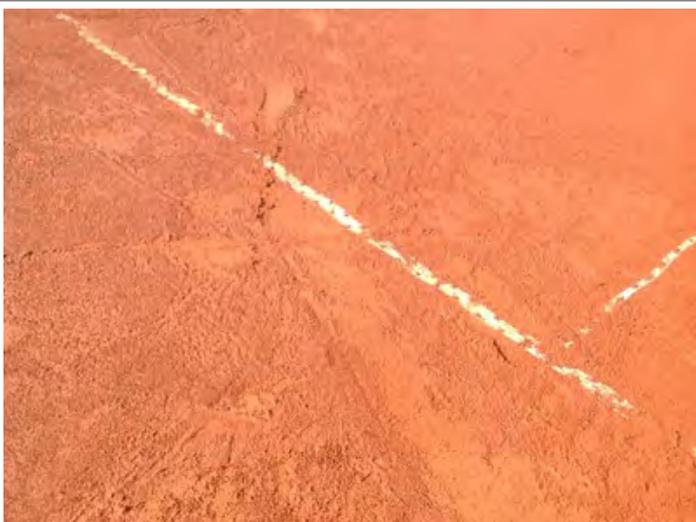
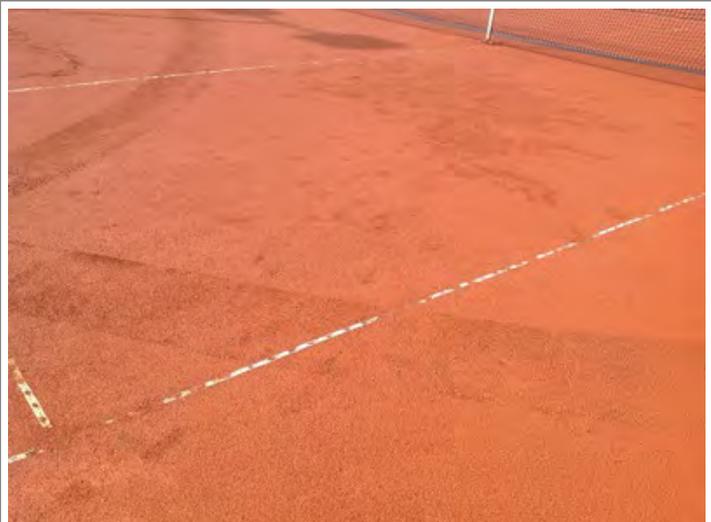
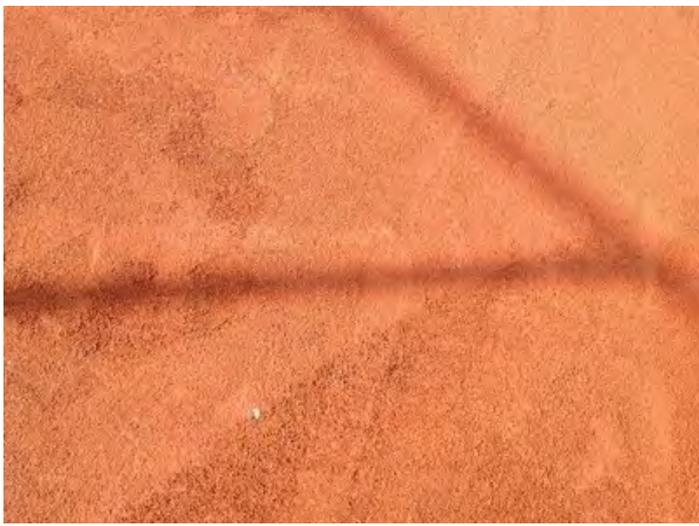
Court condition photos

Unique court number	1
Surface condition rating	Good Issues/Observations: Excessively worn surface in high wear areas
Surface type	Red Porous
Surface life span	10+ years
Court condition notes	The court is in quite good condition with little sign of aggregate showing through the court, although there is some in high wear areas along the baseline. There is a good covering of top dressing. There is a depression at the baseline at the northern end.

Are there any critical safety issues?	No
Enclosure recommendations	Trim tree branches from western fence line. Continue to maintain good level of top dressing on court.

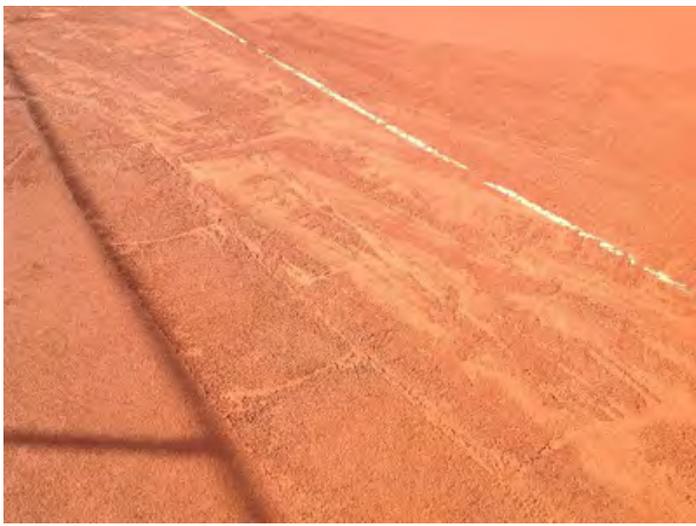
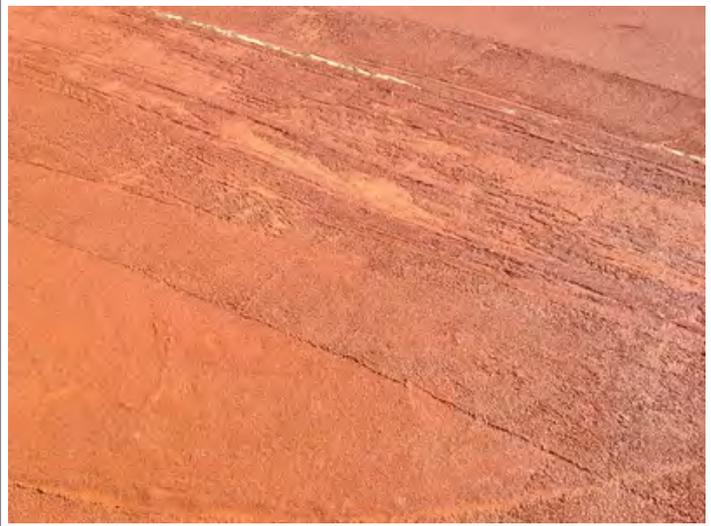
Court condition photos

Net post life span	6-10 years
Net life span	6-10 years
Net / post notes	
Net / post photos	
No photos taken	
Court compliance	
Is the court run off compliant?	yes Runoffs North: 6100m South: 6300m East: 3500m West: 3600m
Could the court be made compliant?	n/a
Is the court to the standard dimensions?	yes
Court orientation	North-south
Are netball goal posts outside tennis court run off areas?	no
Are lockable post hole covers fitted and safe?	no
Compliance notes	The court meets run off requirements to all directions.
Compliance photos	
No photos taken	
Courts	
Condition	
Unique court number	2
Surface condition rating	Good Issues/Observations: Minor ponding evident Excessively worn surface in high wear areas
Surface type	Red Porous
Surface life span	10+ years
Court condition notes	The court is in quite good condition with little sign of aggregate showing through the court, although there is some in high wear areas along the baseline. There is a good covering of top dressing. There is some pooling of water behind the baselines, as expected after rain although this is not apparent on the other court in the enclosure.

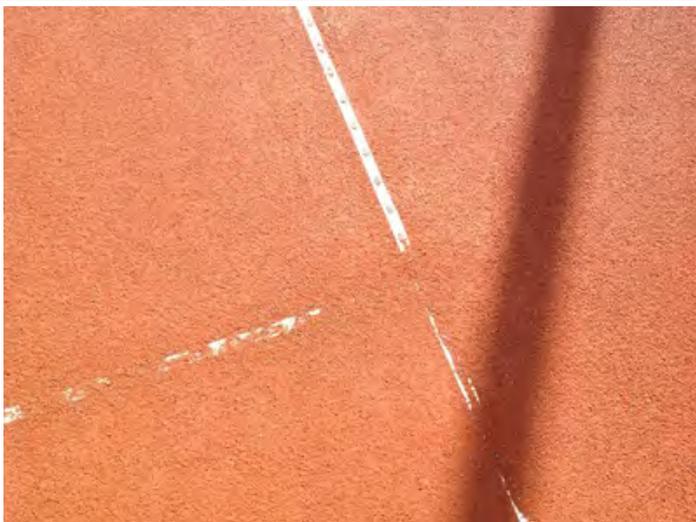
Line marking condition photos

Line marking description	Tennis only lines
Line marking rating	Good Issues/Observations: Inconsistent bounce likely
Line marking condition notes	The lines are standard for red porous courts and there are no obvious signs of breakage.

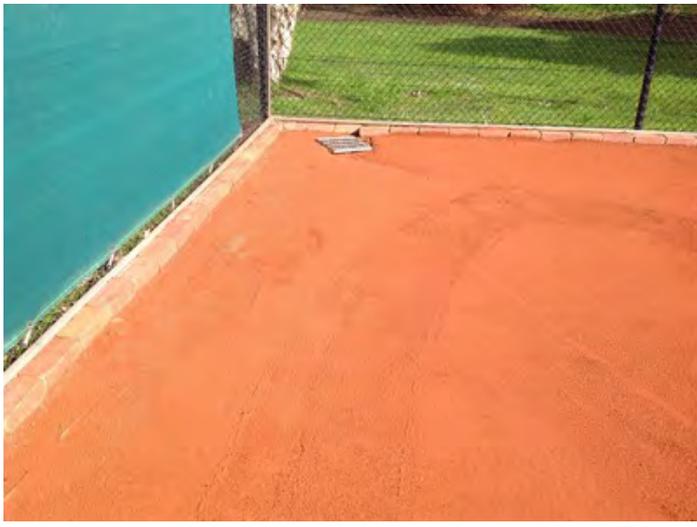
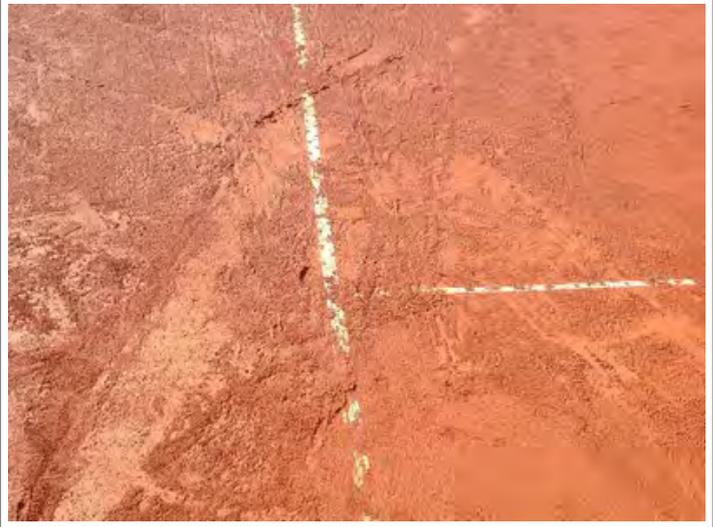
Drainage photos	
<div style="border: 1px solid black; height: 40px; width: 100%;"></div>

Net post life span	10+ years
Net life span	6-10 years
Net / post notes	
Net / post photos	
No photos taken	
Court compliance	
Is the court run off compliant?	yes Runoffs North: 6100m South: 6200m East: 3200m West: 3400m
Could the court be made compliant?	n/a
Is the court to the standard dimensions?	yes
Court orientation	North-south
Are netball goal posts outside tennis court run off areas?	no
Are lockable post hole covers fitted and safe?	no
Compliance notes	The court meets run off requirements to all directions.
Compliance photos	
No photos taken	
Drainage	
Drainage infrastructure	Formed
What type of drainage is in place?	Grated pit(s)
Are drains, pits or other infrastructure provided within the court enclosure?	yes
Are drains, pits or other infrastructure provided within the run-off areas?	no
Drainage rating	Good Issues/Observations: Ponding evident
Drainage notes	Although ponding is evident, considerable rain has fallen prior to the inspection. The majority of the enclosure has drained well. Grated pits exist in the south western corner of each court.

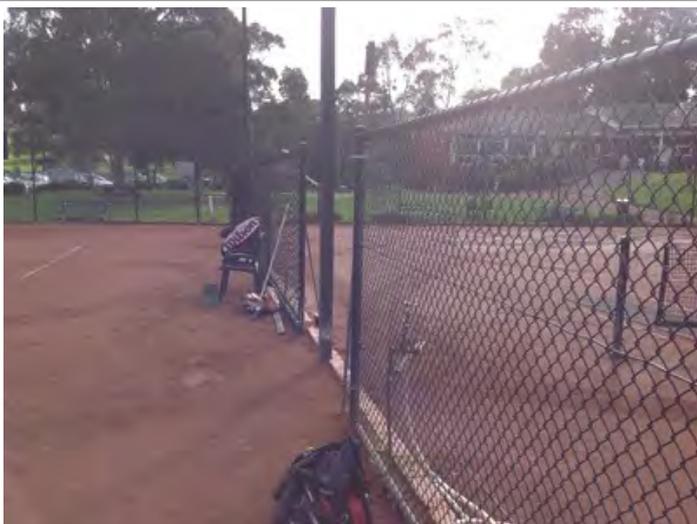
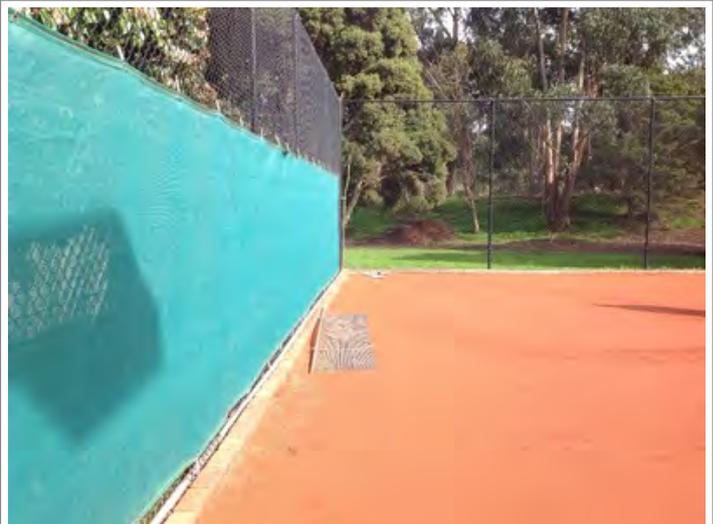
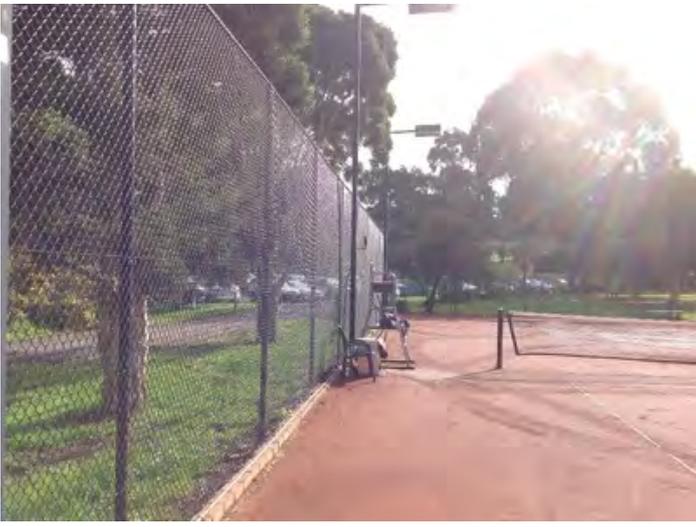
Fencing photos

Fence type	Black PVC chain mesh
Fence Rails	Fence rail top: yes Fence rail bottom: yes
Fence height	3.6m and over Low level side fencing installed: yes
Fence attachments	Sightscreens
Fence condition rating	Very Good Issues/Observations: Trees overhanging enclosure
Fencing life span	10+ years
Fence notes	The fencing is very new and only requires some trimming of a tree overhanging the western boundary. Low level fencing exists between the two courts.

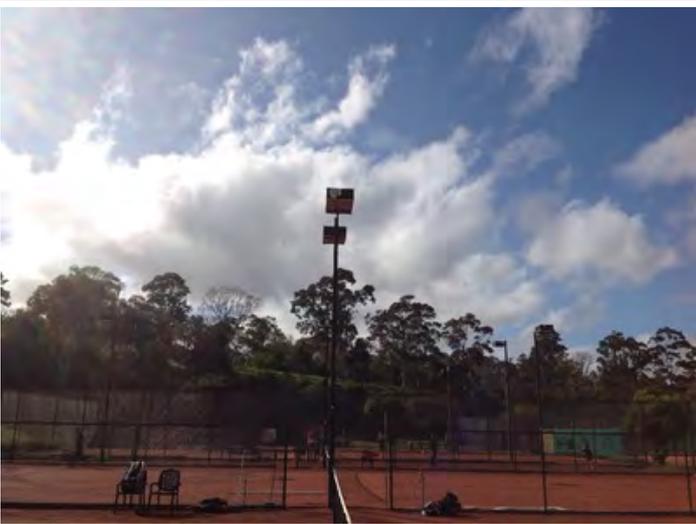
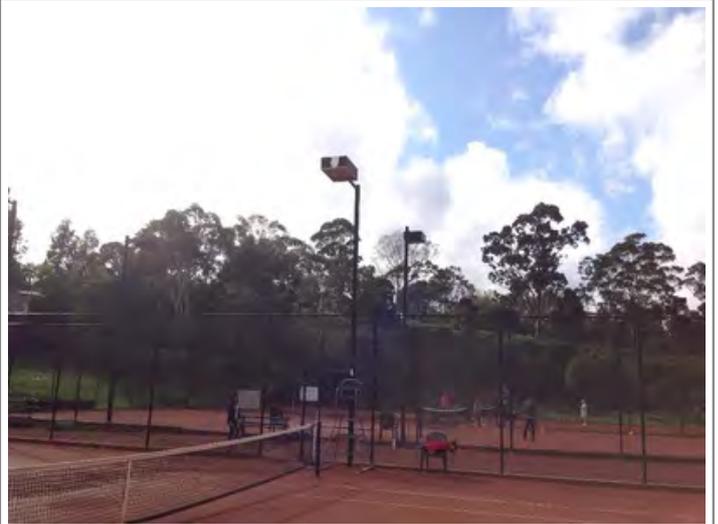
Lighting photos

Does this enclosure have lighting	Yes
Total number of lit courts per enclosure	2
Lighting infrastructure type	Black powder coated low level - Steel poles
Lighting infrastructure position	Side
Light fittings	One per tower
Lighting infrastructure design	Standard
Lighting infrastructure rating	Good
	Issues/Observations: Infrastructure and fittings in very good condition - likely to achieve required lux standards
Lighting life span	10+ years
Lighting notes	Although the lighting appears to be in very good condition, there is some paint peeling from the lighting boxes on the poles.

Court	Trim trees/shrubs away from court enclosure and fencing Hang drag mats on fencing
Drainage	
Infrastructure	Trim vegetation away from fencing
Lighting	Conduct a lighting lux level test

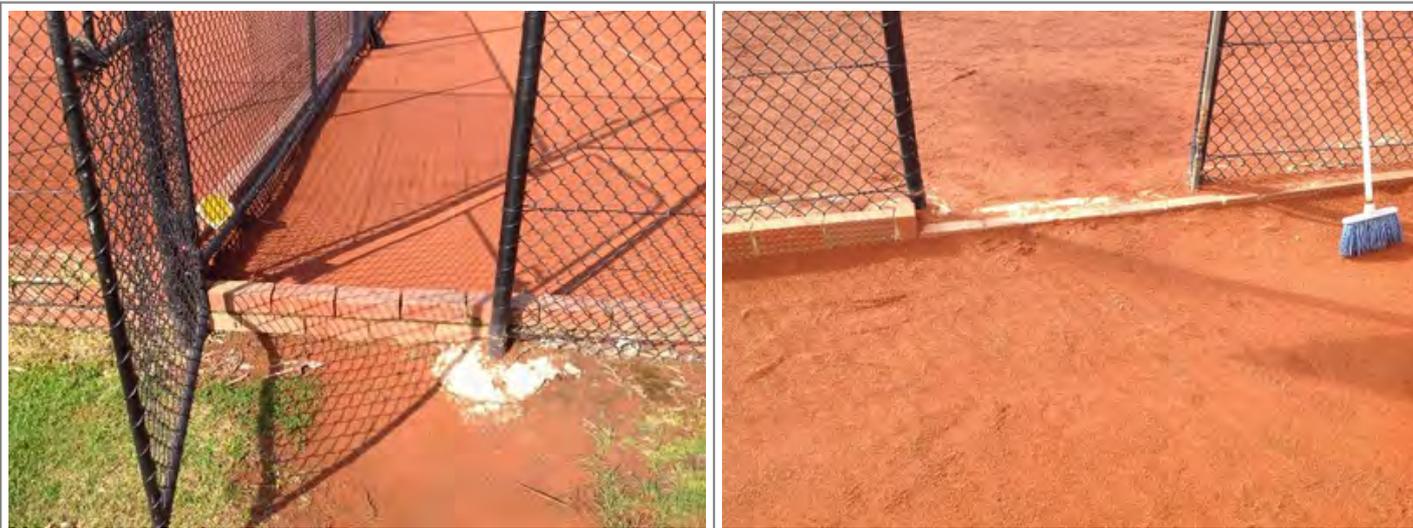
Accessibility photos

Court enclosure accessibility	Formed paths Trip hazards identified: yes Ramped access provided: no
Path material(s)	Other material?
Main gate dimensions	Standard pedestrian gate 1000mm x 2100mm
Accessibility notes	The enclosure can be accessed over grass or a red porous path, with bricks to step over in each court.

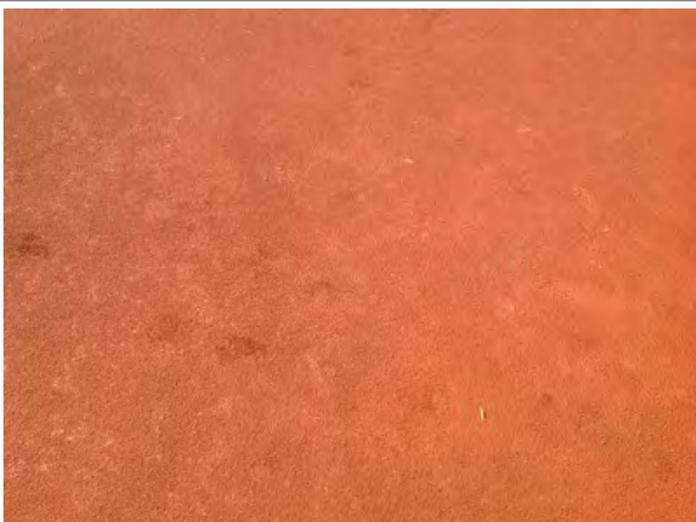
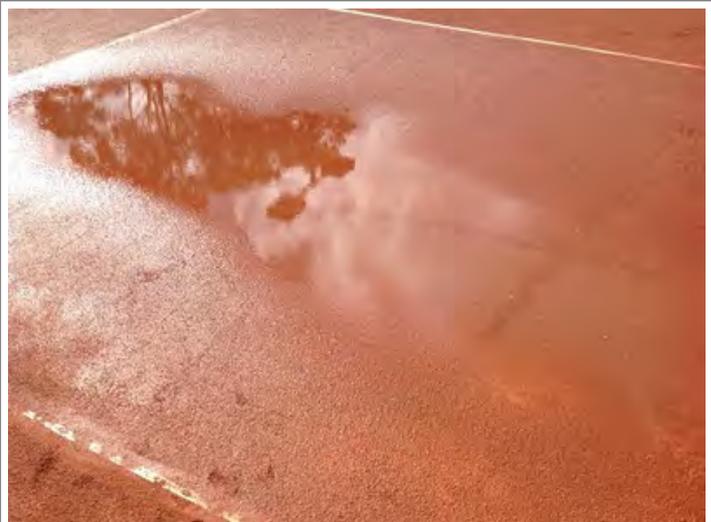
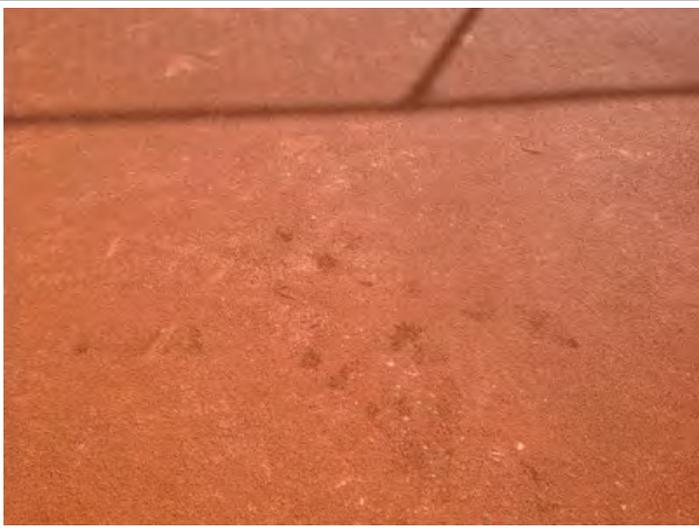
Court condition photos

Unique court number	3
Surface condition rating	Good Issues/Observations: Minor ponding evident Excessively worn surface in high wear areas
Surface type	Red Porous
Surface life span	10+ years
Court condition notes	The court is in good condition with a good covering of top dressing. It is starting to wear in high wear areas, with aggregate showing through at the northern baseline, pooling of water near the net and more aggregate showing through at the southern baseline.

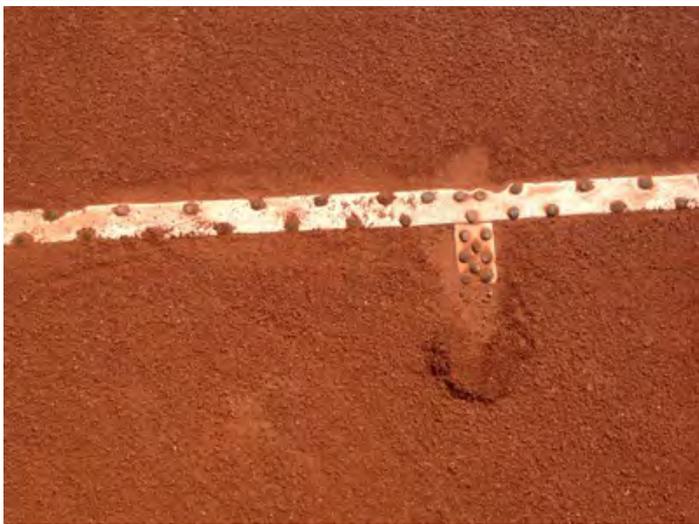
Line marking condition photos

Line marking description	Tennis only lines
Line marking rating	Good Issues/Observations: Cracked Inconsistent bounce likely
Line marking condition notes	The lines are standard for red porous courts with some sign they are beginning to wear and break in parts.

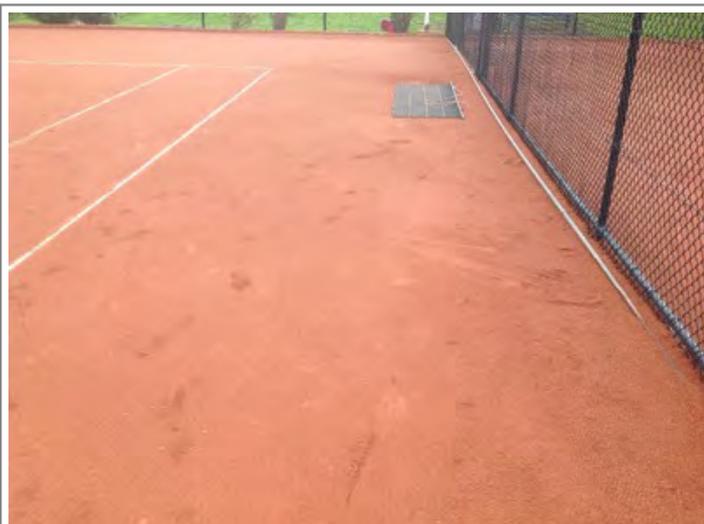
Compliance photos

Is the court run off compliant?	no Runoffs North: 6200m South: 6200m East: 3000m West: 3500m
--	--

Compliance notes	The court is borderline compliant to the eastern sideline due to cabling running inside the fence line. The court could be moved slightly to the west and would be compliant if it is not already.
-------------------------	--

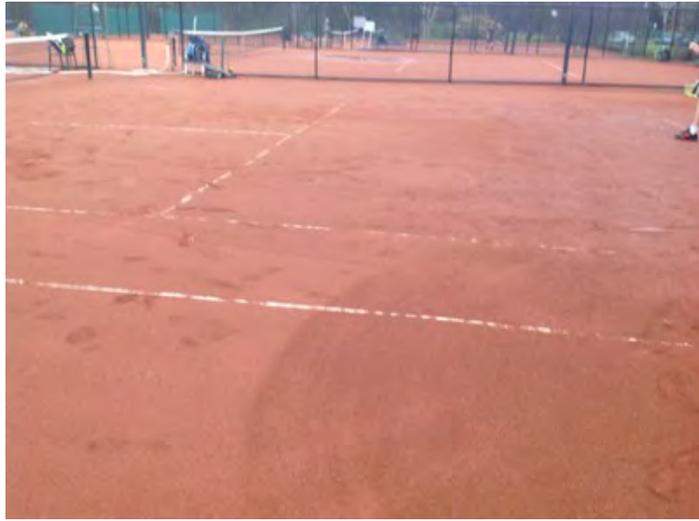
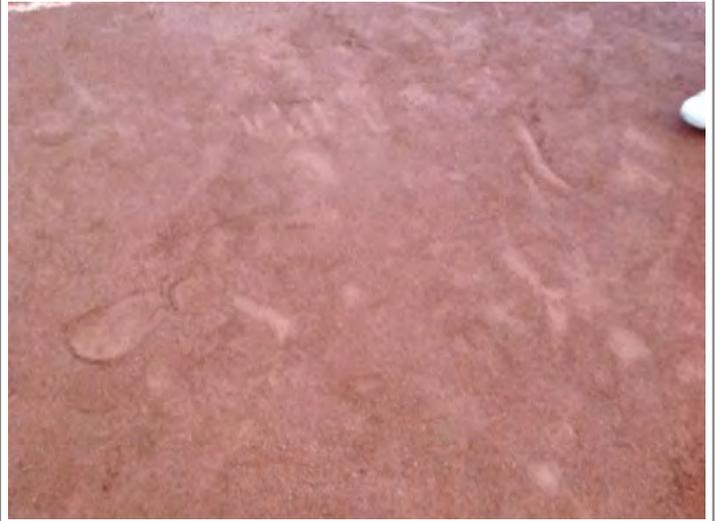
Court condition photos

Surface condition rating	Good
	Issues/Observations:
Surface type	Red Porous
Surface life span	10+ years
Court condition notes	This court appears to be less worn than court three and as a result there is less aggregate showing through the surface. The top dressing is heavy and there is a good coverage.

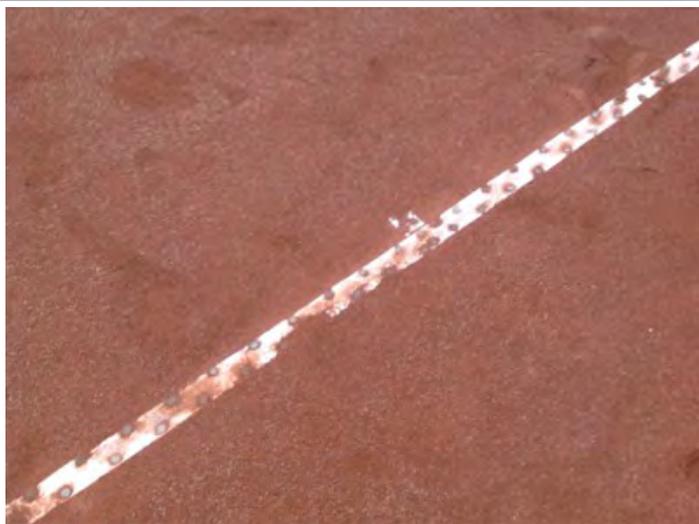
Line marking condition photos

Line marking description	Tennis only lines
Line marking rating	Good
	Issues/Observations: Inconsistent bounce likely
Line marking condition notes	The lines are standard for red porous courts and they appear to be in good condition.

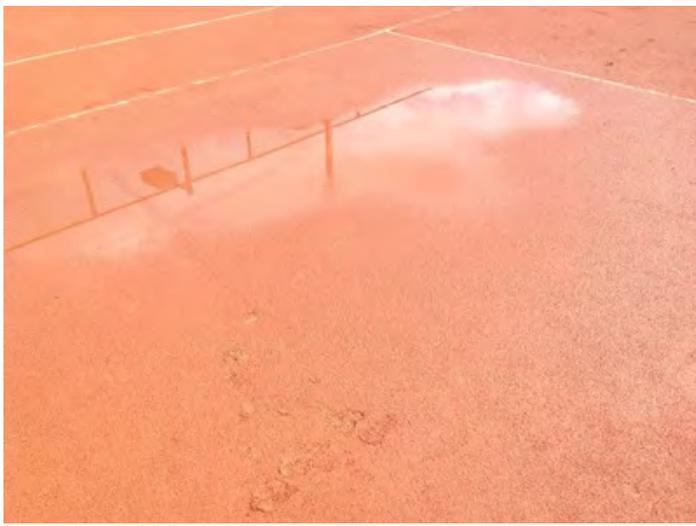
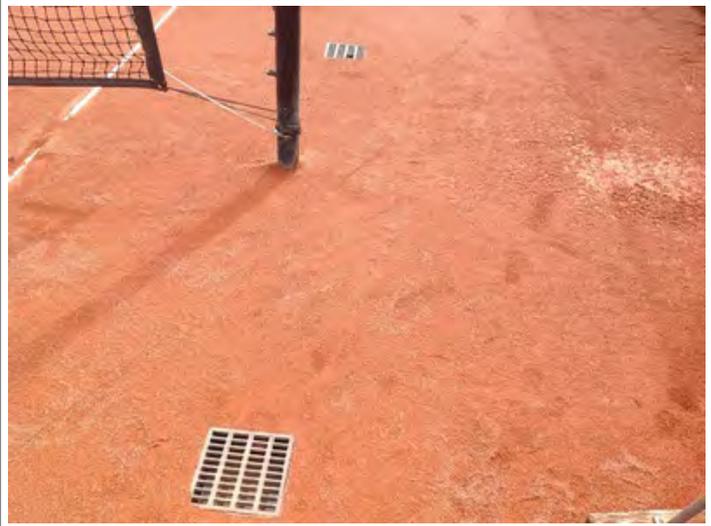
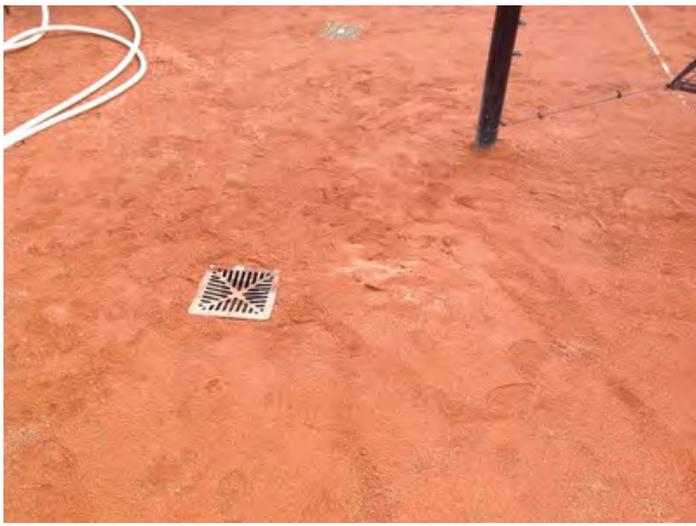
Drainage photos

Are drains, pits or other infrastructure provided within the run-off areas?	no
Drainage rating	Good Issues/Observations: Ponding evident
Drainage notes	There are grated pits in the centre of the enclosure, adjacent to each court. There is also a pit in the south eastern corner and south western corner. There is some pooling of water in the enclosure although this does not effect the the whole area.

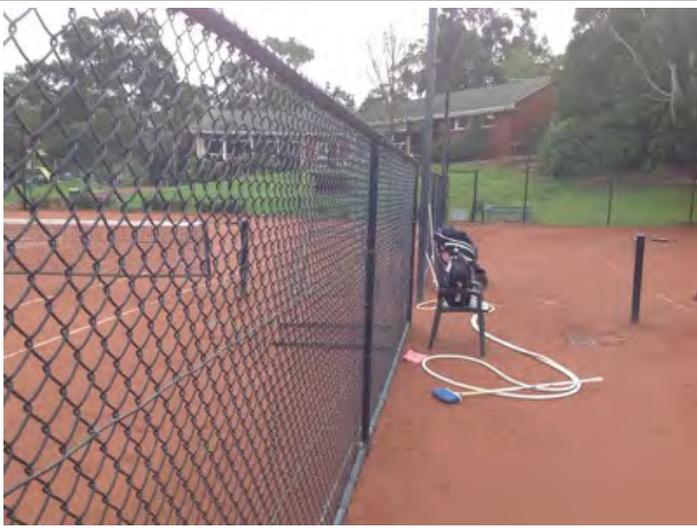
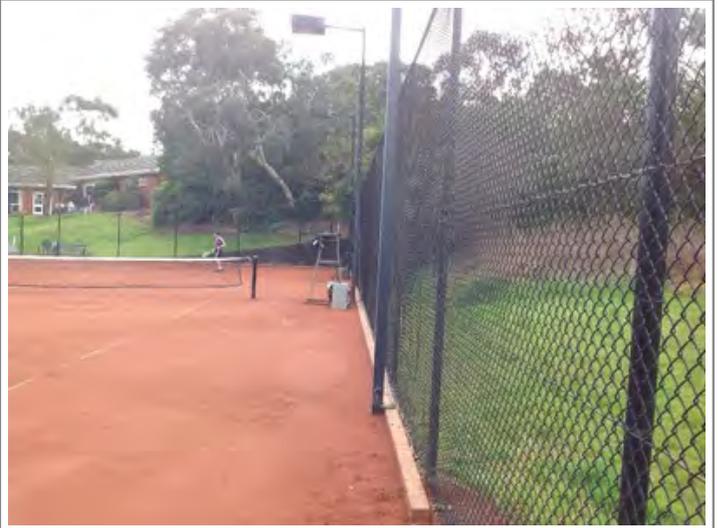
Fencing photos

Fence type	Black PVC chain mesh
Fence Rails	Fence rail top: yes Fence rail bottom: yes
Fence height	3.6m and over Low level side fencing installed: yes
Fence attachments	There are no fence attachments.
Fence condition rating	Very Good Issues/Observations: Trees overhanging enclosure
Fencing life span	10+ years
Fence notes	The fencing is very new and only requires some trimming of a tree overhanging the eastern boundary. Low level fencing exists between the two courts.

Are there any critical safety issues?	No
Enclosure recommendations	Trim tree from eastern fence line. Continue to maintain good level of top dressing on court.

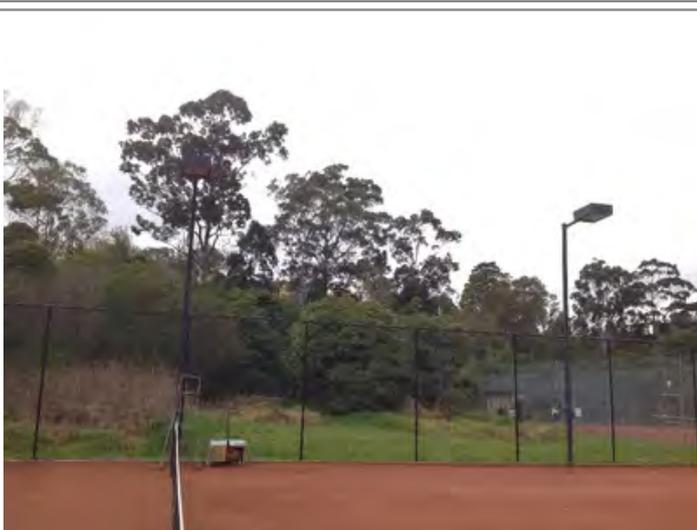
Lighting photos

Does this enclosure have lighting	Yes
Total number of lit courts per enclosure	2
Lighting infrastructure type	Black powder coated low level - Steel poles
Lighting infrastructure position	Side
Light fittings	One per tower
Lighting infrastructure design	Standard
Lighting infrastructure rating	Good
	Issues/Observations: Infrastructure and fittings in very good condition - likely to achieve required lux standards
Lighting life span	10+ years
Lighting notes	The lighting appears to be in very good condition.

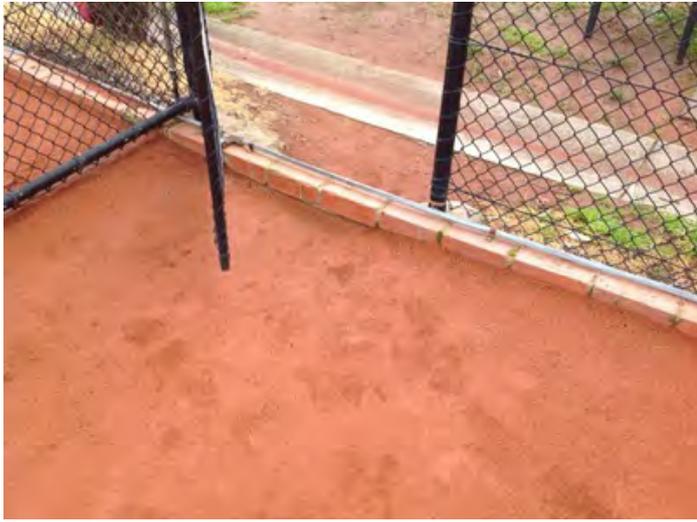
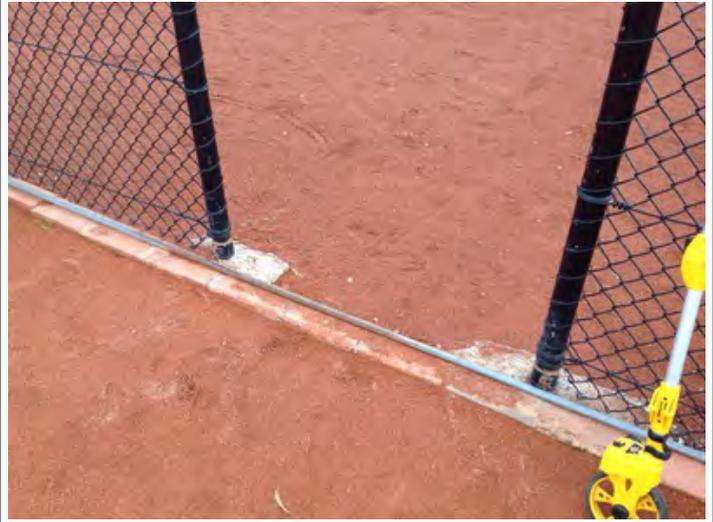
Accessibility photos

Court enclosure accessibility	Formed paths Trip hazards identified: yes Ramped access provided: no
Path material(s)	Other material?
Main gate dimensions	Standard pedestrian gate 1000mm x 2100mm
Accessibility notes	The enclosure can be accessed over grass or a red porous path, with bricks to step over in each court.

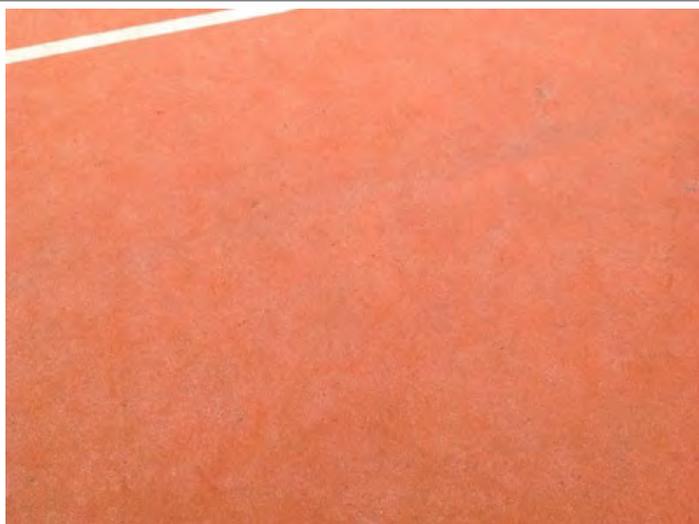
Court condition photos

Unique court number	5
Surface condition rating	Good Issues/Observations: Debris present mainly around the perimeter Excessively worn surface in high wear areas
Surface type	Synthetic Clay
Surface life span	4-5 years
Court condition notes	The court does not appear to suffer from any seam stress, although does appear to be quite worn behind the baselines. The court also undulates in places.

Are there any critical safety issues?	No
Enclosure recommendations	Trim trees from western fence line. Plan for surface replacement within the next ten years.

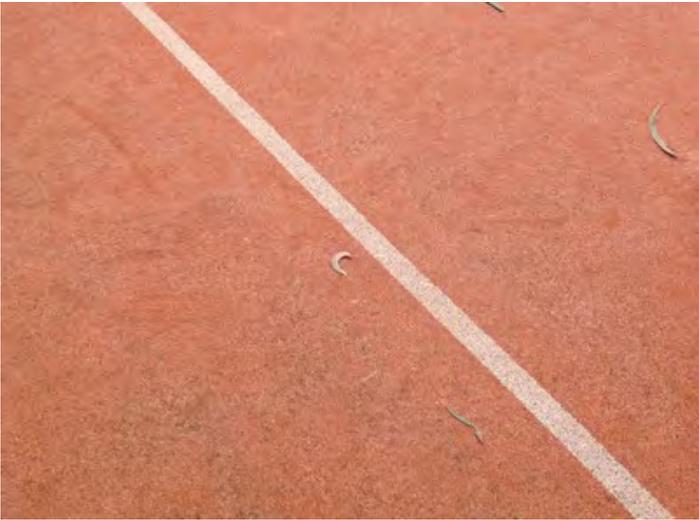
Line marking rating	Good Issues/Observations: Clear and bright Straight and clean
Line marking condition notes	The lines are in the same condition as the rest of the court.
Line marking condition photos

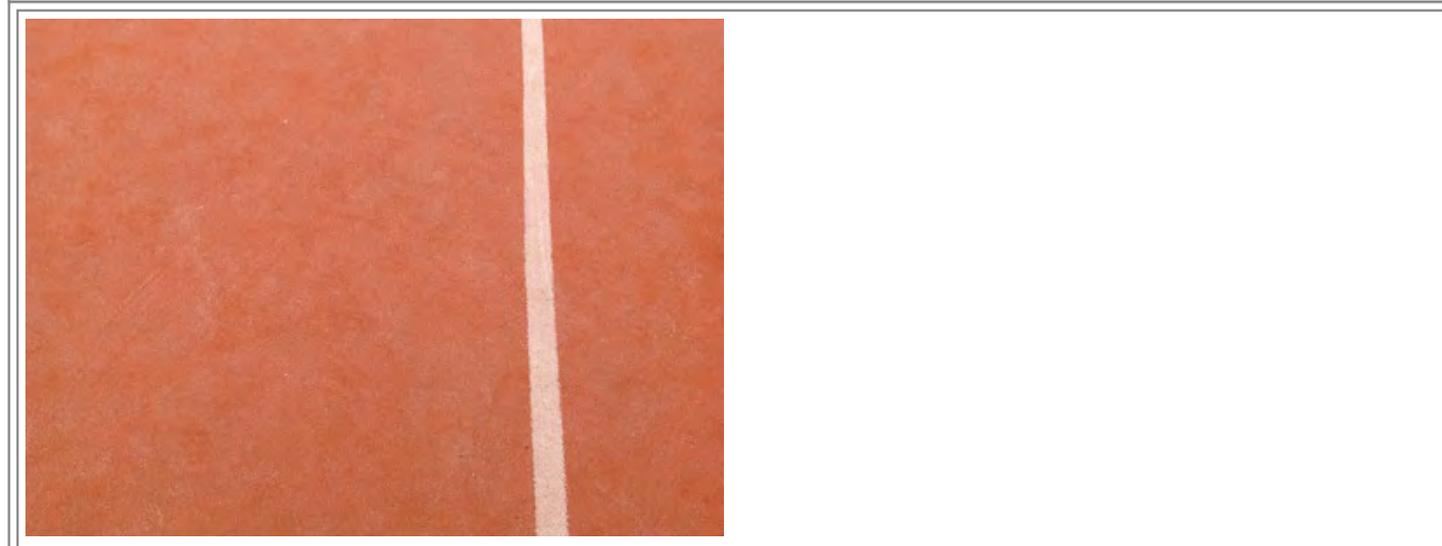
Court condition photos

Unique court number	6
Surface condition rating	Good Issues/Observations: Excessively worn surface in high wear areas
Surface type	Synthetic Clay
Surface life span	4-5 years
Court condition notes	The court does not appear to suffer from any seam stress, although does appear to be quite worn behind the baselines. The court also undulates in places.

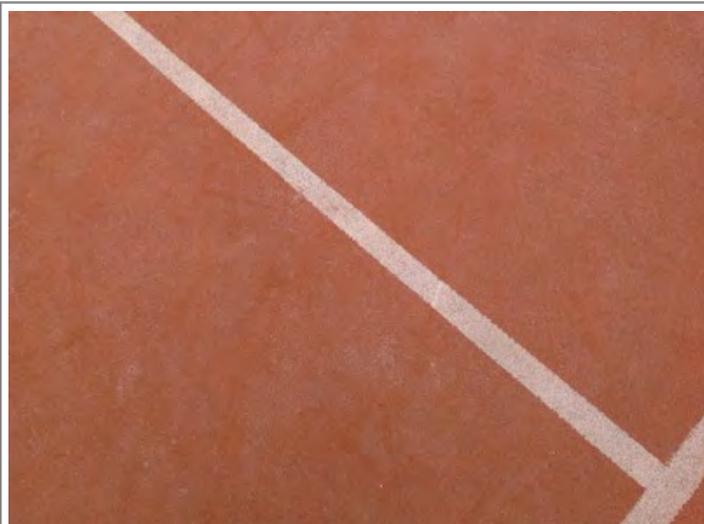
Line marking condition photos

Line marking condition notes	The lines are in the same condition as the rest of the court.
------------------------------	---

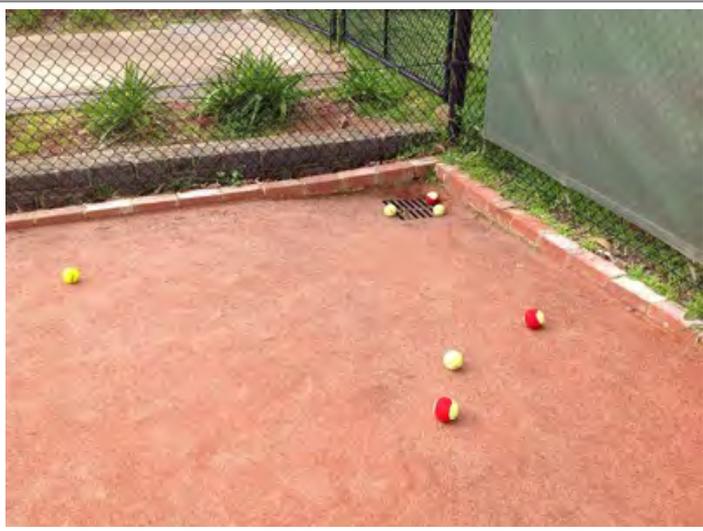
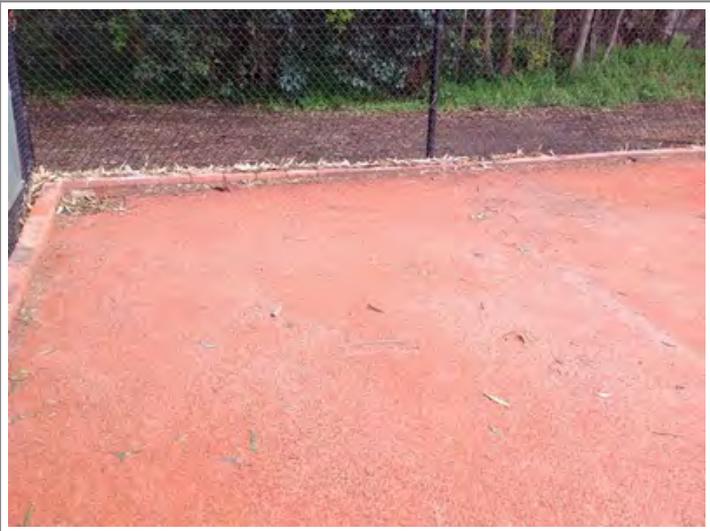
Drainage photos

Drainage infrastructure	Formed
What type of drainage is in place?	Grated pit(s)
Are drains, pits or other infrastructure provided within the court enclosure?	yes
Are drains, pits or other infrastructure provided within the run-off areas?	no
Drainage rating	Good Issues/Observations: Ponding evident Leaf litter build up
Drainage notes	Grated pits exist in the south western and eastern corners of the enclosure. There is no sign of significant pooling of water on the surface. Some silt and leaf litter build up is evident in the south western corner.

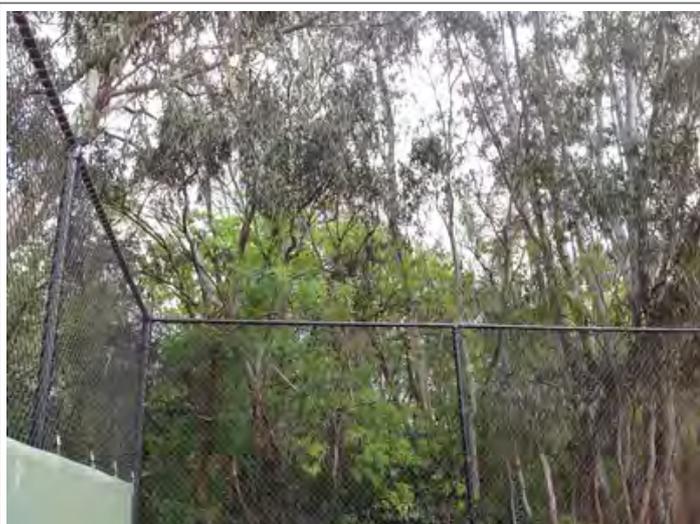
Fencing photos

Fence type	Black PVC chain mesh
Fence Rails	Fence rail top: yes Fence rail bottom: no
Fence height	3.6m and over Low level side fencing installed: yes
Fence attachments	Windbreaks
Fence condition rating	Very Good Issues/Observations: Trees overhanging enclosure
Fencing life span	10+ years
Fence notes	The fencing is very new and requires only some trimming of branches on the western fence line.

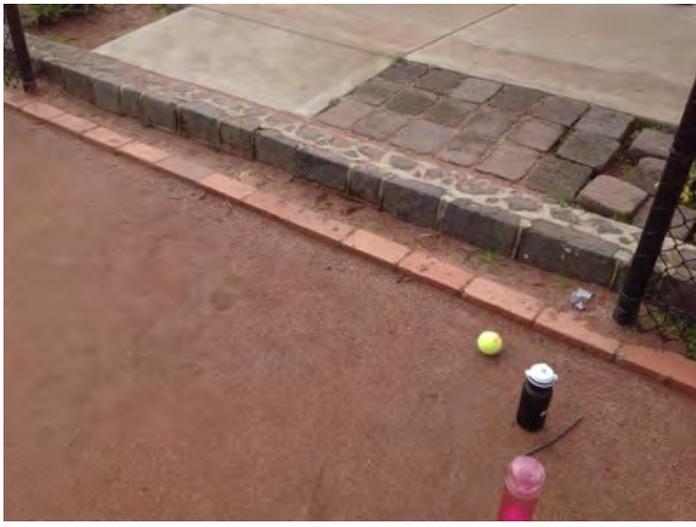
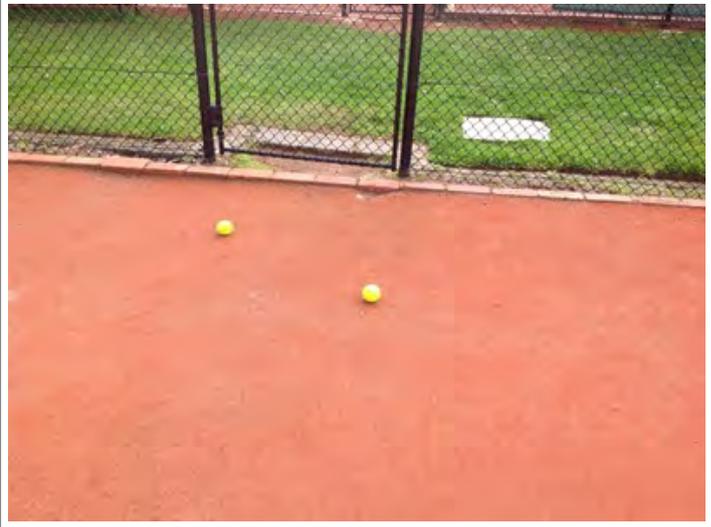
Accessibility photos

Accessibility notes The enclosure can be accessed over grass or a concrete path, with bricks to step over in each court.

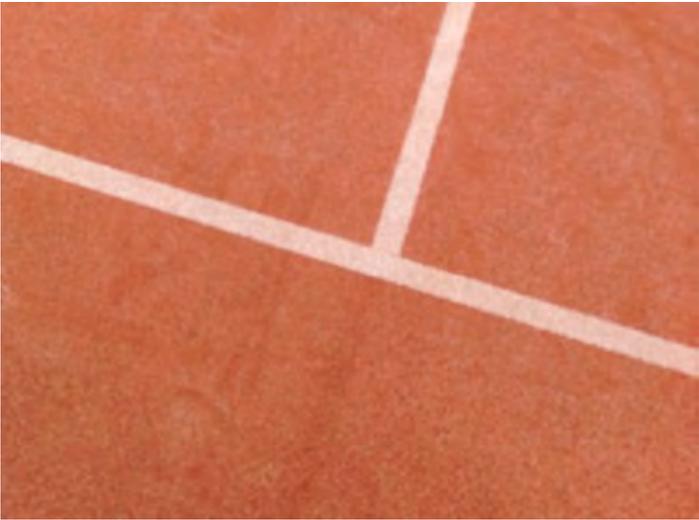
Line marking rating	Good Issues/Observations: Clear and bright Straight and clean
Line marking condition notes	The lines are in the same condition as the rest of the court.
Line marking condition photos

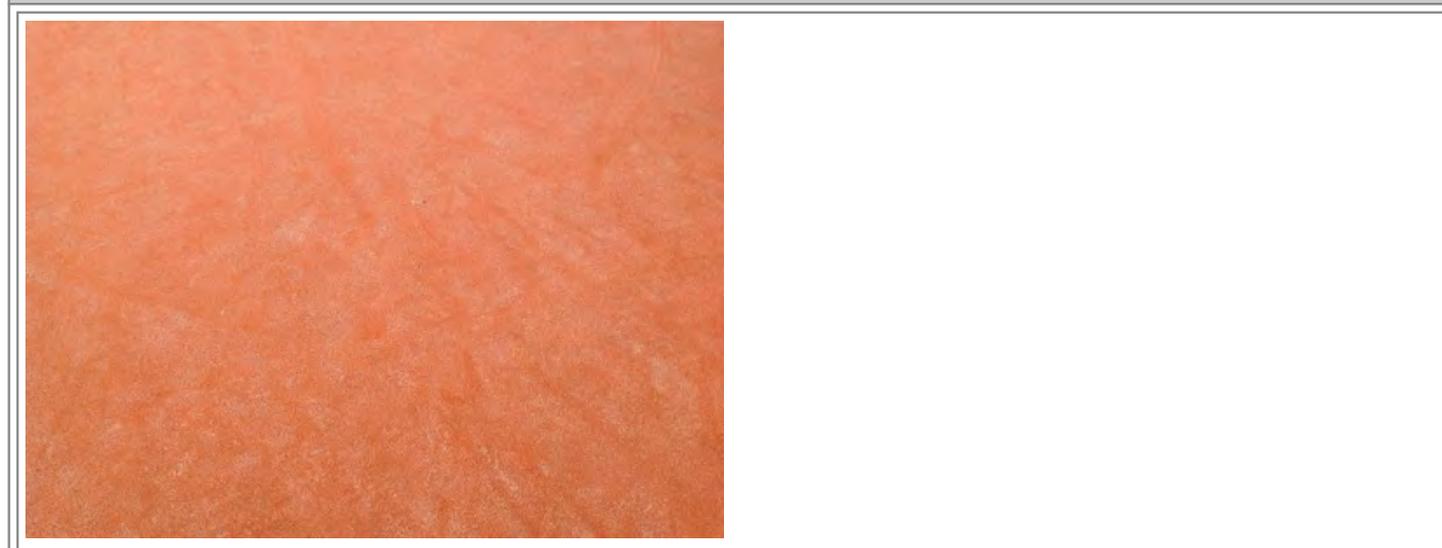
Court condition photos

Unique court number	8
Surface condition rating	Good Issues/Observations: Excessively worn surface in high wear areas
Surface type	Synthetic Clay
Surface life span	4-5 years
Court condition notes	The court does not appear to suffer from any seam stress, although does appear to be quite worn behind the baselines. The court also undulates in places.

Are there any critical safety issues?	No
Enclosure recommendations	Trim trees from fence line. Plan for surface replacement within the next ten years.

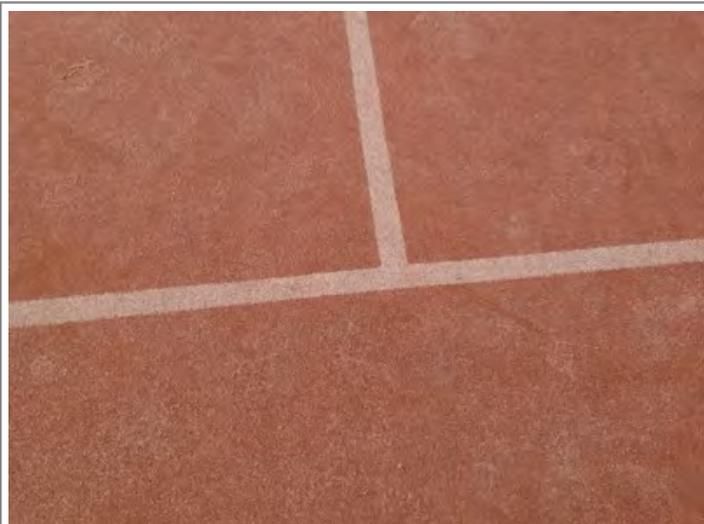
Line marking condition photos

Line marking condition notes	The lines are in the same condition as the rest of the court.
-------------------------------------	---

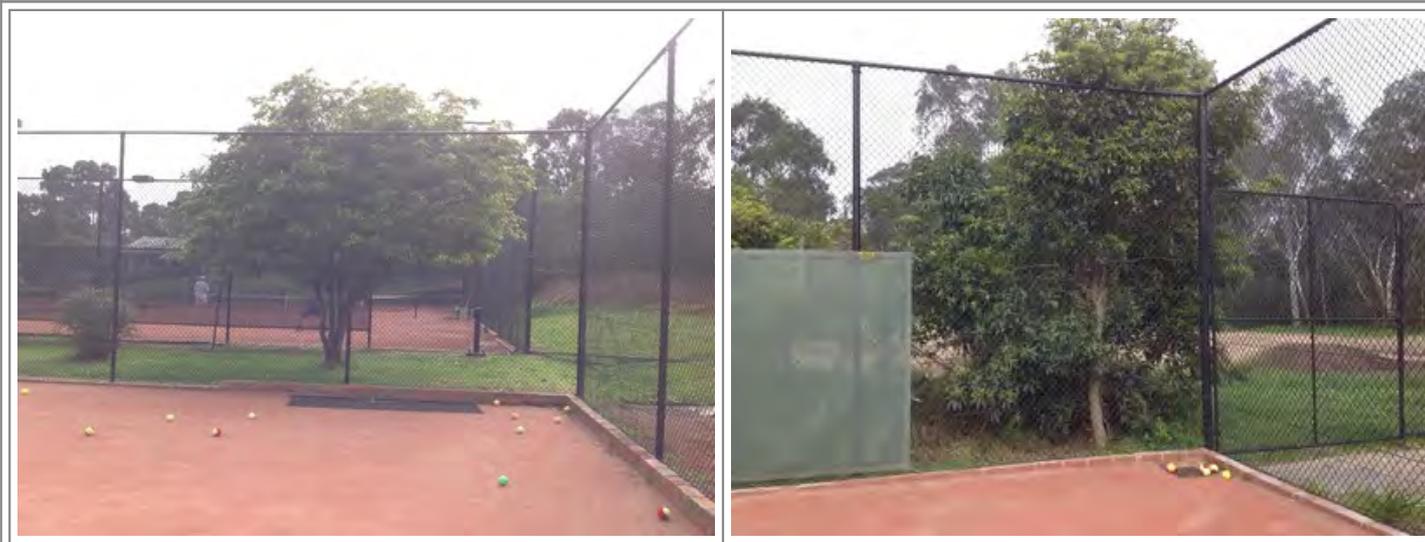
Fencing photos

Fence Rails	Fence rail top: yes Fence rail bottom: no
Fence height	3.6m and over Low level side fencing installed: yes
Fence attachments	Windbreaks
Fence condition rating	Very Good Issues/Observations: Trees overhanging enclosure
Fencing life span	10+ years
Fence notes	The fencing is very new and requires only some trimming of branches in the south western and north eastern corner.

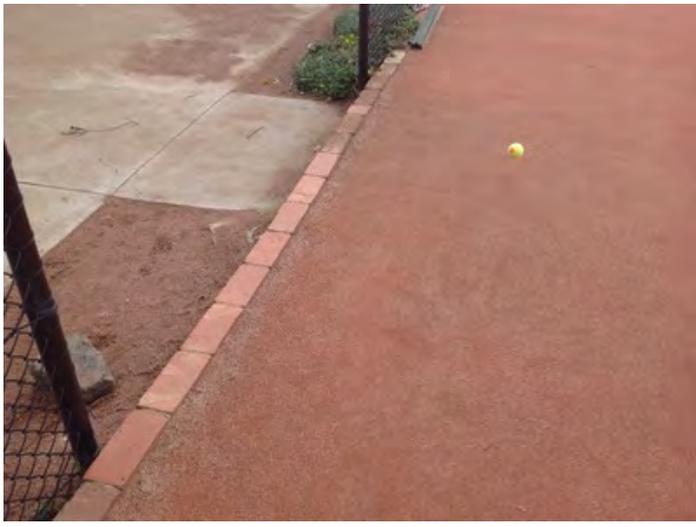
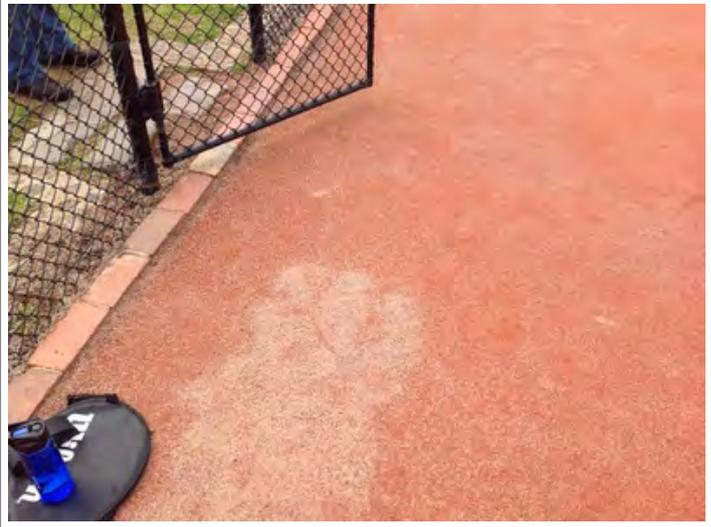
Accessibility photos

Accessibility notes The enclosure can be accessed over grass or a concrete path, with bricks to step over in each court.

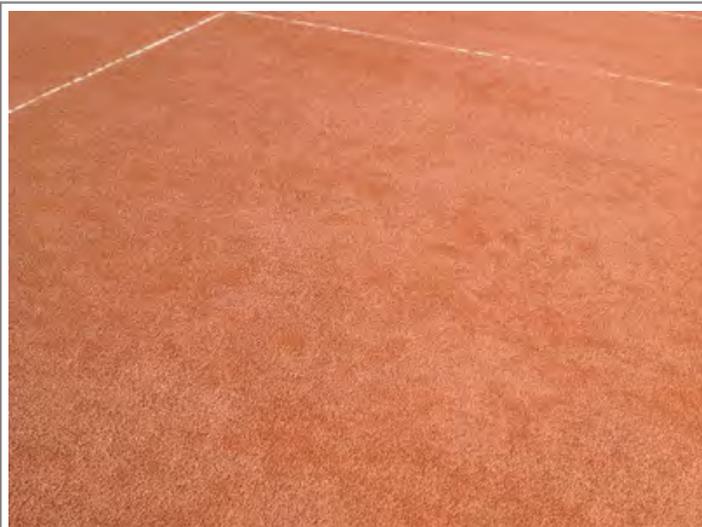
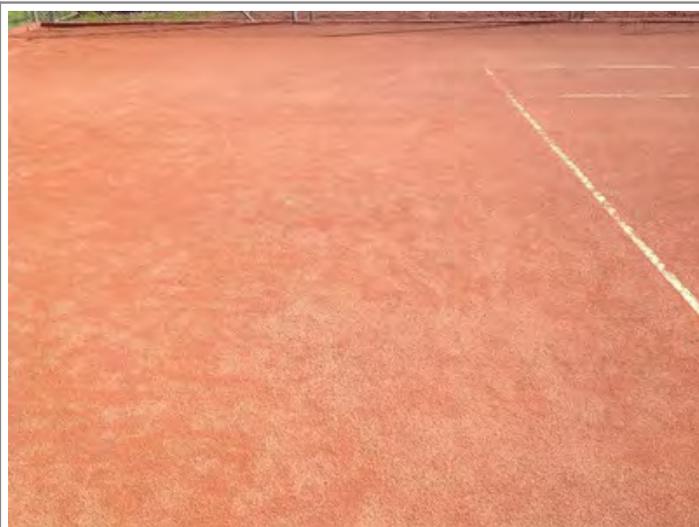
Court condition photos

Unique court number	9
Surface condition rating	Good
	Issues/Observations:
Surface type	Red Porous
Surface life span	10+ years
Court condition notes	The court is in quite good condition with little sign of aggregate showing through the court. Top dressing is adequate and even across the court.
