Burke Road North Tennis Facility Audit

Document number	000209
Client / Site	Tennis Victoria
Location	Off the Boulevard East Ivanhoe VIC 3079
Auditor	Andrew Sodomaco
Audit date	30 Aug 2015

Site summary	
Total number of enclosures	5
Total number of courts	10
Total number of floodlit courts	4
Total number of enclosed mini courts	0
Hierarchy	District

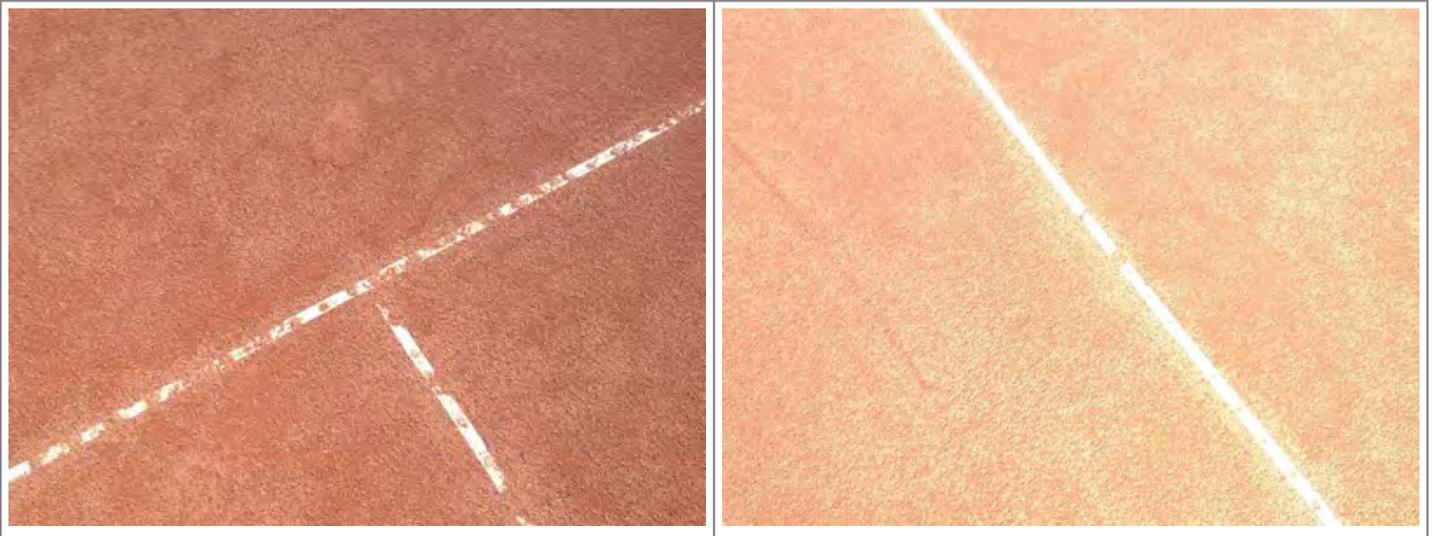
Line marking condition photos

Line marking description	Tennis only lines
Line marking rating	Moderate
	Issues/Observations: Cracked Inconsistent bounce likely

Line marking condition notes	The lines are standard for red porous courts and there are some signs of damage.
------------------------------	--

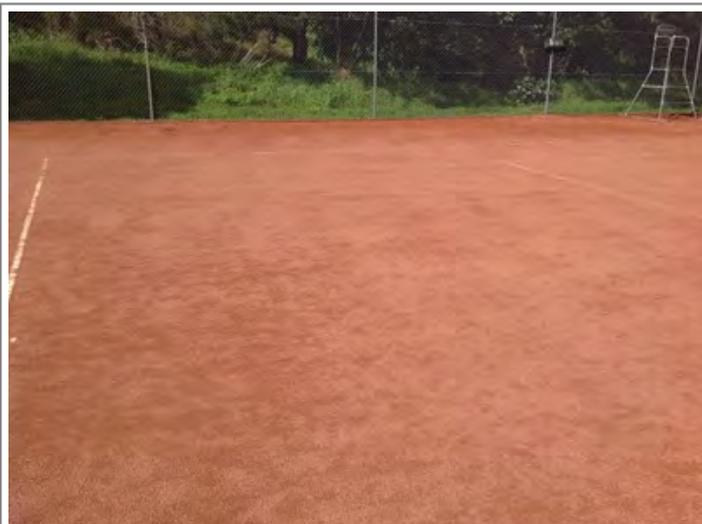
Court condition photos

Unique court number	10
Surface condition rating	Good Issues/Observations:
Surface type	Red Porous
Surface life span	10+ years
Court condition notes	The court is in quite good condition with little sign of aggregate showing through the court. Top dressing is adequate and even across the court.

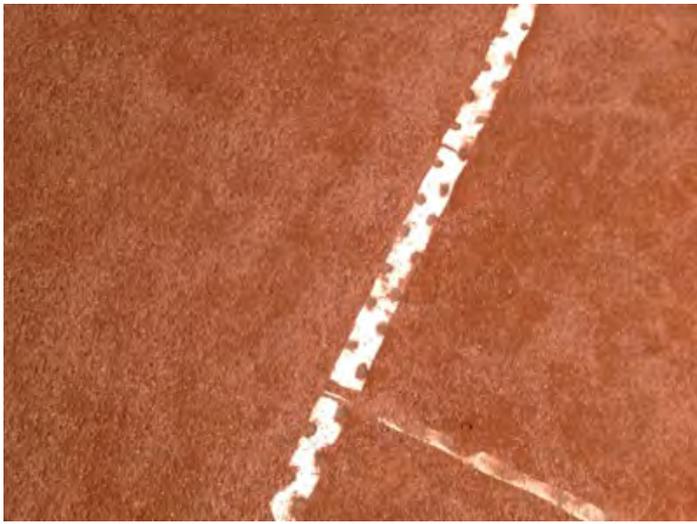
Line marking condition photos

Line marking description	Tennis only lines
Line marking rating	Moderate Issues/Observations: Cracked Inconsistent bounce likely
Line marking condition notes	The lines are standard for red porous courts and there are some signs of damage.

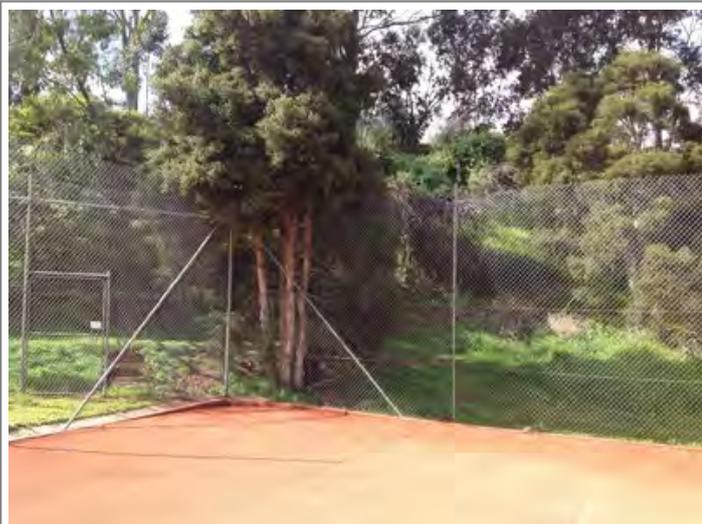
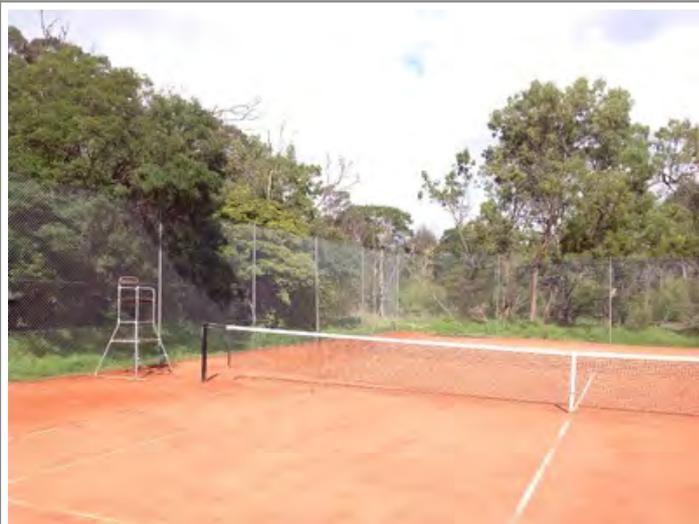
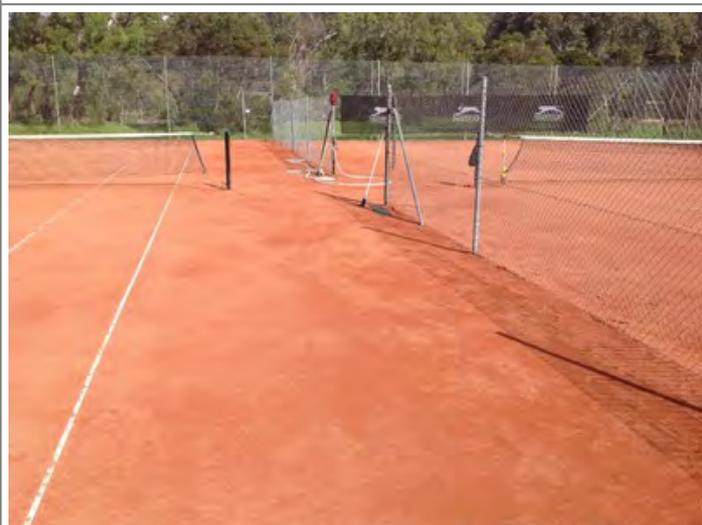
Fencing photos

Fence condition rating	Moderate Issues/Observations: Trees overhanging enclosure Trees/shrubs growing through mesh
Fencing life span	10+ years
Fence notes	The fencing is older than the other enclosures, although is in reasonable condition. In the north eastern corner, a tree has damaged the fence and need to be trimmed. Low level fencing exists between the two courts.

Accessibility notes	The enclosure can be accessed over grass or a red porous path, with bricks to step over in each court.
Accessibility photos	
No photos taken	
Maintenance, Risk management and recommendations	
Court	Trim trees/shrubs away from court enclosure and fencing Hang drag mats on fencing Repair lines
Drainage	
Infrastructure	Repair damaged fencing Trim vegetation away from fencing
Lighting	
Safety Issues	
Are there any critical safety issues?	No
Enclosure recommendations	Trim tree from fence lines and continue to maintain good level of top dressing on court.

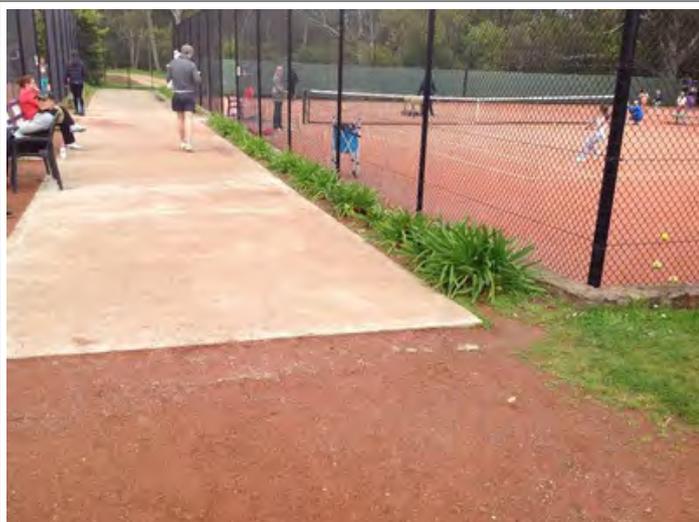
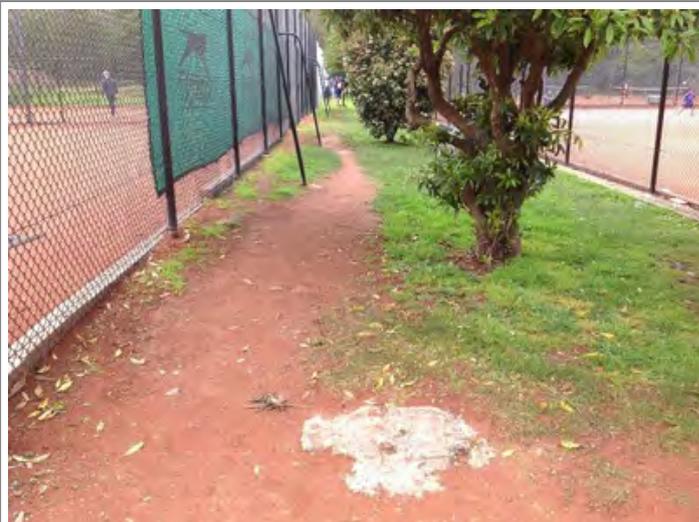
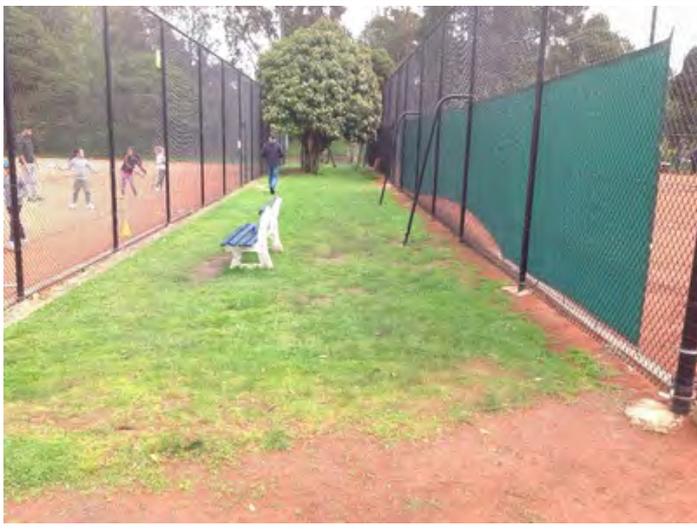
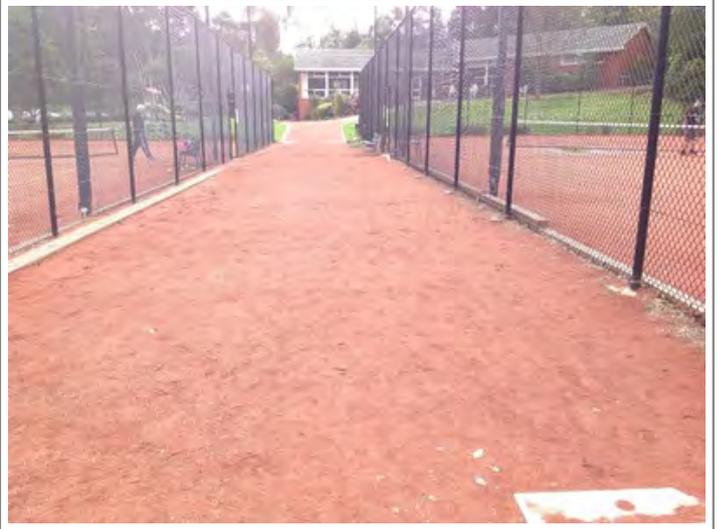
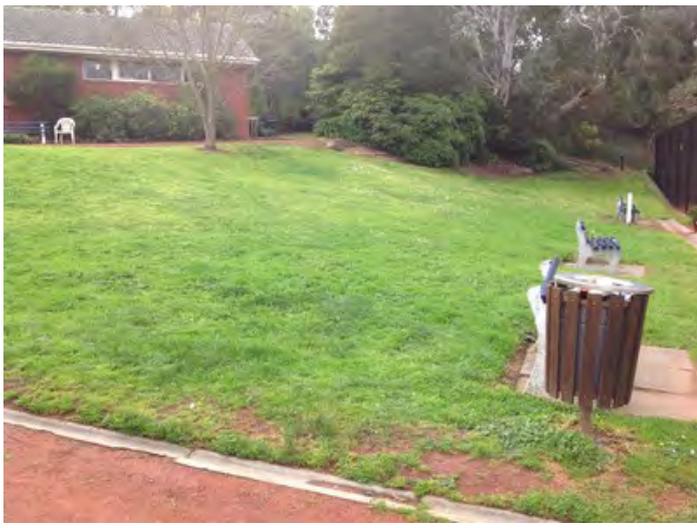
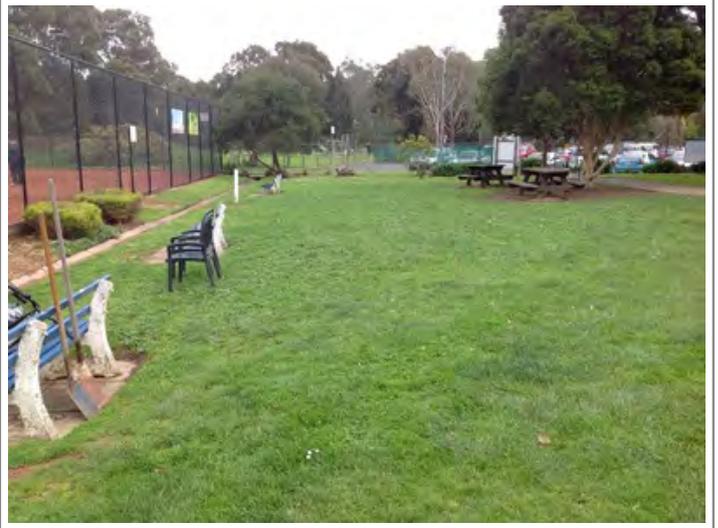
Grounds and surrounds photos

Condition of ground and court surrounds	Good
Court surround notes	Paths and walkways link the clubhouse and court enclosures, with a number of trees and shrubs located throughout the venue. Most infrastructure appears to be in very good condition.
Water supply	Potable
Water notes	
Natural Shade	Sufficient shade available within viewing range
Man made Shade	Purpose built shelter
Shade notes	
Car parking	On street: Off street: 41-60 spaces Overflow:
Does the site have any hit up walls	no
Car park notes	A car park services the tennis club and parklands adjacent.
Adjacent facilities	Park/playground
Does the site have any potential expansion opportunities?	The site could potentially expand south into the bmx track area.

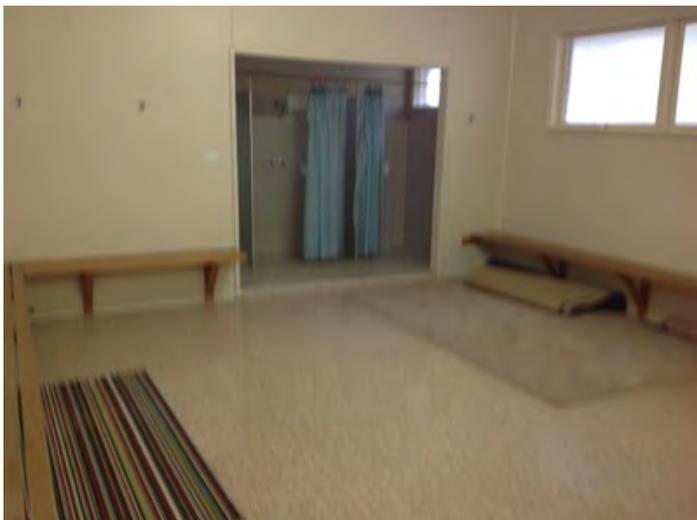
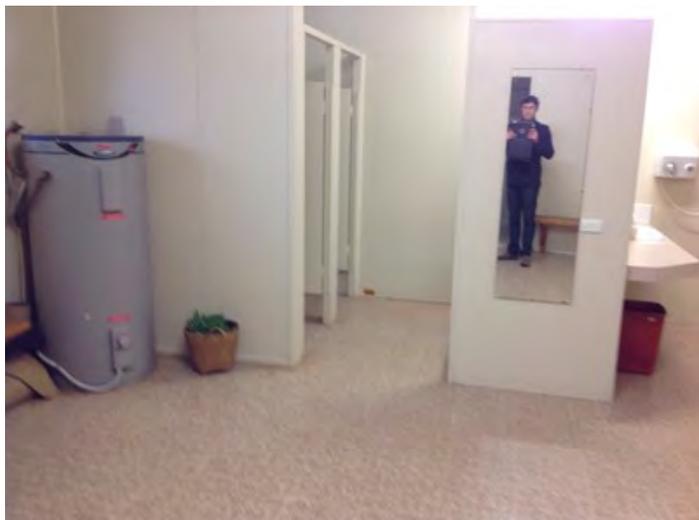
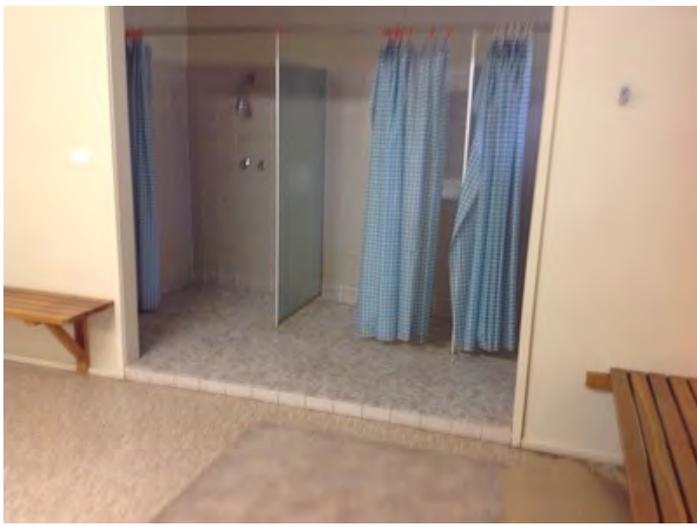
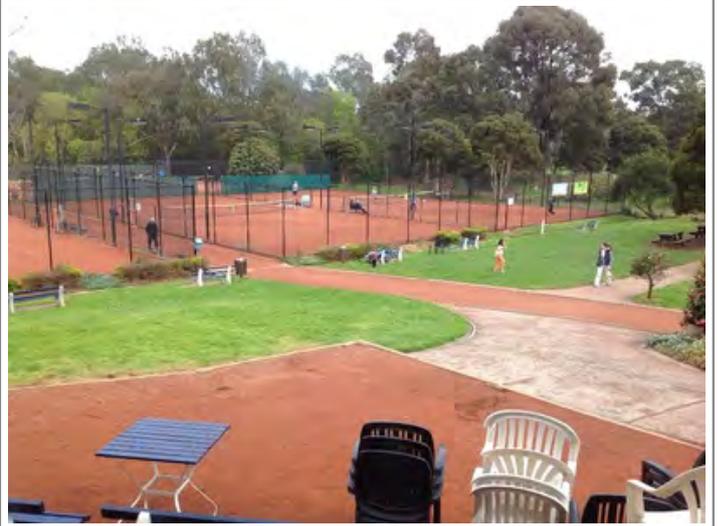
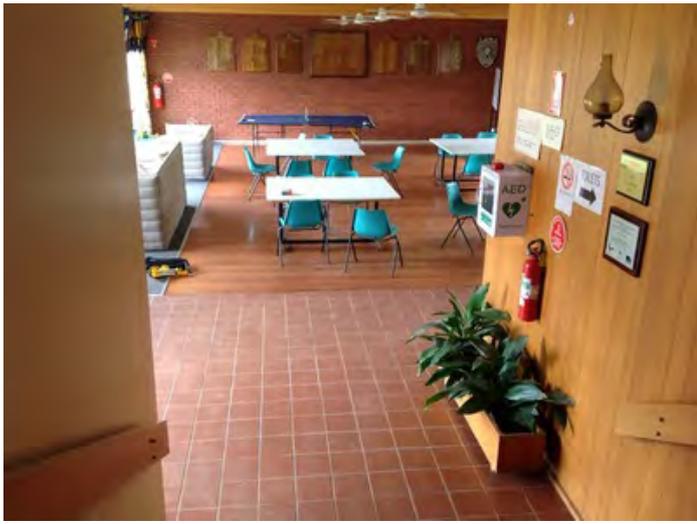
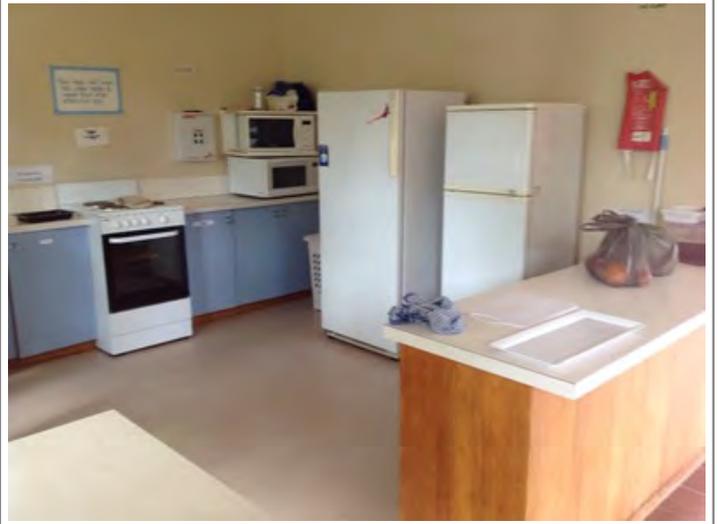
Clubroom condition photos

Building Condition	Good
Estimated building age	30+ years
Building materials	Brick
Accessible entry to building	no
Kitchen	Standard
Bar	no
Player change rooms	Male: 1 Female: 1 Unisex: 0
Social area	101 m2
Social area comments	The social area looks out over the courts and provides ample seating and a large kitchen.
Toilets	Male: yes Female: yes Accessible: no
Clubroom condition notes	The clubhouse is in good condition however the male and female toilets and change rooms can only be accessed via a set of stairs from the main social area.
Other amenities provided within or outside clubrooms	Tournament box Children's play area
Other amenities condition notes	
Are there any safety concerns within clubrooms?	no
