**RE: PEER REVIEW ARBORICULTURAL TREE HEALTH AND HAZARD ASSESSMENT  
OF THE PROPOSED TREE TOP CLIMBING AND ADVENTURE FACILITY BY ECOLINE**

**Yarra Flats Park  
East Ivanhoe**

**Otto Leenstra  
Principal Consultant Arborist**

**2<sup>nd</sup> June 2021**

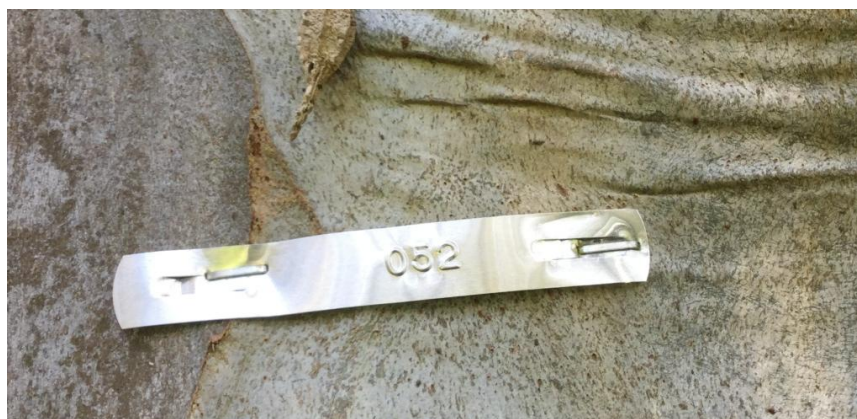
As presented in the Executive Summary in section 2, the main shortcoming of the Arborist Report is an inability easily correlate the recommendations made, with the trees onsite. To address this each tree must be numbered with a numbered tag. On trees such as River Red Gums a 14 mm staple would not be a significant injury to the tree. As an example the six trees that information was collected on were tagged as shown in the following photograph.

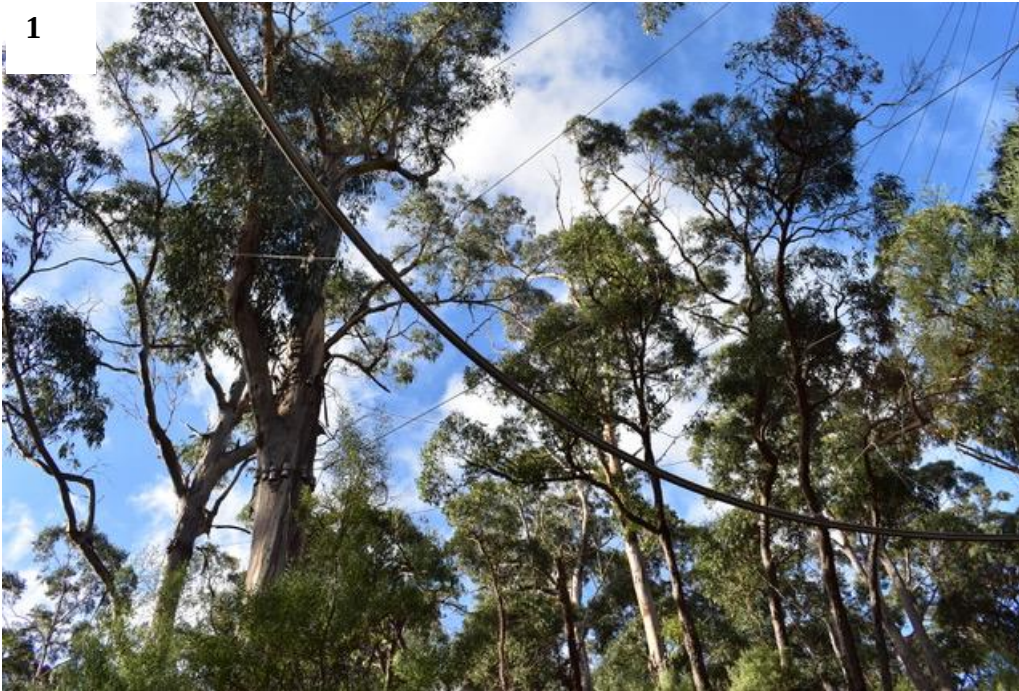
**Plate 1 Above** - This is the existing called the Shock Wave Zip Coaster constructed by Ecoline. Tree Protection and attachment methods are shown in **Plate 2**. The canopy density and health indicators of these trees remain within normal limits.

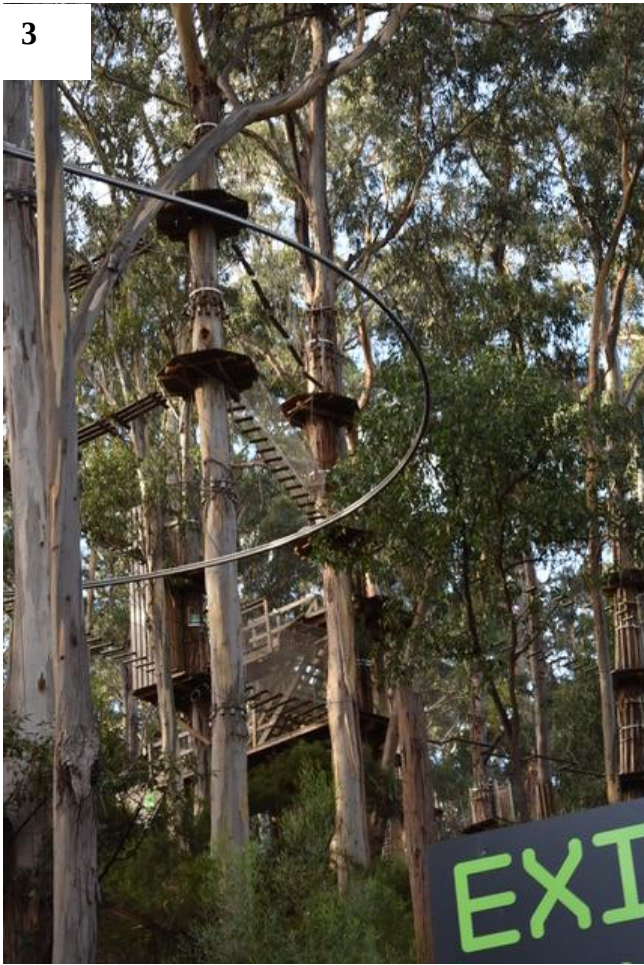
3

**Plate 3** This photograph shows the Tree top adventure course also associated with the Livewire park in Lorne. The course is amongst predominantly Victorian Blue Gums. There health indicators are within normal limits with normal foliage density.

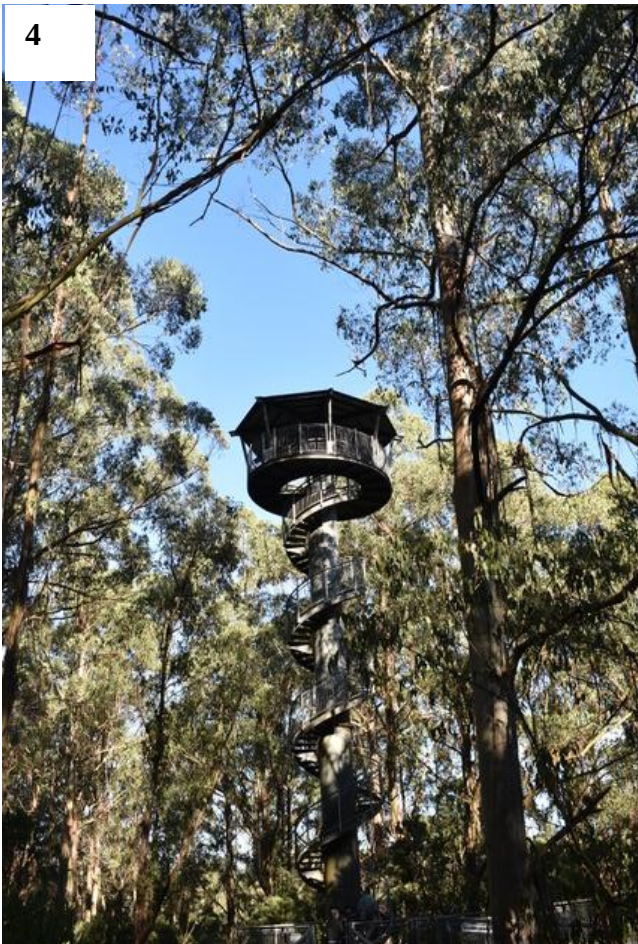
4

**Plate 4** The Iconic Otway Fly. 8 metre sections of this structure were transported along the paths and erected onsite. There is no sign of any impacts to the Mountain Ash Forest

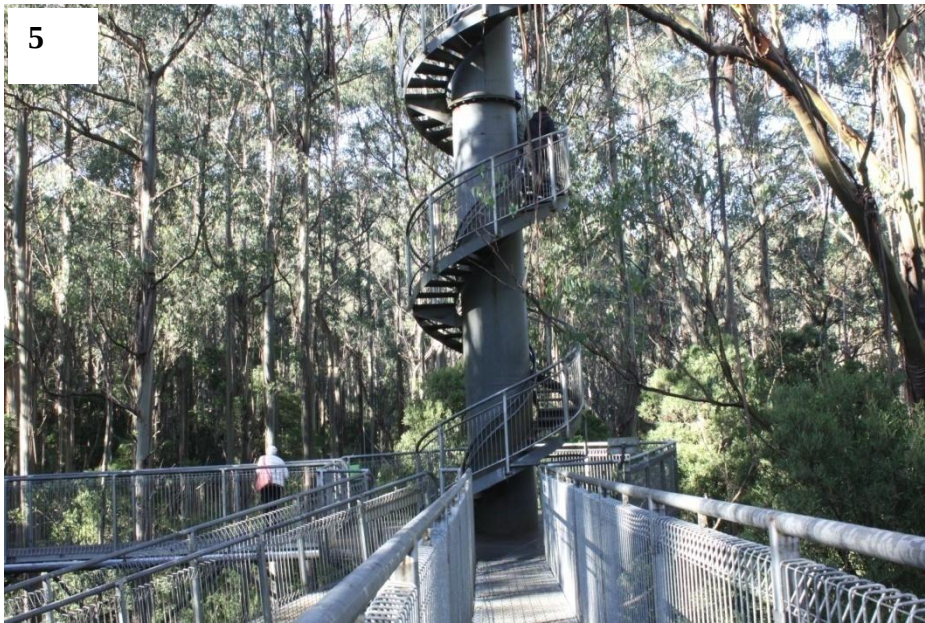
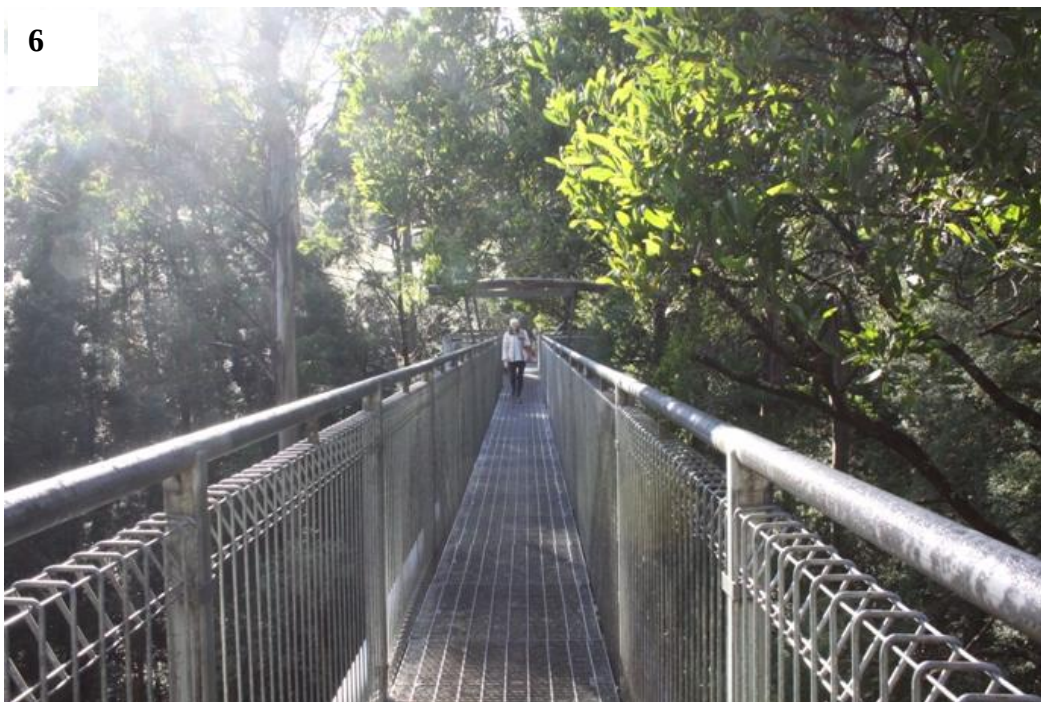
**Plate 5** (above) and **plate 6** below. This substantial structure was assembled in this wet forest. It represents the more extreme development and yet it is now an integral part of the forest

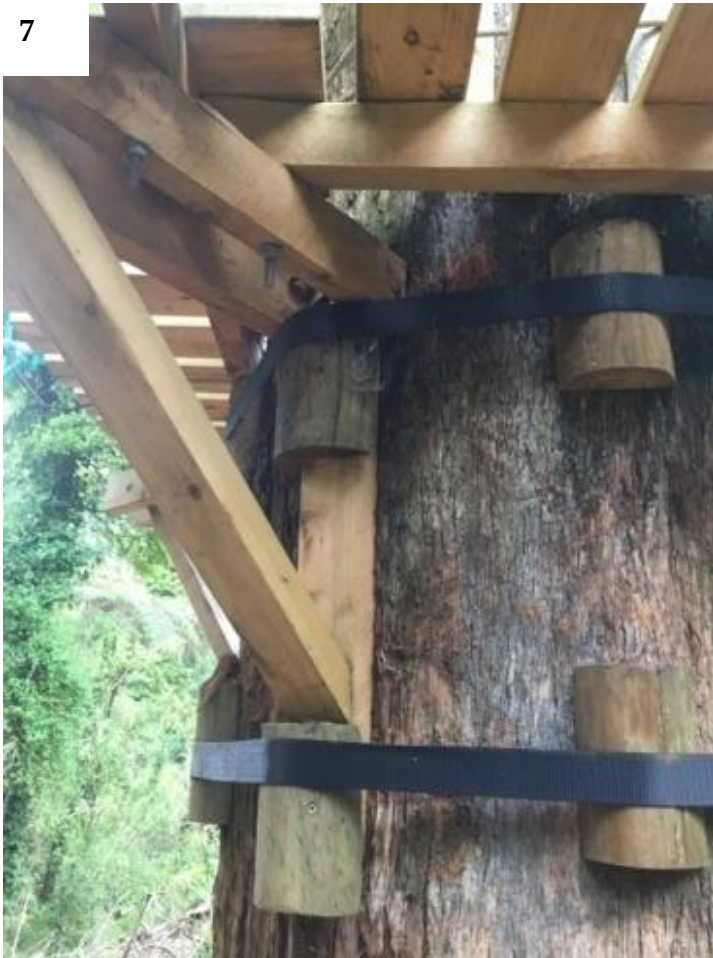
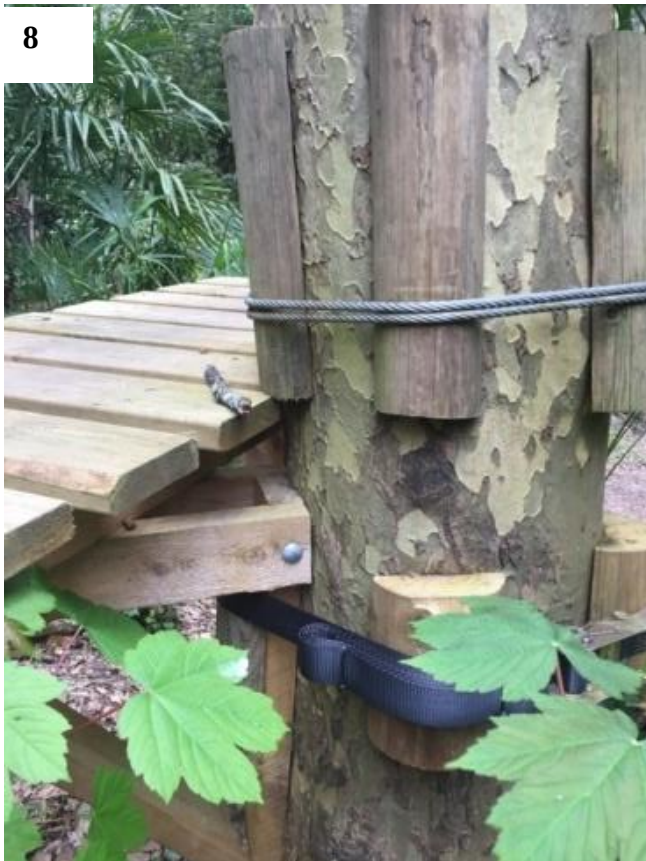
7

**Plate 7** This is the closeup of attachment methods at the Glen Harrow Park in Belgrave. There are no locating spikes with all platforms mounded with adjustable ratchet straps and **Plate 8** cables

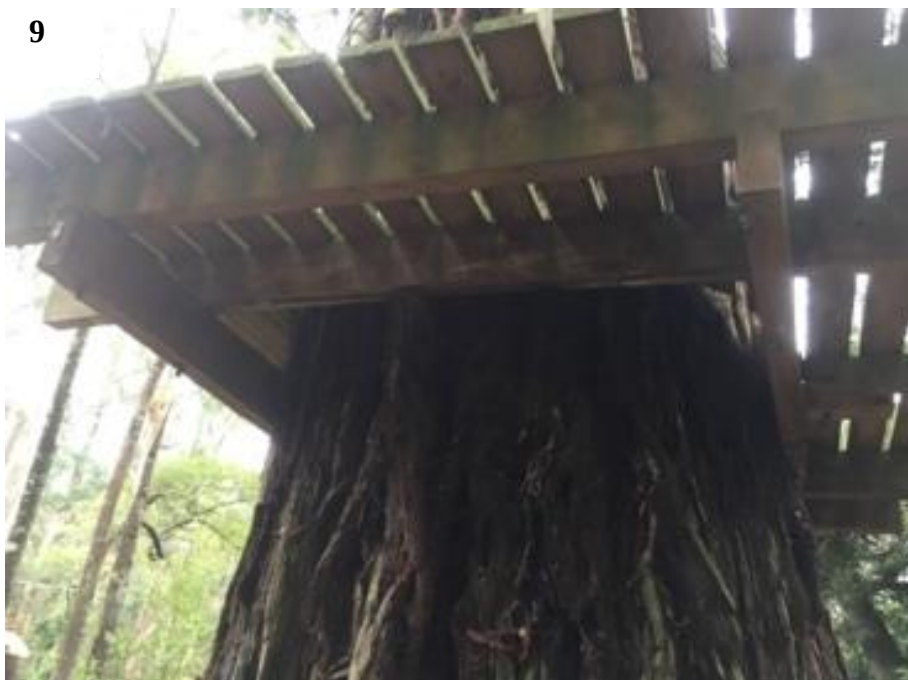
9

**Plate 9** This photograph is a of a platform setup at the Enchanted Maze. The course is located in a Messmate Stringybark Woodland area

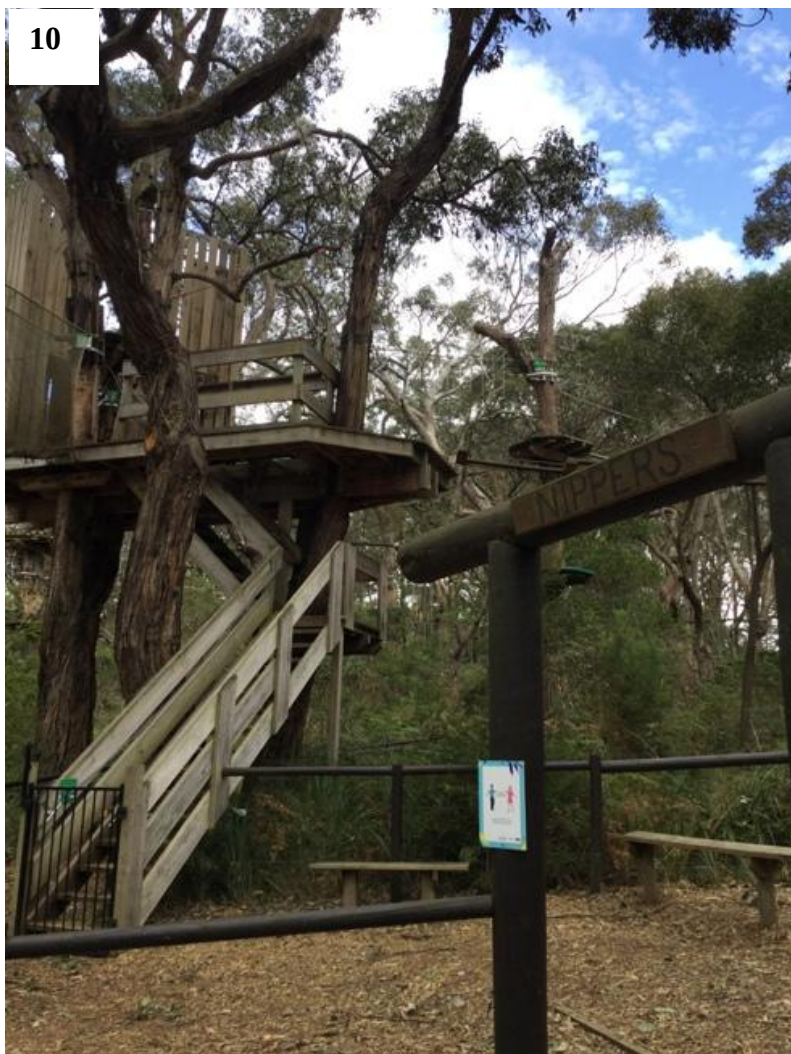
10

**Plate 10** This photograph shows a more substantial construction at the start of one of the courses. The canopy density of the trees is a good indicator of stress and remains normal.

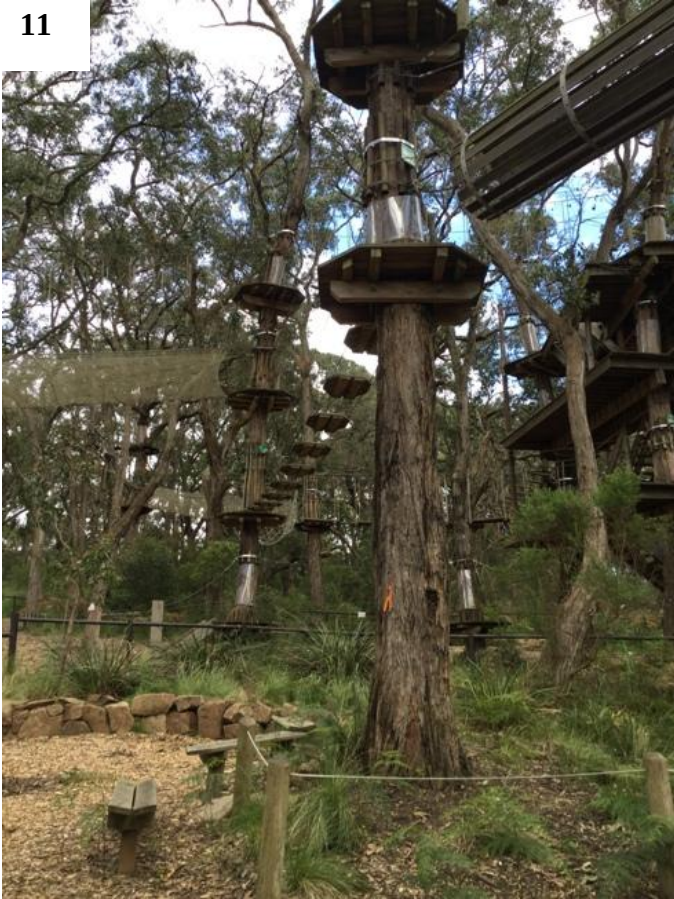
Plate 11 (Above). The Enchanted Maze is one of the most longest running tree top courses in Australia. The trees have been inspected by Arborist Reports Australia since 2013 and the trees to this day remain in good health, with no tree failure attributed to the course
