## Yallambie Park Facility Audit

Document number	000206
Client / Site	Tennis Victoria
Location	Off Moola Close Yallambie VIC 3085
Auditor	Andrew Sodomaco
Audit date	28 Aug 2015

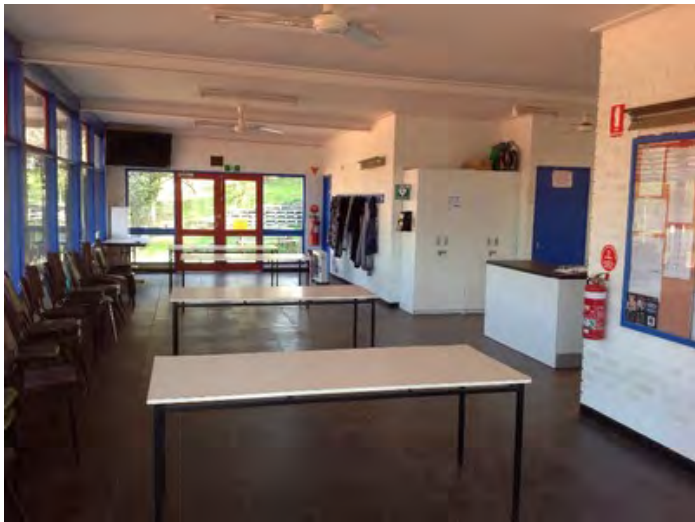
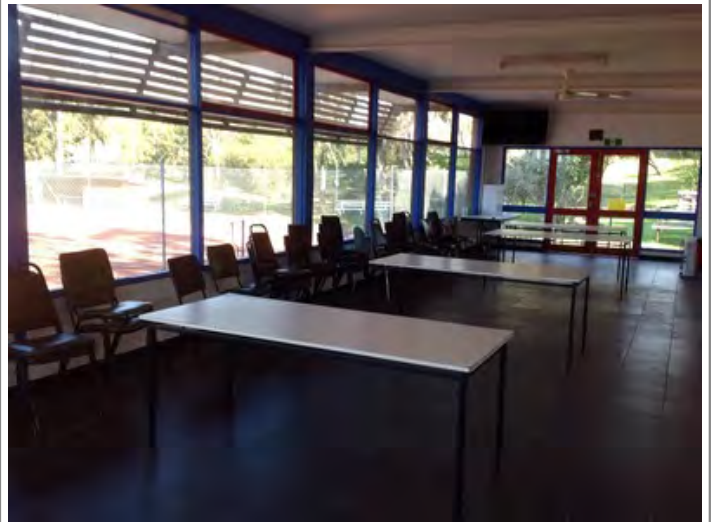
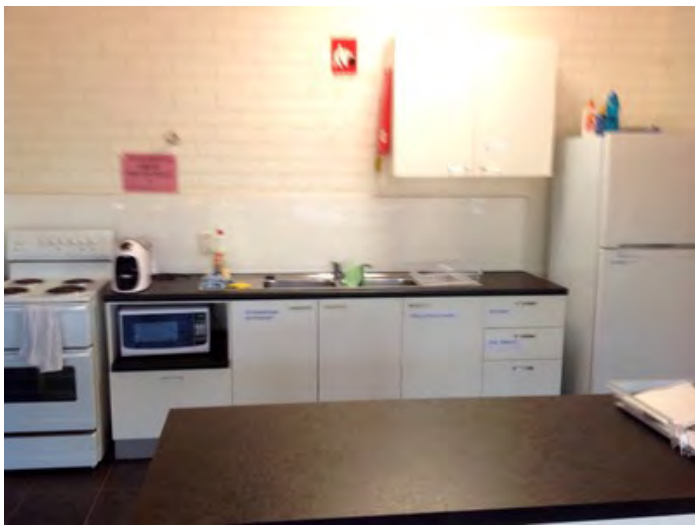
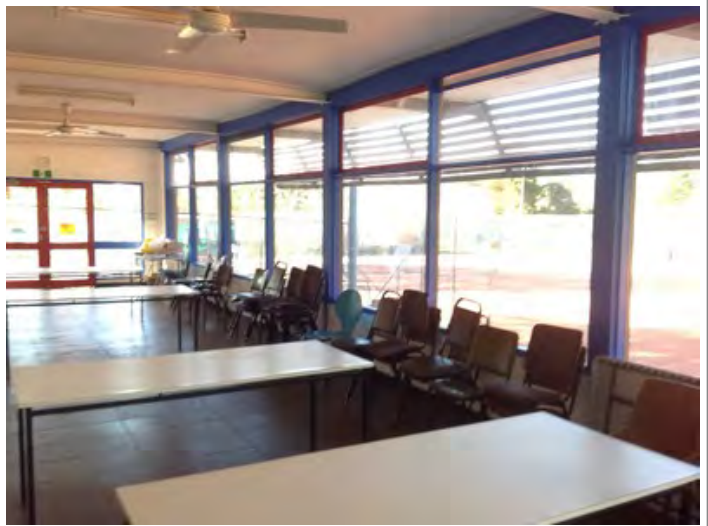
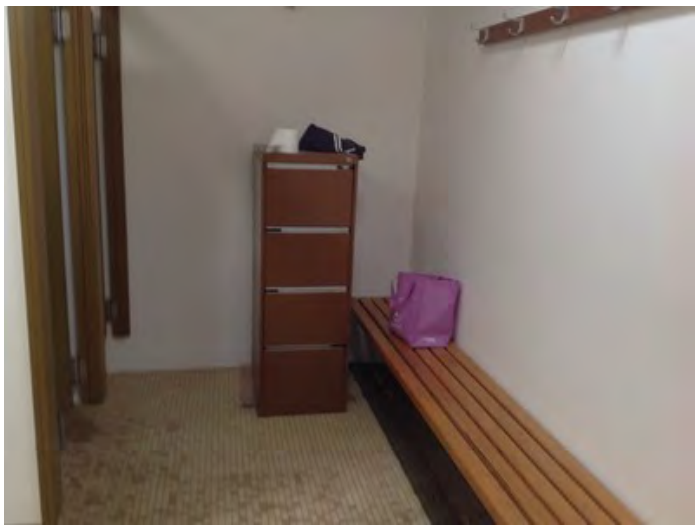
### Clubroom condition photos

Building Condition	Good
Estimated building age	30+ years
Building materials	Brick
Accessible entry to building	no
Kitchen	Standard
Bar	no
Player change rooms	Male: 1 Female: 1 Unisex: 0
Social area	65 m2
Social area comments	
Toilets	Male: yes Female: yes Accessible: no
Clubroom condition notes	The clubhouse is neat and tidy and appears to be in good condition. It sits higher than the courts and offers excellent views. Despite being a little aged, the toilets and change facilities offer some room for players to get changed after their match.
Other amenities provided within or outside clubrooms	Equipment storage BBQ /outdoor seating area
Other amenities condition notes	
Are there any safety concerns within clubrooms?	no
