Rutherford Facility Audit

Document number	000207
Client / Site	Tennis Victoria
Location	96-120 Rutherford Road Viewbank VIC 3084
Auditor	Andrew Sodomaco
Audit date	28 Aug 2015

Site summary	
Total number of enclosures	5
Total number of courts	8
Total number of floodlit courts	8
Total number of enclosed mini courts	0
Hierarchy	District

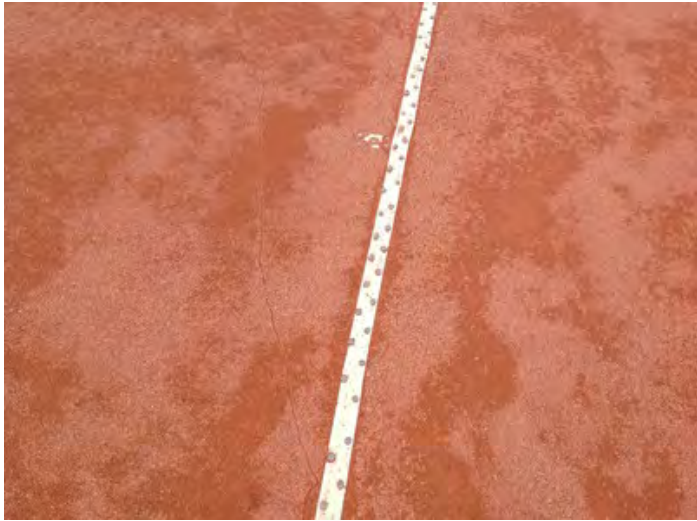
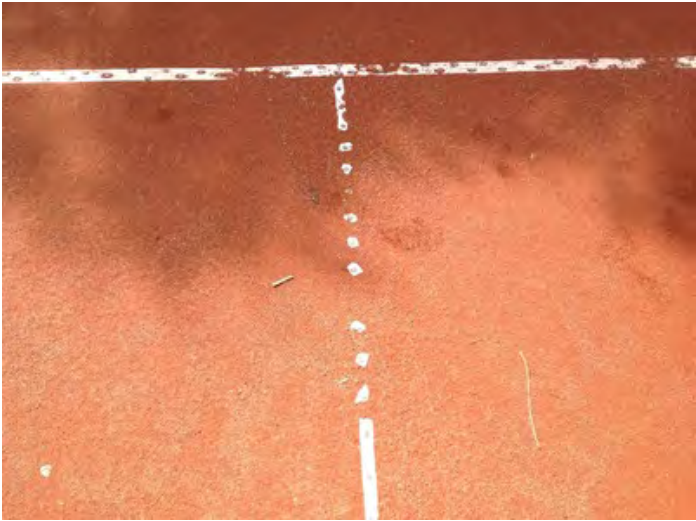
Line marking rating	Moderate
	Issues/Observations: Cracked Torn Inconsistent bounce likely
Line marking condition notes	The court lines are standard for a red porous court and are nailed into the surface. They are a little aged but otherwise do not appear to be cracked or broken, except where this has occurred quite extensively in the north eastern corner of the court.
Line marking condition photos

Court	Hang drag mats on fencing Repair lines
Drainage	
Infrastructure	Repair damaged fencing Trim vegetation away from fencing
Lighting	Conduct a lighting lux level test

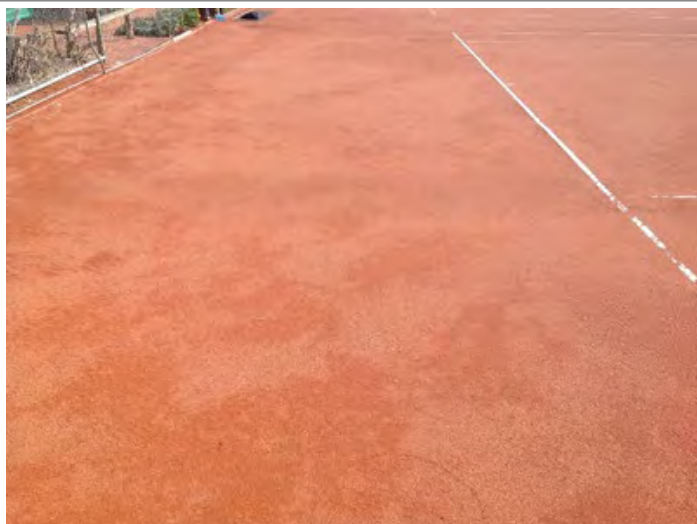
Is the court run off compliant?	no Runoffs North: 4800m South: 4800m East: 3700m West: 3700m
Could the court be made compliant?	no
Is the court to the standard dimensions?	yes
Court orientation	North-south
Are netball goal posts outside tennis court run off areas?	no
Are lockable post hole covers fitted and safe?	no
Compliance notes	The court is not run off compliant to the north or south behind the baselines.

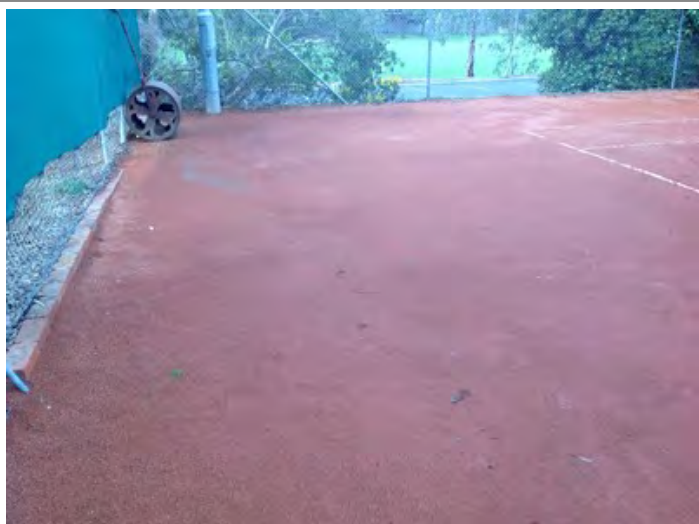
Could the court be made compliant?	no
Is the court to the standard dimensions?	yes
Court orientation	North-south
Are netball goal posts outside tennis court run off areas?	no
Are lockable post hole covers fitted and safe?	no
Compliance notes	The court is not run off compliant to the north or south behind the baselines. Light posts inside the enclosure are also within run off areas.

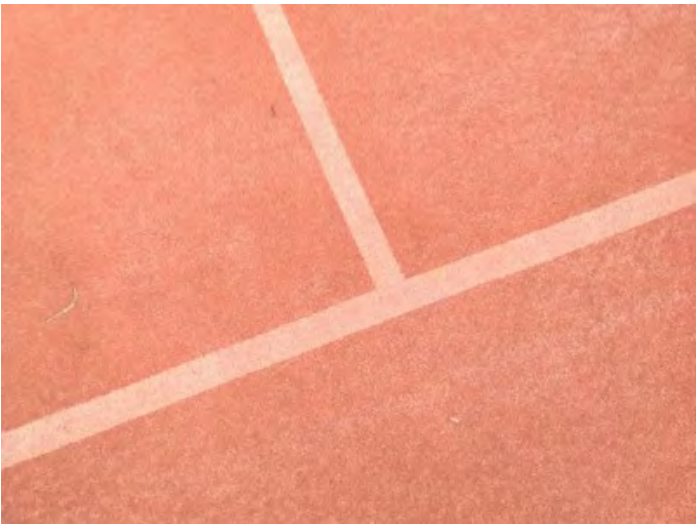
Line marking condition notes	The lines are in the same condition as the rest of the court.
Line marking condition photos

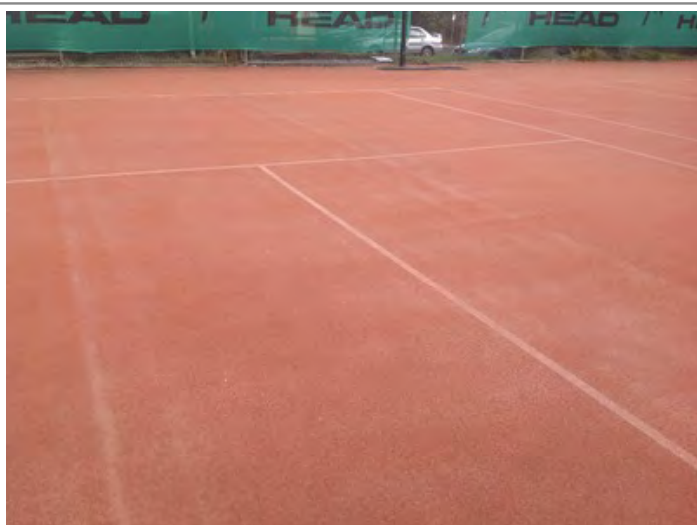
Unique court number	5
Surface condition rating	Good
	Issues/Observations:
Surface type	Synthetic Clay
Surface life span	6-10 years
Court condition notes	This court appears to be in very good condition. There are no obvious signs of seam stress and there is an even cover of sand across the surface.

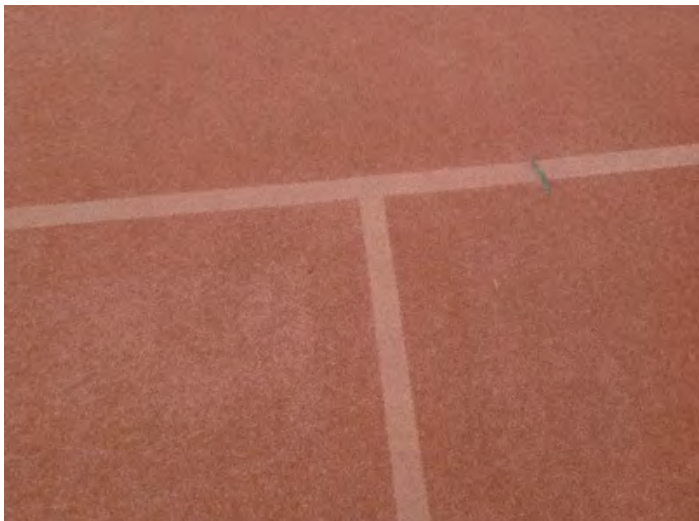
Line marking description	Tennis only lines
Line marking rating	Good Issues/Observations: Clear and bright Straight and clean
Line marking condition notes	The lines are in the same condition as the rest of the court.
Line marking condition photos

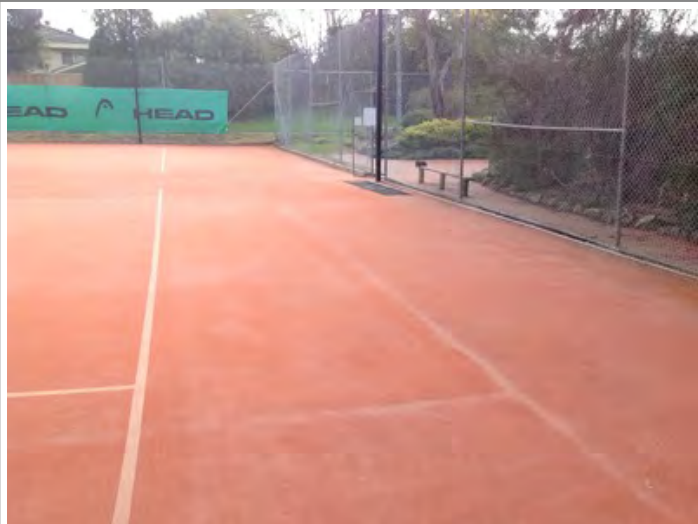
Could the court be made compliant?	no
Is the court to the standard dimensions?	yes
Court orientation	North-south
Are netball goal posts outside tennis court run off areas?	no
Are lockable post hole covers fitted and safe?	no
Compliance notes	The court is not run off compliant to the north or south behind the baselines.
Compliance photos

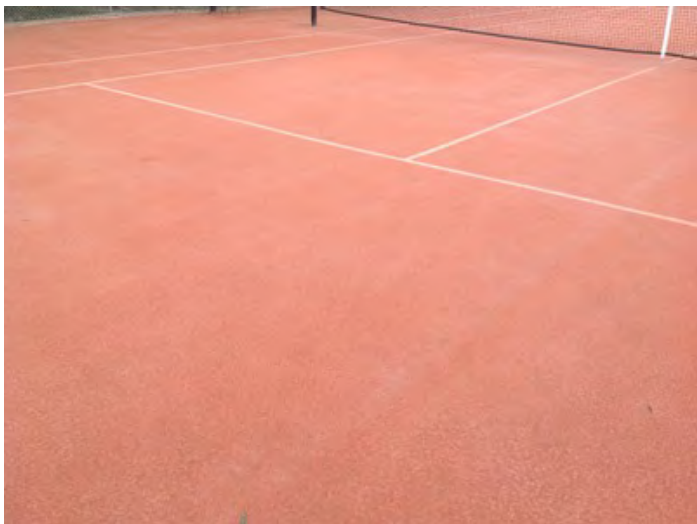
Unique court number	6
Surface condition rating	Good
	Issues/Observations:
Surface type	Synthetic Clay
Surface life span	6-10 years
Court condition notes	This court appears to be in very good condition. There are no obvious signs of seam stress and there is an even cover of sand across the surface.

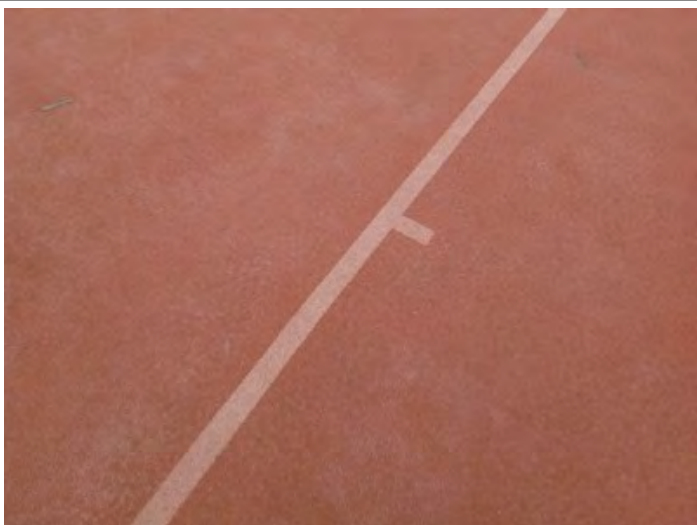
Line marking description	Tennis only lines
Line marking rating	Good Issues/Observations: Clear and bright Straight and clean
Line marking condition notes	The lines are in the same condition as the rest of the court.

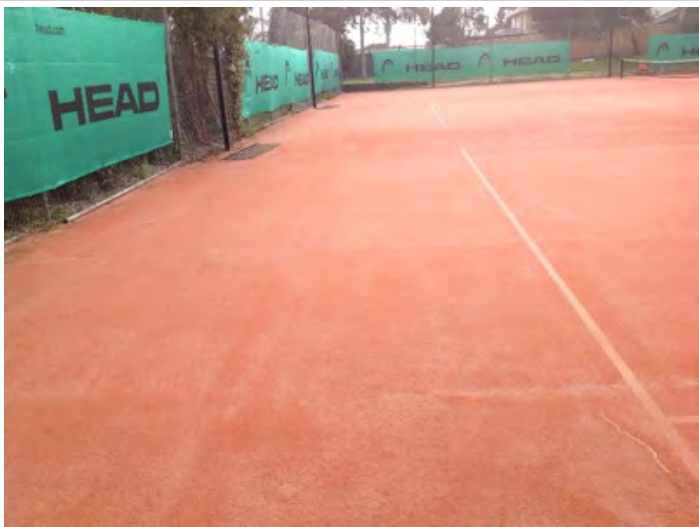
Net post life span	10+ years
Net life span	6-10 years
Net / post notes	
Net / post photos	
No photos taken	
Court compliance	
Is the court run off compliant?	no Runoffs North: 4700m South: 4700m East: 3900m West: 3700m
Could the court be made compliant?	no
Is the court to the standard dimensions?	yes
Court orientation	North-south
Are netball goal posts outside tennis court run off areas?	no
Are lockable post hole covers fitted and safe?	no
Compliance notes	The court is not run off compliant to the north or south behind the baselines.
Compliance photos

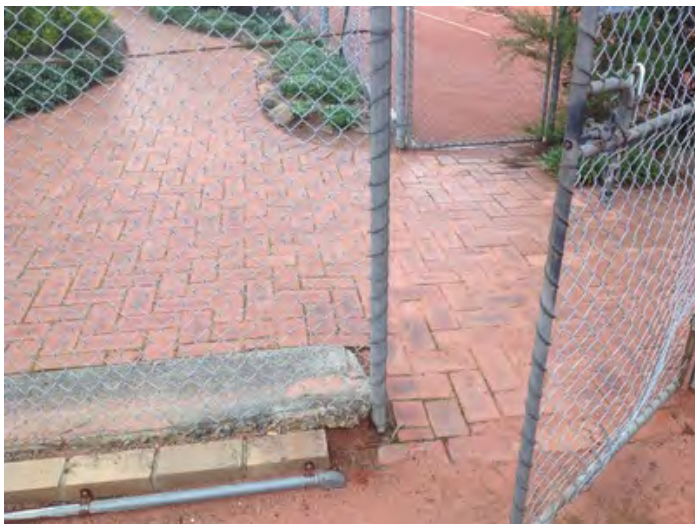
Court enclosure accessibility	Formed paths Trip hazards identified: yes Ramped access provided: no
Path material(s)	Other material?
Main gate dimensions	Standard pedestrian gate 1000mm x 2100mm
Accessibility notes	Pavers lead from the clubhouse to the enclosure.

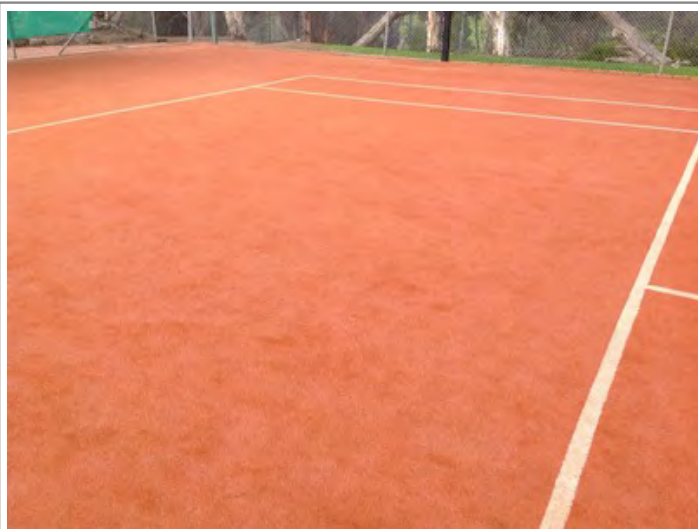
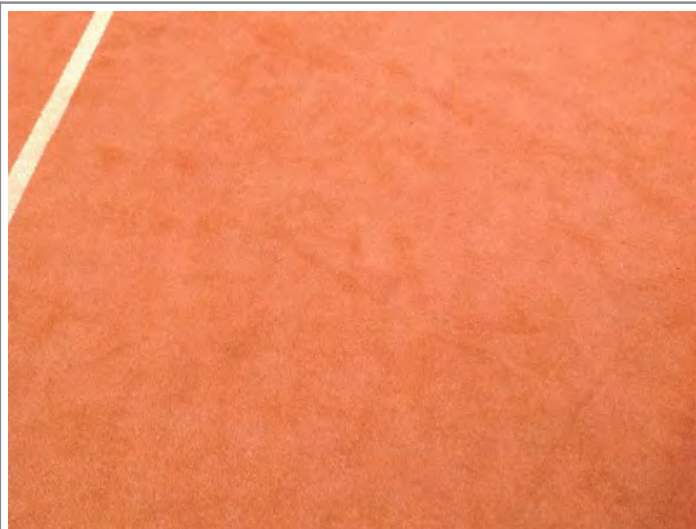
Unique court number	3
Surface condition rating	Very Good
	Issues/Observations:
Surface type	Synthetic Clay
Surface life span	6-10 years
Court condition notes	This court appears to be in very good condition. There are no obvious signs of seam stress and there is an even cover of sand across the surface. The court appears to be newest at the facility.

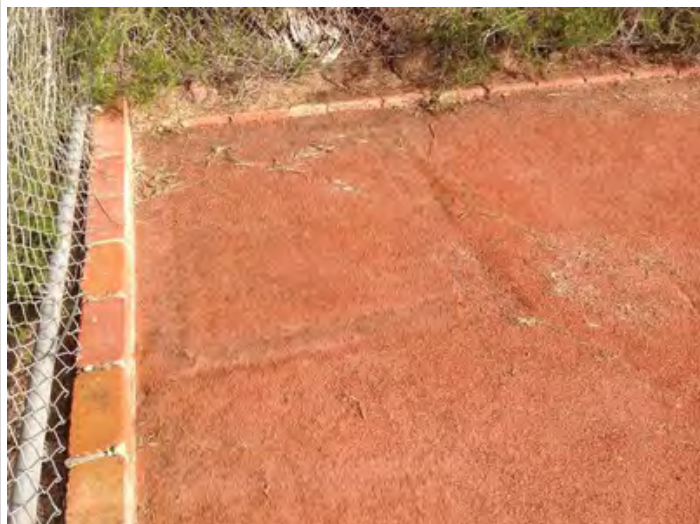
Drainage infrastructure	Formed
What type of drainage is in place?	Grated pit(s)
Are drains, pits or other infrastructure provided within the court enclosure?	yes
Are drains, pits or other infrastructure provided within the run-off areas?	yes
Drainage rating	Good
	Issues/Observations: Ponding evident
Drainage notes	There is a grated pit in the south eastern corner has been covered by the synthetic clay surface. There are some signs of pooling of water along the southern and northern fence lines.

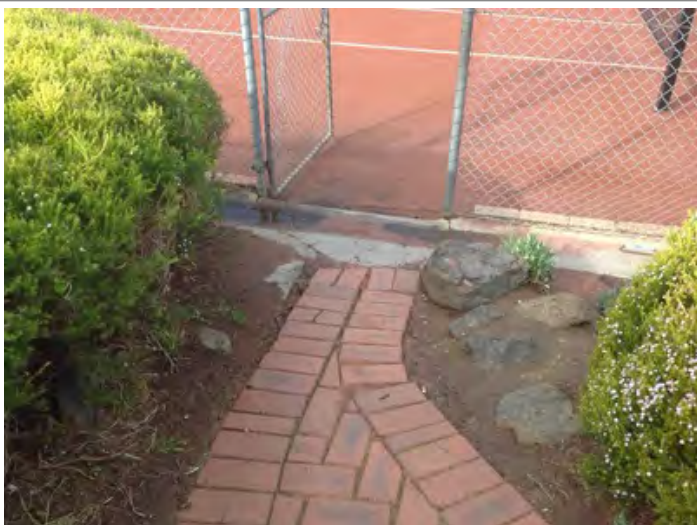
Court enclosure accessibility	Formed paths Trip hazards identified: yes Ramped access provided: no
Path material(s)	Other material?
Main gate dimensions	Standard pedestrian gate 1000mm x 2100mm
Accessibility notes	Pavers lead from the clubhouse to the enclosure.

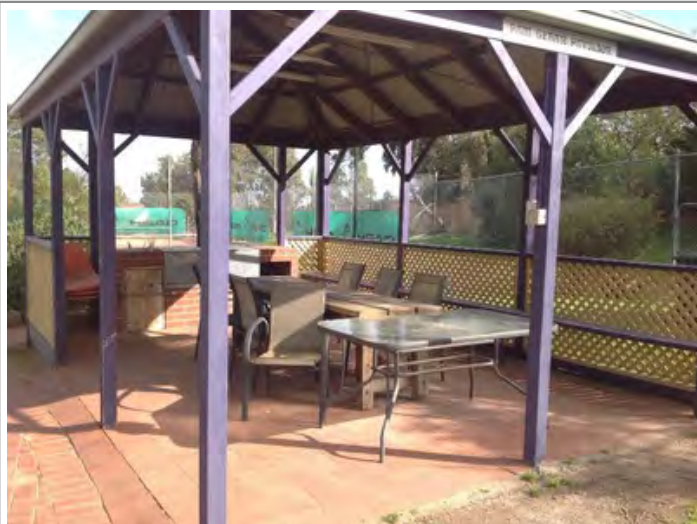
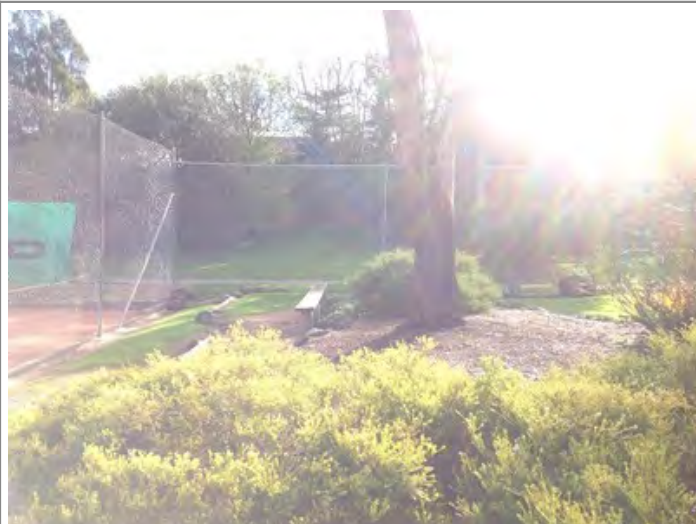
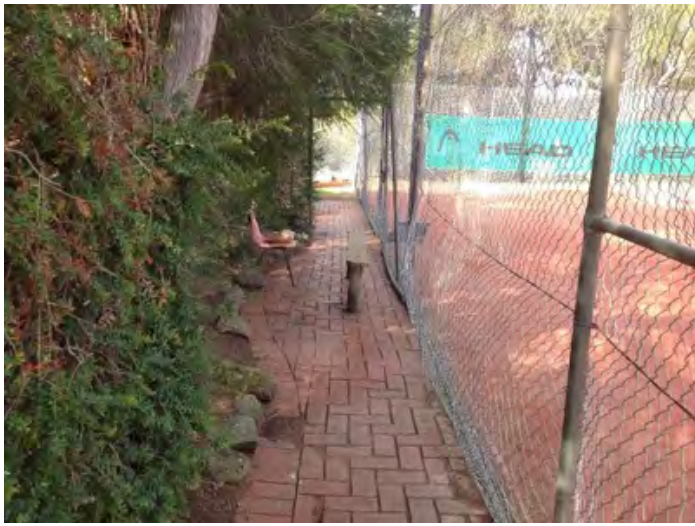
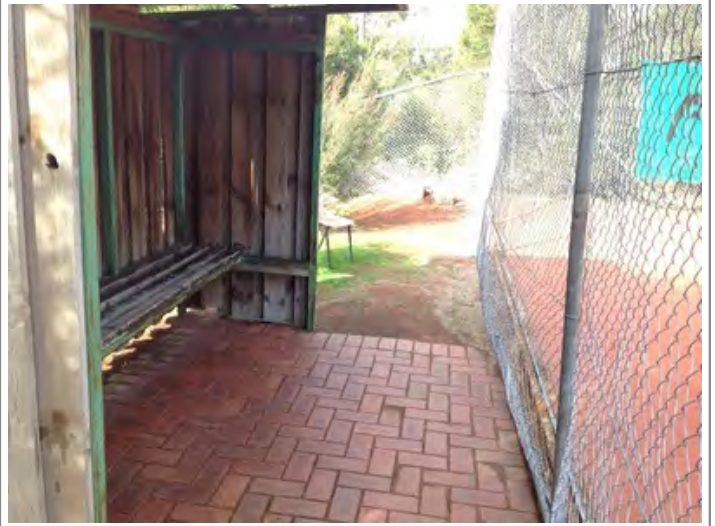
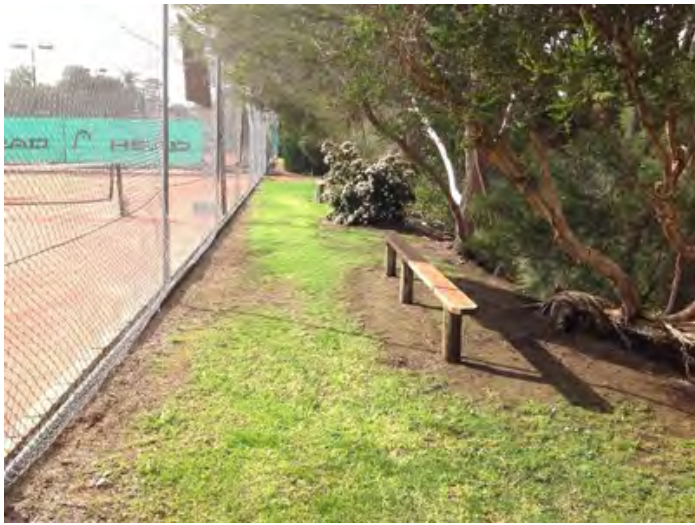
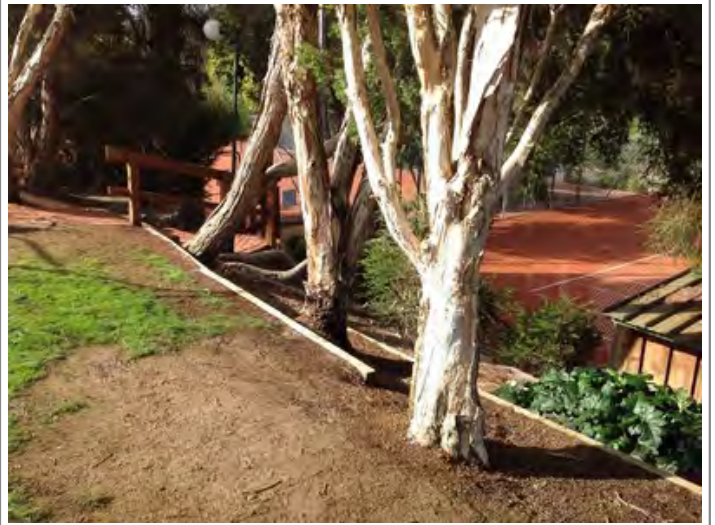
Condition of ground and court surrounds	Good
Court surround notes	Court surrounds are extensive and offer numerous sitting and spectator areas. A bbq area is also covered, and plenty of shade is afforded to spectators.
Water supply	Unknown
Water notes	
Natural Shade	Sufficient shade available within viewing range
Man made Shade	Purpose built shelter
Shade notes	A clubhouse verandah also exists.
Car parking	On street: Off street: 41-60 spaces Overflow:
Does the site have any hit up walls	no
Car park notes	
Adjacent facilities	Oval/playing field Community centre
Does the site have any potential expansion opportunities?	no

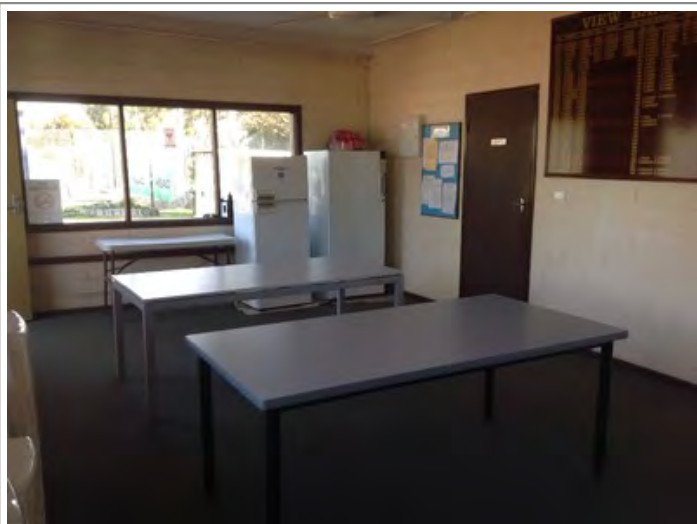
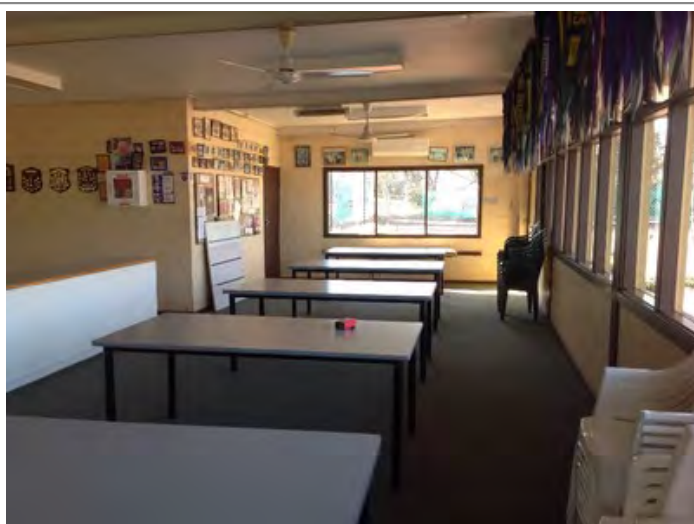
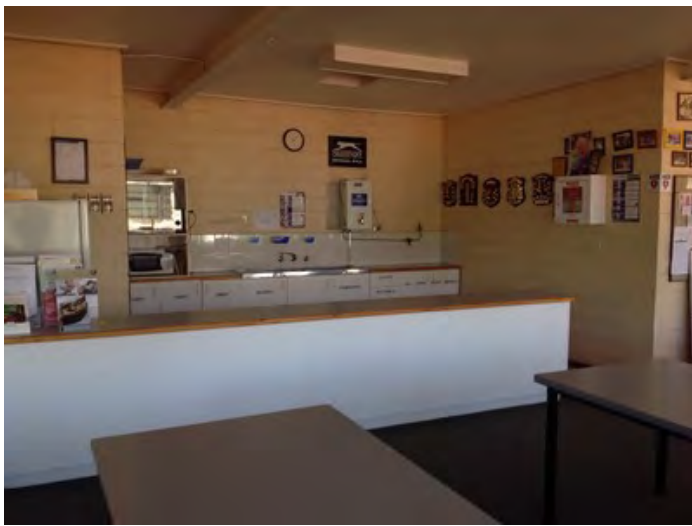
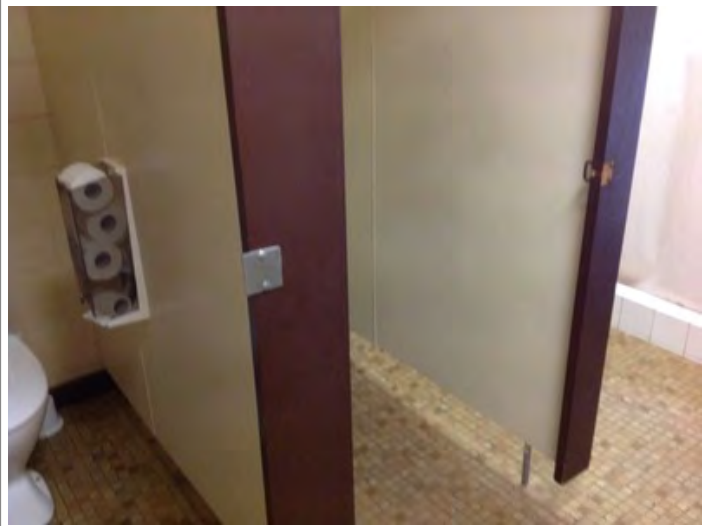
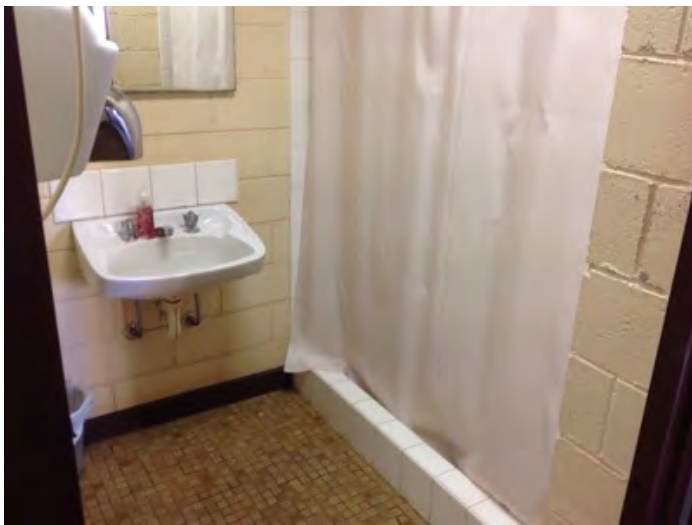
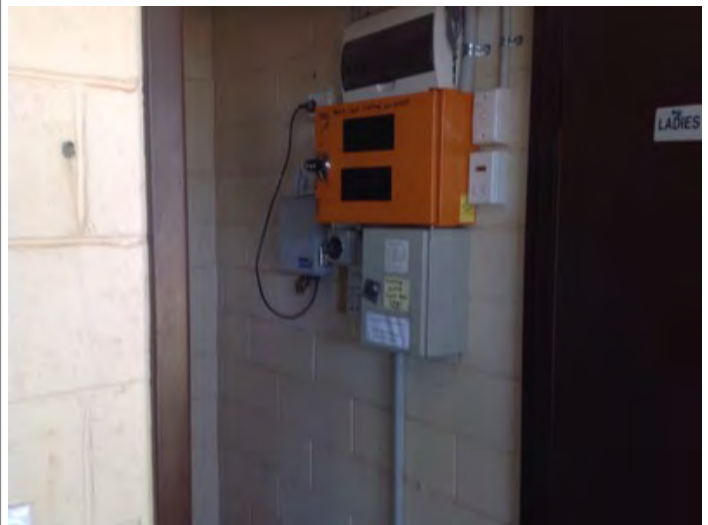
Building Condition	Good
Estimated building age	30+ years
Building materials	Brick
Accessible entry to building	no
Kitchen	Standard
Bar	no
Player change rooms	Male: 0 Female: 0 Unisex: 0
Social area	69 m2
Social area comments	
Toilets	Male: Female: Accessible:
Clubroom condition notes	The clubhouse consists of an open social area with a large kitchen. There are large windows which look out on to court three. There is some damage to the brick work on the interior of the clubhouse. Plastic chairs are stacked for use at a row of tables.
Other amenities provided within or outside clubrooms	Equipment storage BBQ /outdoor seating area
Other amenities condition notes	
Are there any safety concerns within clubrooms?	no
