Arboricultural Impact Assessment & Tree Management Report

421 Upper Heidelberg Road, Ivanhoe

Prepared for Development Victoria

Tree Logic Ref. 12133

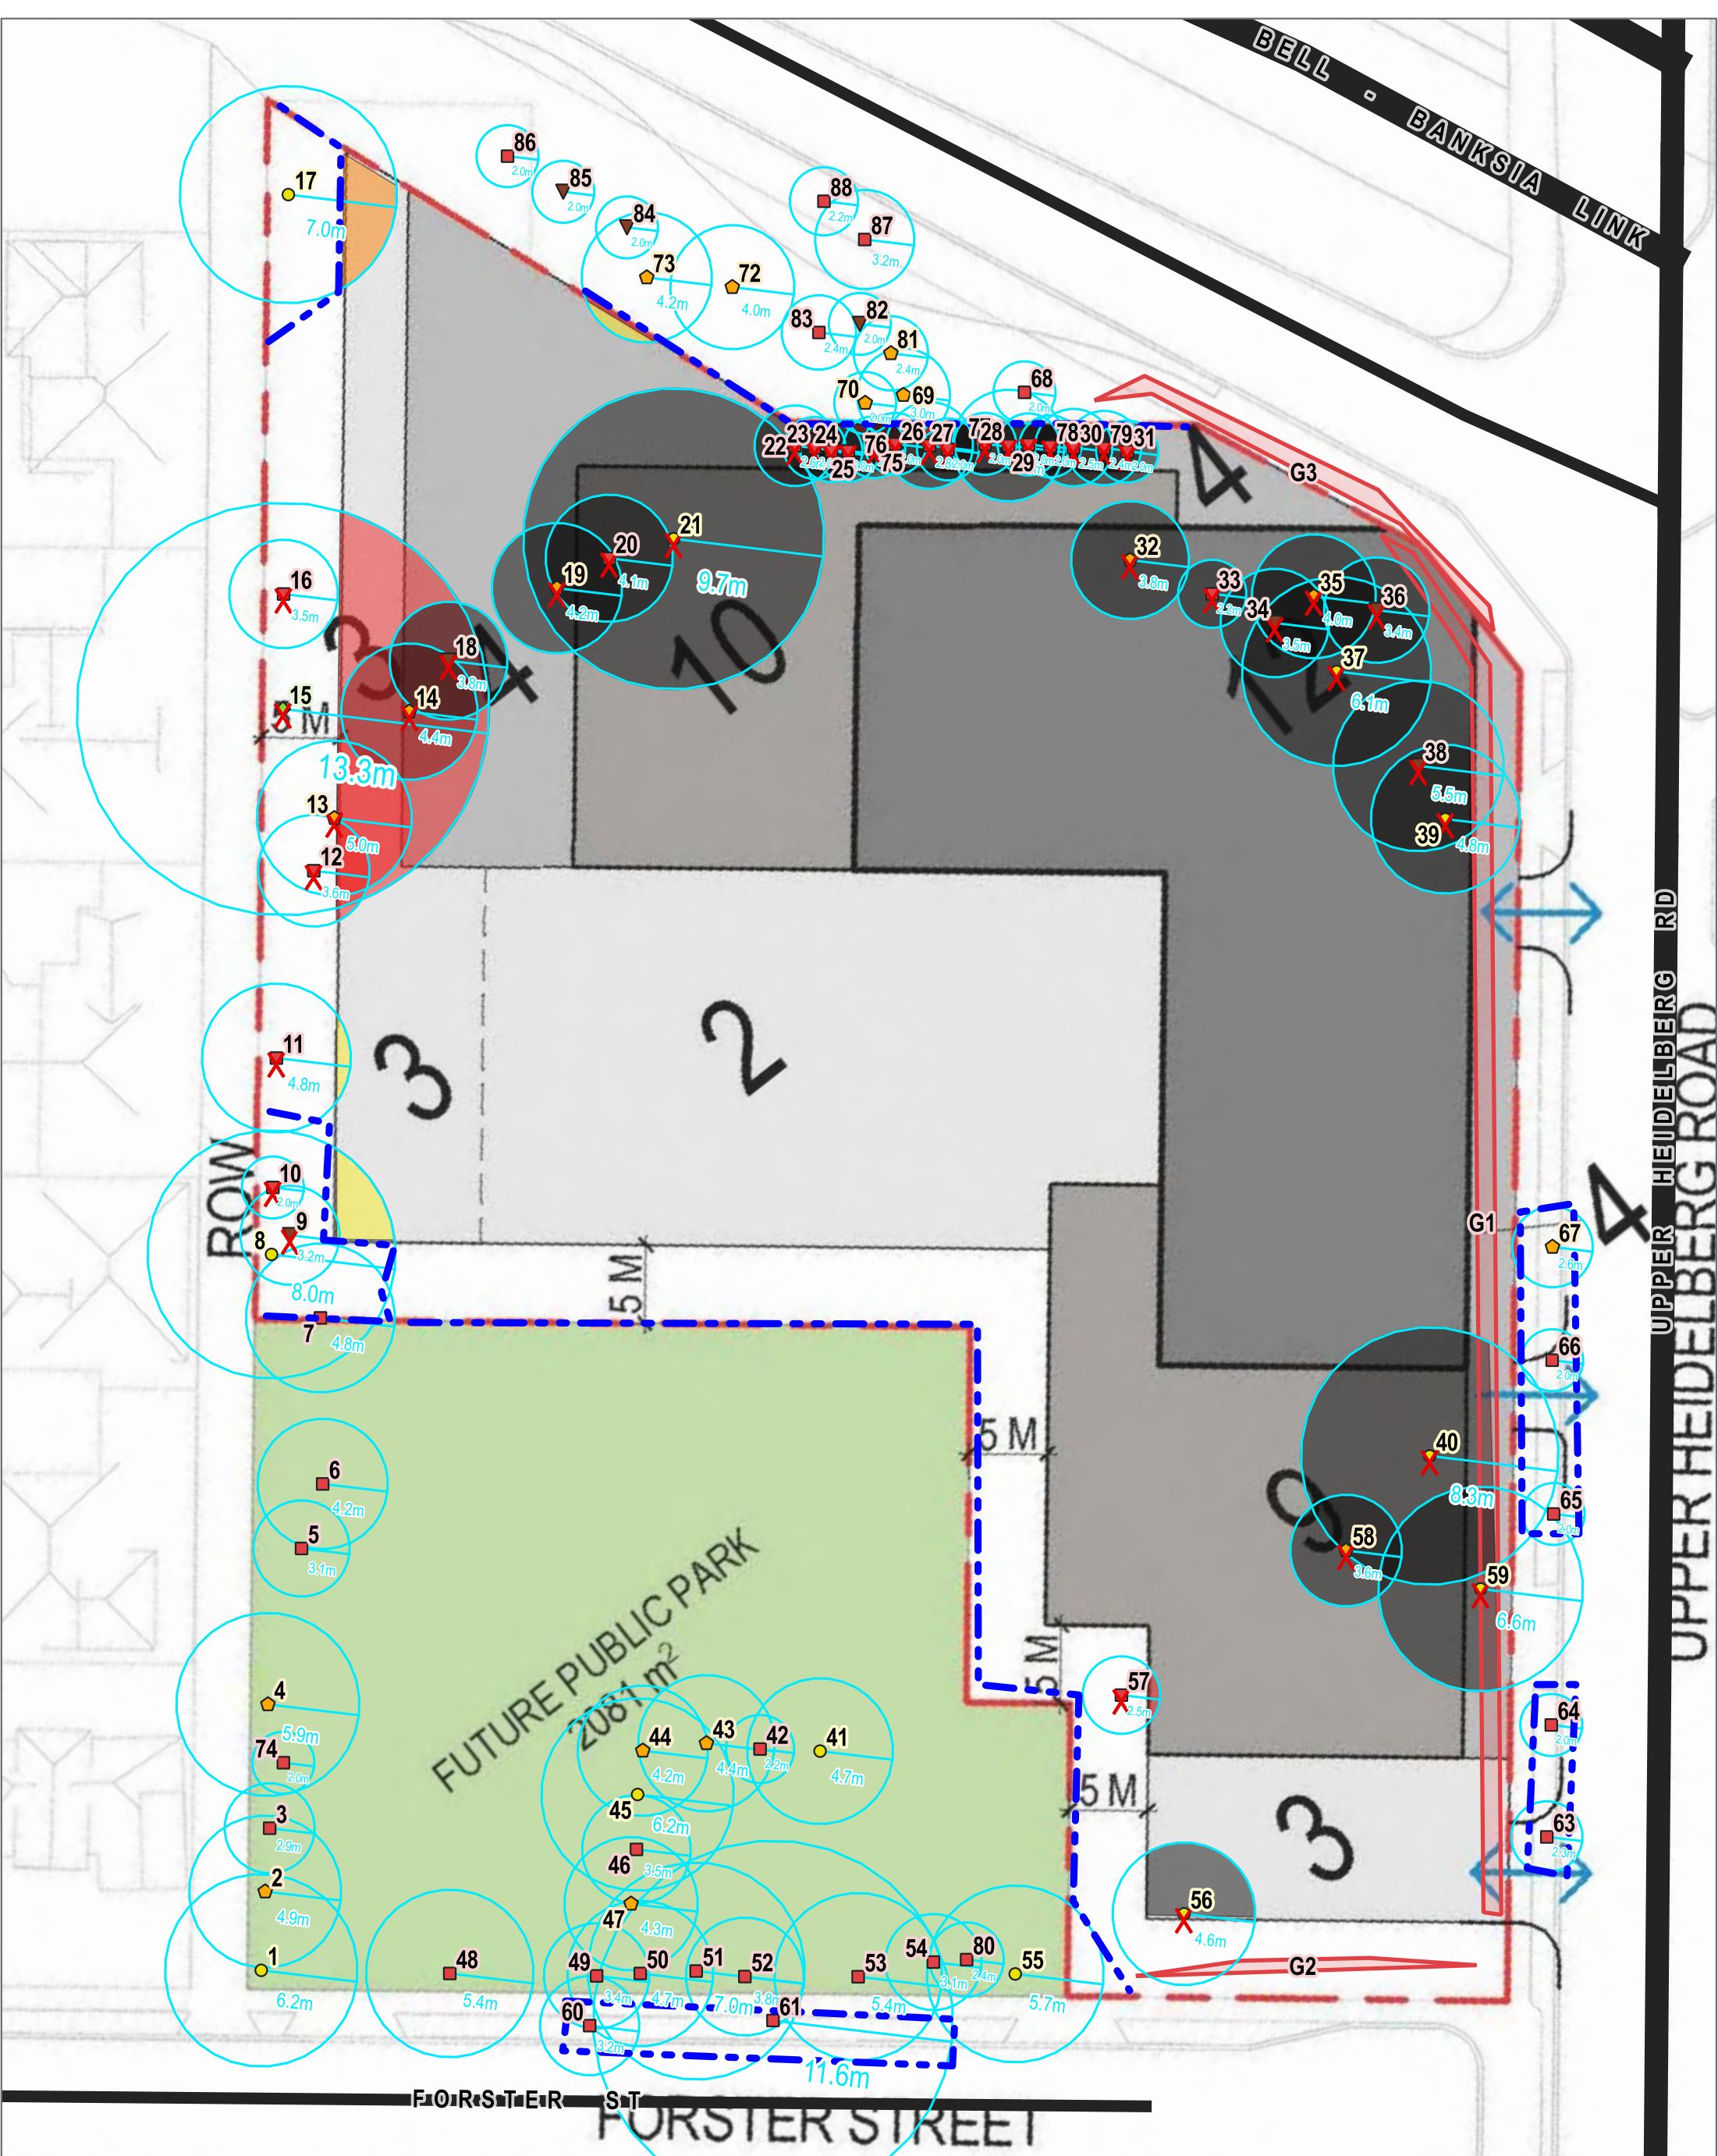
APPENDIX 2 — TREE IMPACTS & PROTECTION ZONE FENCES

Based on the supplied plan as shown in Appendix 2C (A.DA0100 (*Development Plan Concept Plan*), *Ivanhoe Tank Site, Architectus Melbourne dated 25 July 2023*), 40 of 43 trees within the current development parcel are not compatible with retention under the proposed design due to being directly within or extremely close to the building footprint (inclusive of structures without basement excavation).

This includes Tree 15, a Moderate A rated River Red Gum, which cannot be retained under the proposed design due to a TPZ encroachment of approximately 32% (irrespective of location of retaining walls) and no contiguous root space for the tree to recover from such significant root loss. Additionally, retention of such a large tree of this species in such close proximity to a new development is not recommended due to ongoing maintenance issues as well as the high risk potential from large tree part failure onto building structures, due to tree decline exacerbated by construction impacts.

1. Under the current design;
 - Thirty two (32) trees exist within the design footprint and will need to be removed.
 - Six (6) trees have works encroaching the Structural Root Zone (SRZ) and are at risk of decline and instability.

- Tree 17 will have TPZ encroachment of 13%. Arborist supervision will be required when the initial site excavation works occur to determine the quantity and condition of any roots exposed during the initial excavation and to appropriately prune them if necessary.
