St Mary's Facility Audit

Document number	000205
Client / Site	Tennis Victoria
Location	58 Yando Street Greensborough VIC 3088
Auditor	Andrew Sodomaco
Audit date	28 Aug 2015

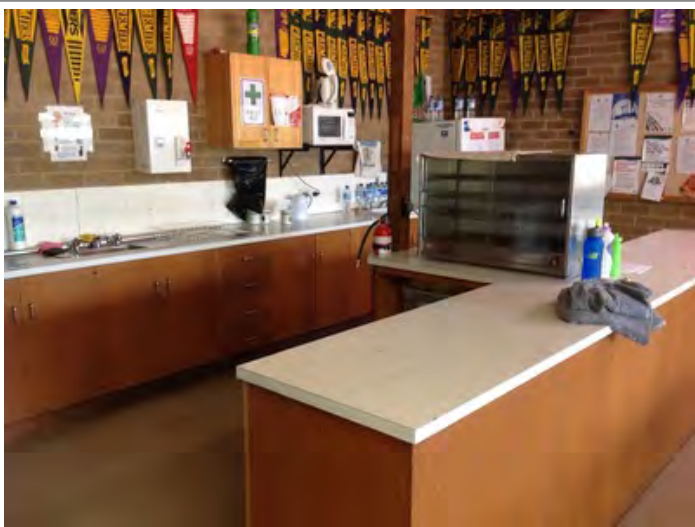
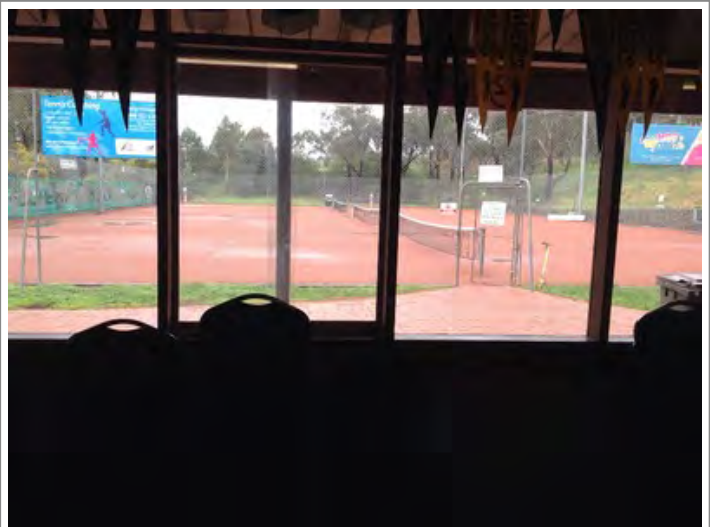
Clubroom condition photos

Building Condition	Moderate
Estimated building age	30+ years
Building materials	Brick
Accessible entry to building	no
Kitchen	Standard
Bar	no
Player change rooms	Male: 1 Female: 1 Unisex: 0
Social area	81 m2
Social area comments	
Toilets	Male: yes Female: yes Accessible: no
Clubroom condition notes	The clubhouse is in reasonable condition, although it is aged and in need of refurbishment. The change rooms and toilet areas are particularly in need of replacement. The roof of the clubhouse and verandah is heavily covered in algae and appears to be quite aged.
Other amenities provided within or outside clubrooms	BBQ /outdoor seating area
Other amenities condition notes	
Are there any safety concerns within clubrooms?	no

Classification	-
Overall Facility recommendation(s)	Plan for refurbishment of clubhouse and the court base for each of the courts. Although aged, most facilities appear to have been well maintained.
