## Malcolm Blair Reserve Facility Audit

Document number	000214
Client / Site	Tennis Victoria
Location	Karingal Drive Briar Hill VIC 3088
Auditor	Andrew Sodomaco
Audit date	04 Sep 2015

## Enclosure 1

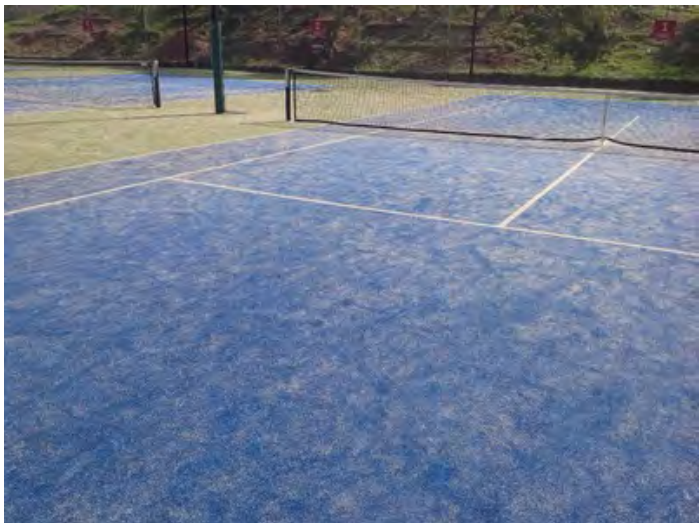
Line marking rating	Very Good
	<b>Issues/Observations:</b> Clear and bright Straight and clean
Line marking condition notes	The lines are in the same condition as the rest of the court surface.
Line marking condition photos

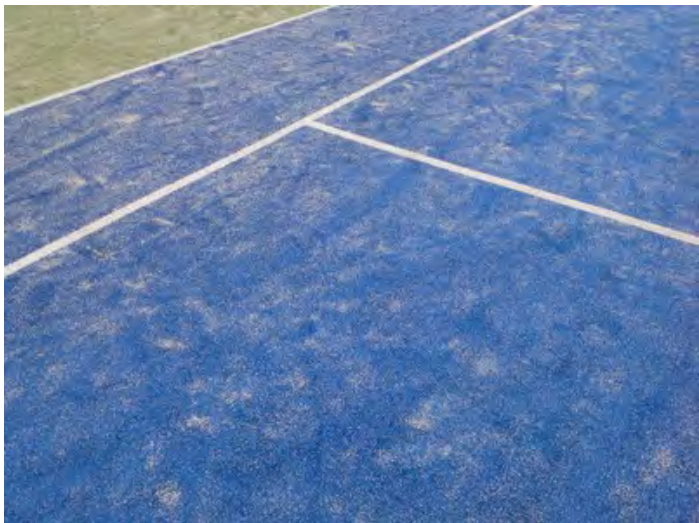
Line marking rating	Very Good
	<b>Issues/Observations:</b> Clear and bright Straight and clean
Line marking condition notes	The lines are in the same condition as the rest of the court surface.
Line marking condition photos

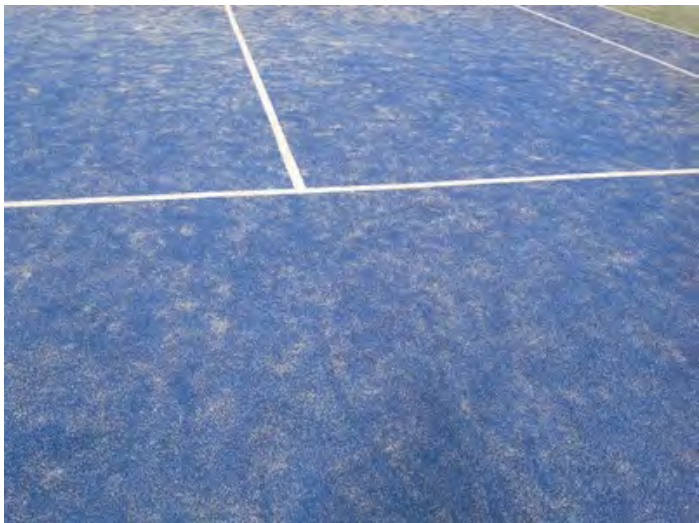
Line marking rating	Very Good
	<b>Issues/Observations:</b> Clear and bright Straight and clean
Line marking condition notes	The lines are in the same condition as the rest of the court surface.
Line marking condition photos

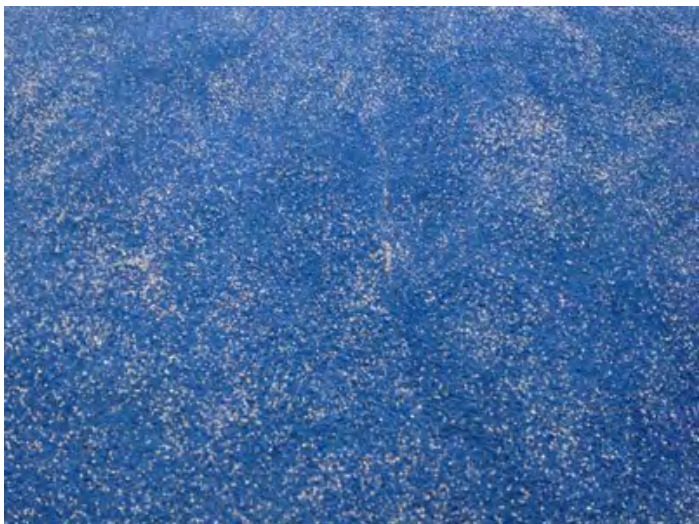
Could the court be made compliant?	n/a
Is the court to the standard dimensions?	yes
Court orientation	North-south
Are netball goal posts outside tennis court run off areas?	no
Are lockable post hole covers fitted and safe?	no
Compliance notes	The court meets run off requirements to all directions.
Compliance photos	
No photos taken	
<b>Courts</b>	
<b>Condition</b>	
Unique court number	4
Surface condition rating	Good  <b>Issues/Observations:</b> Seam stress
Surface type	Synthetic Grass
Surface life span	6-10 years
Court condition notes	The court appears to be quite new and in good condition. There is a line where the carpet has been joined that has separated a little and should be investigated before it comes a major concern. Otherwise there is a good coverage of grass and a sufficient pile height for play.
Court condition photos

Are there any critical safety issues?	No
Enclosure recommendations	Investigate seam stress evident across all courts, as this should be considered now before it becomes a significant issue. Repair damaged fencing and trim vegetation from fence line.

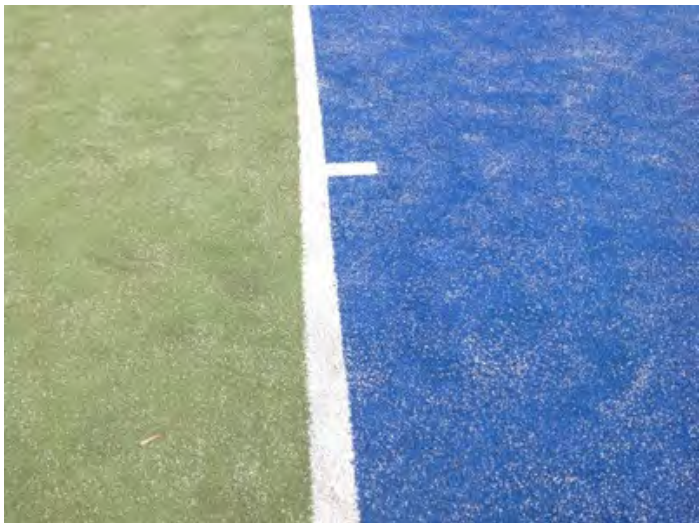
Line marking rating	Very Good
	<b>Issues/Observations:</b> Clear and bright Straight and clean
Line marking condition notes	The lines are in the same condition as the rest of the court surface.
Line marking condition photos

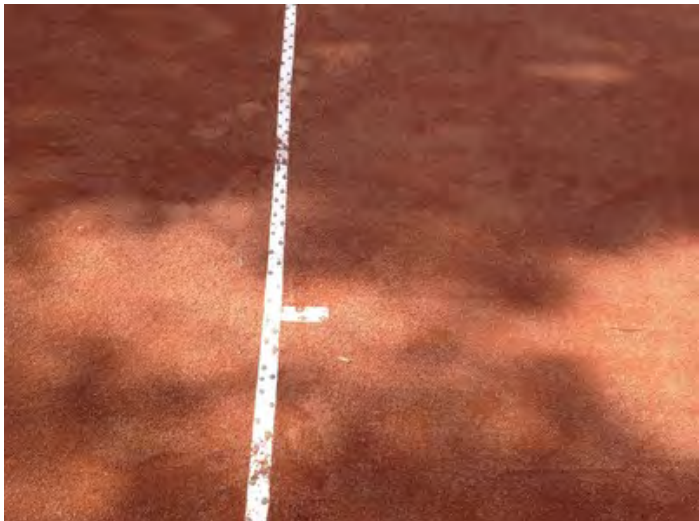
Line marking description	Tennis only lines
Line marking rating	Good  <b>Issues/Observations:</b> Inconsistent bounce likely

Line marking condition notes	The lines are standard for this surface, with no obvious signs of breaking or cracking.
Line marking condition photos

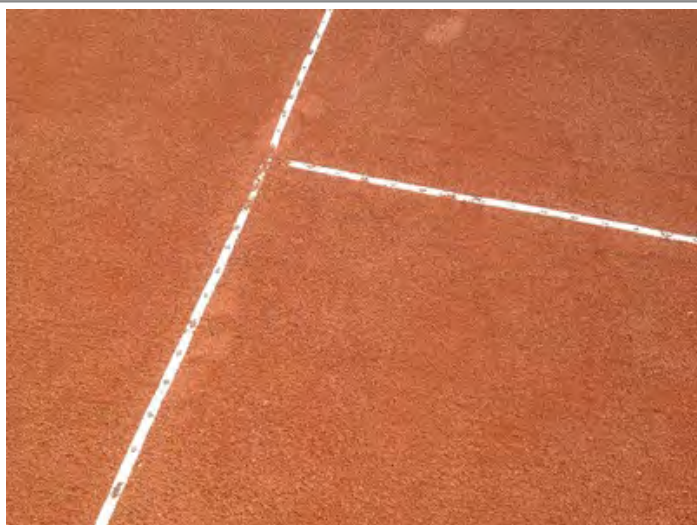
Line marking description	Tennis only lines
Line marking rating	Good  <b>Issues/Observations:</b> Inconsistent bounce likely
Line marking condition notes	The lines are standard for this surface, with no obvious signs of breaking or cracking.

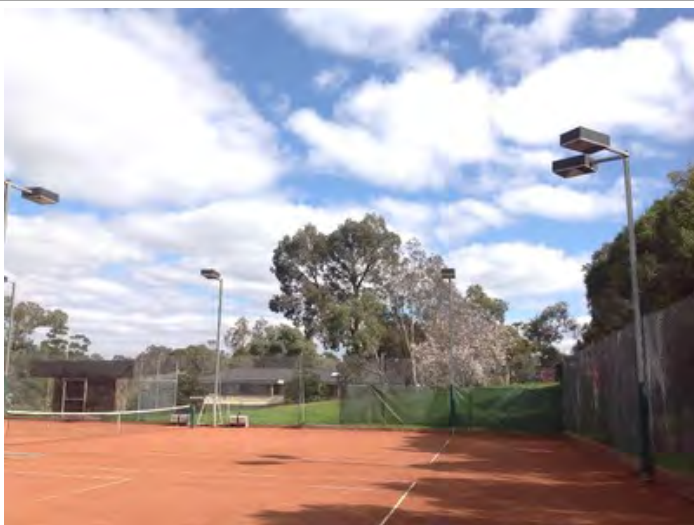
Does this enclosure have lighting	Yes
Total number of lit courts per enclosure	2
Lighting infrastructure type	Black powder coated low level - Steel poles
Lighting infrastructure position	Side
Light fittings	One per tower
Lighting infrastructure design	Standard
Lighting infrastructure rating	Very Good  <b>Issues/Observations:</b> Infrastructure and fittings in very good condition - likely to achieve required lux standards
Lighting life span	10+ years
Lighting notes	All lighting appears to be in very good condition and would likely achieve required lux standards.

<b>Court</b>	Remove weed growth from court enclosure Trim trees/shrubs away from court enclosure and fencing Hang drag mats on fencing
<b>Drainage</b>	
<b>Infrastructure</b>	Repair damaged fencing Trim vegetation away from fencing
<b>Lighting</b>	Conduct a lighting lux level test

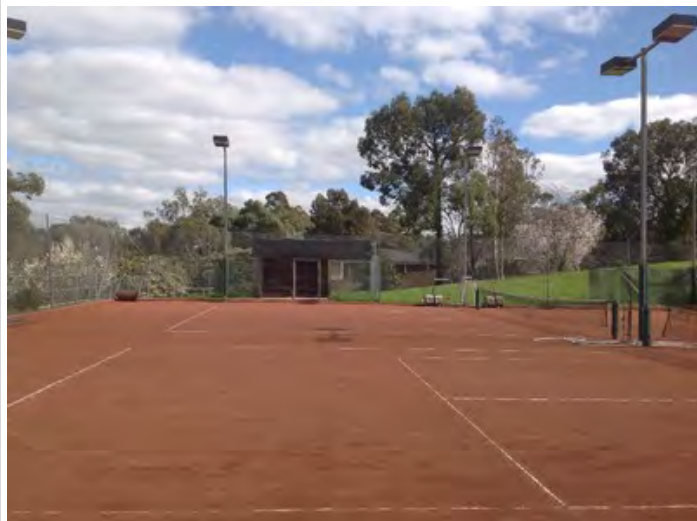
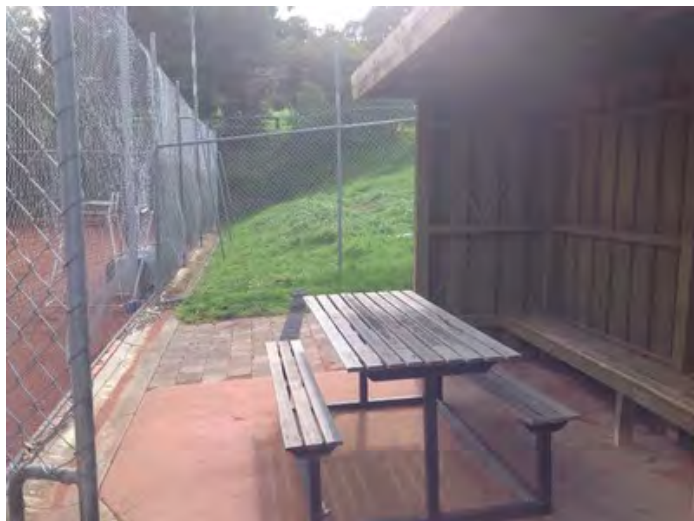
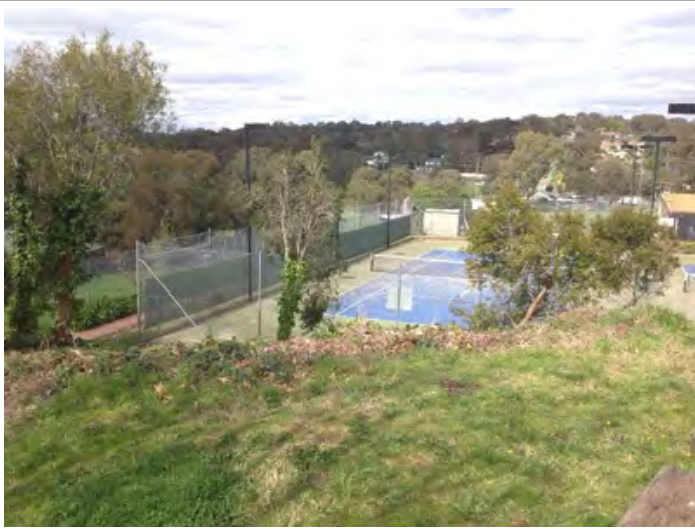
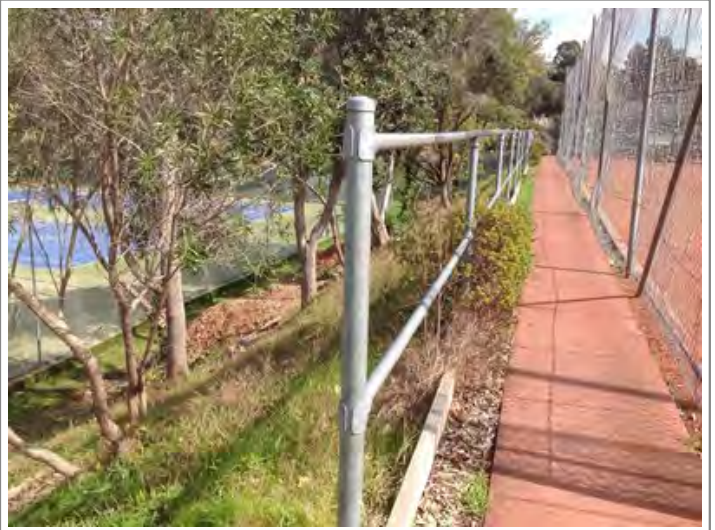
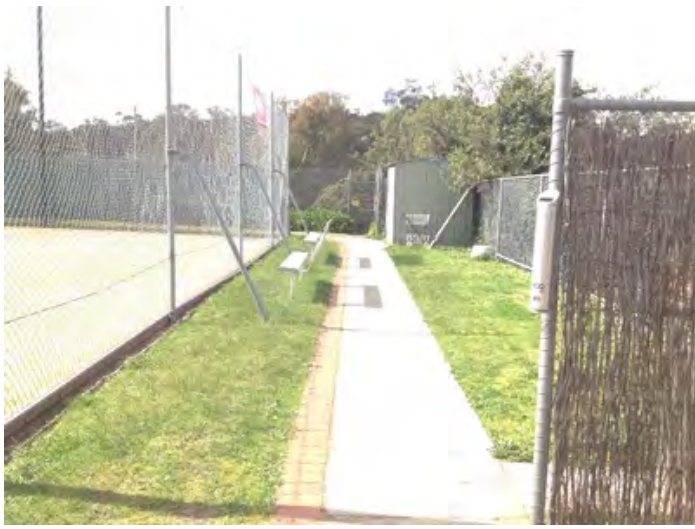
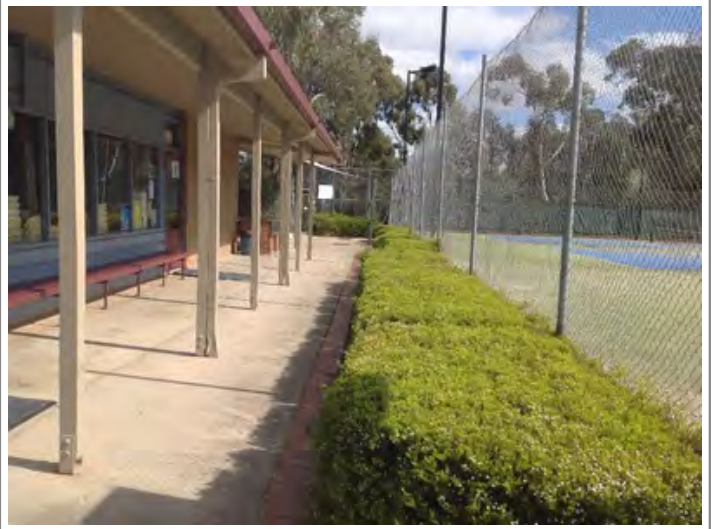
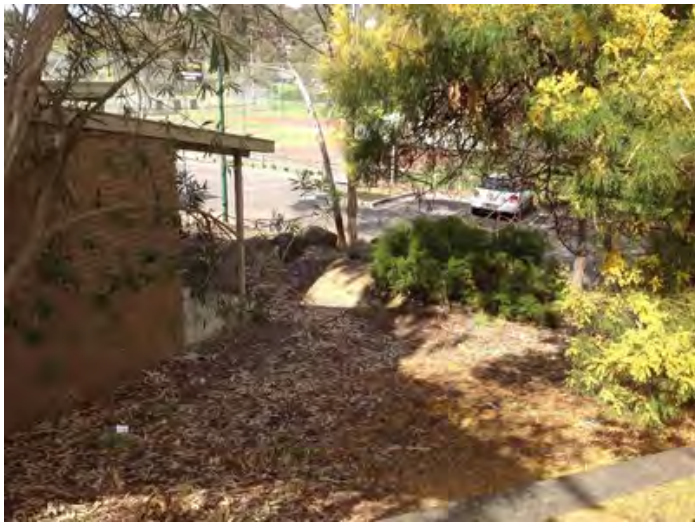
Condition of ground and court surrounds	Good
Court surround notes	The surrounds are well kept and consist of a clubhouse verandah and pathways with vegetation leading between enclosures. A bbq and shade sail area is provided adjacent to the clubhouse area.
Water supply	Potable
Water notes	
Natural Shade	No natural shade
Man made Shade	Clubhouse veranda
Shade notes	A shade sail is also provided at the venue.
Car parking	On street: Off street: 21-40 spaces Overflow:
Does the site have any hit up walls	no
Car park notes	The car park is shared with the adjacent baseball club.
Adjacent facilities	Other sports facility
Does the site have any potential expansion oppotunities?	no

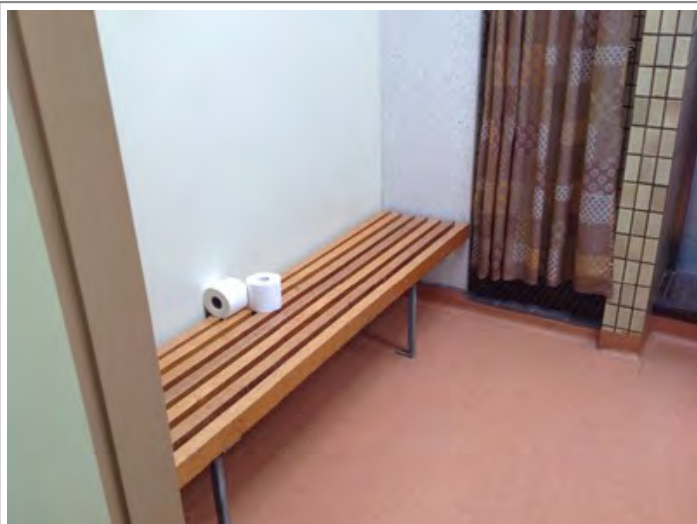
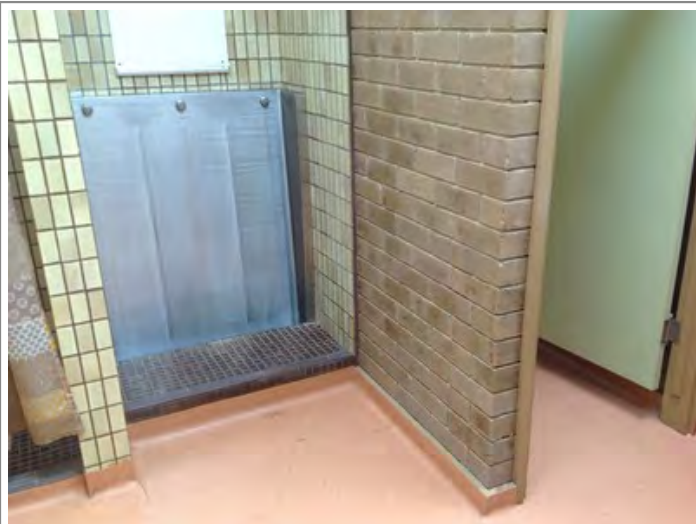
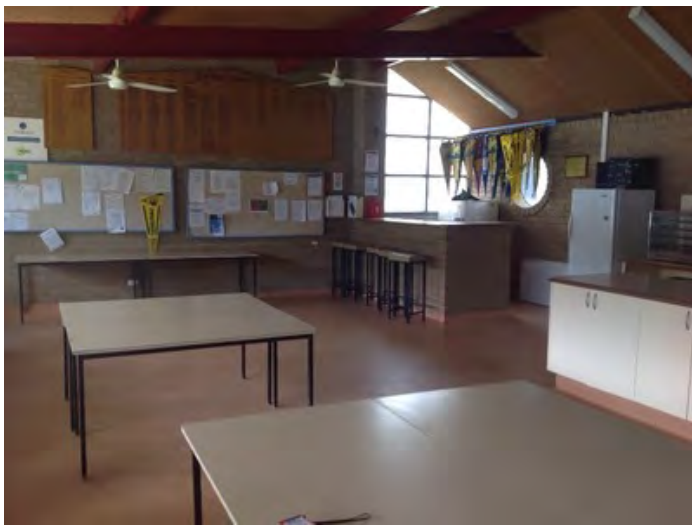
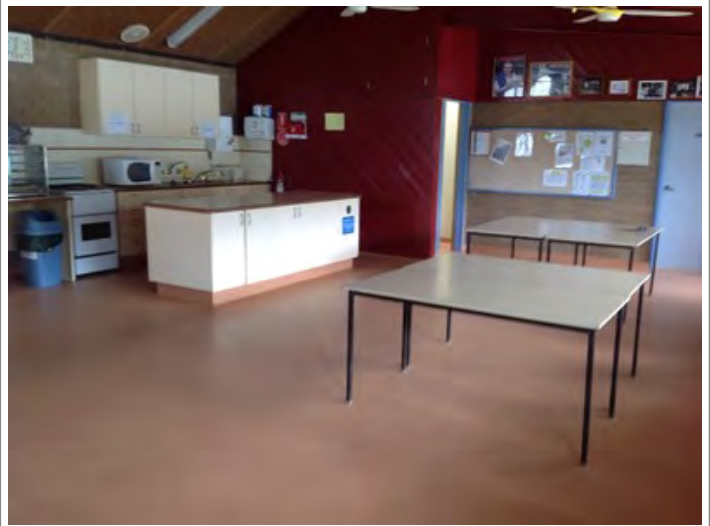
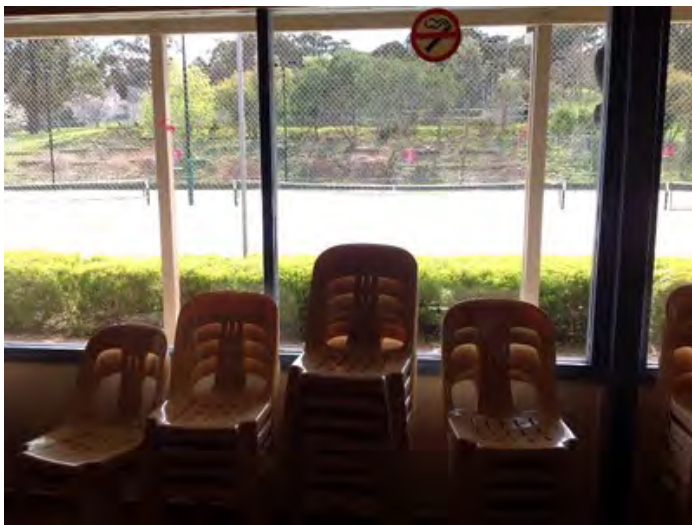
Building Condition	Moderate
Estimated building age	30+ years
Building materials	Brick
Accessible entry to building	no
Kitchen	Standard
Bar	Package sales
Player change rooms	Male: 1 Female: 1 Unisex: 0
Social area	72 m2
Social area comments	
Toilets	Male: yes Female: yes Accessible: no
Clubroom condition notes	The clubhouse is an open space area with toilets adjacent to the social area. Good views are provided over the courts. Although a little aged, the clubhouse is in good condition.
Other amenities provided within or outside clubrooms	Equipment storage BBQ /outdoor seating area
Other amenities condition notes	
Are there any safety concerns within clubrooms?	no
Clubroom condition photos
