Ivanhoe Park Facility Audit

Document number	000212
Client / Site	Tennis Victoria
Location	John Street Ivanhoe VIC 3079
Auditor	Andrew Sodomaco
Audit date	30 Aug 2015

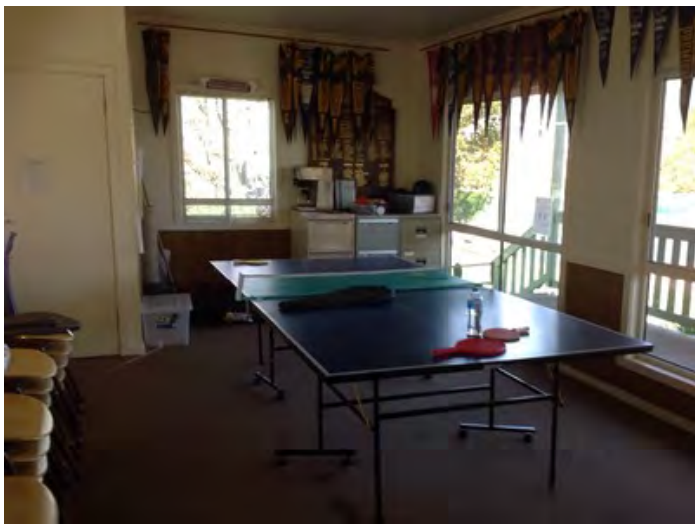
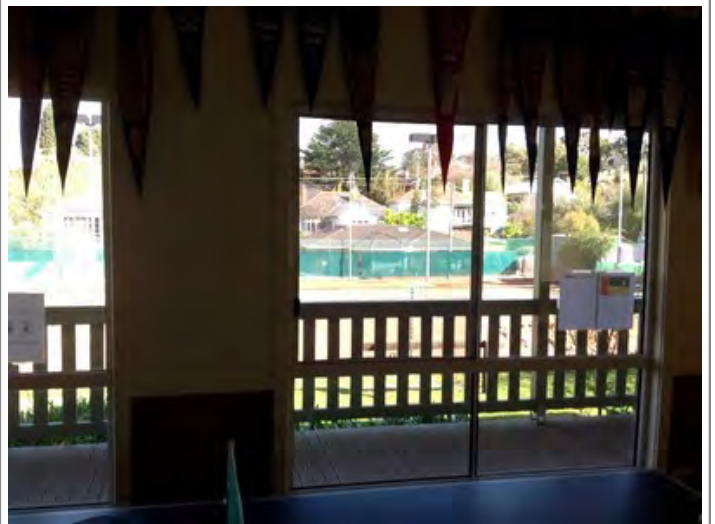
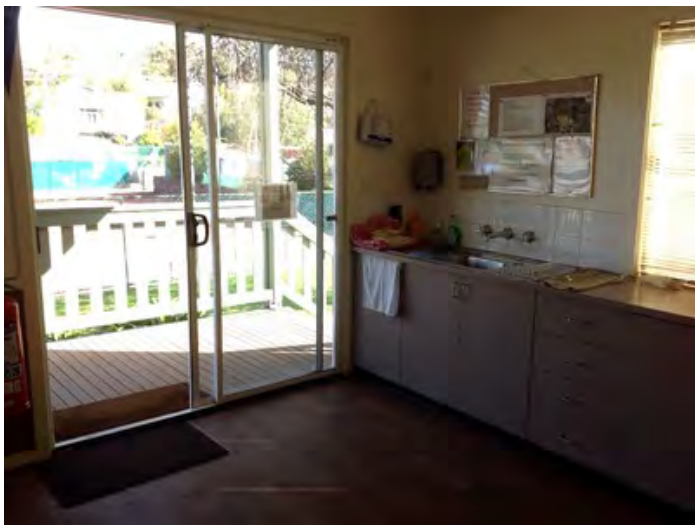
Clubroom condition photos

Building Condition	Good
Estimated building age	21-30 years
Building materials	Weatherboard
Accessible entry to building	no
Kitchen	Standard
Bar	no
Player change rooms	Male: 0 Female: 0 Unisex: 0
Social area	40 m2
Social area comments	
Toilets	Male: no Female: no Accessible: no
Clubroom condition notes	The clubhouse is a simple weatherboard room with a kitchenette and sitting areas. No toilets or showers are provided, although these can be accessed in the neighbouring bowls club clubhouse.
Other amenities provided within or outside clubrooms	no options selected
Other amenities condition notes	
Are there any safety concerns within clubrooms?	no

Classification	-
Overall Facility recommendation(s)	Plan for upgrade of courts given the signs of age they are showing. Remove vegetation from fence lines. Investigate the cost of addition of toilets and change facilities to the clubhouse.
