Central Park Facility Audit

Document number	000216
Client / Site	Tennis Victoria
Location	63 Plenty Lane Greensborough VIC 3088
Auditor	Andrew Sodomaco
Audit date	04 Sep 2015

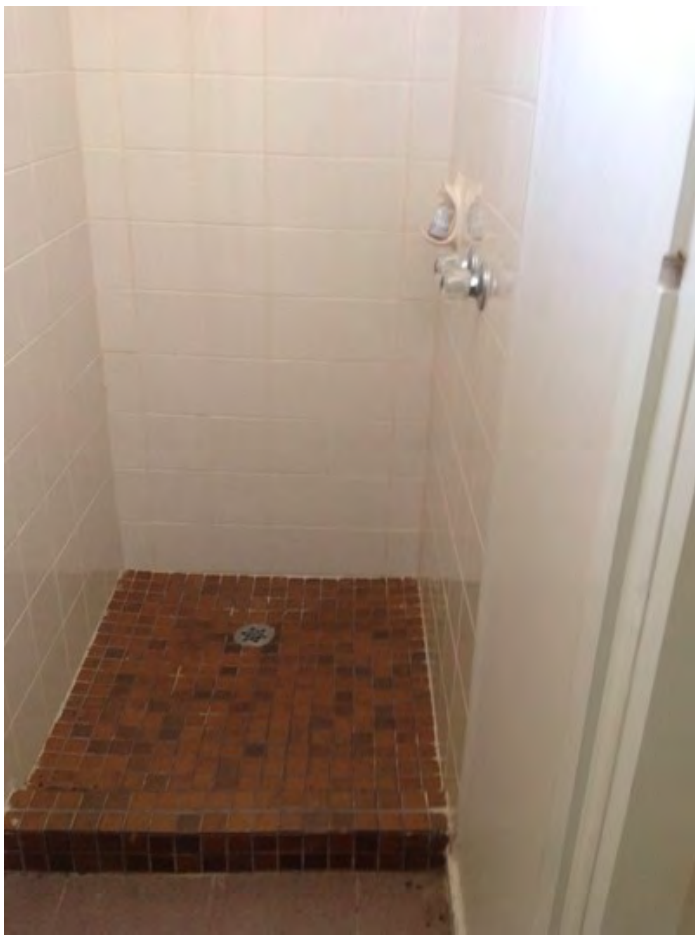
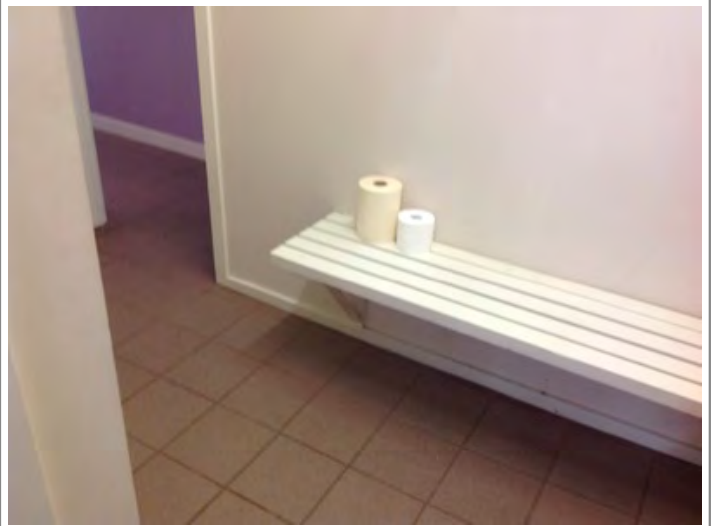
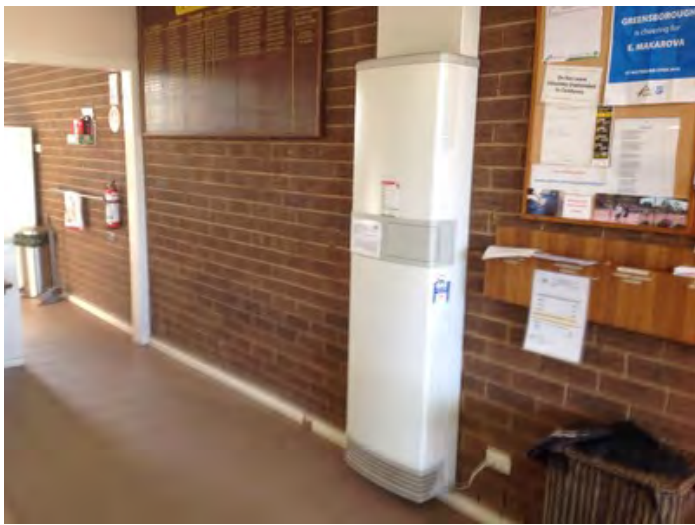
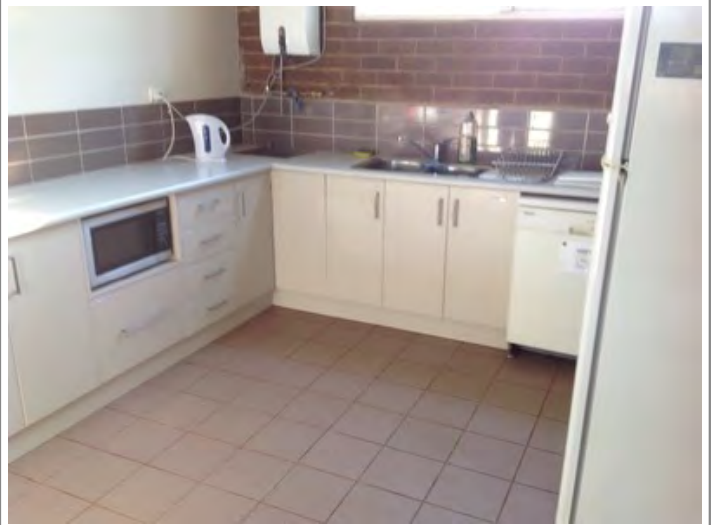
Clubroom condition photos

Building Condition	Moderate
Estimated building age	30+ years
Building materials	Brick
Accessible entry to building	no
Kitchen	Standard
Bar	no
Player change rooms	Male: 1 Female: 1 Unisex: 0
Social area	64 m2
Social area comments	
Toilets	Male: yes Female: yes Accessible: no
Clubroom condition notes	The clubhouse consists of an open social area which looks out on to the courts and outdoor shaded area. Couches and seating is provided for spectators. There are no obvious signs of damage on the inside of the clubhouse. Change facilities are provided for both males and females.
Other amenities provided within or outside clubrooms	BBQ /outdoor seating area
Other amenities condition notes	
Are there any safety concerns within clubrooms?	no
