Burke Road North Tennis Facility Audit

Document number	000209
Client / Site	Tennis Victoria
Location	Off the Boulevard East Ivanhoe VIC 3079
Auditor	Andrew Sodomaco
Audit date	30 Aug 2015

Site summary	
Total number of enclosures	5
Total number of courts	10
Total number of floodlit courts	4
Total number of enclosed mini courts	0
Hierarchy	District

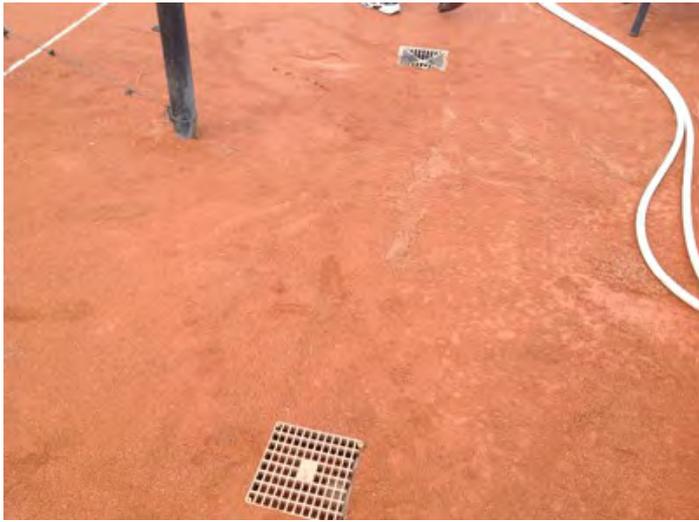
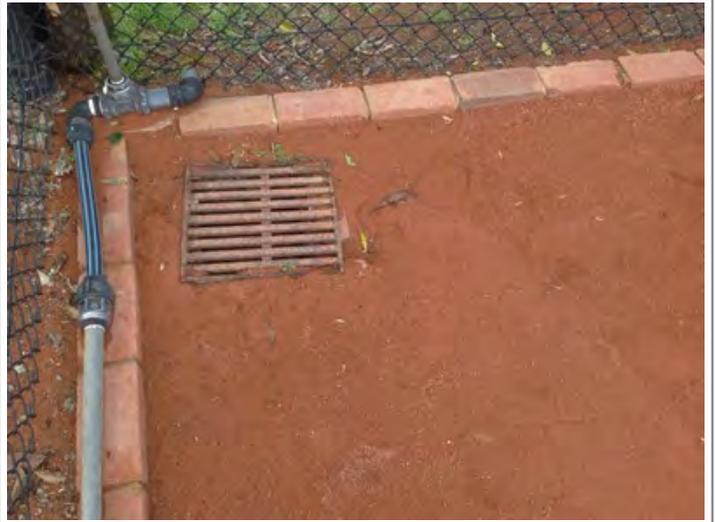
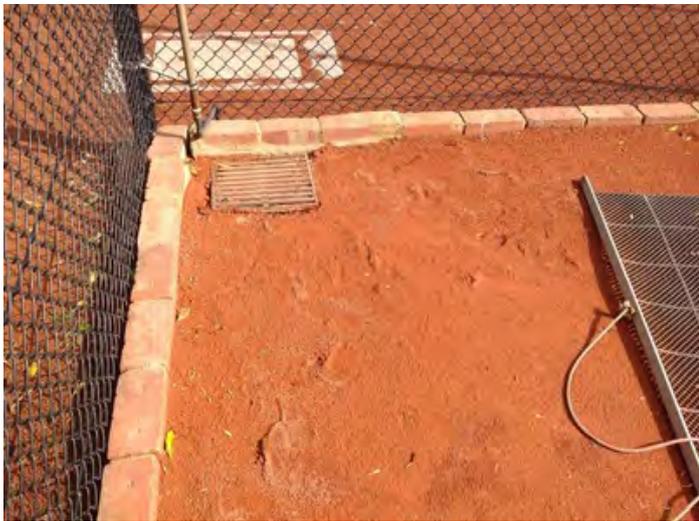
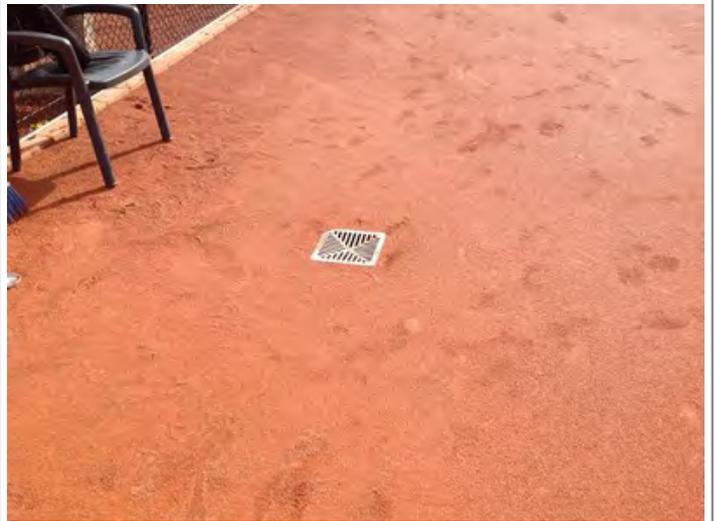
Drainage photos

Are drains, pits or other infrastructure provided within the run-off areas?	no
Drainage rating	Good Issues/Observations: Ponding evident
Drainage notes	There are grated pits in the centre of the enclosure, adjacent to each court. There is also a pit in the south eastern corner and south western corner. There is some pooling of water in the enclosure although this does not effect the the whole area.

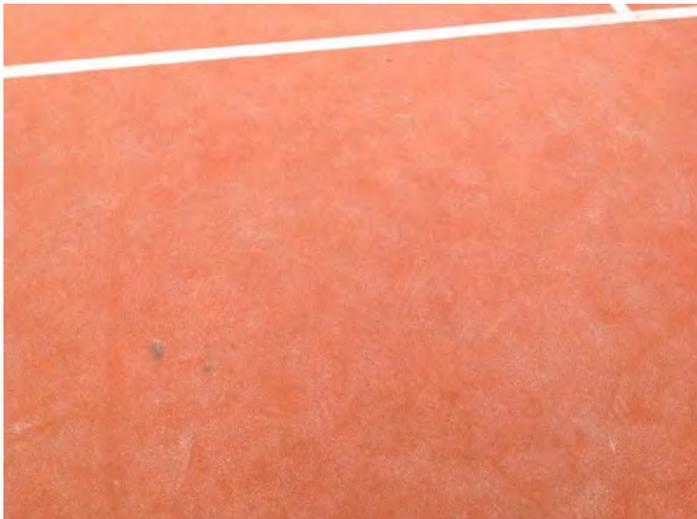
Court condition photos

Unique court number	7
Surface condition rating	Good Issues/Observations: Excessively worn surface in high wear areas
Surface type	Synthetic Clay
Surface life span	4-5 years
Court condition notes	The court does not appear to suffer from any seam stress, although does appear to be quite worn behind the baselines. The court also undulates in places.

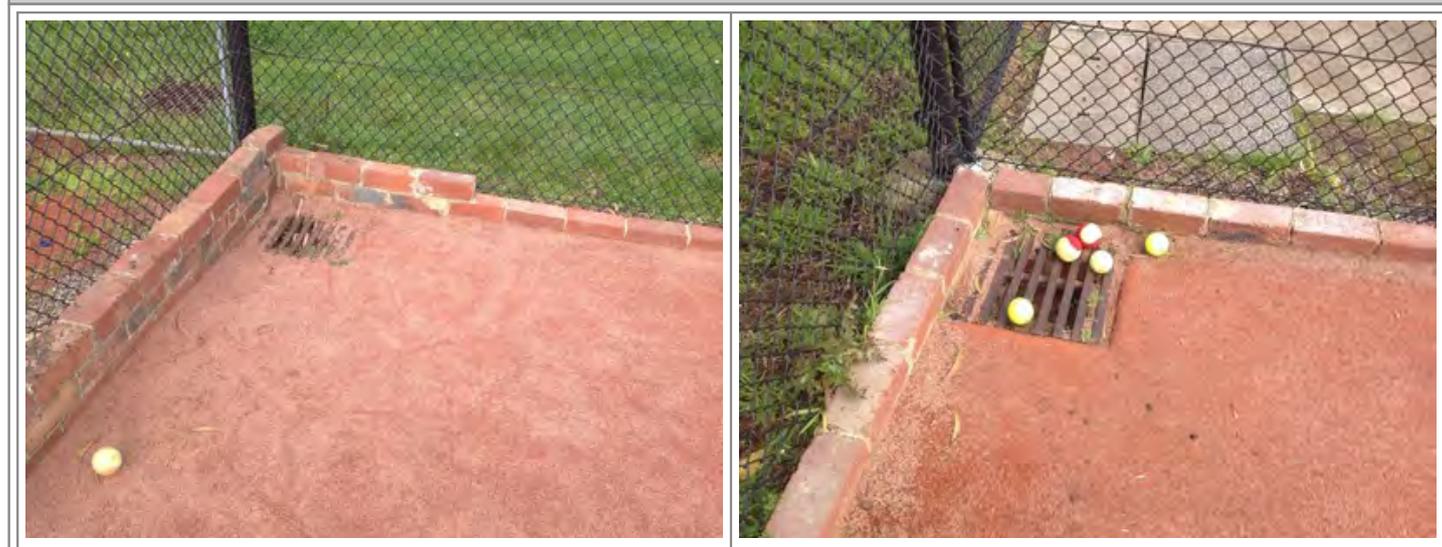
Drainage photos

Drainage infrastructure	Formed
What type of drainage is in place?	Grated pit(s)
Are drains, pits or other infrastructure provided within the court enclosure?	yes
Are drains, pits or other infrastructure provided within the run-off areas?	no
Drainage rating	Good Issues/Observations: Ponding evident
Drainage notes	Grated pits exist in the south western and eastern corners of the enclosure. There is no sign of significant pooling of water in the surface.

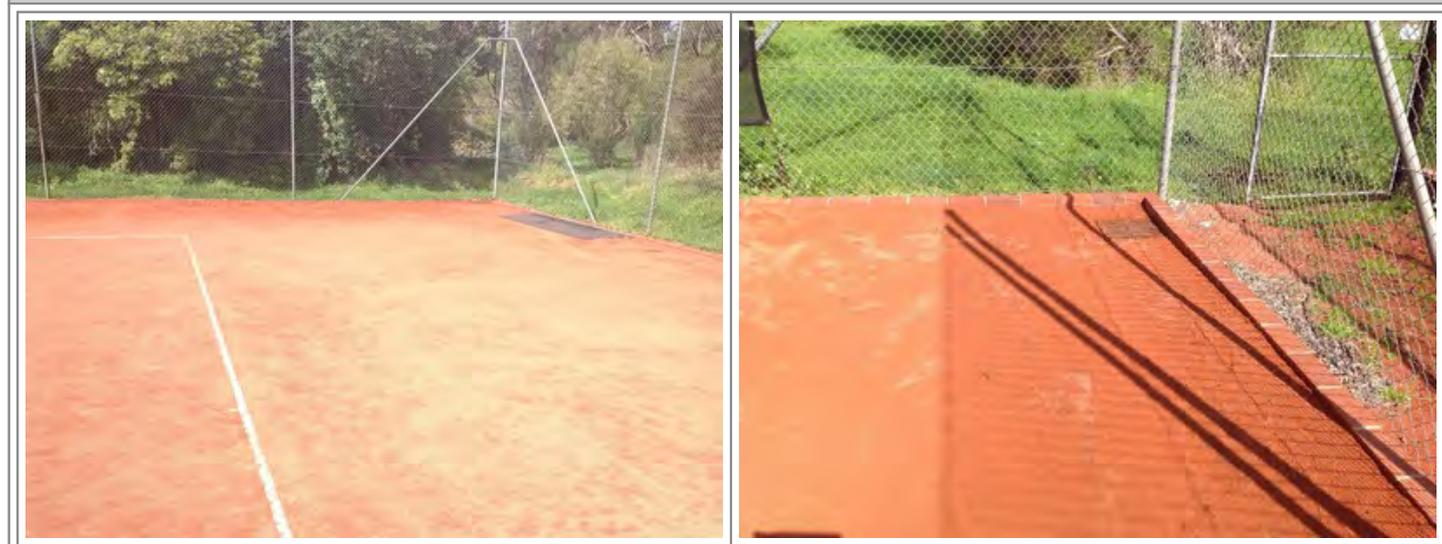
Drainage photos

Drainage notes	There is a grated pit located in the south western corner of the enclosure. There is little sign of pooling across the surface, although the surface is more damp around the perimeter of the enclosure.
-----------------------	--
